STUDY OF FAILURE OF REINFORCED CONCRETE

HIGHWAY BRIDGES IN EAST PAKISTAN

A
THESIS

JANUARY, 1967

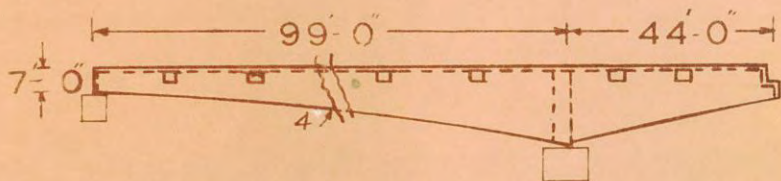
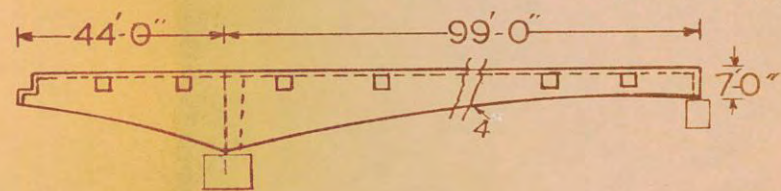
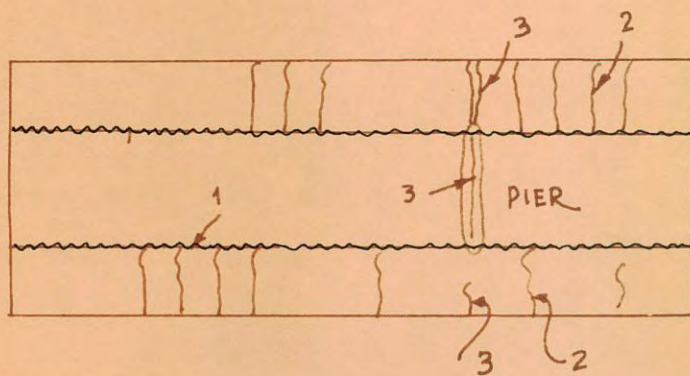
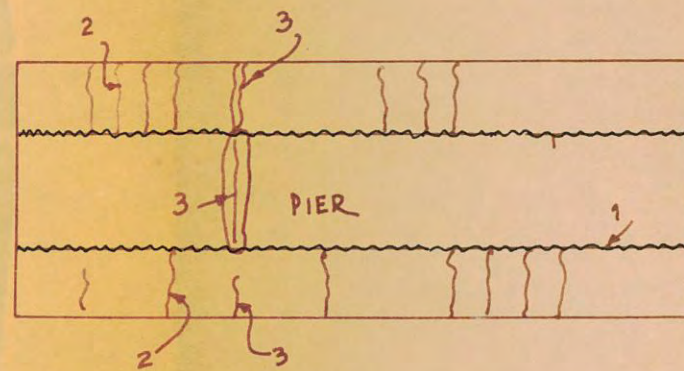
FIG. 4-3

Longitudinal cracks (Fig. 3.3) are type I cracks. Absence of top reinforcements in the cantilevered side-walk was the cause of the failure. The top rods were displaced down during casting. This displacement of reinforcements occurred due to the displacement of steel chairs and movement of labours on reinforcements during casting of the slab.

The thickness of the cantilevered side-walk at the cracks is about 3". Downward displacement of reinforcements causes reduction in effective depth and lowers the moment resisting capacity of the section. The displacement was probably quite high to cause failure.

Transverse cracks are of two types as shown in Fig. 3.3.

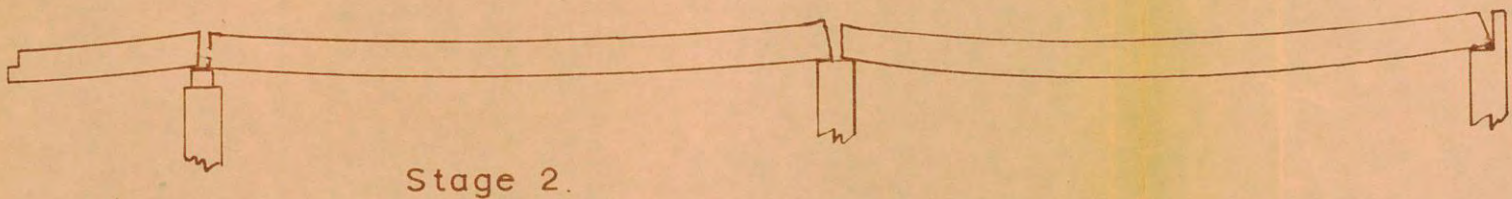
Stage 1-as originally constructed : only girder ribs cast.

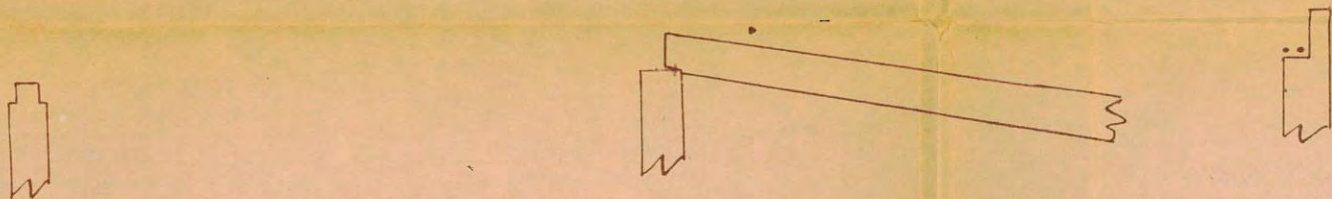
Girder failed due to improper bond between conc. & steel. One end of girder in span 2 fell down into the river still having support at other end. The girder ribs were removed by breaking conc. in parts.

Girder in span 1 fell down into river bed and was removed by breaking conc. in parts.

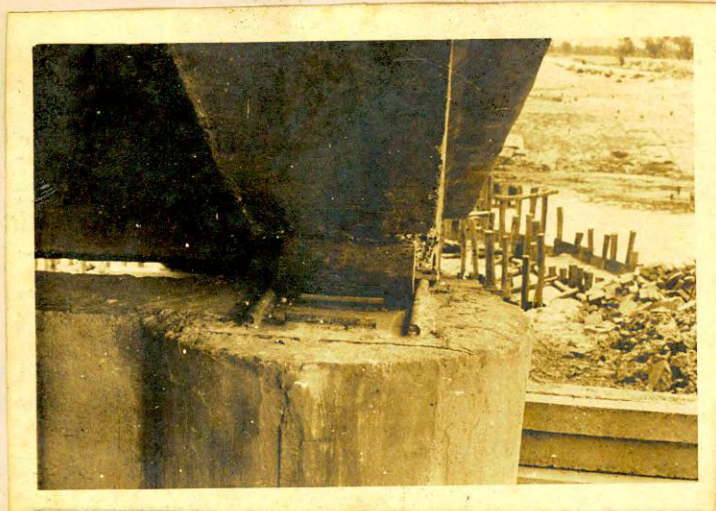
Plate 2.3 Mathabhanga Bridge
(Showing rollers in displaced position)

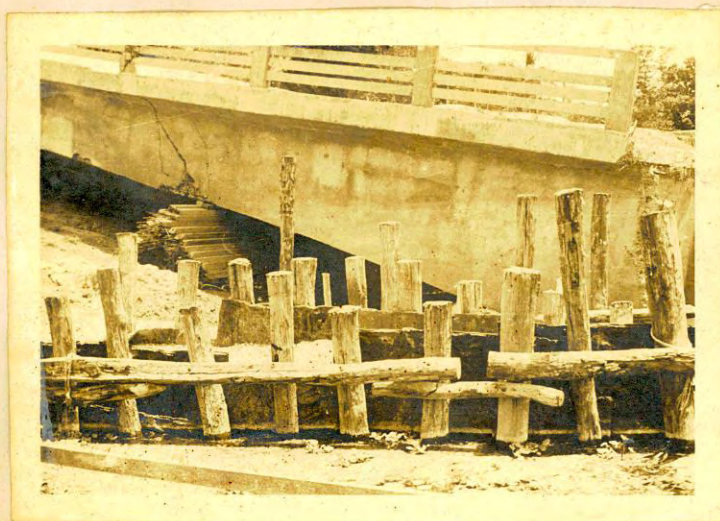
An embankment was built round the damaged well No.2 in the river bed on the Kushtia side. As water was pumped out of the well, water seeped through the ring embankment. So the river bed round the well could not be seen and thorough investigation was not possible. Thereafter a second embankment was built and water could be pumped out completely (Plate 2.4).

Plate 2.4 Mathabhanga Bridge
(The ring embankment for investigation)

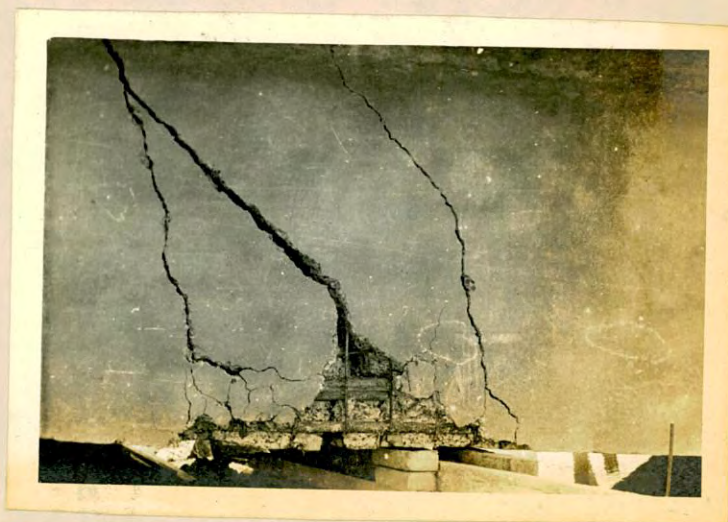
f) The cracks in the girder (Plate 2.5) have developed possibly due to the impact on falling.

Plate 2.5 Mathabhanga Bridge
(Cracks in the girder due to impact on falling)

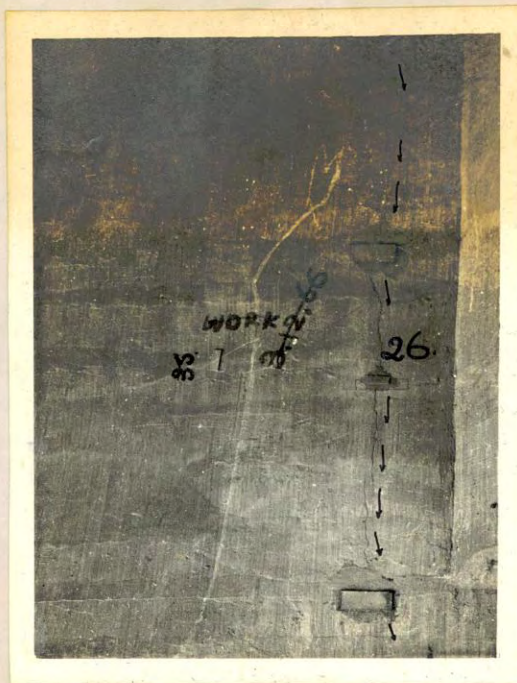
Plate 5.2 A Tongi Bridge
(Vertical crack in the down-stream main
girder near the pier)

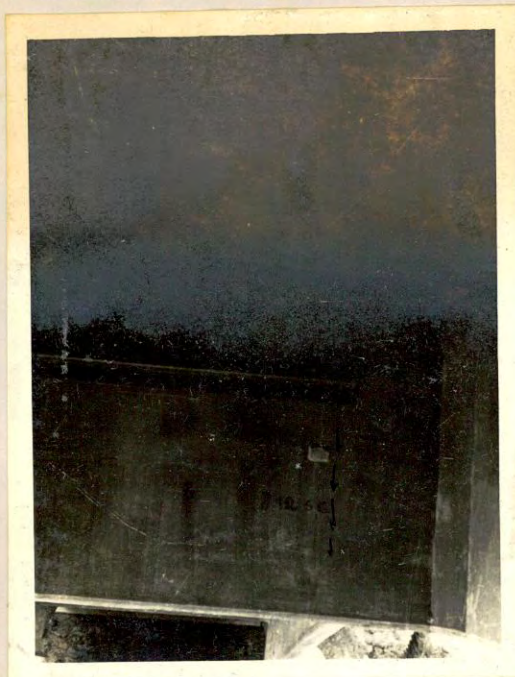
Plate 5.2 B Tongi Bridge
(Crack in the cross-girder at articulation,
showing the bolts that connected two opposite
cross-girders at articulation)

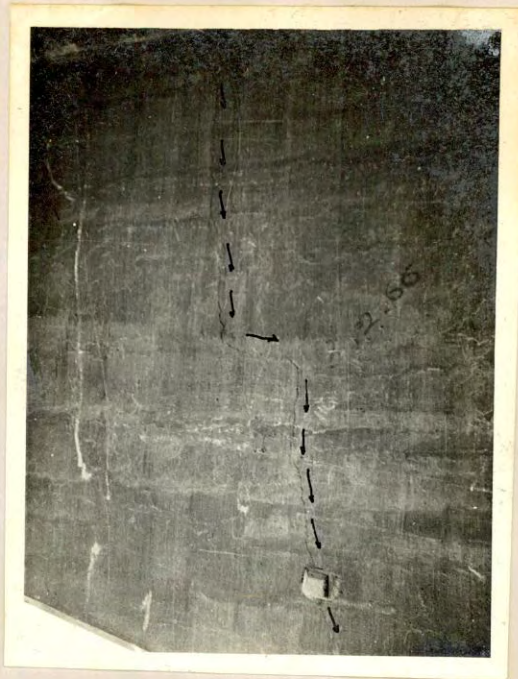
Plate 5.2 C Tongi Bridge
(Crack in the upstream main girder; the wide crack is vertical, then horizontal and vertical again at the bottom)

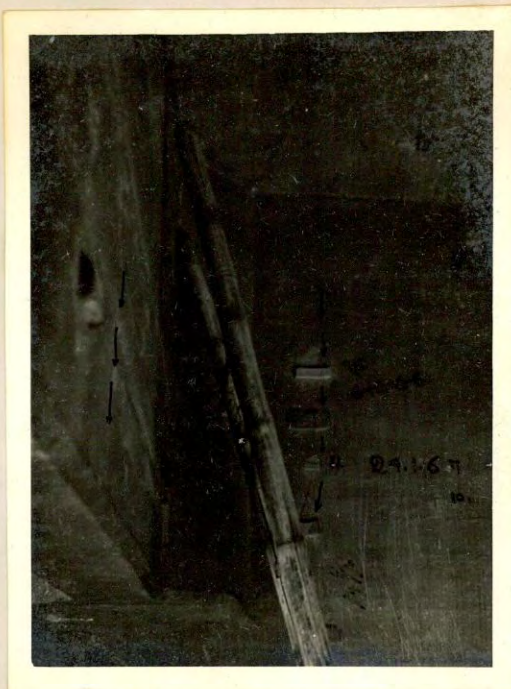
Plate 5.2 D Tongi Bridge
(Cracks in the main girder in the negative zone and in the cross-girder at the pier)

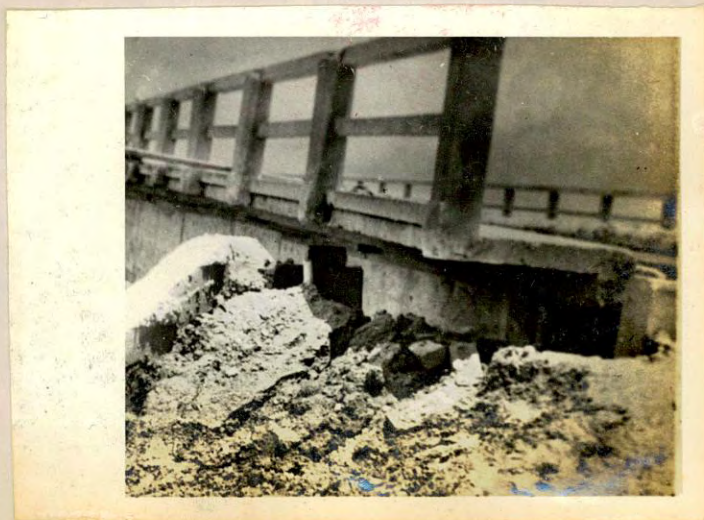
Plate 6.1. B Failure of the wing-wall

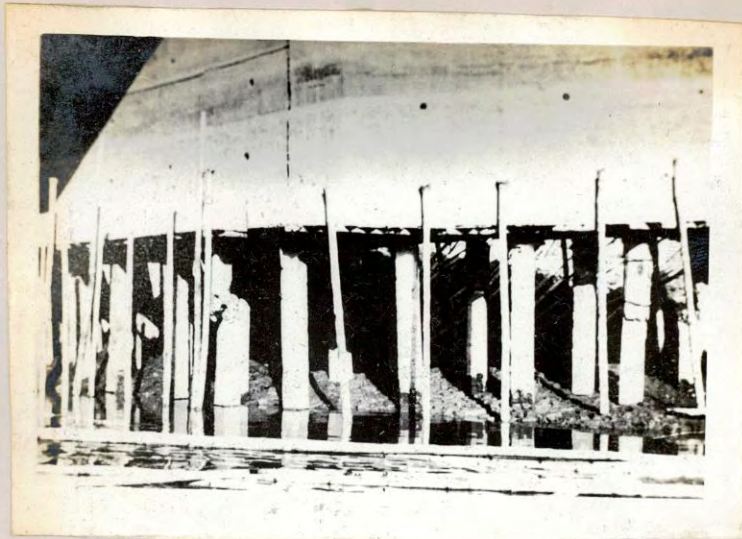
Plate 6.2 Failure by scouring and subsequent breaking of piles under the abutment

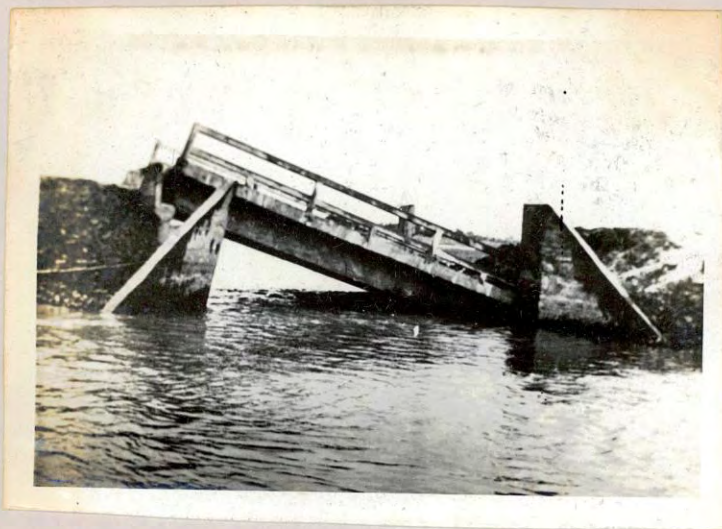
Plate 6.3 Failure of abutment
(Abutment collapsed, but wing-wall remained in position)

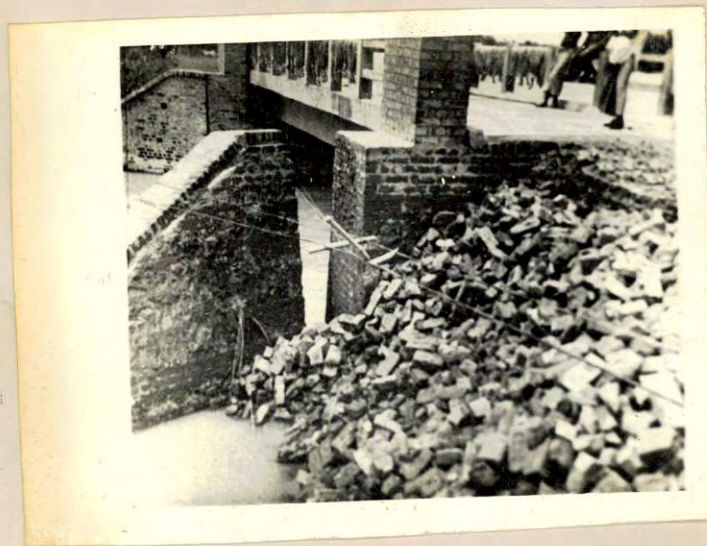
Plate 6.4 Failure of wing wall

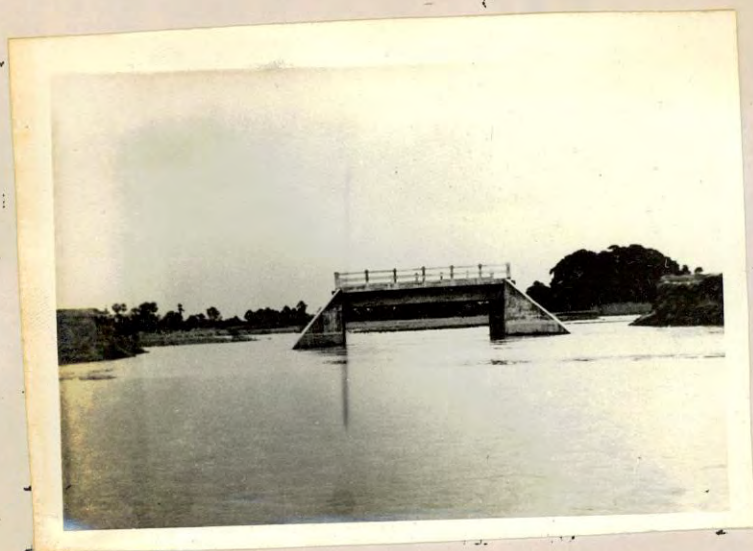
Insufficiency of waterway caused scouring at the river beds and the abutments of a number of bridges in Faridpur and Barisal districts. The approaches to Kamaldi Bridge and the abutment of Chokedar Bridge in Faridpur were washed away during flood of 1964. Failure of wing walls is very predominant in this area.

Plate 6.5 Failure due to insufficiency of water-way
(The approaches were washed away)

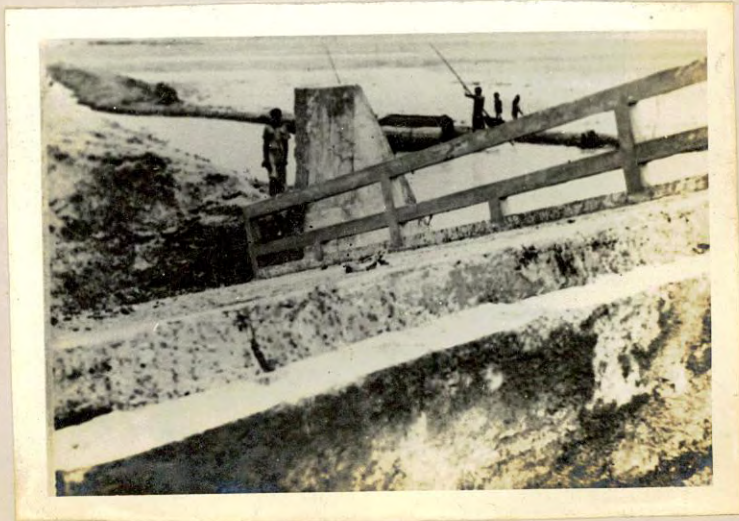
Plate 6.6 Failure of abutment

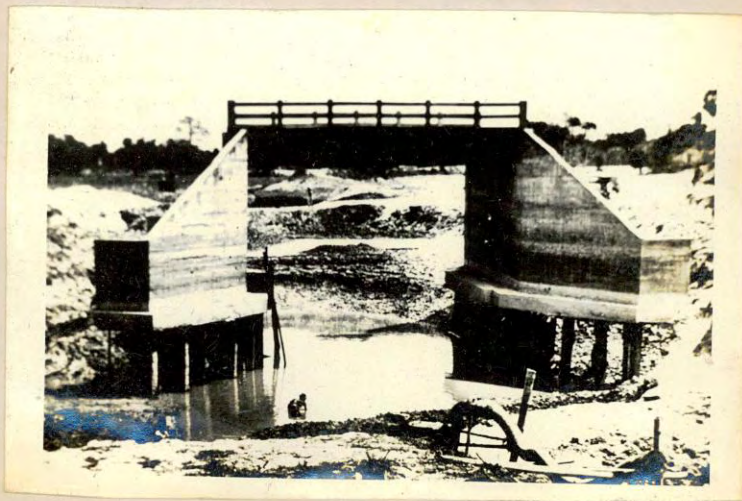
Plate 6.7 Failure due to excessive scouring at the foundation.

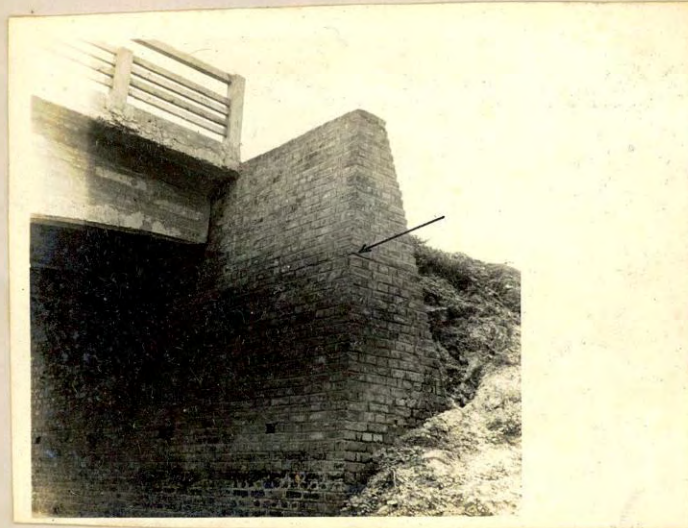
Horizontal cracks in the masonry abutments of a number of bridges on Demra-Daudkandi Road are due to non-functioning of the expansion bearings.

Plate 6.8 Failure due to non-functioning of the expansion bearings (Horizontal cracks in the masonry abutment)

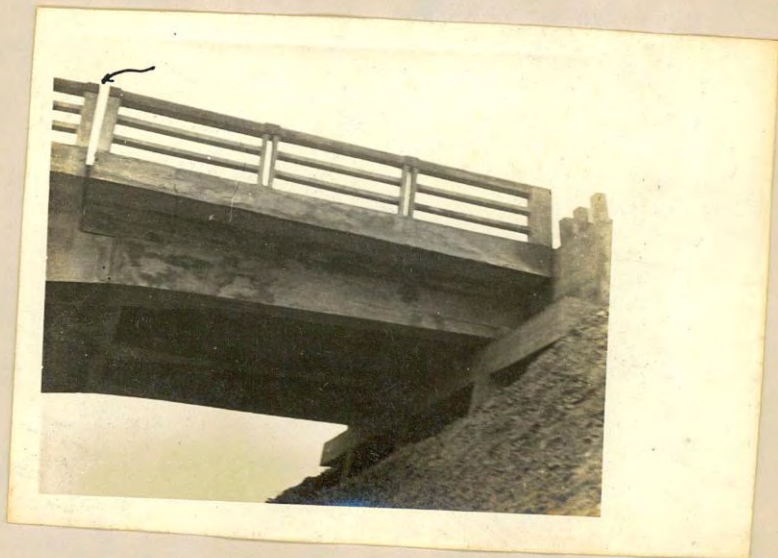
Plate 6.10 Failure of abutment reflected at articulation
