**GEOTECHNICAL ASPECTS OF POLDER EMBANKMENT IN  
SELECTED COASTAL AREA OF BANGLADESH**

A thesis submitted to the Department of Civil Engineering,

Bangladesh University of Engineering and Technology,

2013

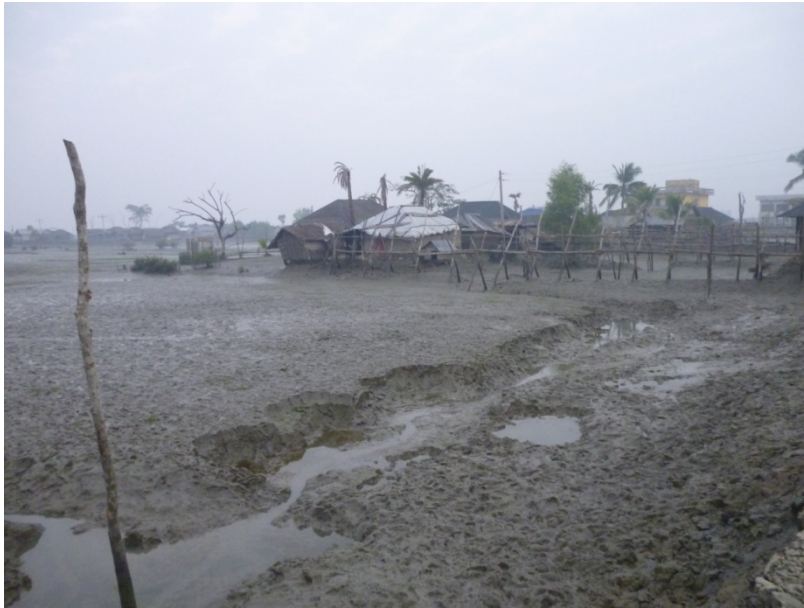
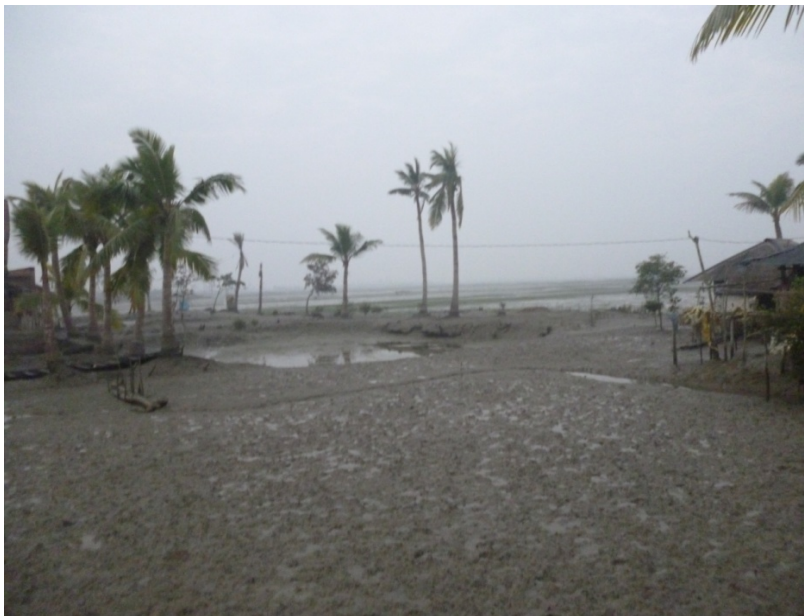
Figure 1.1: Situation of villages after 2 years of devastation caused by Aila in 2009;  
(a) country side (b) river side.

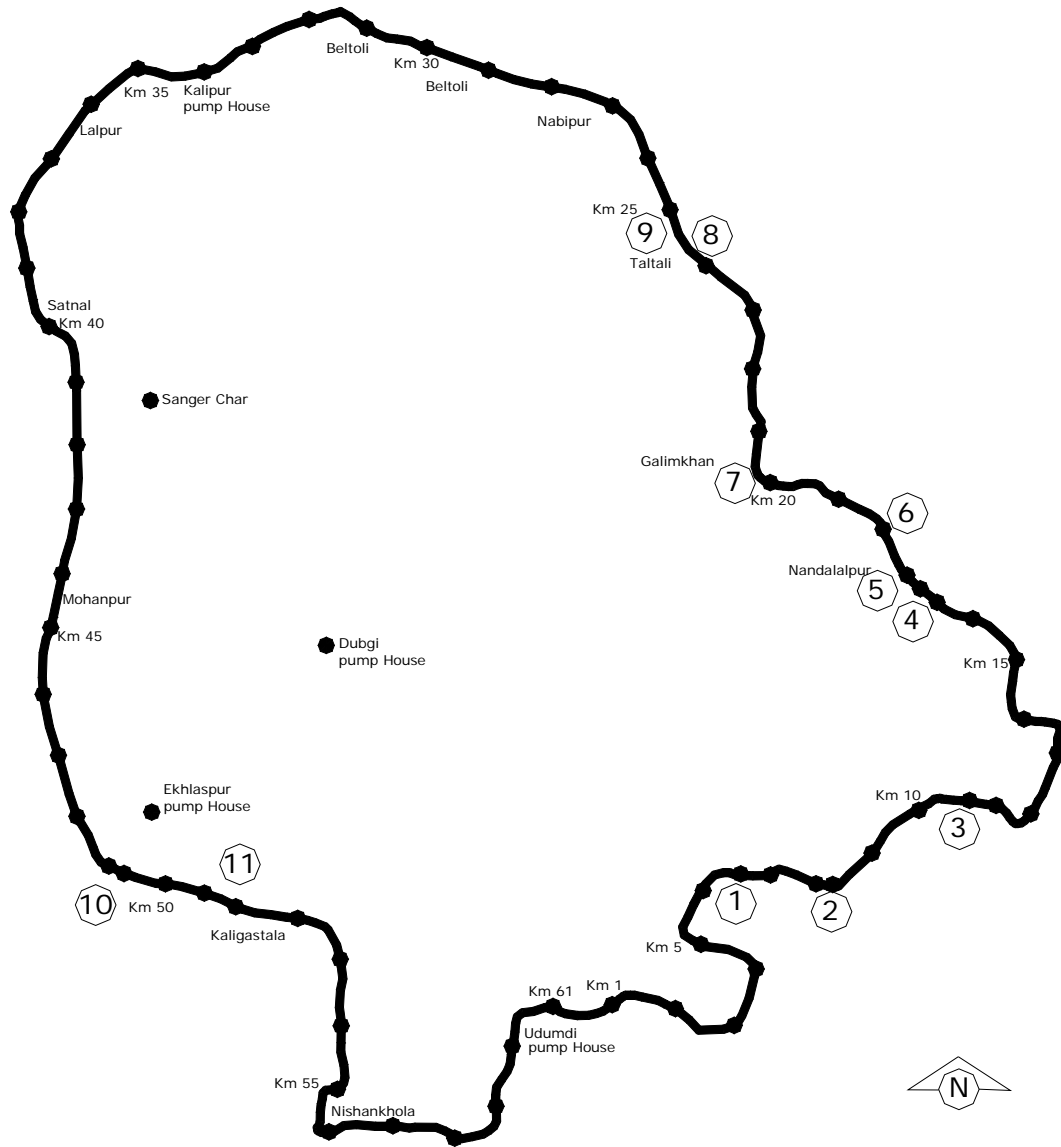
Figure 2.4: Location of boreholes marked by circles and distress areas are marked by numbers in the MDIP.

under tremendous threat to breach. The post flood observation of the sites revealed that the vulnerability of the embankment was primarily because of water seepage through the embankment, especially through the foundation soil. This allowed the finer particles to migrate through the interconnecting voids thus forming an effective water channel within the soil mass and resulted in boiling at several locations.

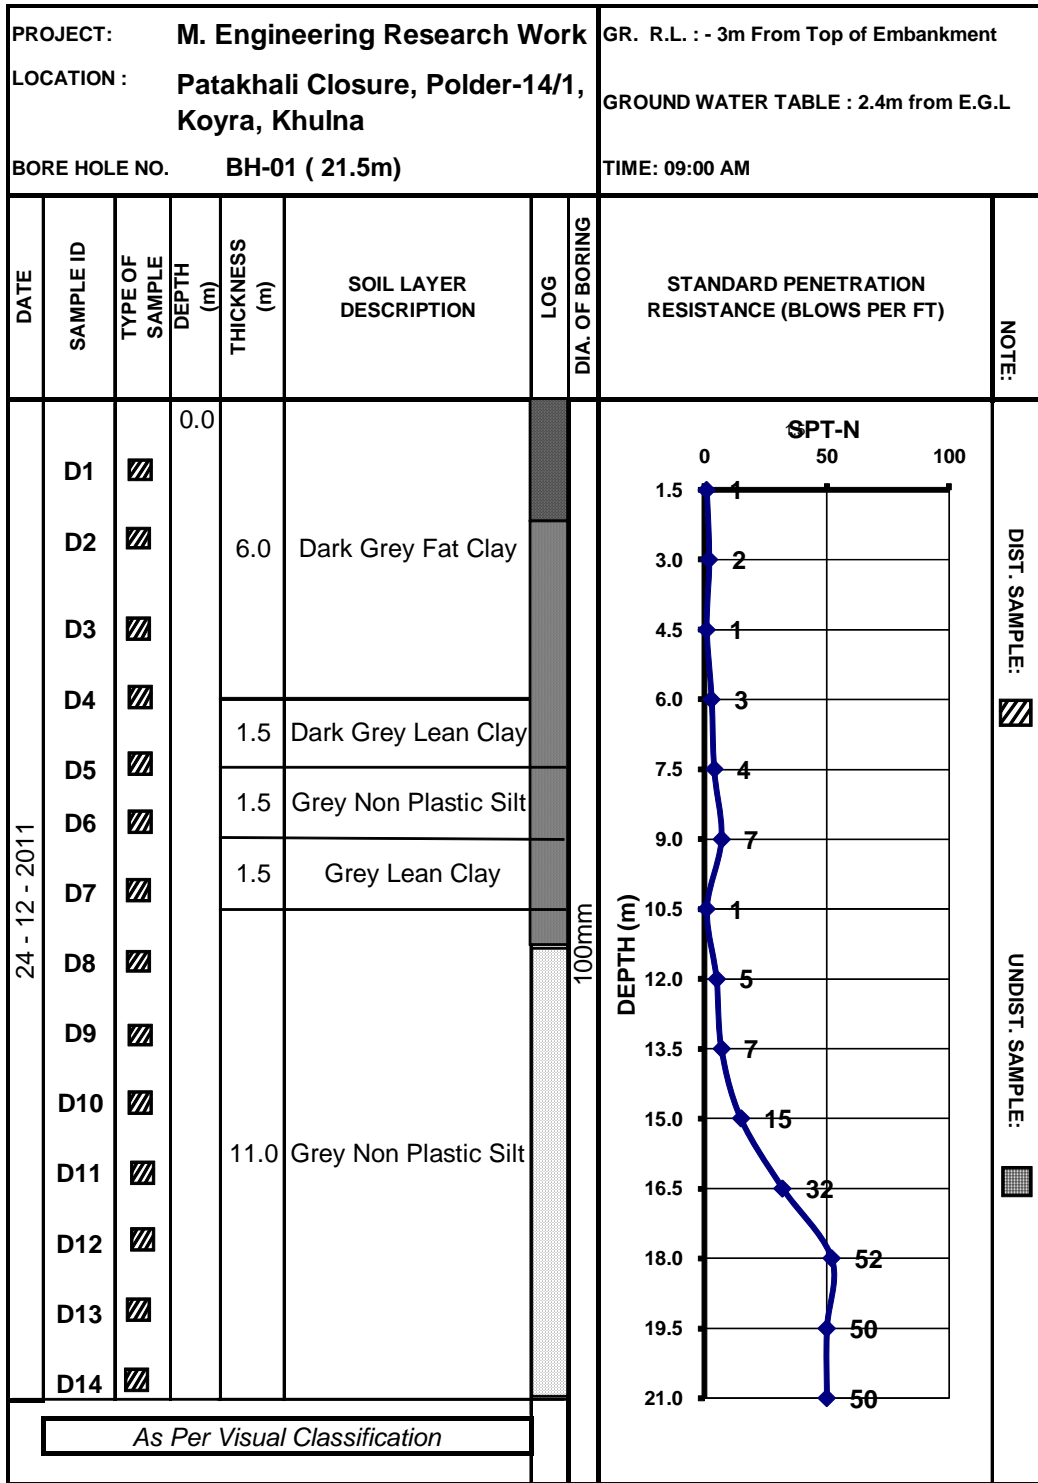
Figure 4.1: Bore log of BH-1 near old embankment at Patakhali closure, Koyra, Khulna

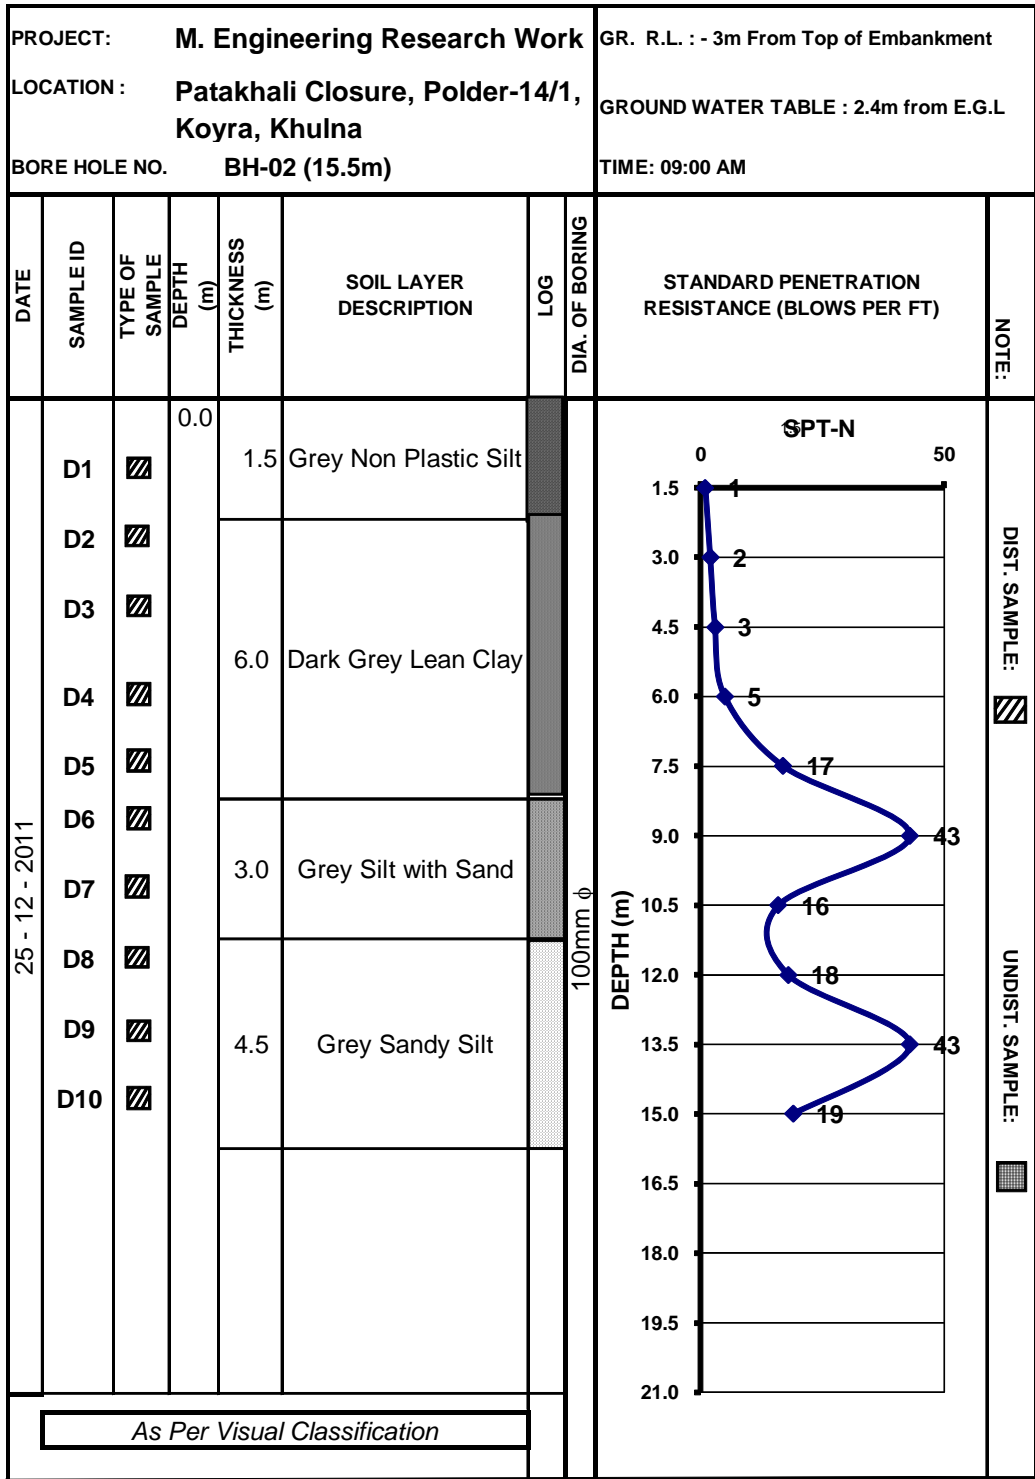
Figure 4.2: Bore log of BH-2 near new embankment at Patakhali closure, Koyra, Khulna

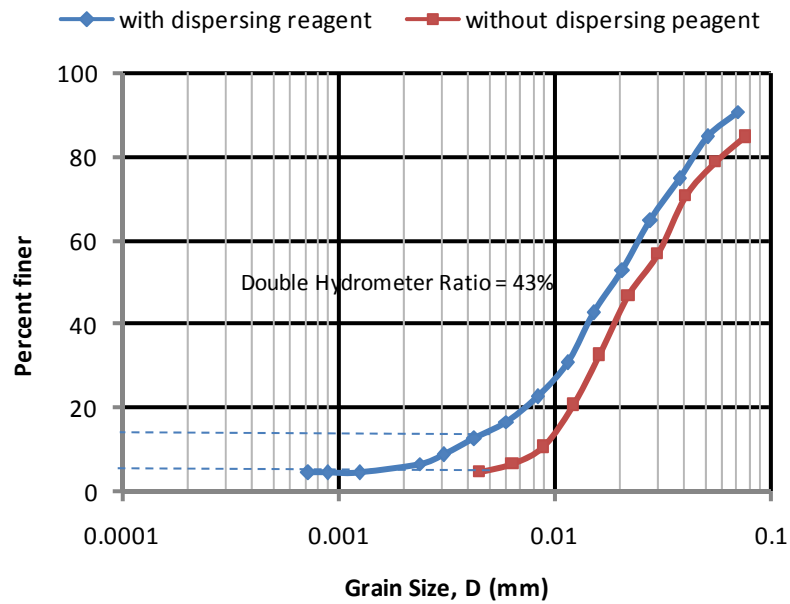
Figure 4.6: Double hydrometer ratio test result of bulk soil sample **B-1 (Lean Clay)** collected from Patakhali closure, Koyra, Khulna.

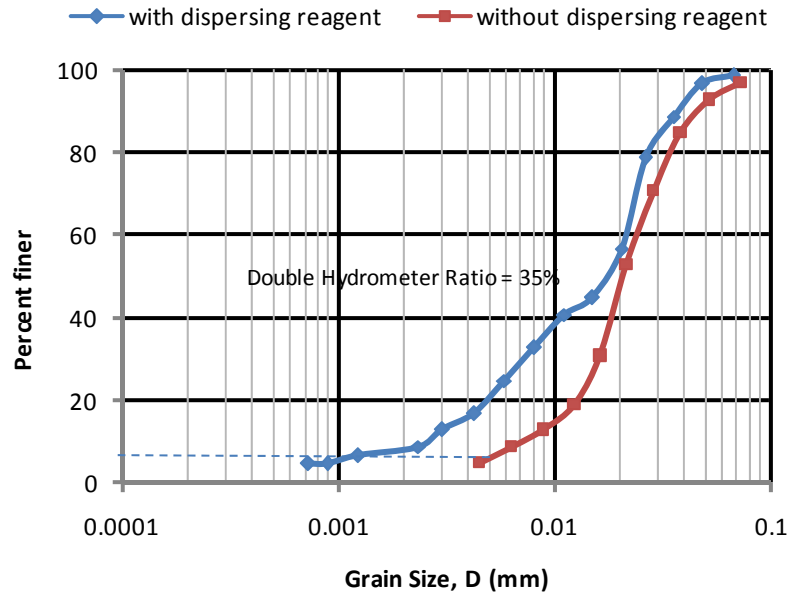
Figure 4.7: Double hydrometer ratio test result of disturbed soil sample **D-2 (Lean Clay)** collected from BH-1, Patakhali closure, Koyra, Khulna.

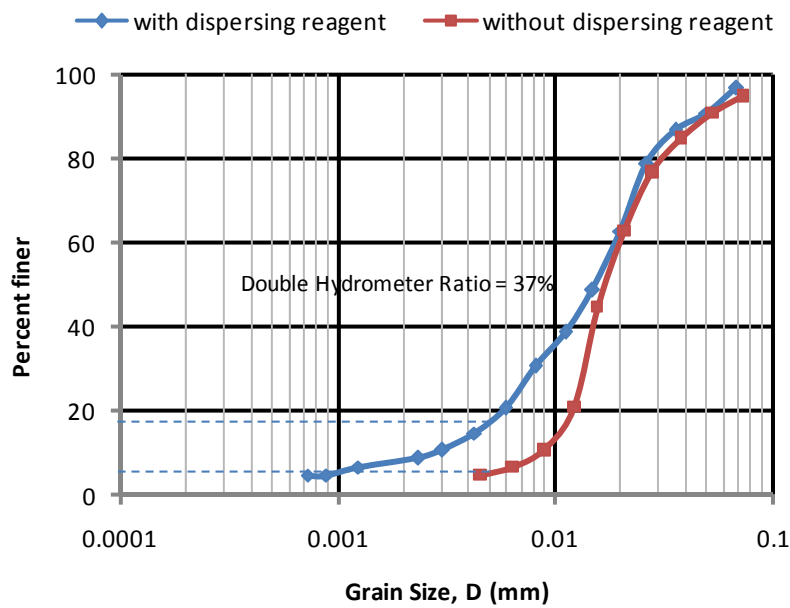
Figure 4.8: Double hydrometer ratio test result of disturbed soil sample **D-3 (Lean Clay)** collected from BH-2, Patakhali closure, Koyra, Khulna.
