# **AN EVALUATION OF OPERATION AND MAINTENACE PRACTICES OF FLOOD EMBANKMENTS**

**AN EVALUATION OF OPERATION AND  
MAINTENACE PRACTICES OF FLOOD  
EMBANKMENTS**

In partial fulfilment of the requirement for the degree of  
Master of Engineering (Water Resources)

Department of Water Resources Engineering  
Bangladesh University of Engineering and Technology

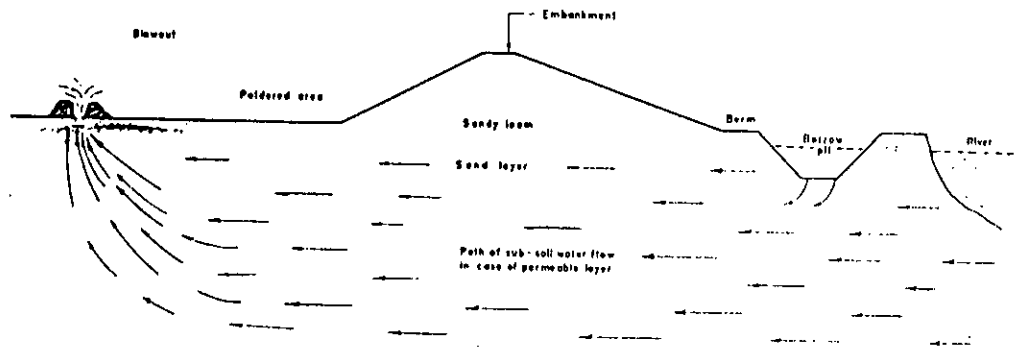
Fig. 6-3: Schematic diagram of situation at the time of MDIP breach

SCHEMATIC DIAGRAM OF A TYPICAL BLOW OUT

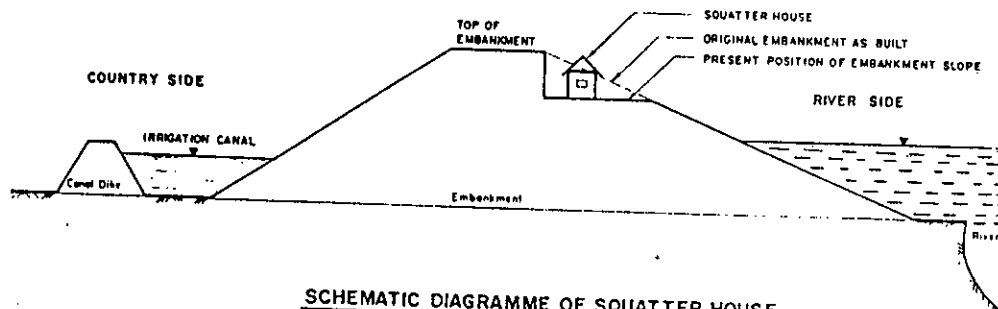
Fig. 7-2: Schematic diagram of squatter housing

SCHEMATIC DIAGRAMME OF SQUATTER HOUSE  
AFTER CUTTING OF EMBANKMENT SLOPE

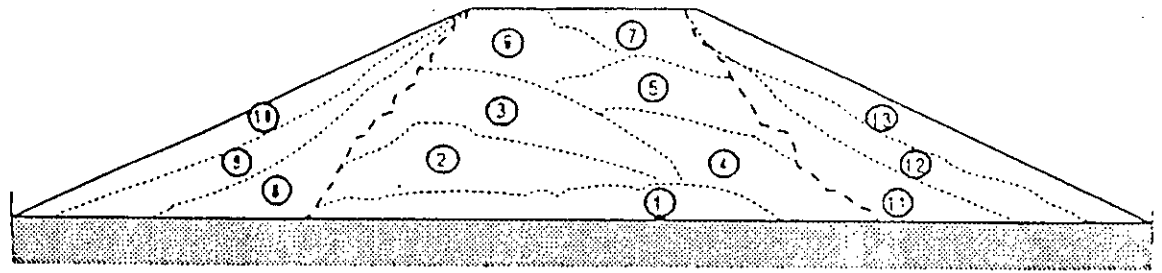
**Fig. 7-5: Order of embankment construction by conventional method**

Filling order of embankments built according to the conventional method. First the core of the embankment is filled up by heaping soil quite haphazardly and without clod breaking or compaction. Next the slopes are built by throwing soil down from the top of the centre part of the embankment. Finally some clod breaking is done on the slopes and the top of the embankment, to create a smooth surface.
