PEDESTRIANIZATION IN DHAKA CITY

PROBLEMS AND PROSPECTS

A THESIS SUBMITTED IN PARTIAL FULFILMENT
OF THE REQUIREMENTS FOR THE DEGREE OF

MASTER OF URBAN AND REGIONAL PLANNING

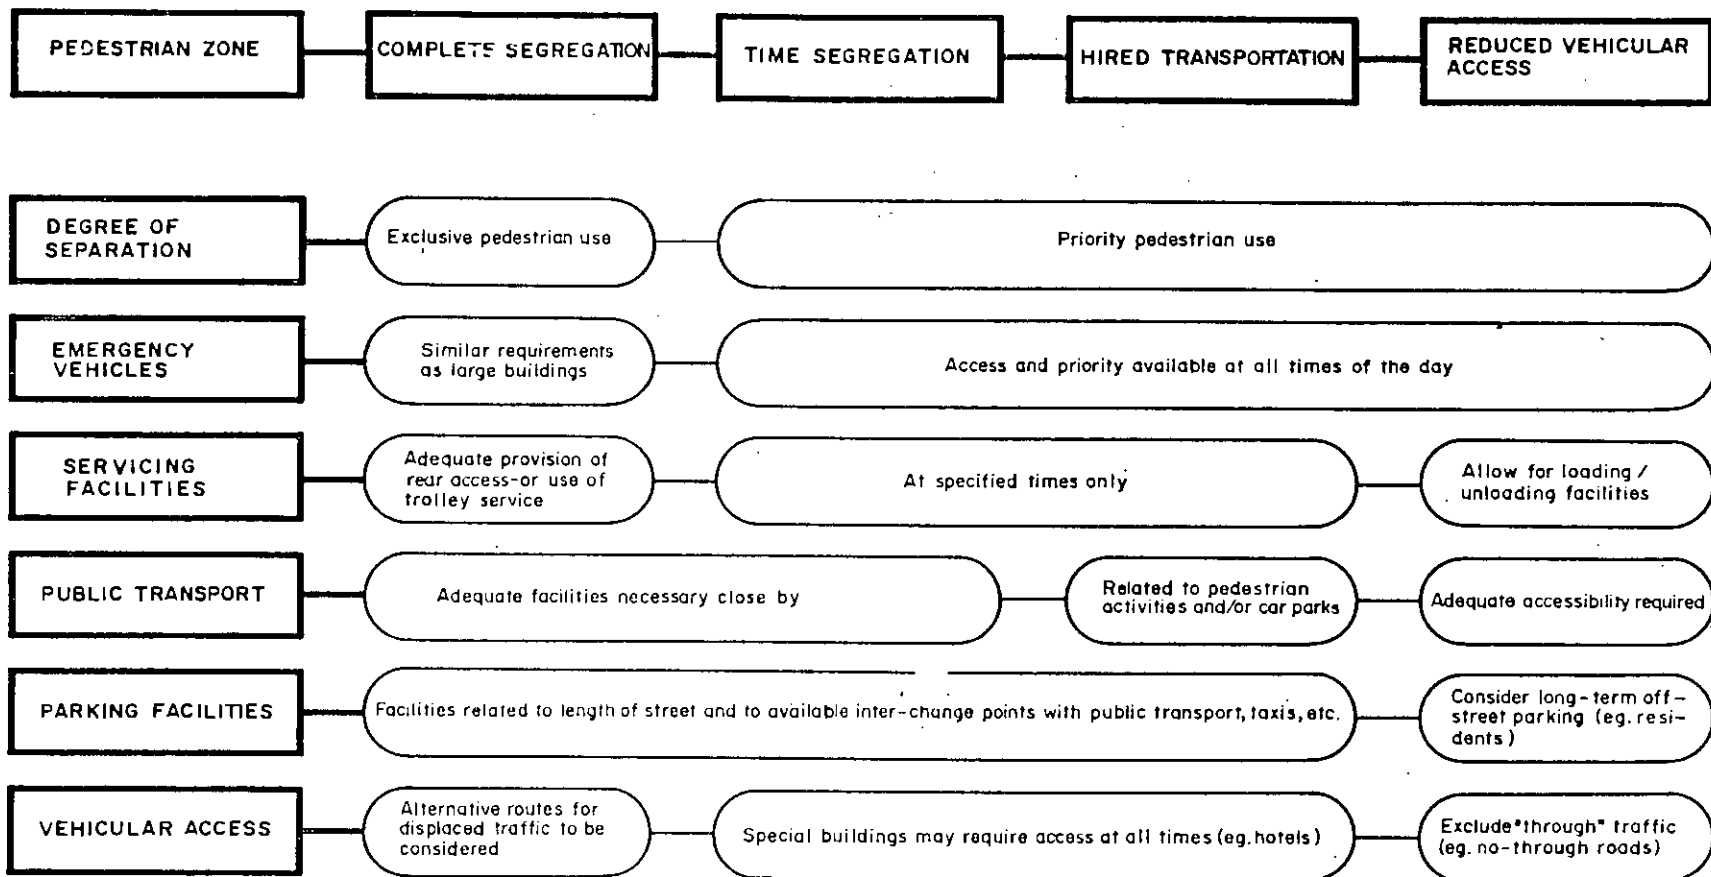
Fig.2.1 Grades of pedestrian access: a range of factors which may have to be considered according to requirements.

Grades of separation were recommended to be achieved by defining different grades of pedestrian free movement as part of the overall circulation network (Antoniou, 1971) (see Fig.2.1). In order to pursue a definition of grades, it was deemed necessary to consider such factors as the amount of vehicular traffic that could be absorbed safely and conveniently, the type of vehicular movement generated by particular activities, etc.

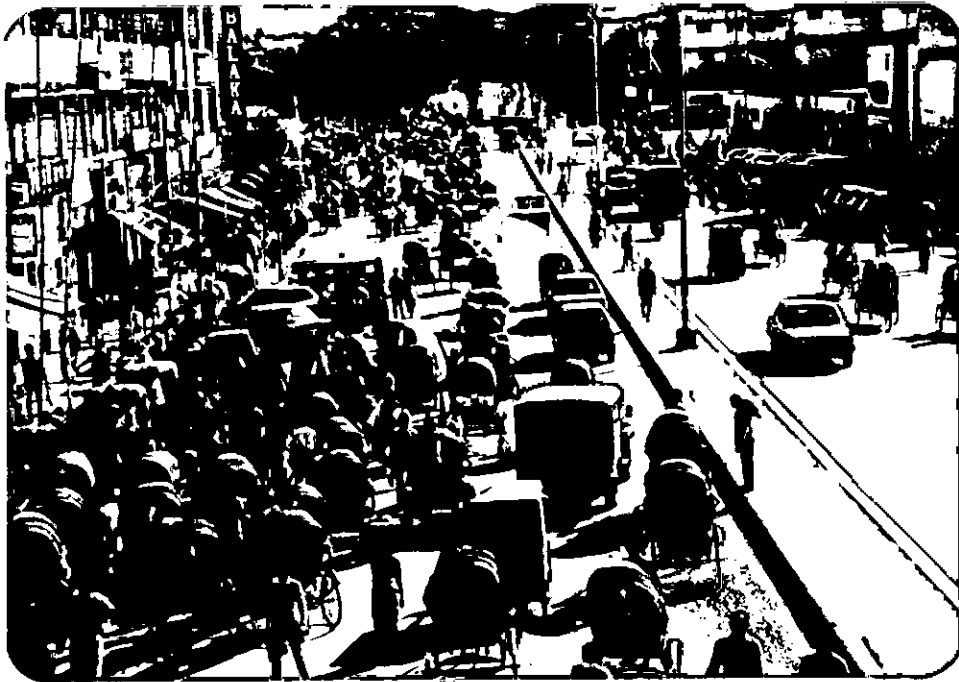
High traffic volumes and low levels of service force the pedestrians and vehicles into close proximity.

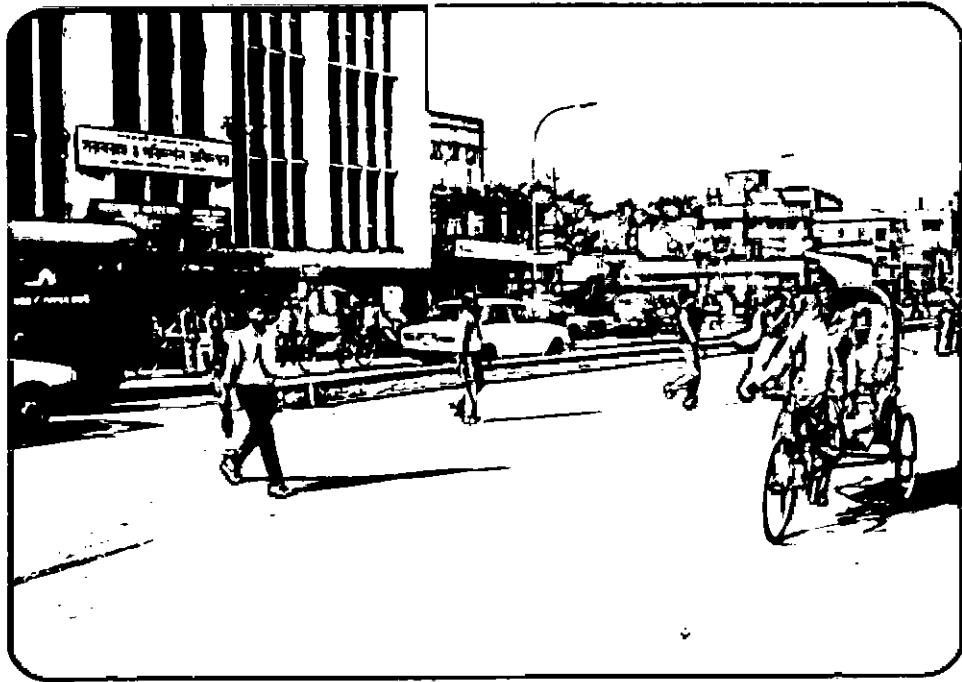
Crosswalks are not marked or not maintained even at many major intersections.

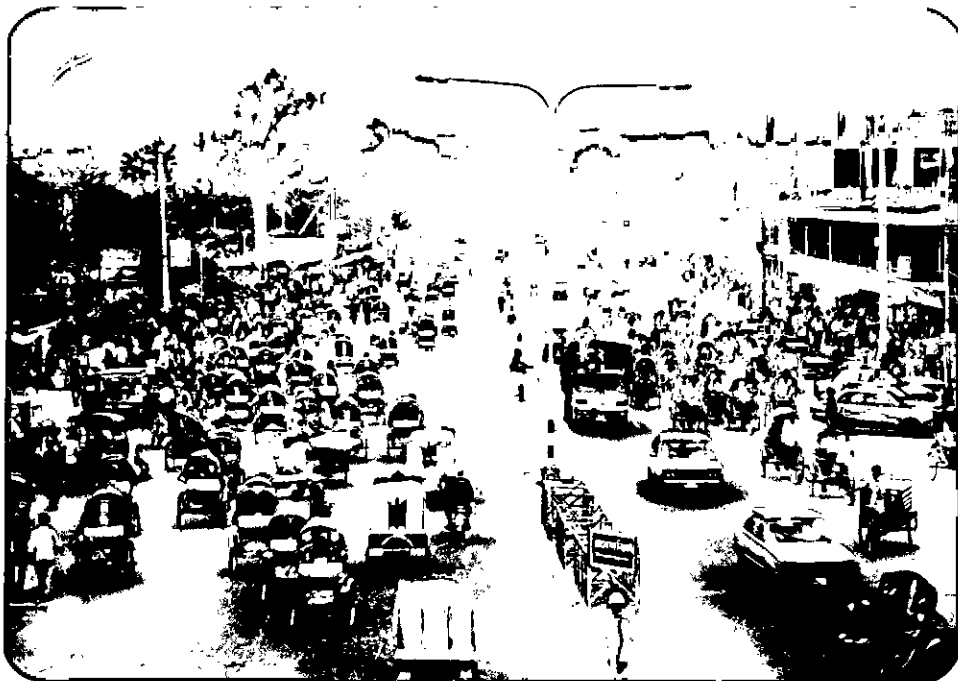
Slow moving vehicles occupy over 75% of the street capacity in the New Market shopping area.

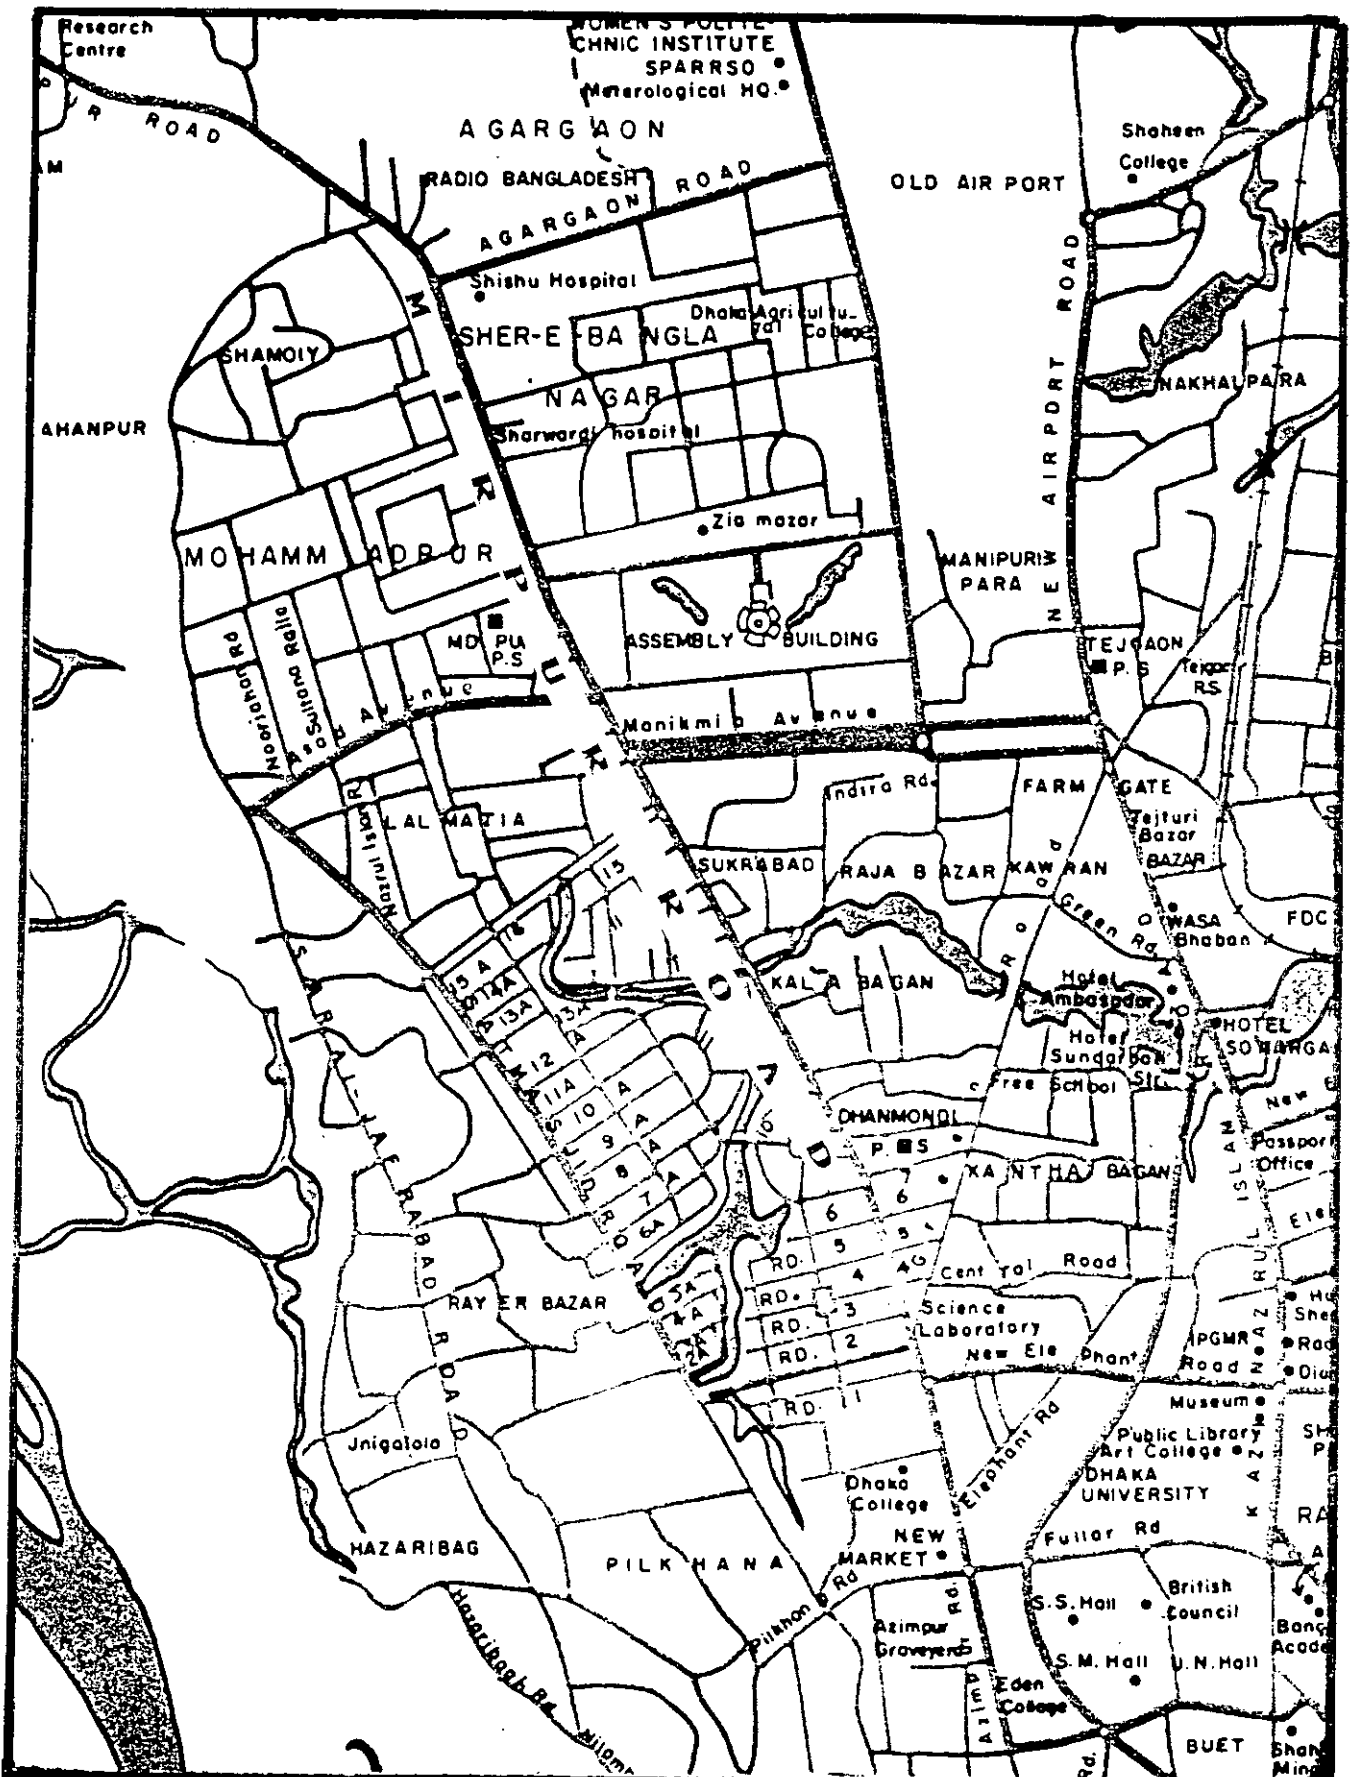
**Fig. 5.1 MIRPUR ROAD:
A MAJOR ARTERY IN DHAKA CITY**
