**EARTHQUAKE INTENSITY-ATTENUATION RELATIONSHIP FOR
BANGLADESH AND ITS SURROUNDING REGION**

*A thesis submitted to the department of Civil Engineering,
Bangladesh University of Engineering and Technology, Dhaka
in partial fulfillment of the requirements for the degree*

MASTER IN ENGINEERING IN CIVIL ENGINEERING

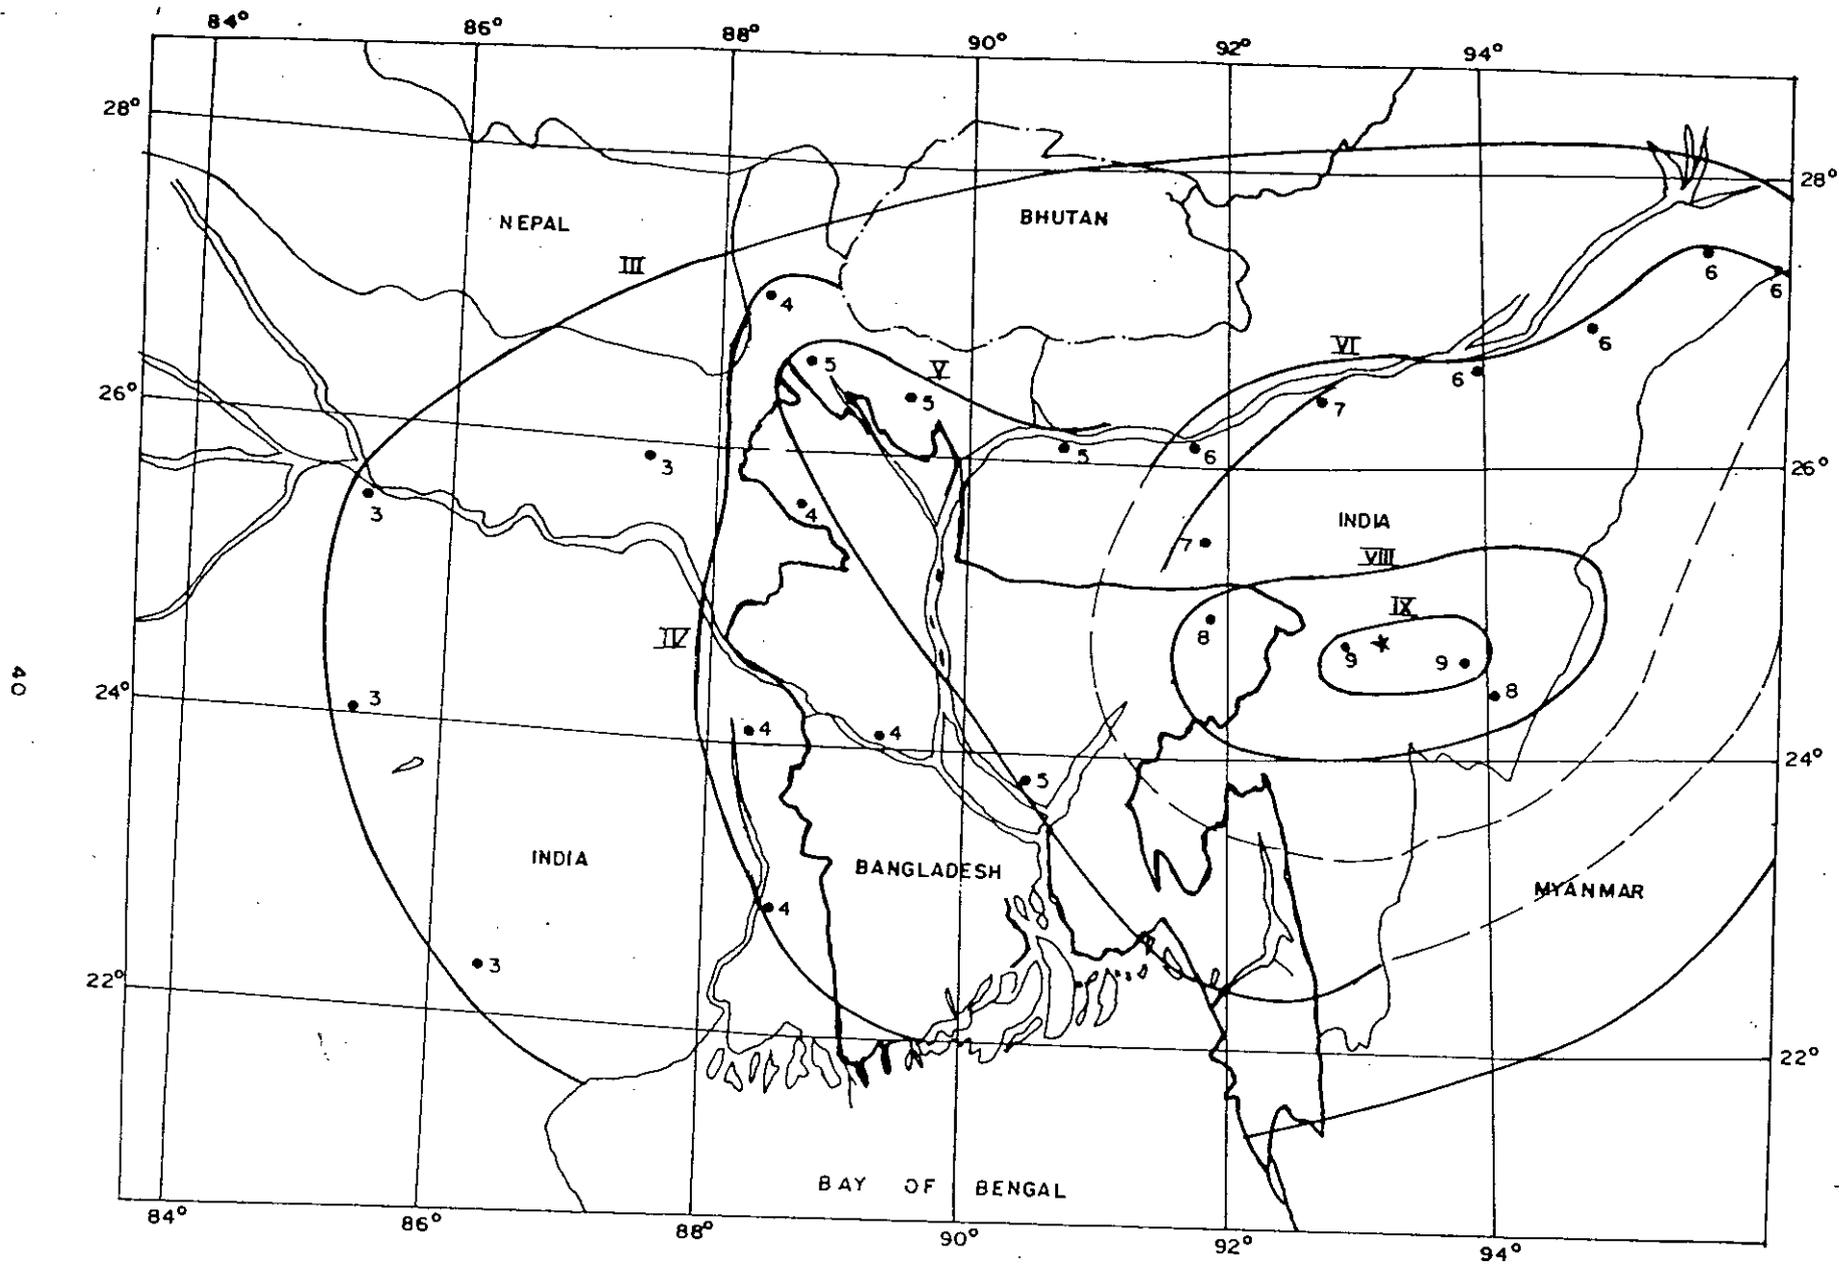
FIG. 2.] ISOSEISMAL MAP (IN TERMS OF EMS SCALE) OF THE MAIN SHOCK OF JANUARY 10, 1869 EARTHQUAKE. THE STAR SHOWS THE MACROSEISMIC EPICENTRE.

damage grades. Intensities are evaluated at 31 sites and presented in the Table 2.1. As a result of assigning these intensities an isoseismal map of the 1869 Cachar earthquake has been constructed and is presented in Fig 2.1.

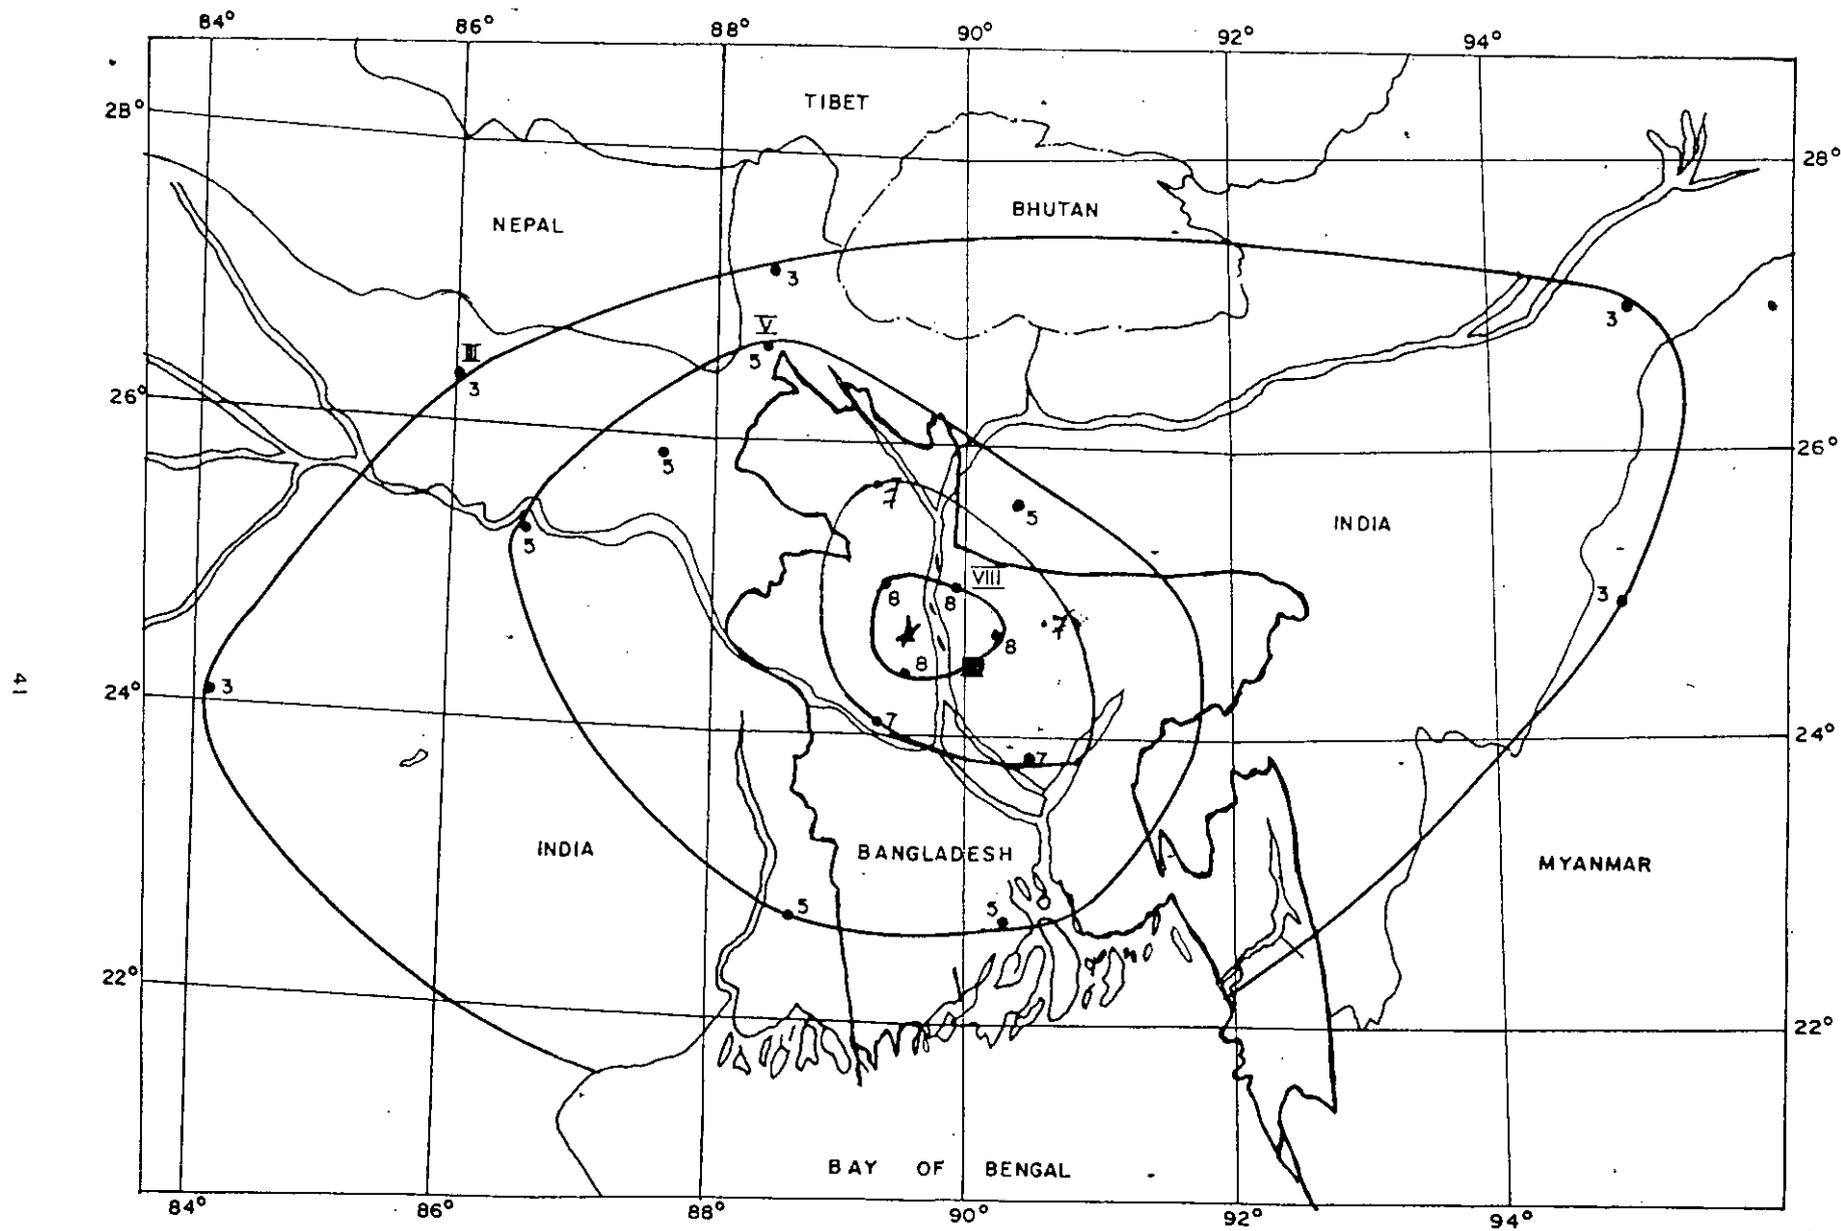
FIG. 2.2 ISOSEISMAL MAP (IN TERMS OF EMS SCALE) OF THE MAIN SHOCK OF JULY 14, 1885 EARTHQUAKE. THE STAR SHOWS THE MACROSEISMIC EPICENTRE. THE SQUARE SHOWS

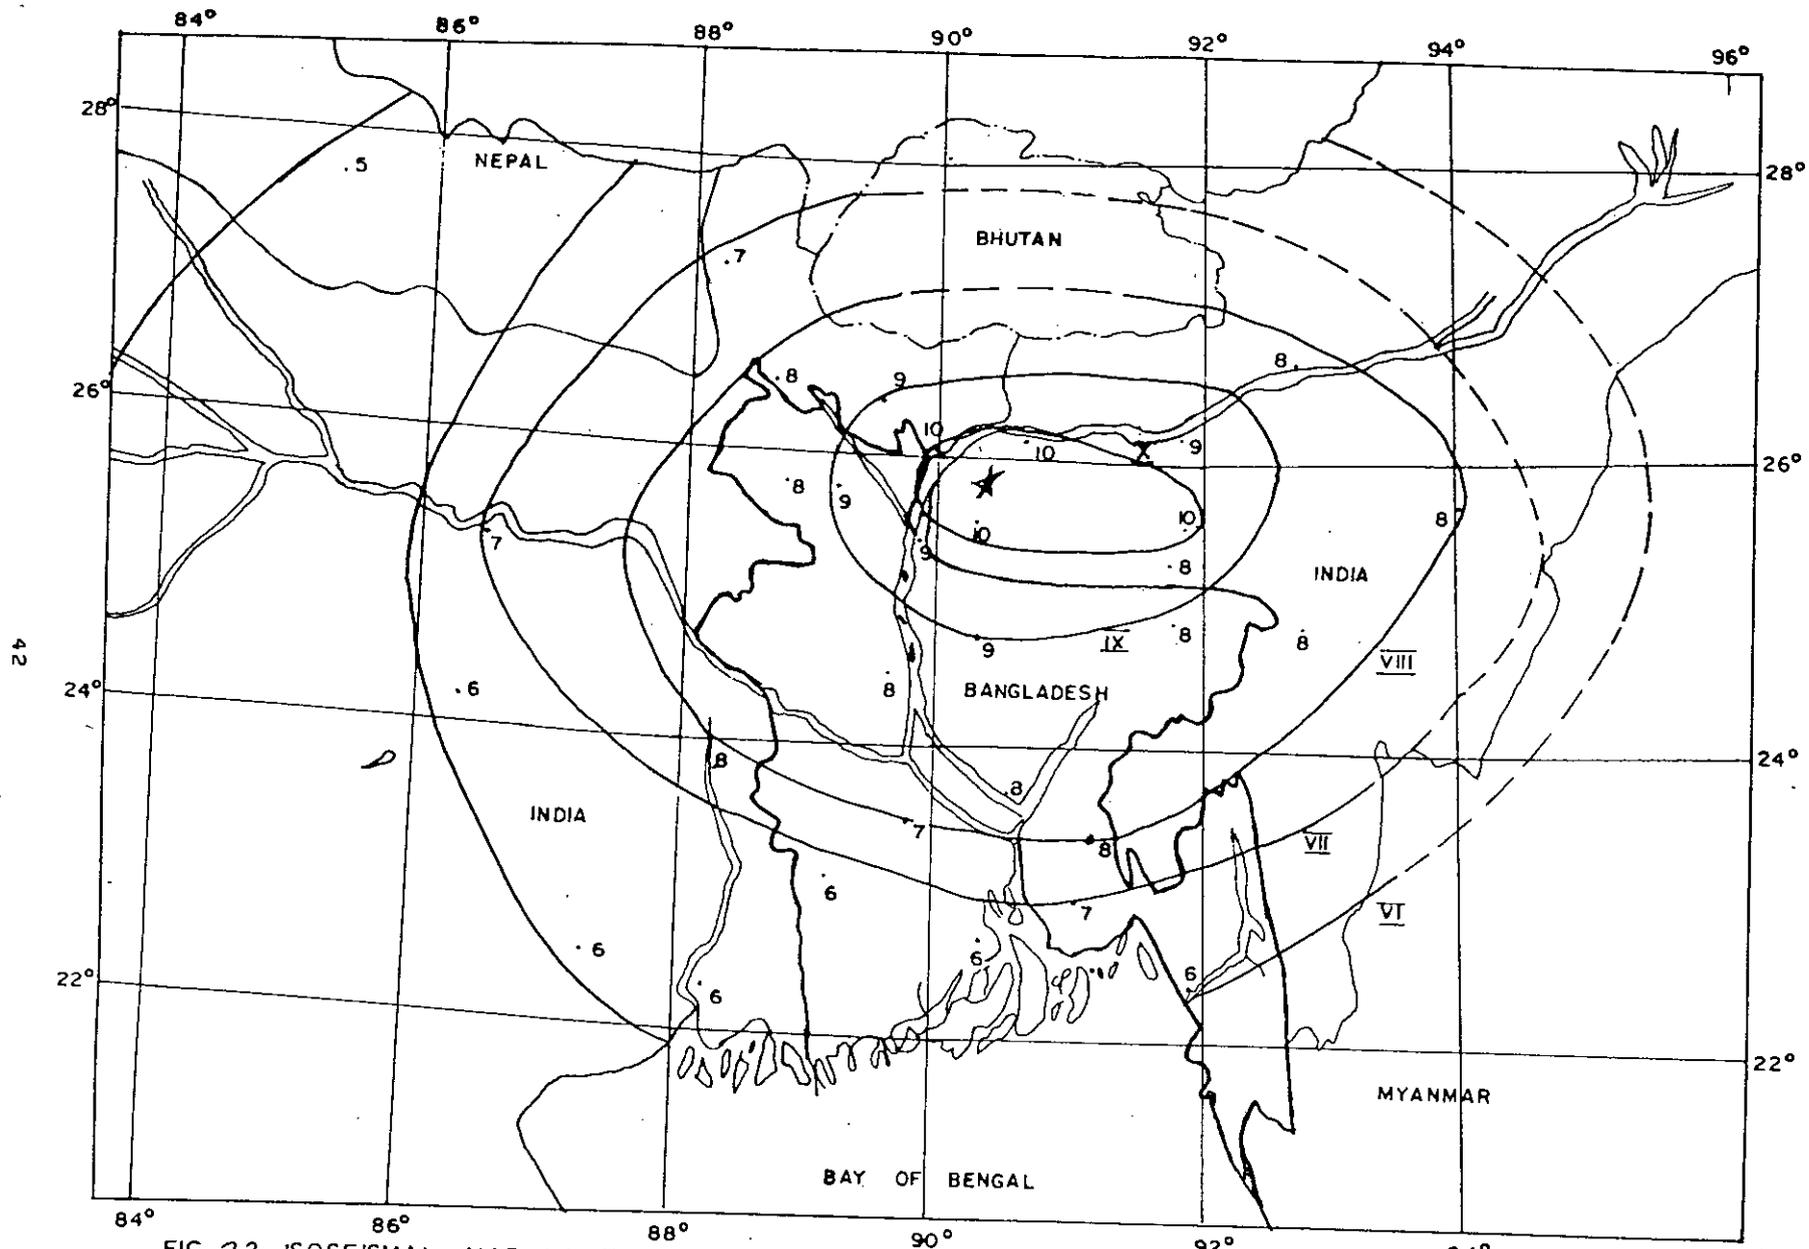
FIG. 2.3 ISOSEISMAL MAP (IN TERMS OF EMS SCALE) OF THE MAIN SHOCK OF JUNE 12, 1897 EARTHQUAKE. THE STAR SHOWS THE MACROSEISMIC EPICENTRE.

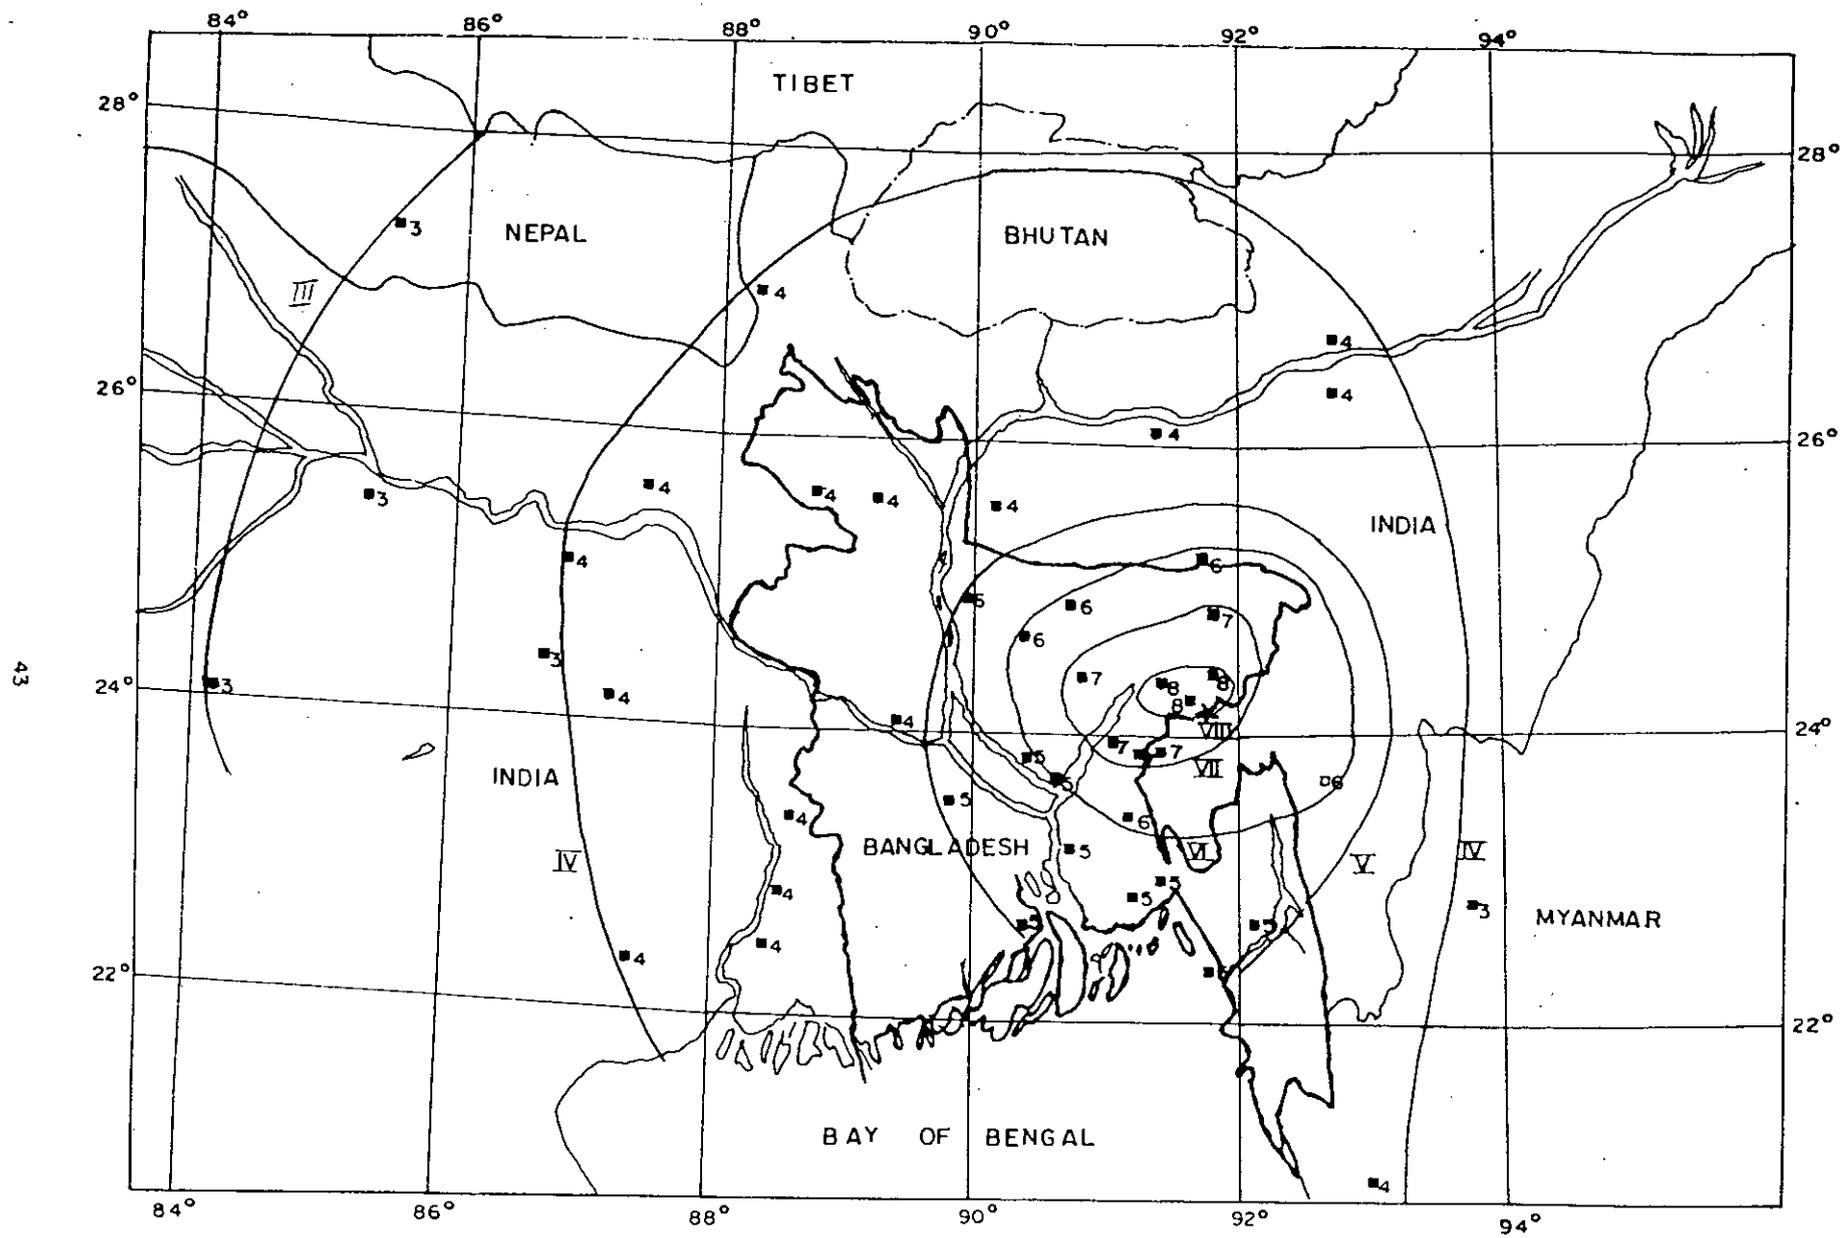
FIG. 2.4 ISOSEISMAL MAP (IN TERMS OF EMS SCALE) OF THE MAIN SHOCK OF JULY 8, 1918 EARTHQUAKE. THE STAR SHOWS THE MACROSEISMIC EPICENTRE.

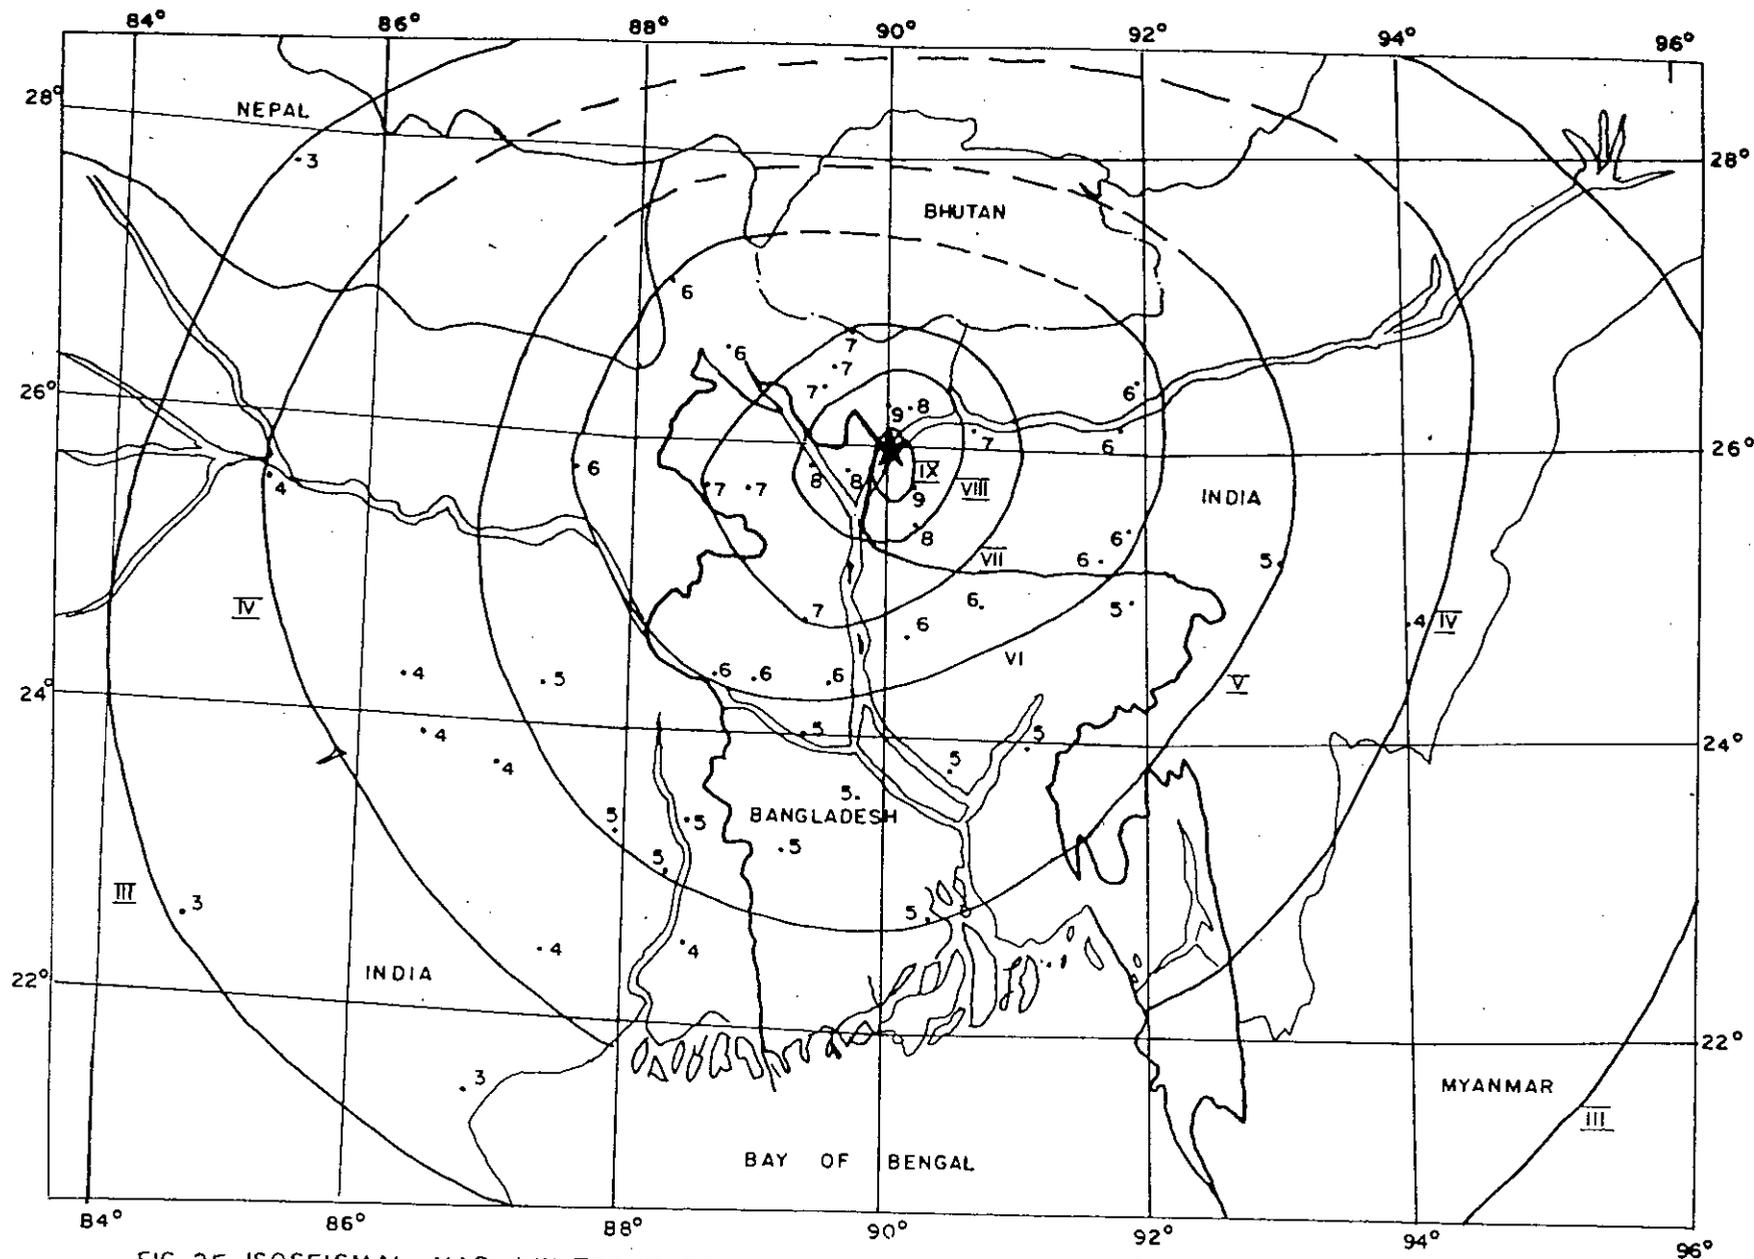
FIG. 25 ISOSEISMAL MAP (IN TERMS OF EMS SCALE) OF THE MAIN SHOCK OF JULY 2, 1930 EARTHQUAKE. THE STAR SHOWS THE MACROSEISMIC EPICENTRE.

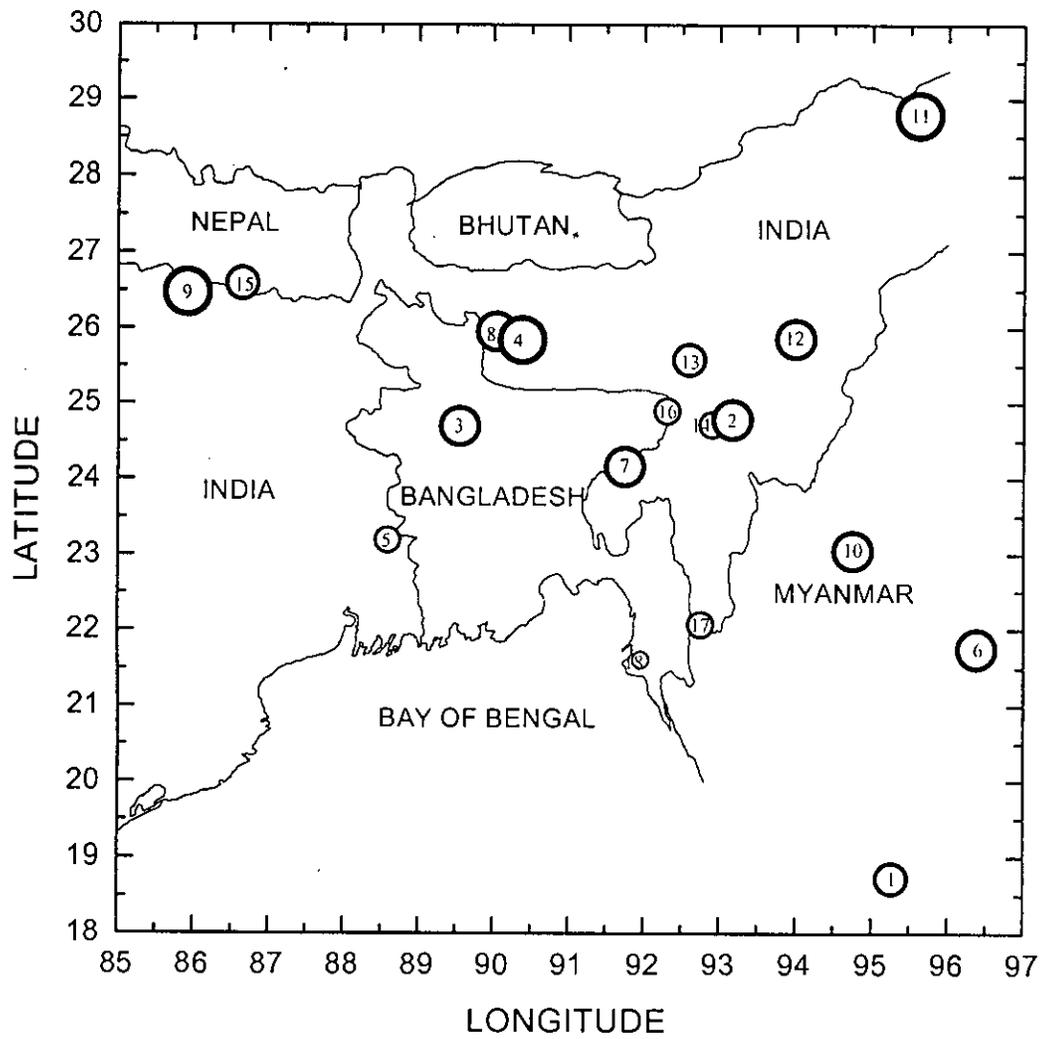
Figure 3.1. The region under consideration under consideration together with the earthquakes in this study

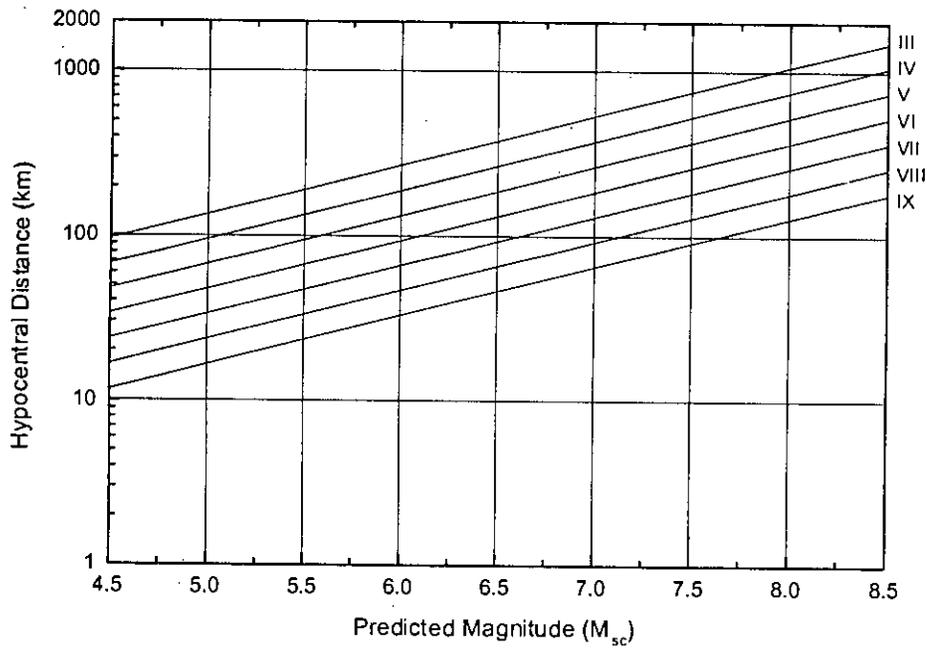
Figure 3.2. Magnitude-intensity relationships for whole data set, plotted for intensities $I = III-IX$

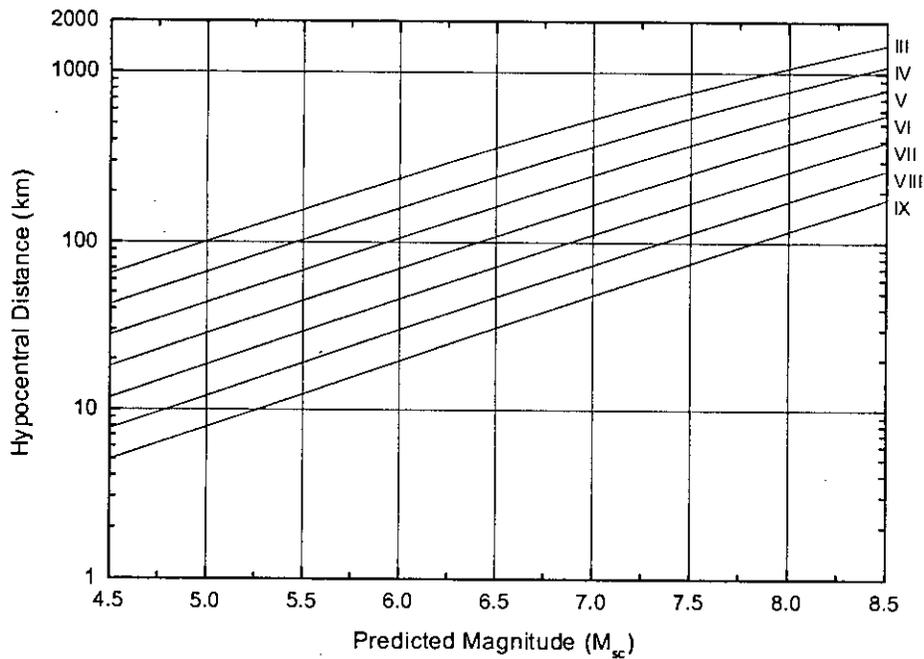
Figure 3.4. Magnitude-intensity relationships for NE-GB data, plotted for intensities $I = \text{III-IX}$

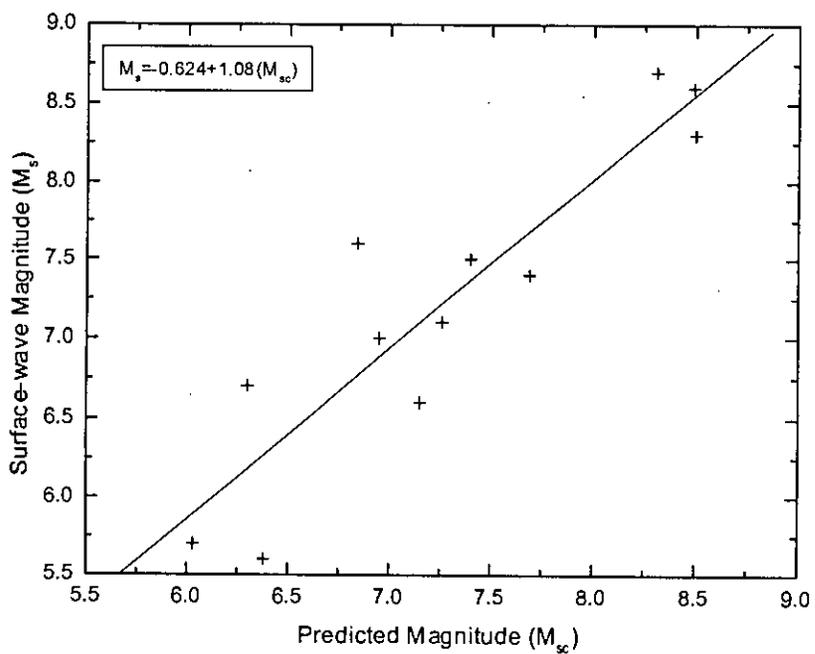
Figure 3.5. Surface-wave magnitudes M_s calculated from instrumental data versus macroseismic magnitudes M_{sc} predicted from the NE-GB data

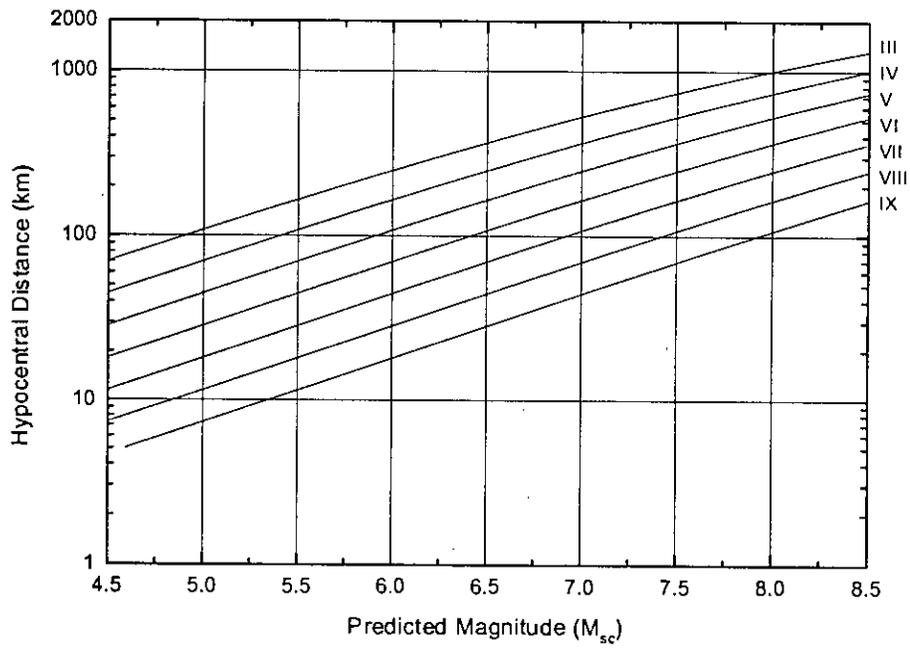
Figure 3.6. Magnitude-intensity relationships for NE data, plotted for intensities $I = \text{III-IX}$

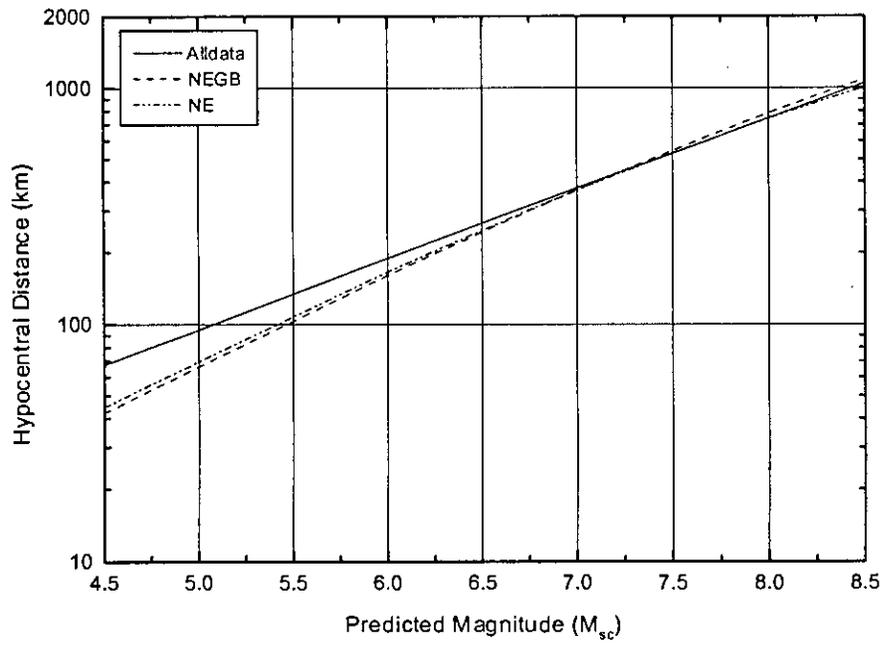
Figure 3.8 (a). Comparison of magnitude-intensity curves for the whole data set, NE-GB data and NE data for intensity $I = IV$

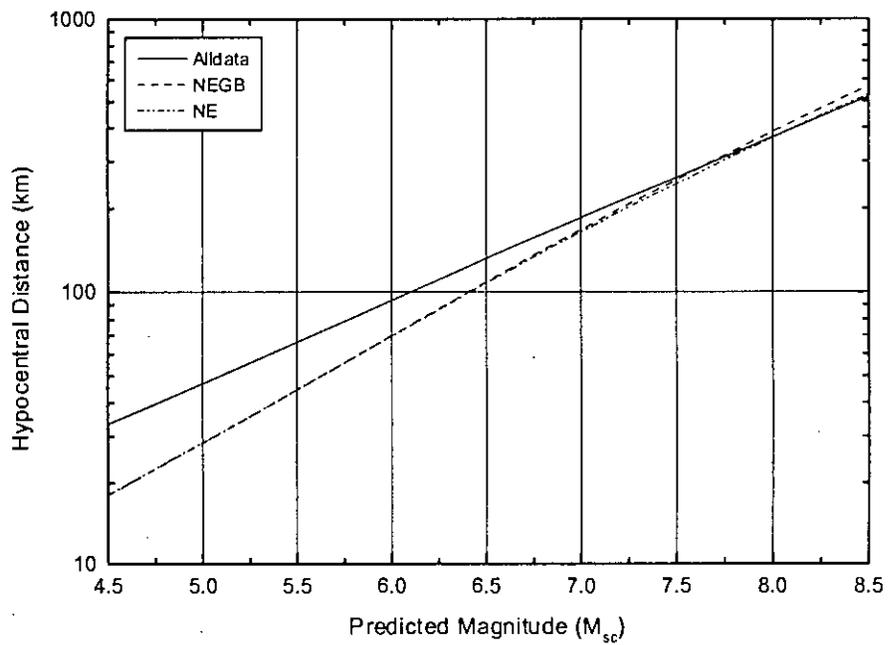
Figure 3.8 (b). Comparison of magnitude-intensity curves for the whole data set, NE-GB data and NE data for intensity $I = VI$

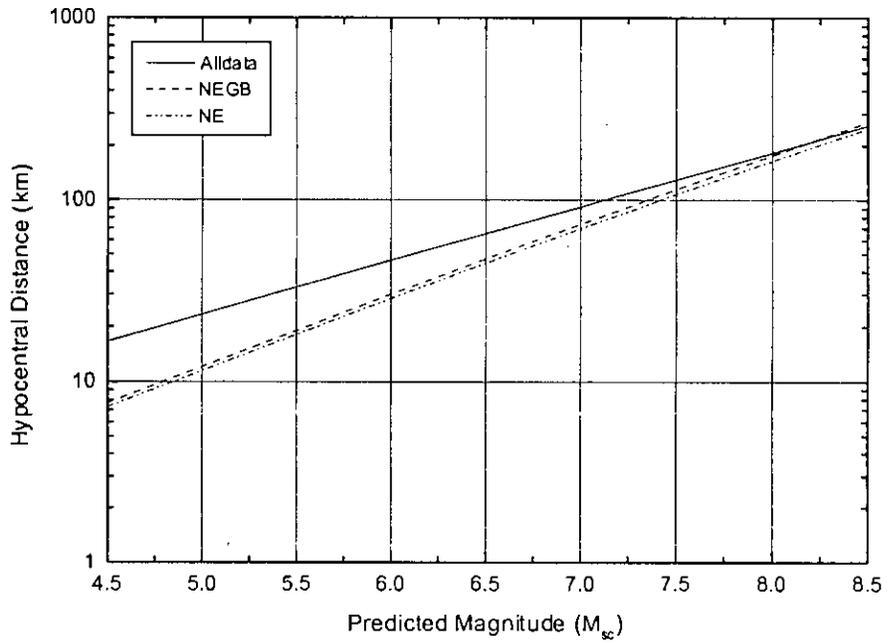
Figure 3.8 (c). Comparison of magnitude-intensity curves for the whole data set, NE-GB data and NE data for intensity $I = VIII$

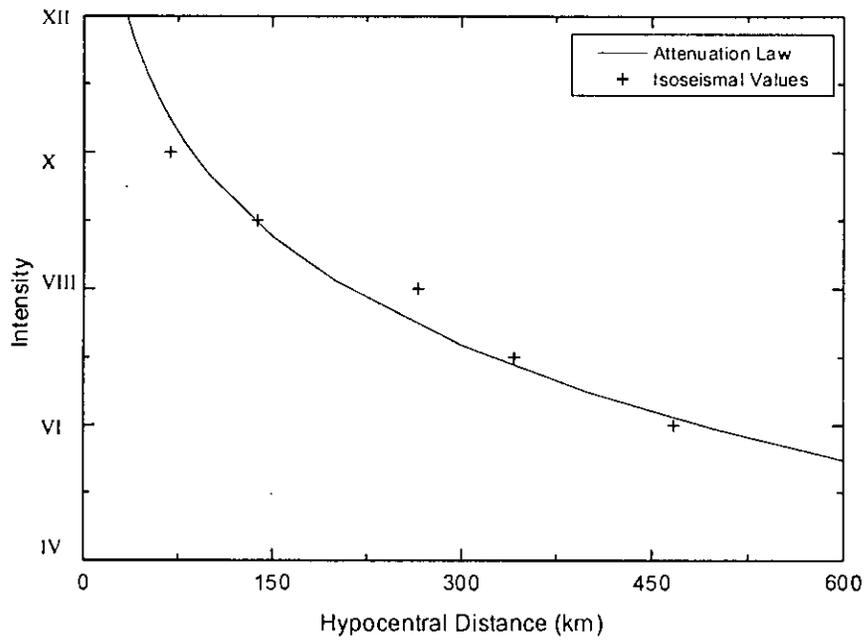
Figure 3.9 (a). Plot of isoseismal (I, D) data for 1897 Great Indian earthquake and mean intensity-attenuation curve for whole data set

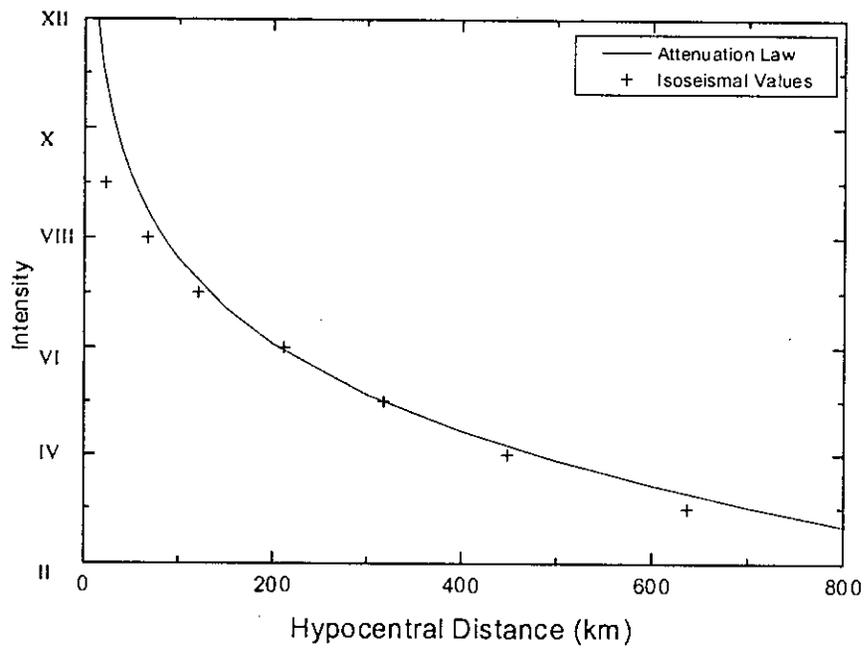
Figure 3.9 (b). Plot of isoseismal (I, D) data for 1930 Dhubri earthquake and mean intensity-attenuation curve for whole data set

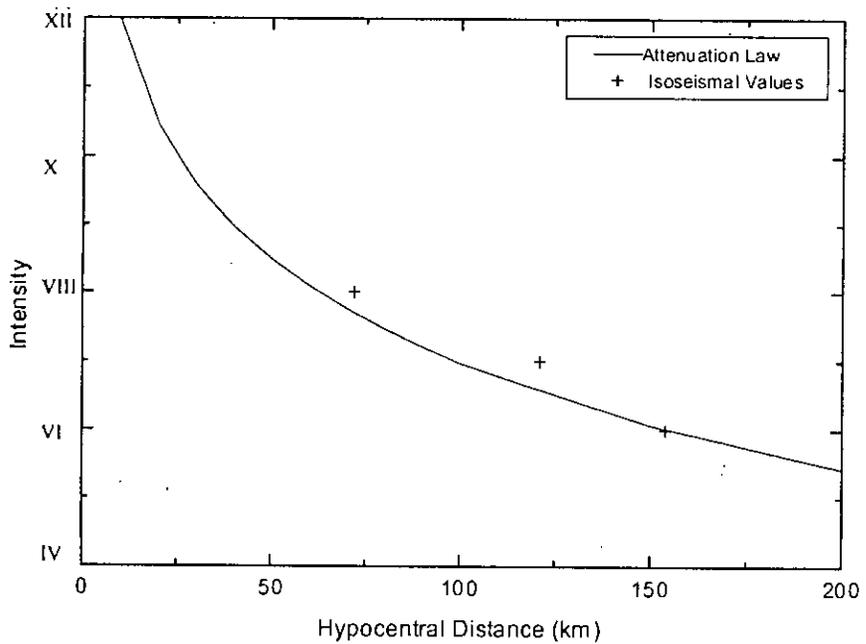
Figure 3.9 (c). Plot of isoseismal (I, D) data for 1988 Bihar-Nepal earthquake and mean intensity-attenuation curve for whole data set

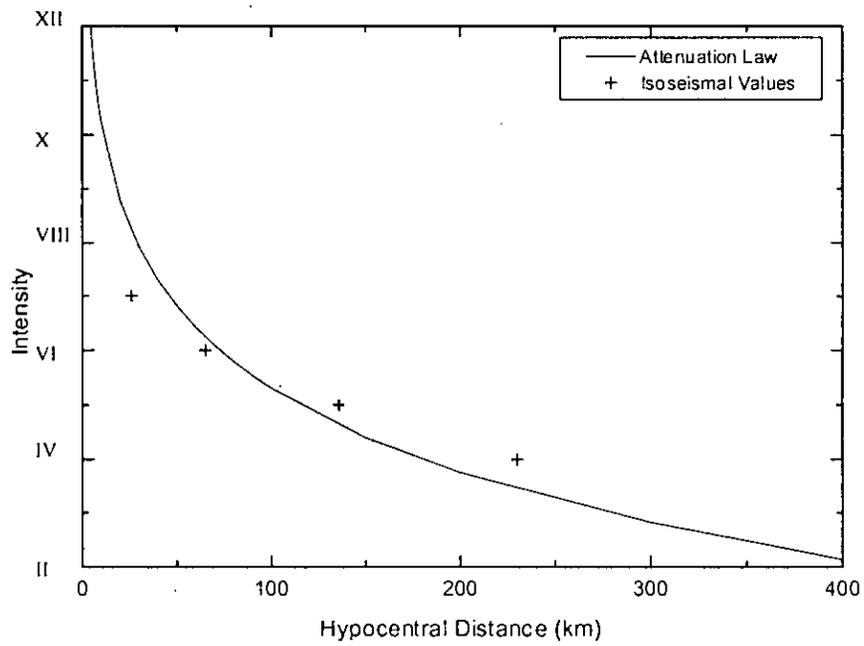
Figure 3.9 (d). Plot of isoseismal (I, D) data for 1997 Bangladesh-Myanmar earthquake and mean intensity-attenuation curve for whole data set

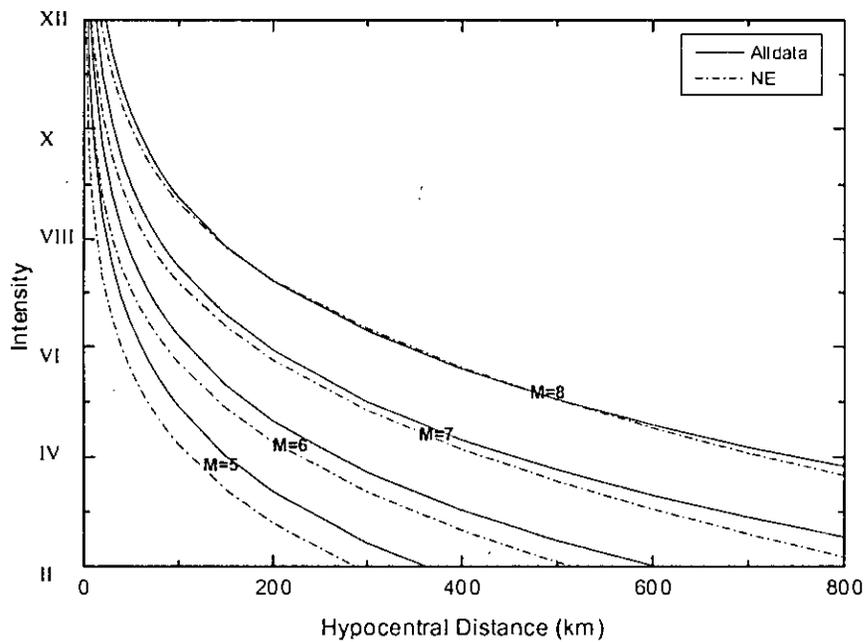
Figure 3.10. Comparison of mean intensity-attenuation curves for whole data set and NE, plotted for different surface-wave magnitudes

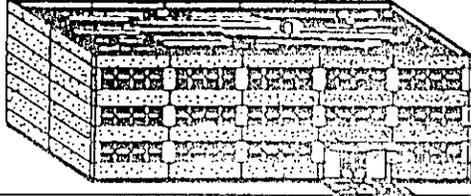
<p>Grade 1: Negligible to slight damage (no structural damage) fine cracks in plaster over frame members and in partitions.</p>

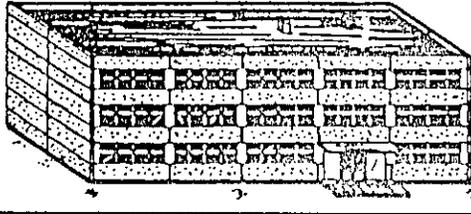
<p>Grade 2: Moderate damage (slight structural damage, moderate non-structural damage) hair-line cracks in columns and beams; mortar falls from the joints of suspended wall panels; cracks in partition walls; fall of pieces of brittle cladding and plaster.</p>

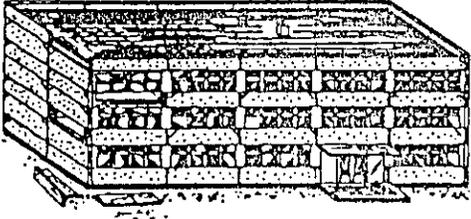
<p>Grade 3: Substantial to heavy damage (moderate structural damage, heavy non-structural damage) cracks in columns with detachment of pieces of concrete, cracks in beams.</p>

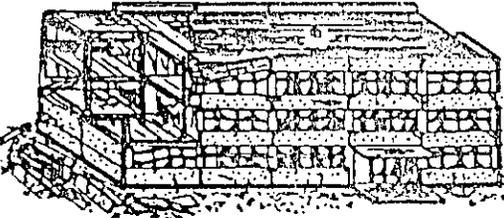
<p>Grade 4: Very heavy damage (heavy structural damage, very heavy non-structural damage). severe damage to the joints of the building skeleton with destruction of concrete and protrusion of reinforcing rods; partial collapse; tilting of columns.</p>

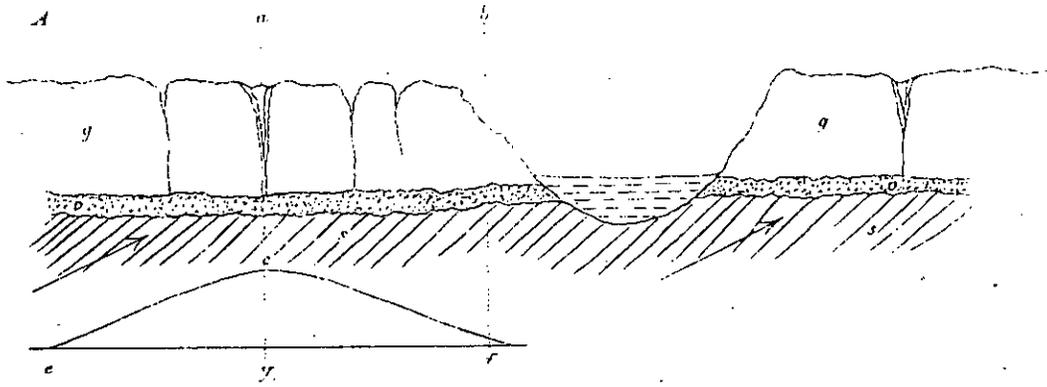
Fig. 1. Diagram to illustrate the formation of Earth fissure

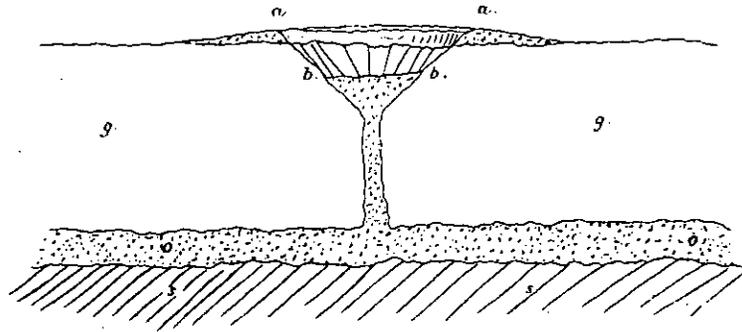
Fig. 2. Diagrammatic section of a sand crater.

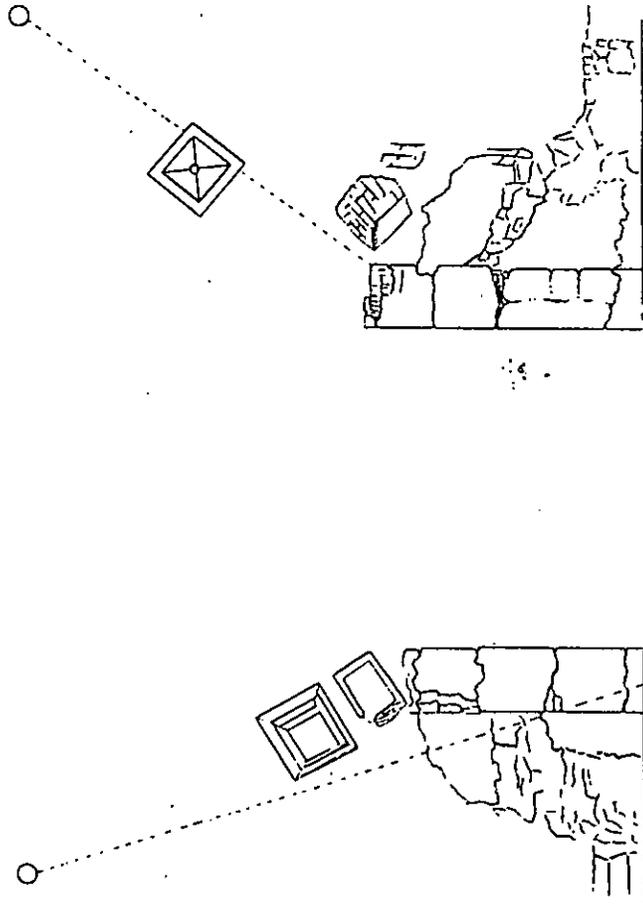
Fig. 2 Sketch Plan of overturned Cemetery gate pillars Silchar

Walls of coarse brick masonry with heavy mortar joints enclosed the old cemetery at Silchar, the mortar showed a very wretched power of adhesion. Within the limits of the cemetery there were many monuments of various kinds. The gate of the enclosure was down. There was abundant evidence of a sudden and violent force producing this overthrow. The boundary walls of the cemetery enclosure had been cracked and broken in several places.

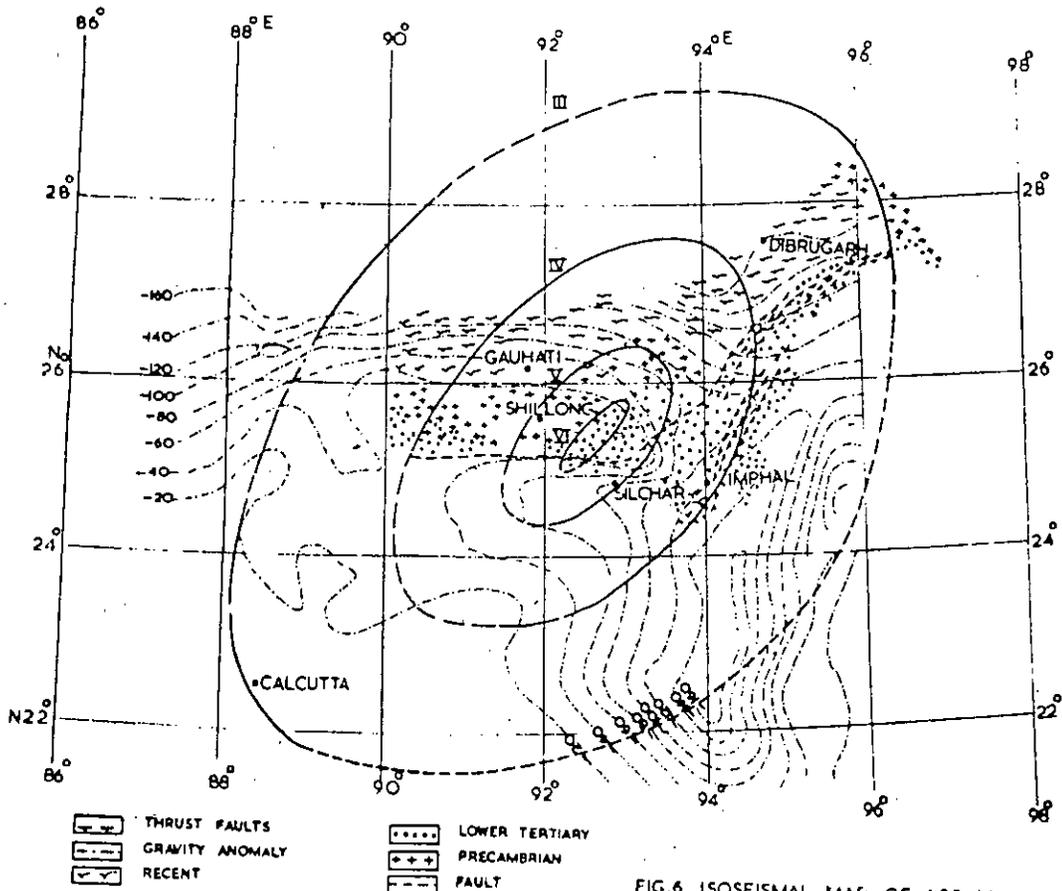
FIG. 6 ISOSEISMAL MAP OF ASSAM EARTHQUAKE OF JULY 8, 1975
