**EARTHQUAKE INTENSITY-ATTENUATION RELATIONSHIP FOR
BANGLADESH AND ITS SURROUNDING REGION**

*A thesis submitted to the department of Civil Engineering,
Bangladesh University of Engineering and Technology, Dhaka
in partial fulfillment of the requirements for the degree*

MASTER IN ENGINEERING IN CIVIL ENGINEERING

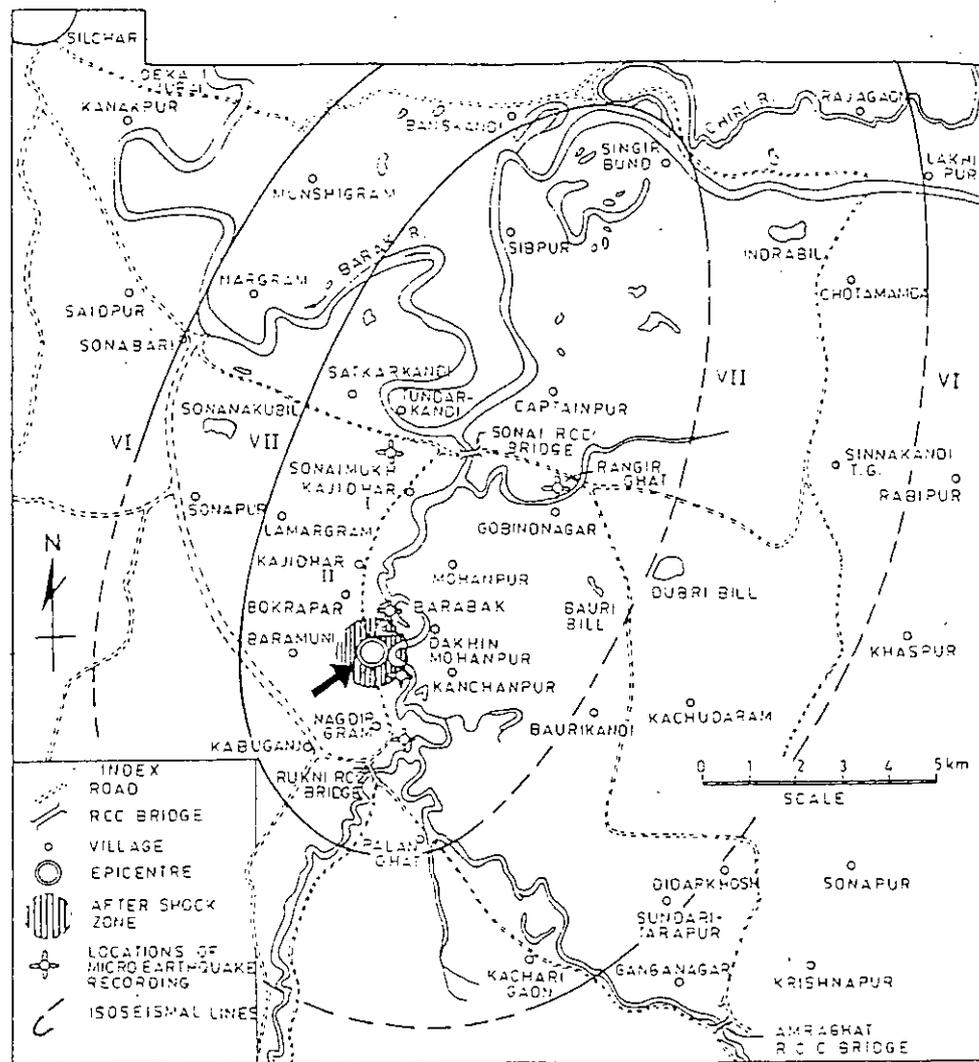
Fig. Isoseismal Map, location of Microearthquake recording and Aftershock Zone, 1988

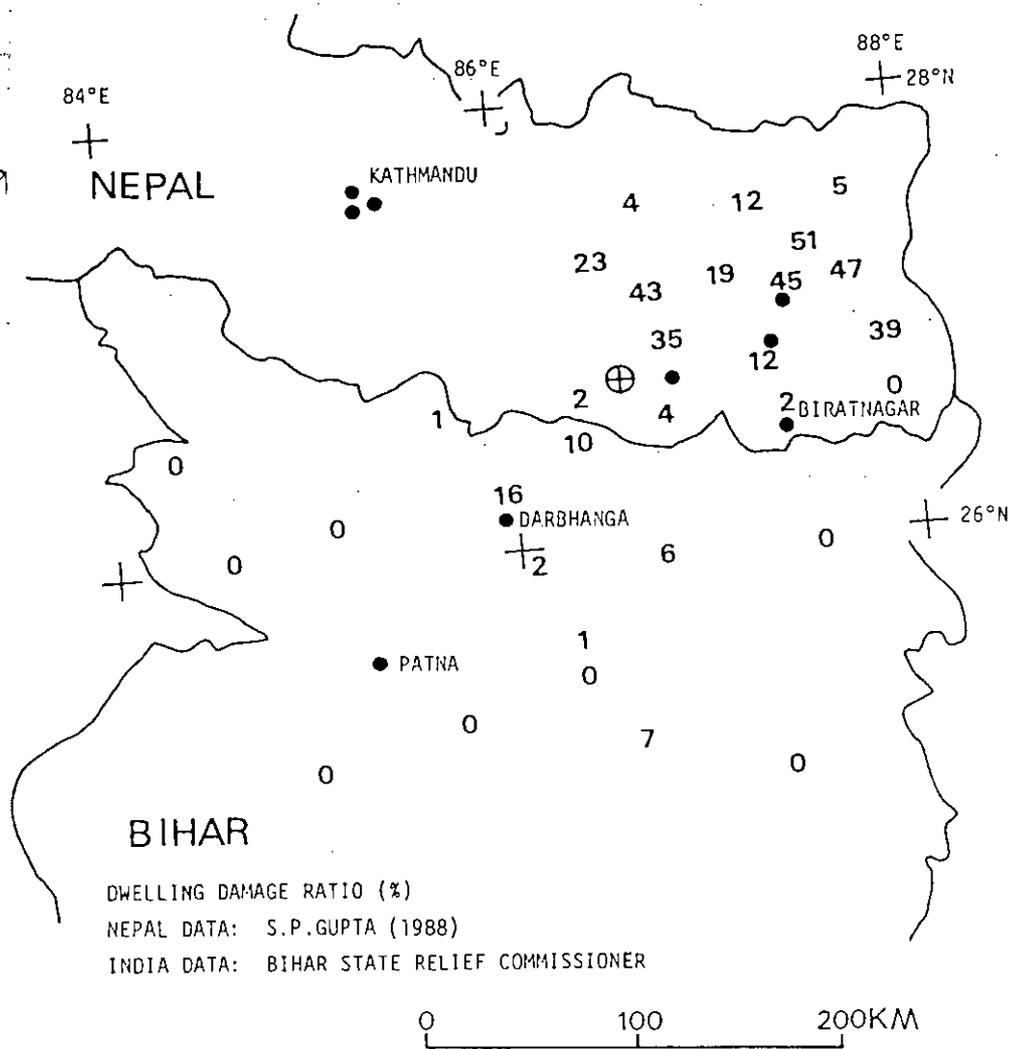
Fig. Map of the affected region showing dwelling damage ratios

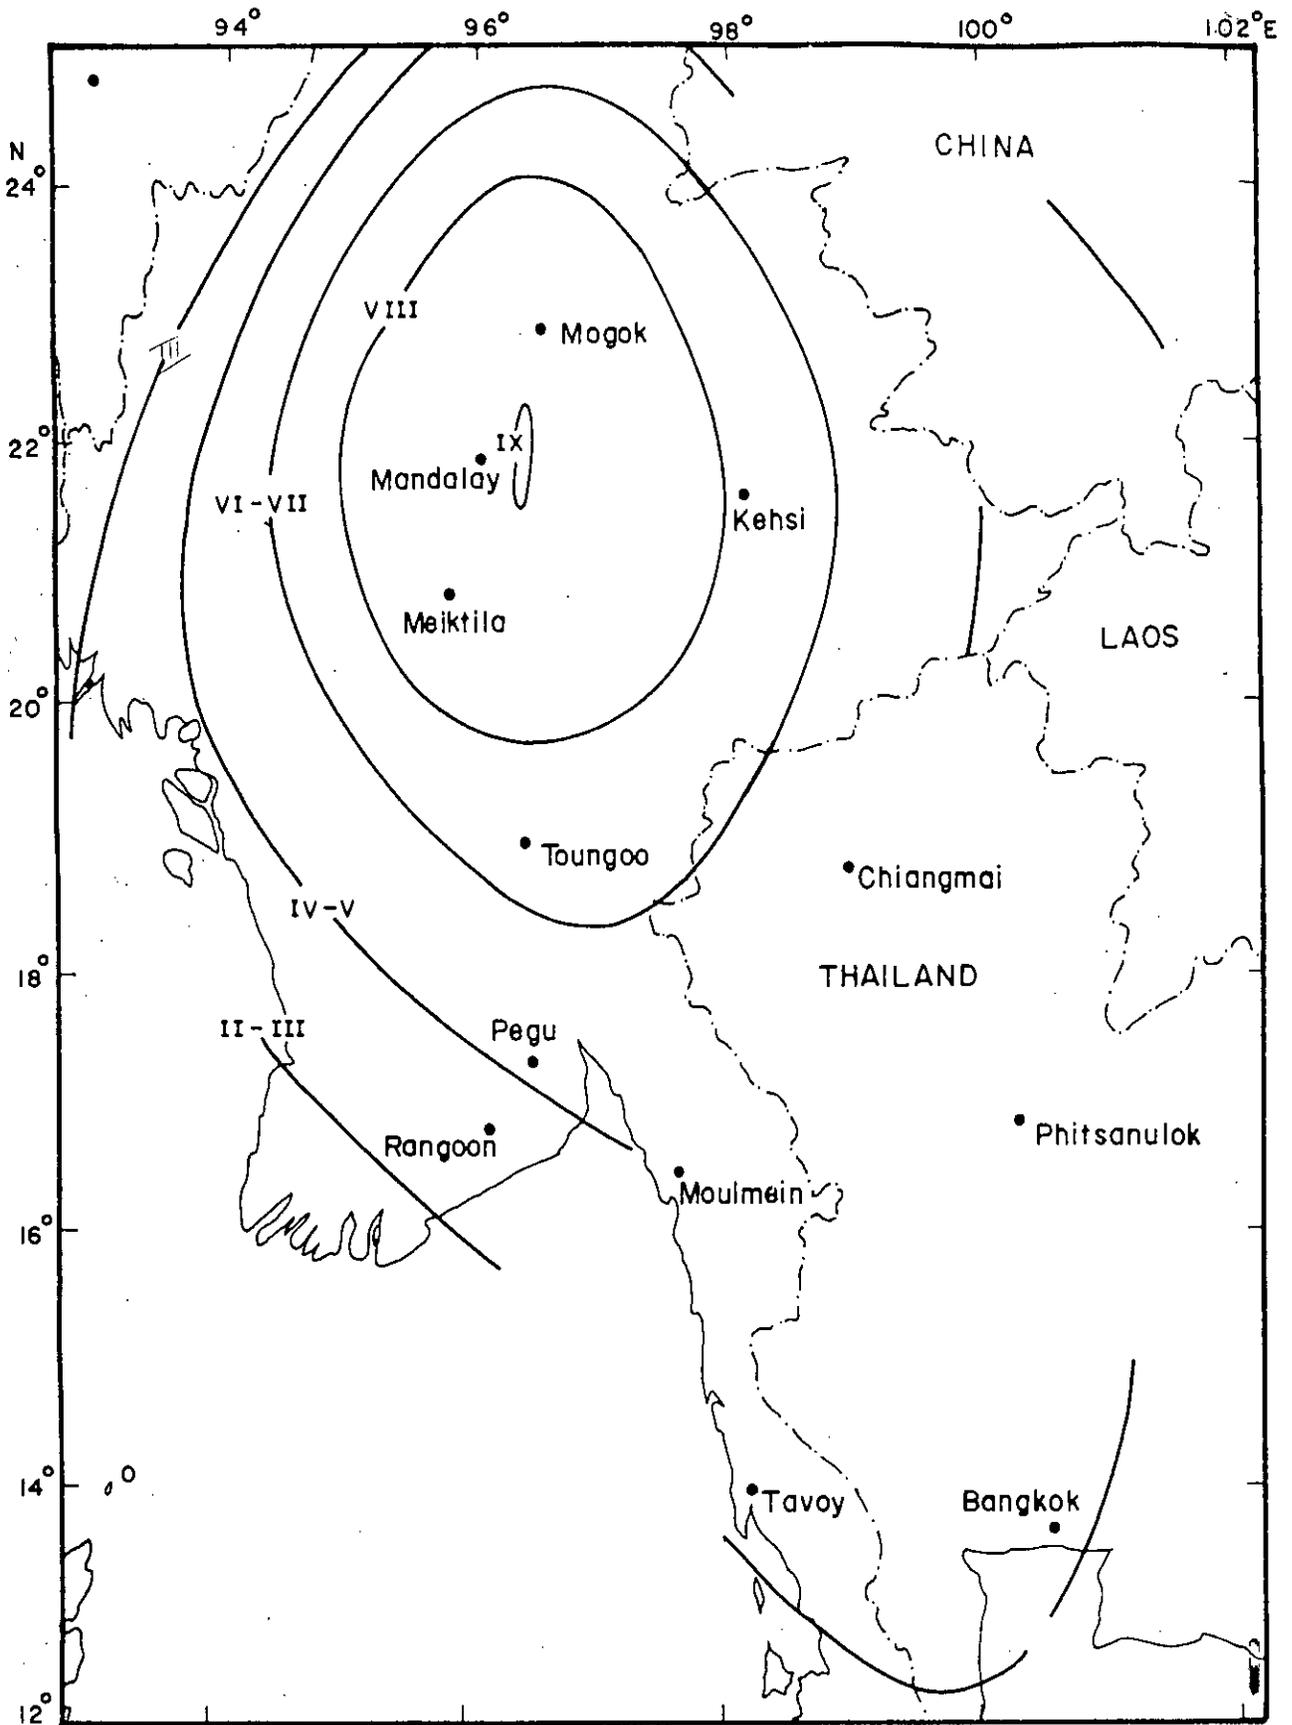
Fig. 5 Isoseismal Map of the Mandalay Earthquake of 23 May 1912 (after Brown, 1914)

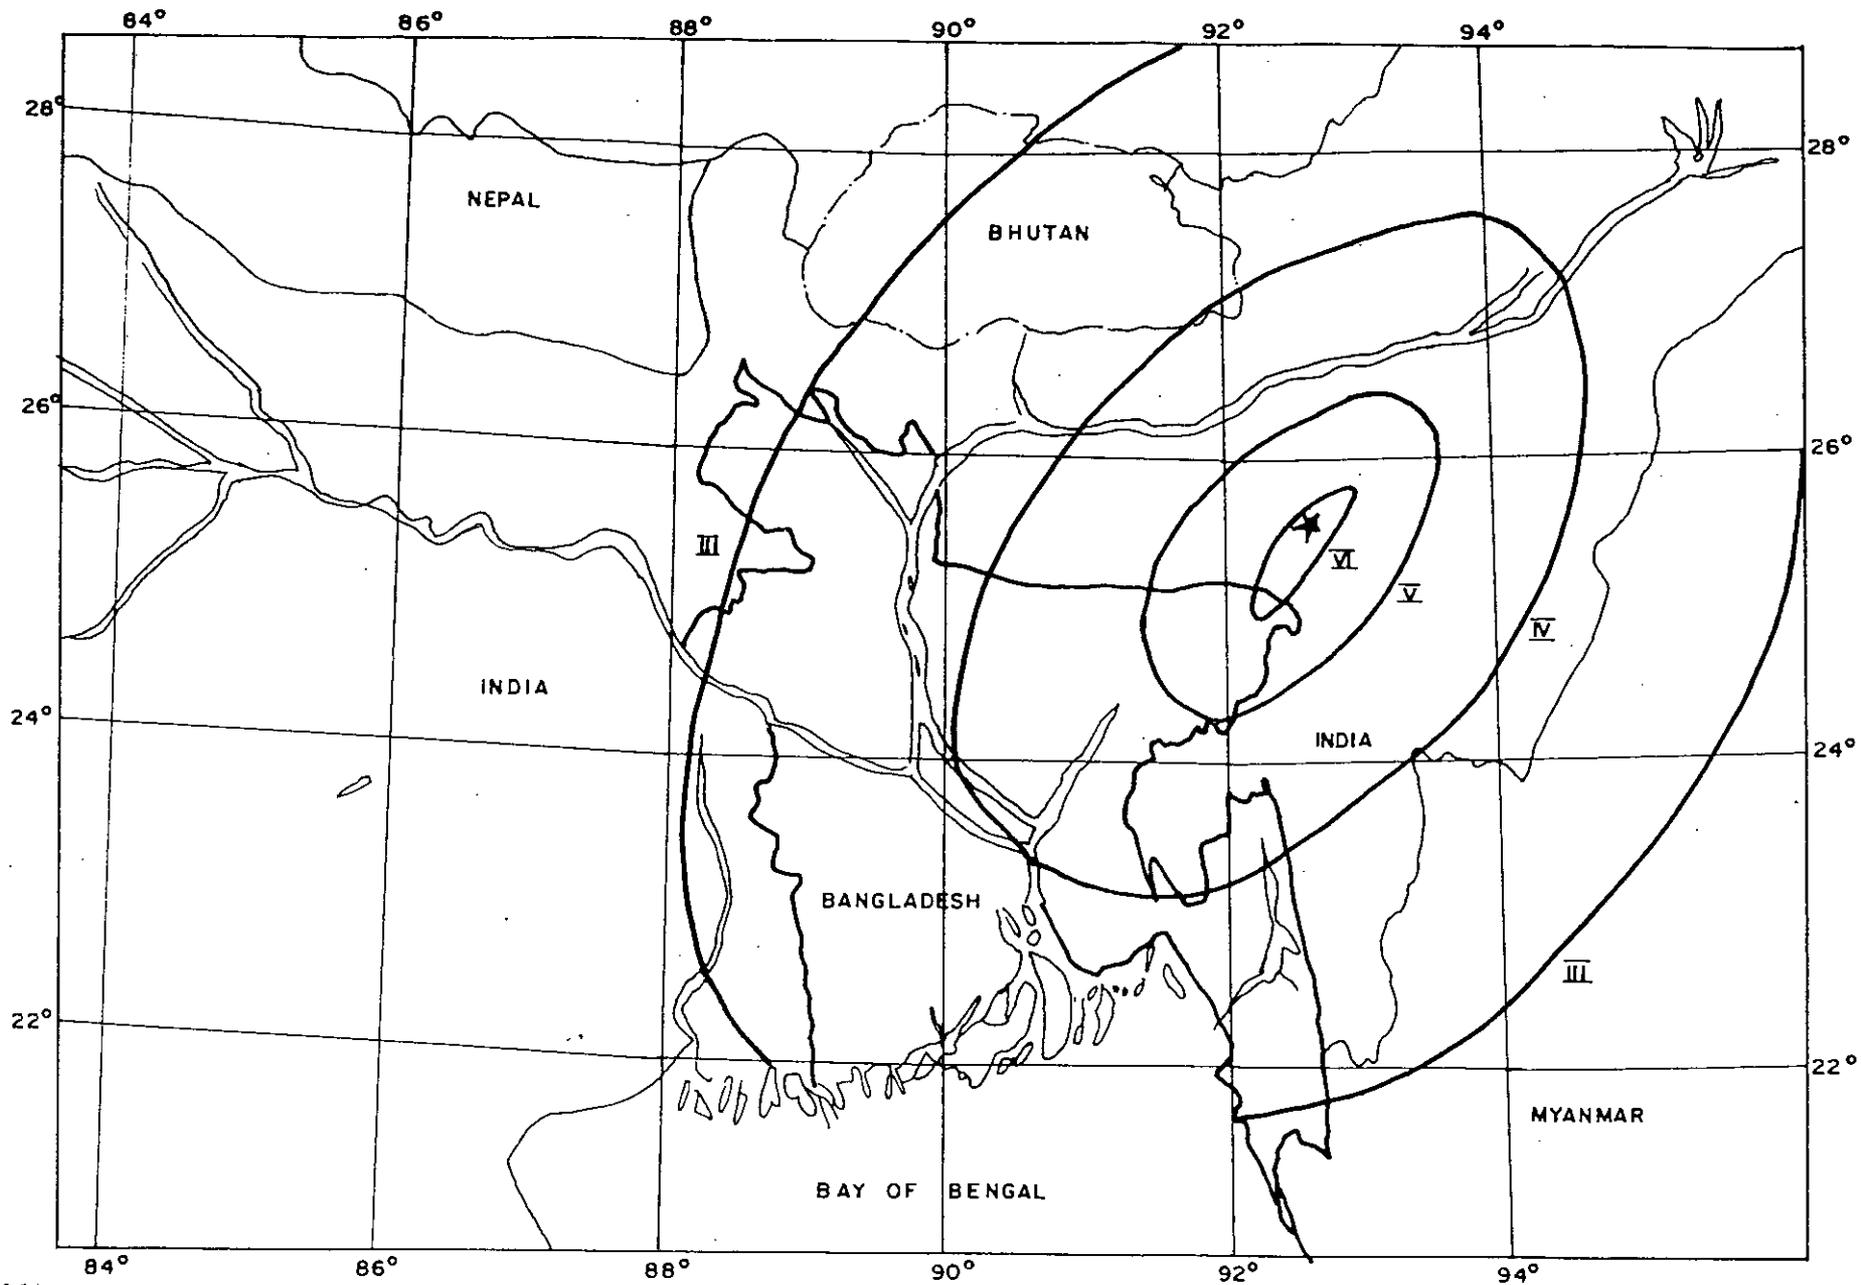
FIG. ISOSEISMAL MAP (IN TERMS OF EMS SCALE) OF THE MAIN SHOCK OF JULY 8, 1975 EARTHQUAKE. THE STAR SHOWS THE MACROSEISMIC EPICENTRE.

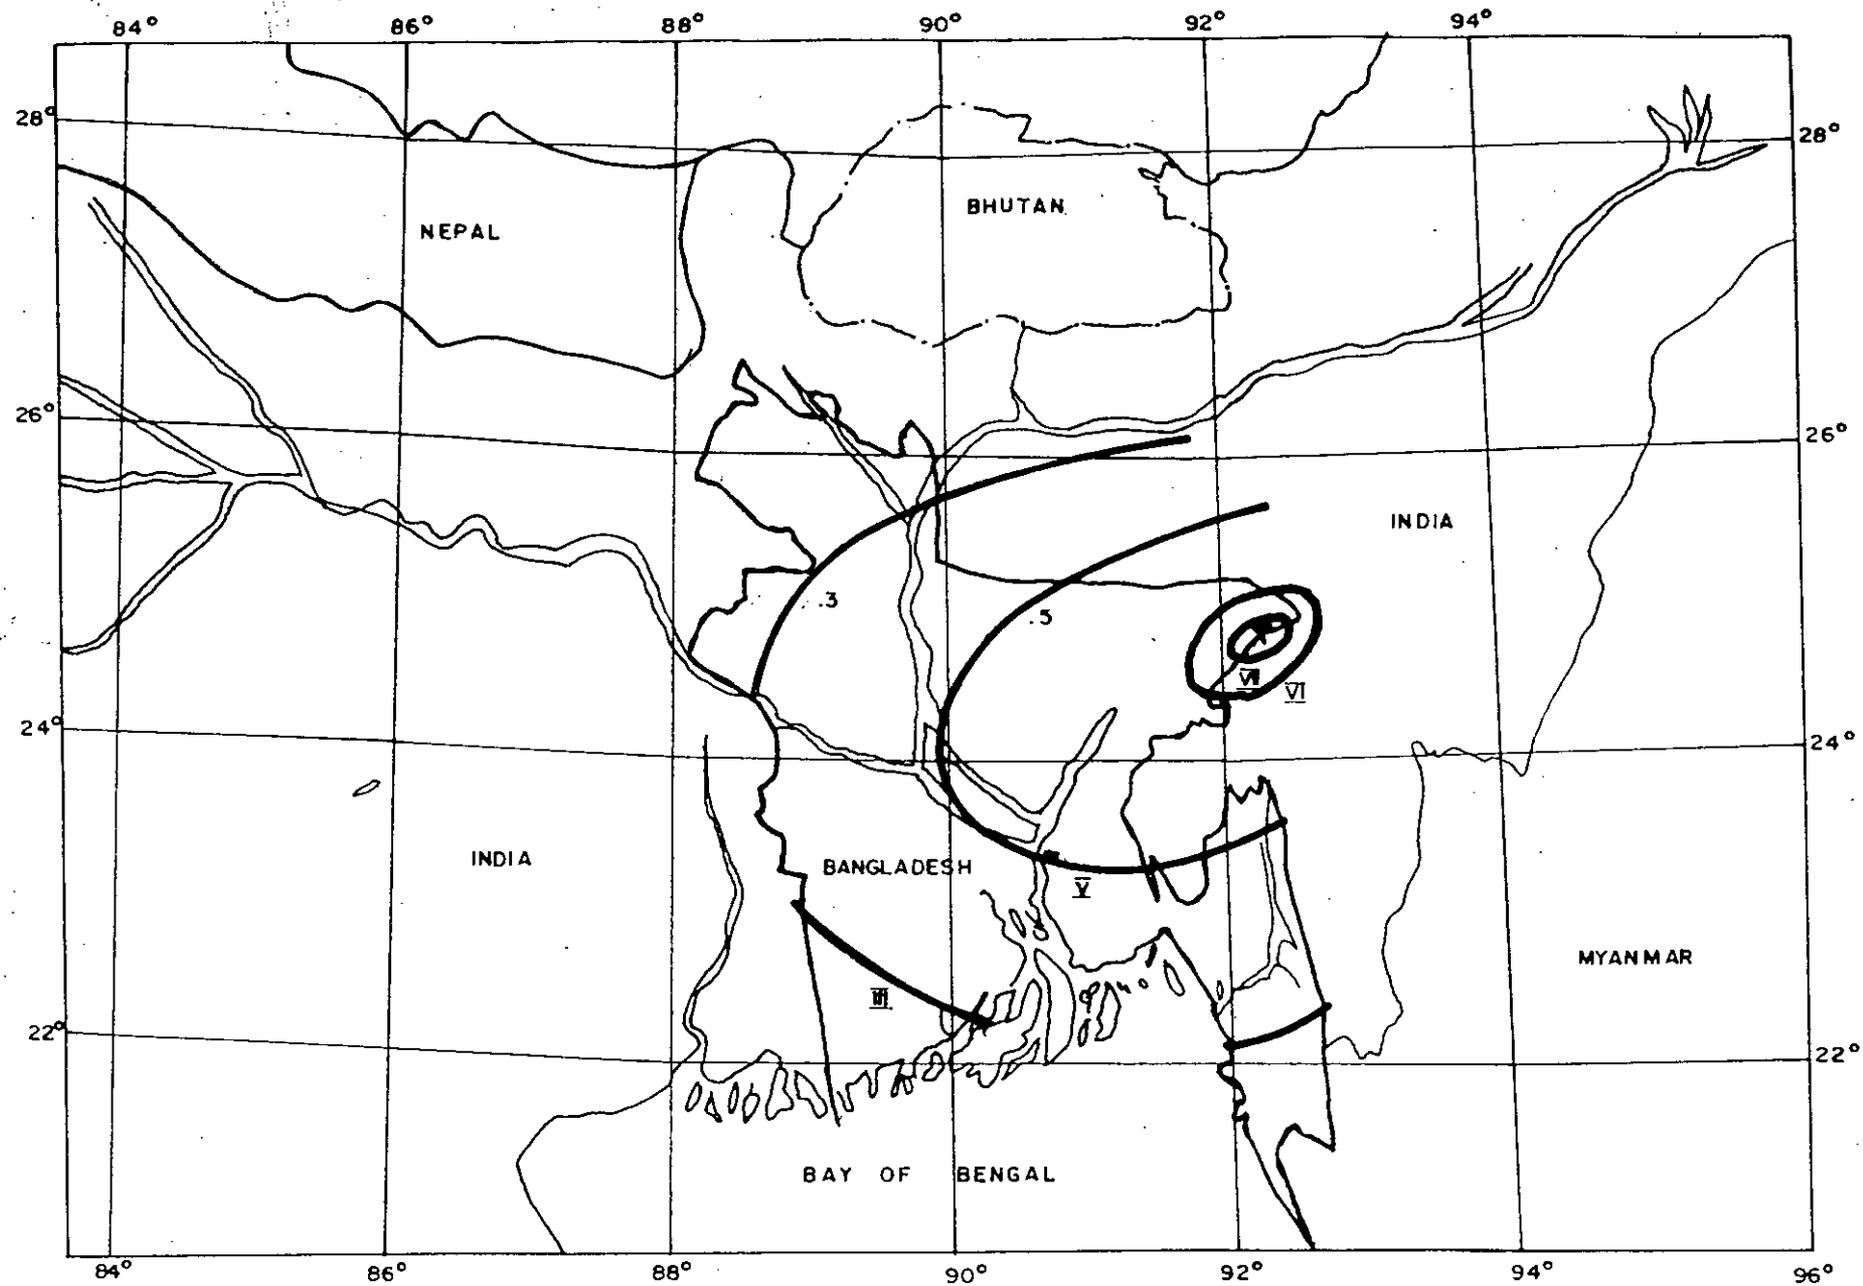
FIG. ISOSEISMAL MAP (IN TERMS OF EMS SCALE) OF THE MAIN SHOCK OF MAY 8, 1997 EARTHQUAKE. THE STAR SHOWS THE MACROSEISMIC EPICENTRE.

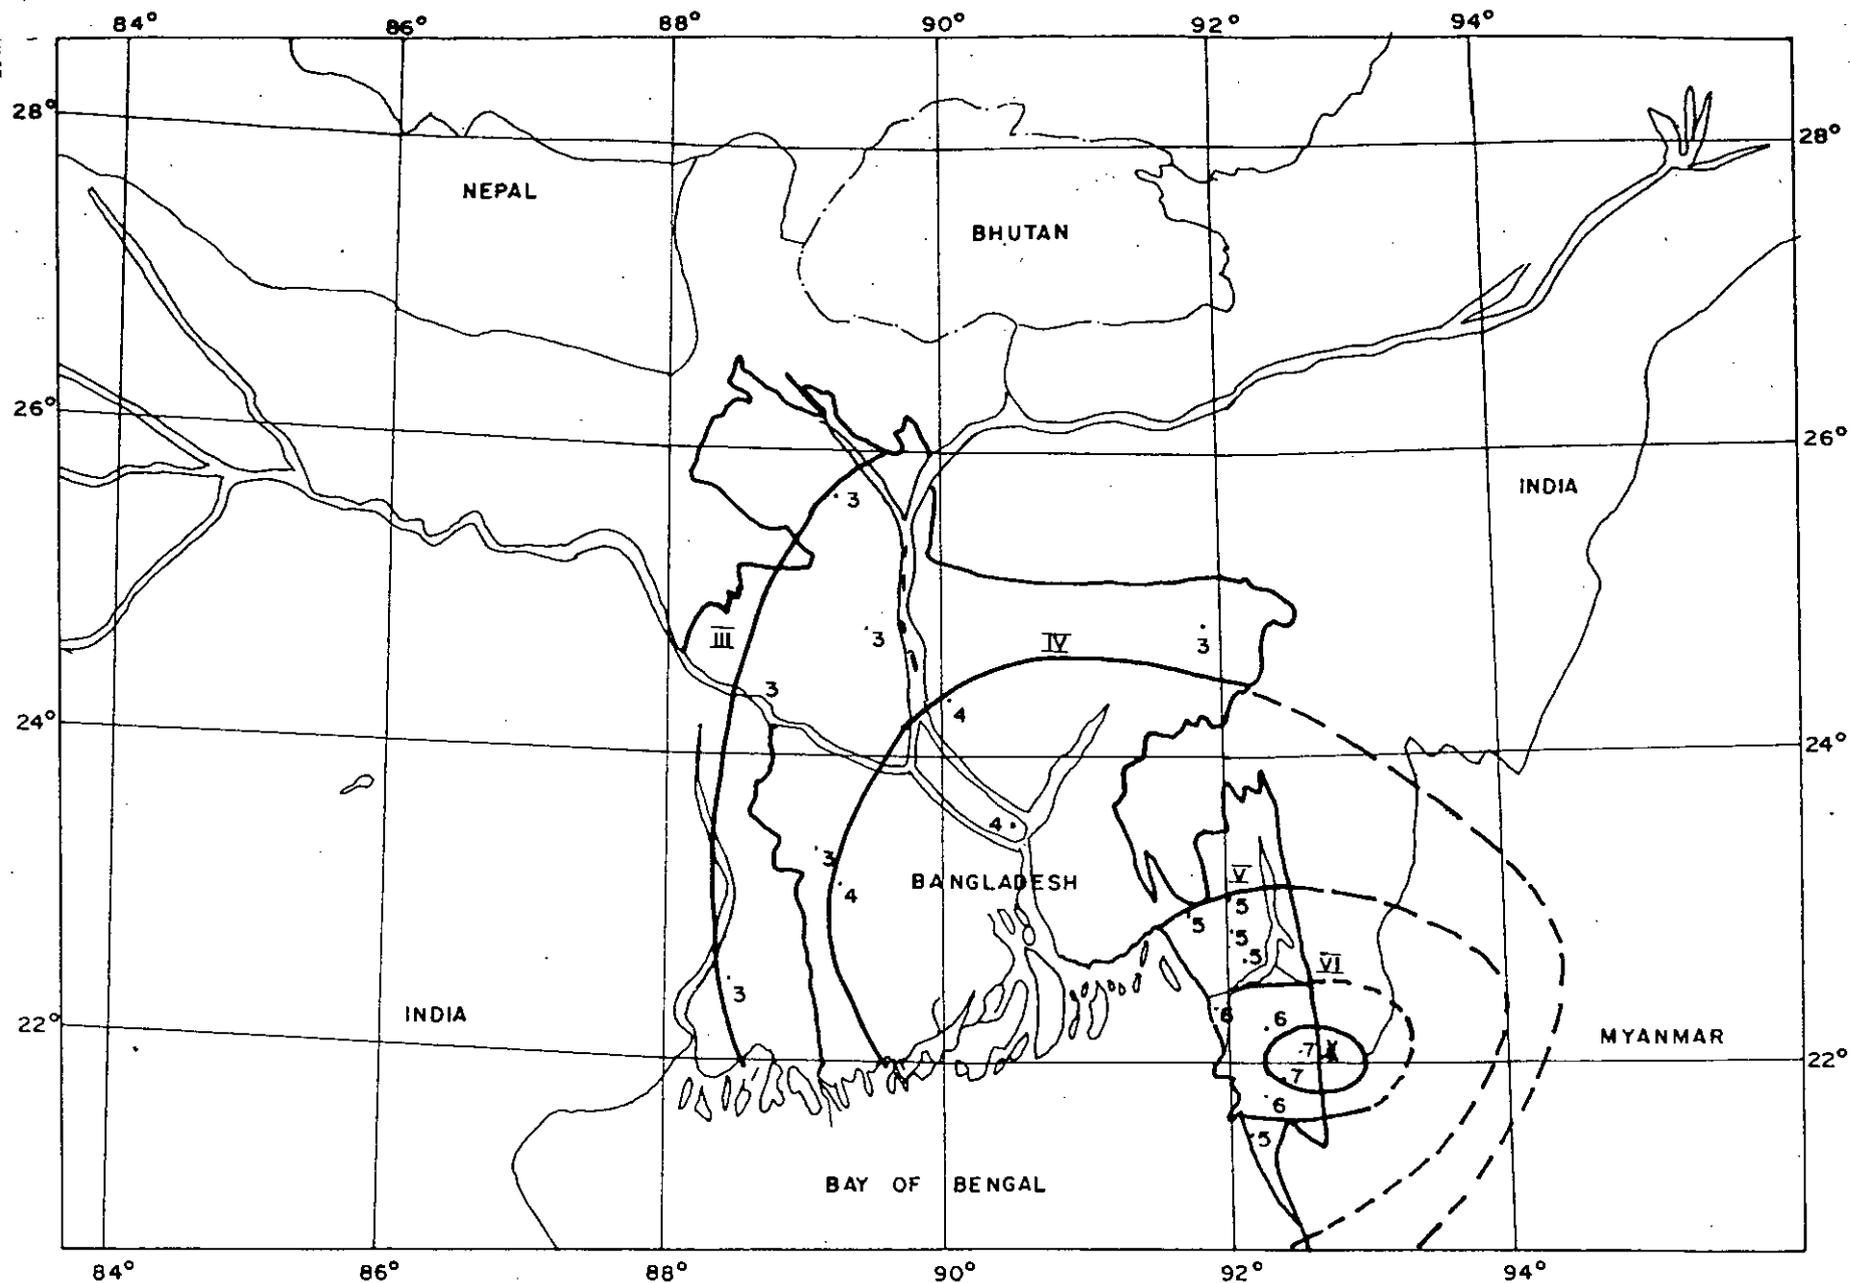
FIG. ISOSEISMAL MAP (IN TERMS OF EMS SCALE) OF THE MAIN SHOCK OF NOVEMBER 21, 1997 EARTHQUAKE. THE STAR SHOWS THE MACROSEISMIC EPICENTRE.
