**PERFORMANCE EVALUATION OF ROAD SAFETY MEASURES IN
DHAKA-ARICHA HIGHWAY**

**DEPARTMENT OF CIVIL ENGINEERING
BANGLADESH UNIVERSITY OF ENGINEERING & TECHNOLOGY
DHAKA, BANGLADESH**

A thesis submitted to the Department of Civil Engineering, Bangladesh University of
Engineering and Technology, Dhaka, in partial fulfillment of the requirements

Master of Science in Civil Engineering

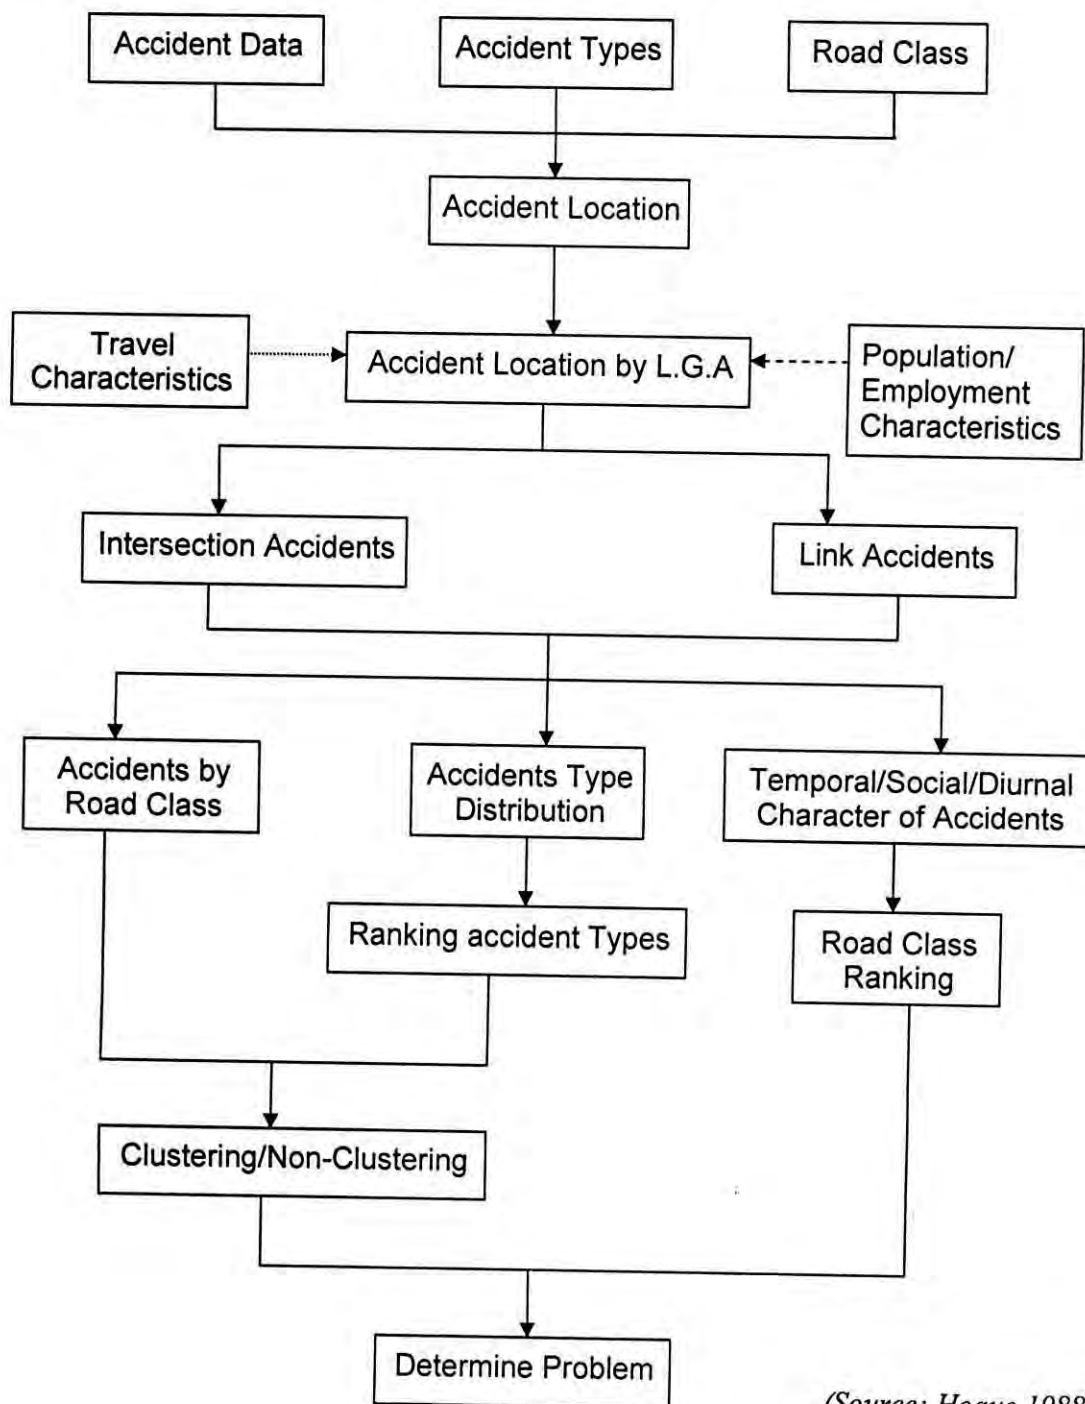
Figure 3.5 Steps Involve in Determining Accident Problem

In this study accident types and locations are identified and are further divided into links/intersections/major links as shown in the framework but further division into local government areas (LGA) by inserting population/employment characteristics is not conducted due to non-availability of relevant data. Clustering/non-clustering of accidents including determination of problem is also conducted.

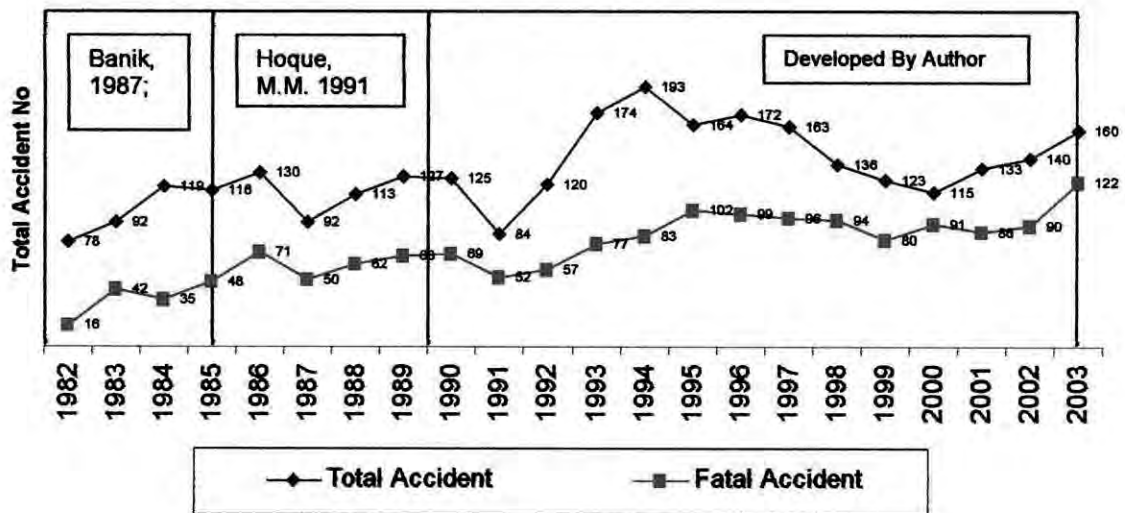
Fig 5.1 Yearwise Accident Statistics Along Dhaka-Aricha Highway

As discussed in Article 4.1, previous studies along Dhaka-Aricha highway contain accident data from 1982 to 1989, collected by Banik, G.C (1987) from 1982 to 1985 and Hoque, M.M. (1991), from 1985 to 1989. Figure 5.1 shows accident statistics along Dhaka-Aricha highway from 1982 to 2003. It shows that total accident is doubled and fatal accident is increased by more than seven times along this corridor. Average accident and fatal accident frequency per year along this corridor during different study durations are 101.25 and 35.25 (1982-1985); 115.5 and 62.75 (1982 to 1989) and 143 and 85.5 (1990-2003).

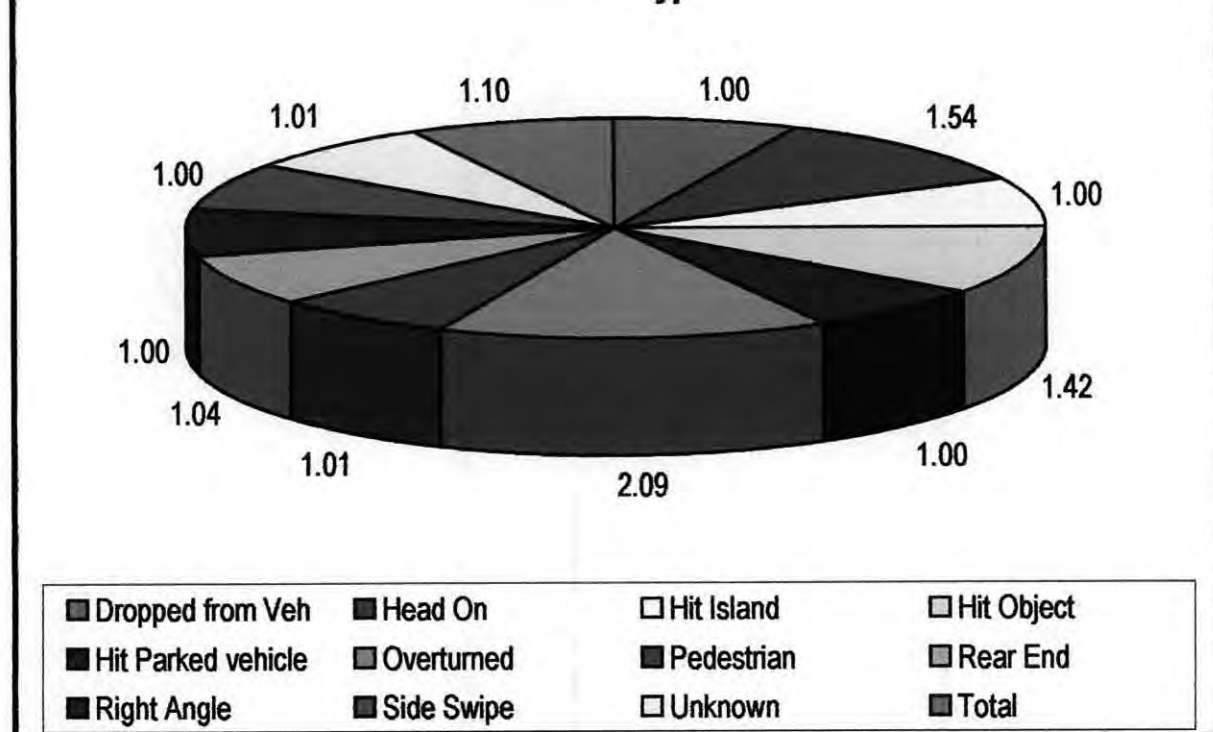
Figure 5.14 Fatality Index of Different Accident Collision Types

Table 5.21 and Figure 5.14 show the fatality Index among the different types of accidents. Table 5.21 reveals that overturned accident has the highest fatality index of 2.1 followed by

head-on (1.54) and Hit object (1.42) type of accident. Table 5.21 also reveals that fatality index of overturn accident is higher by a big margin of 1.5 times than the next higher one. During the field visit it is found that height of the embankment varies from 5-25 ft (2-8 m), with steep slope almost throughout the length of the highway, having very less safe recovery area (Article 4.4). So for any errant vehicle overturning leaving the carriageway and falling into the unprotected ditches is likely to suffer serious consequences.

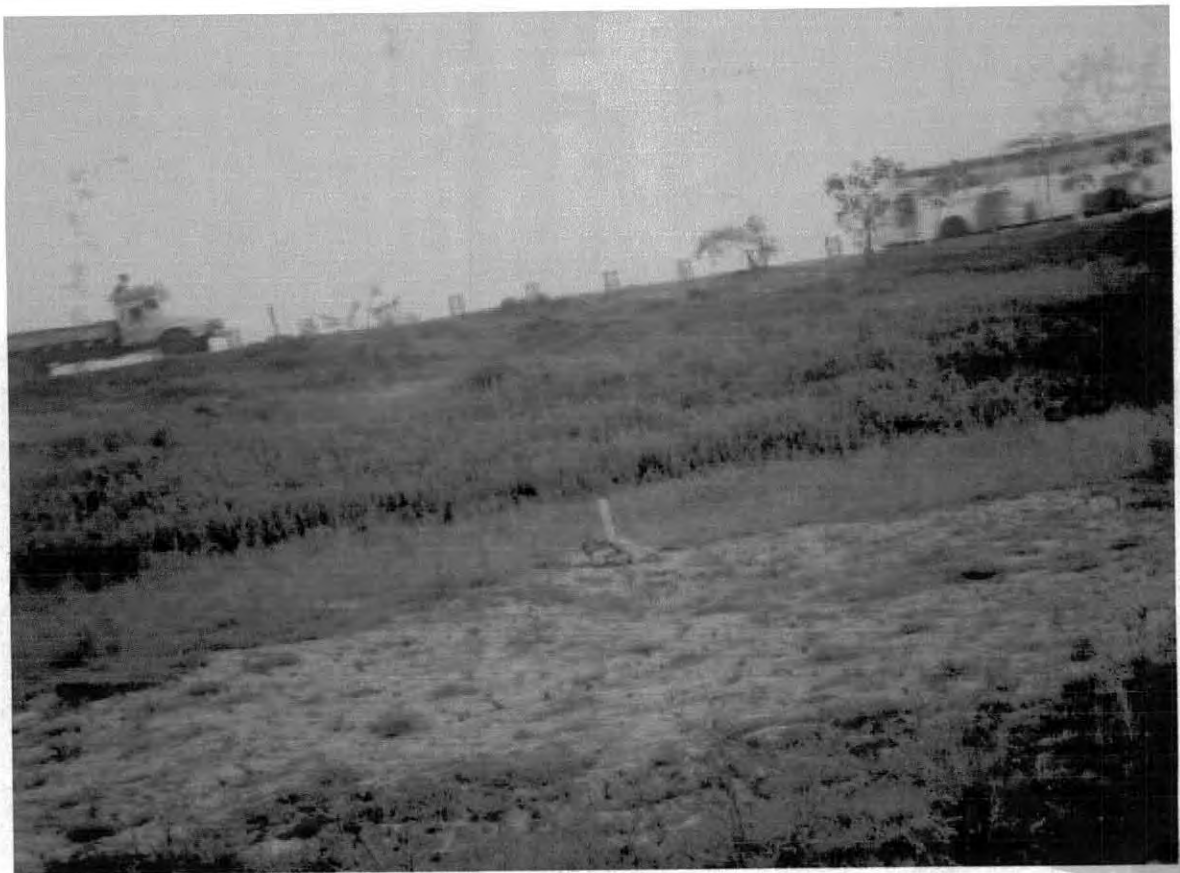
Figure B 4.2 High Embankment is a Unsafe Geometry by itself

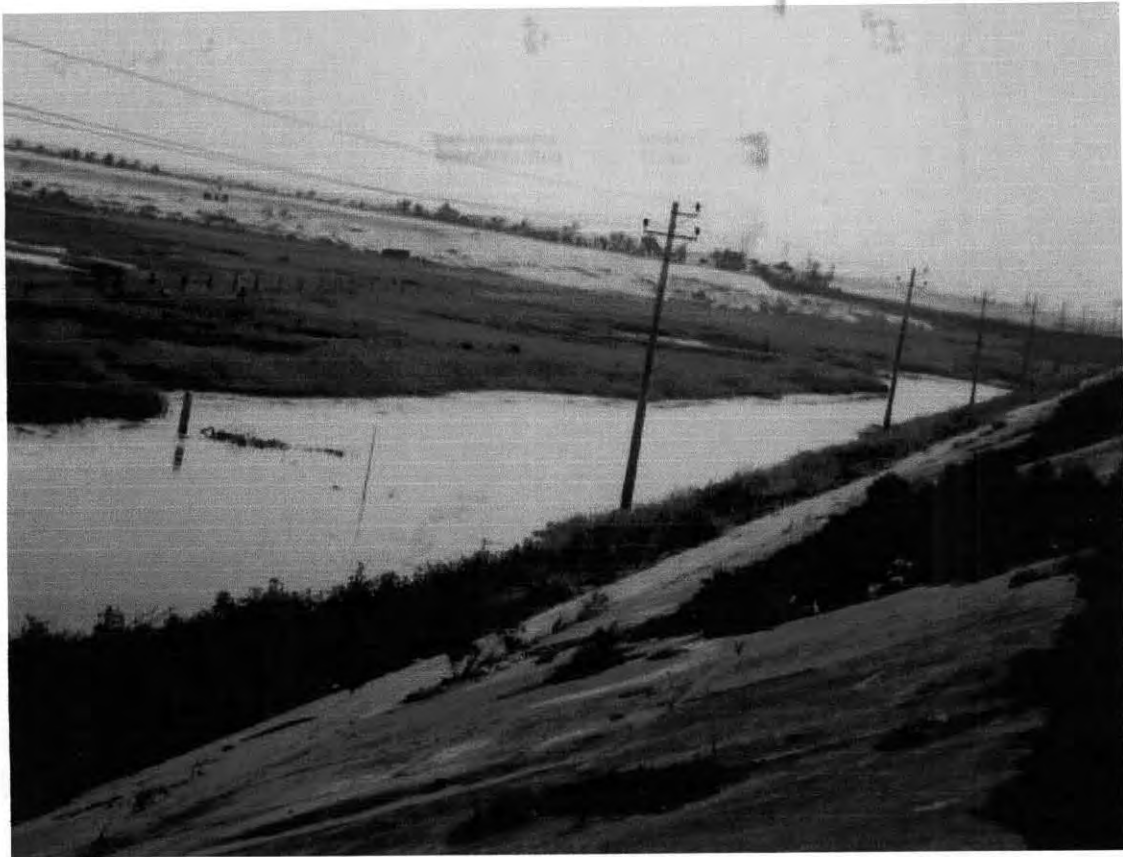
Figure B 4.3 Lack of Adequate Recovery Area is a Common Feature along this Corridor

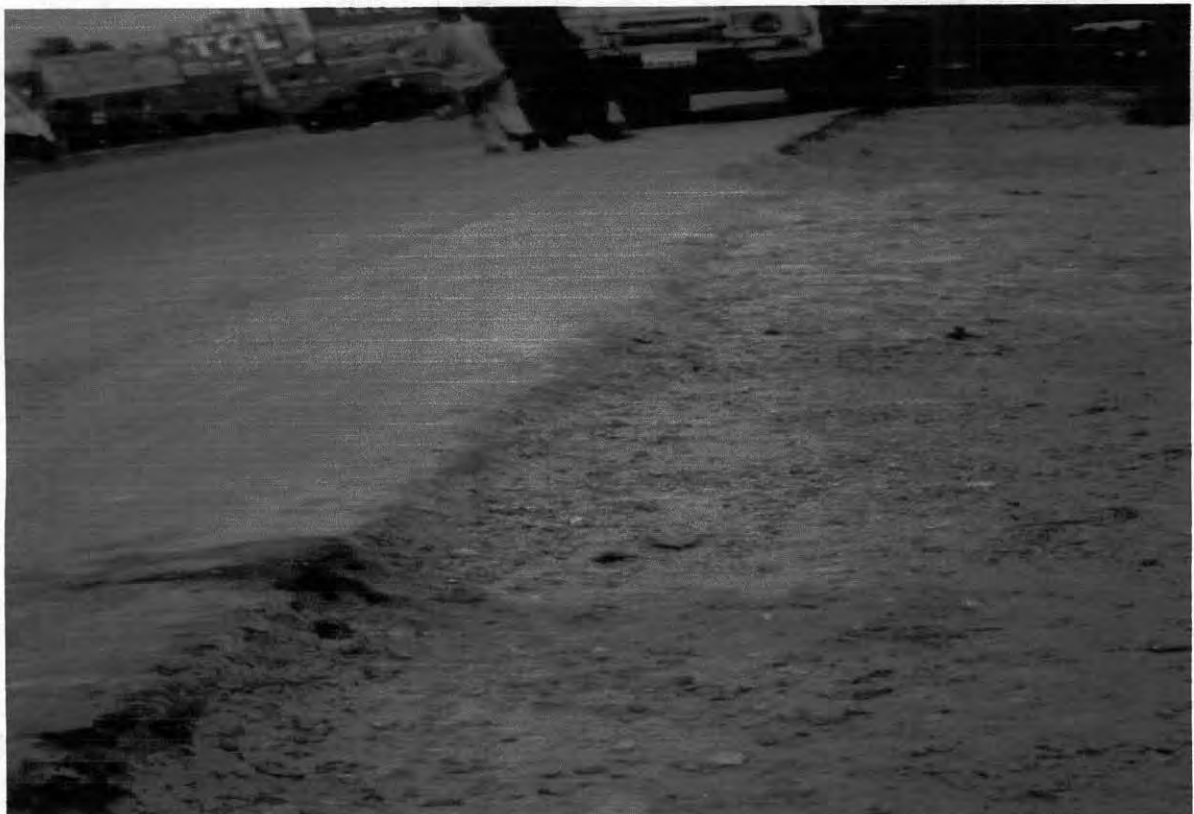
Figure B 4.6 Excessive shoulder drop along the Highway (3-5cm) is Very Hazardous Especially when Loaded Vehicle Reaches the Edge

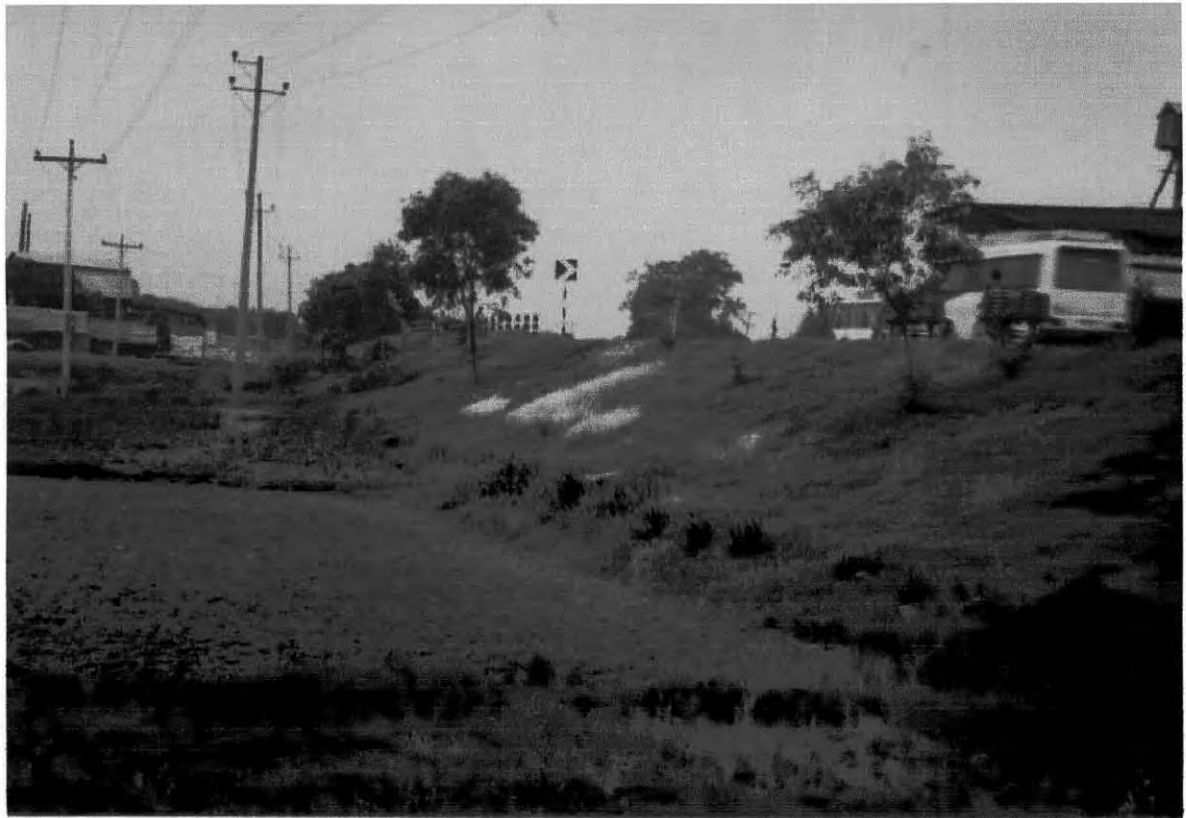
Figure B 4.9 Sharp Bend on High Embankment Further Aggravate the Risk of Overtum Accident

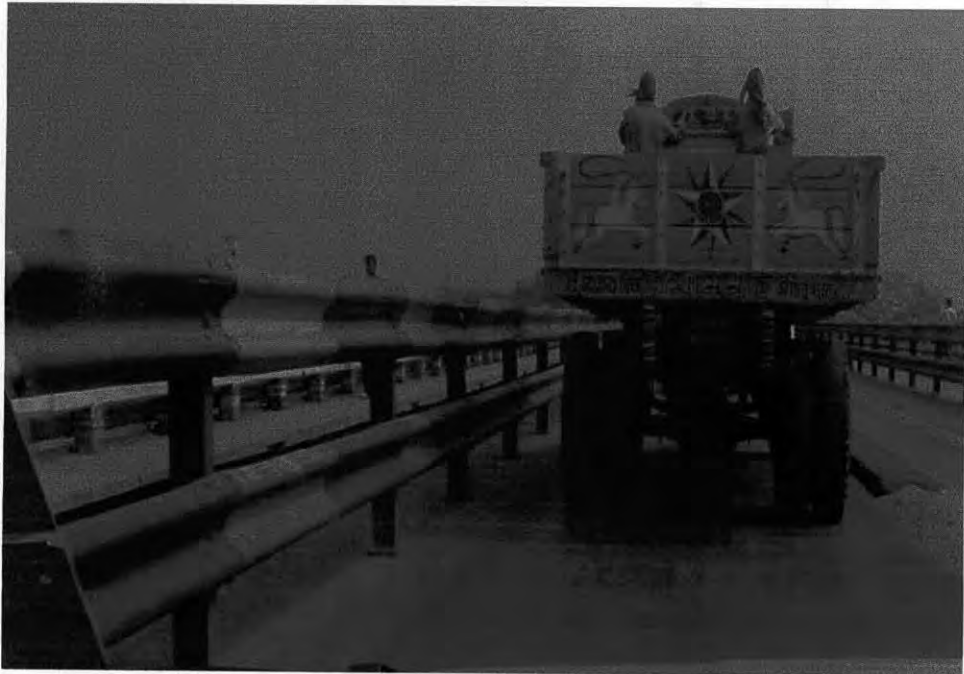
Figure 5.8 W-Beam Type Guard rail is an Ideal solution

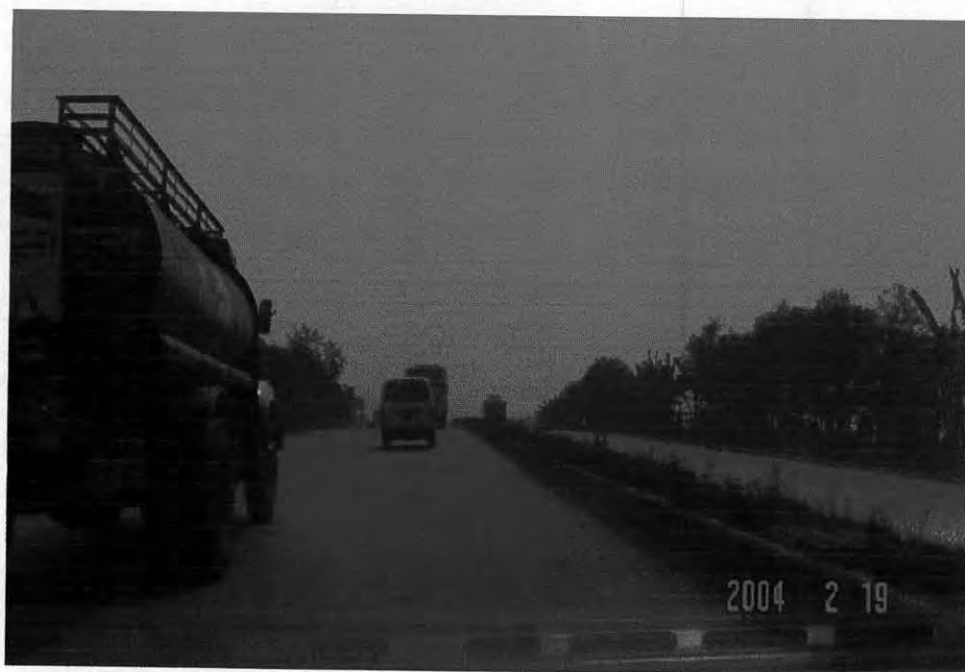
Figure 5.10 Median has Varied Height & Shape

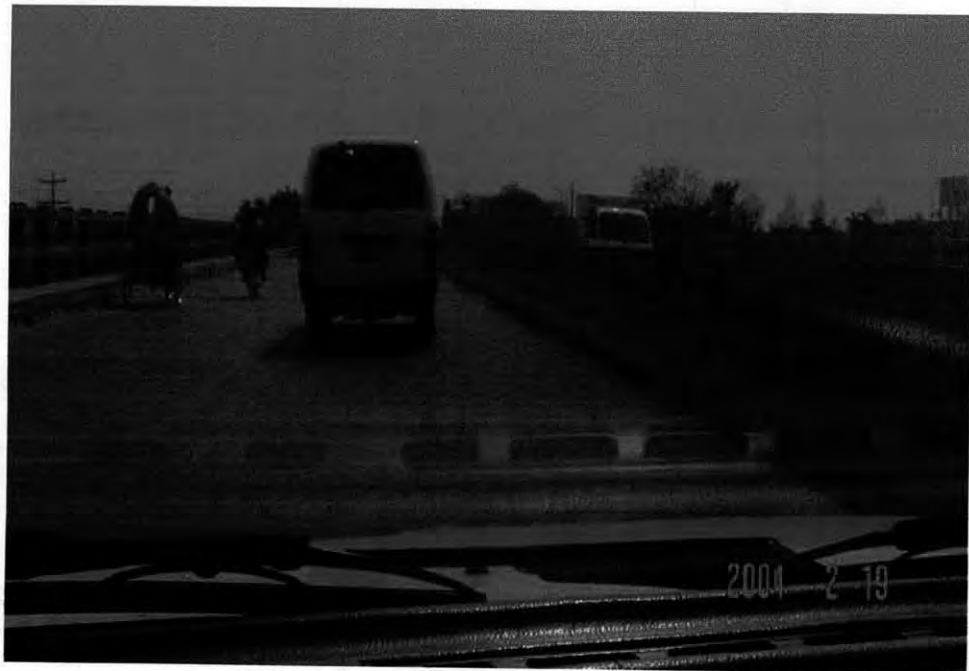
Figure 5.11 New Jersey Type Median Could be an Ideal Solution

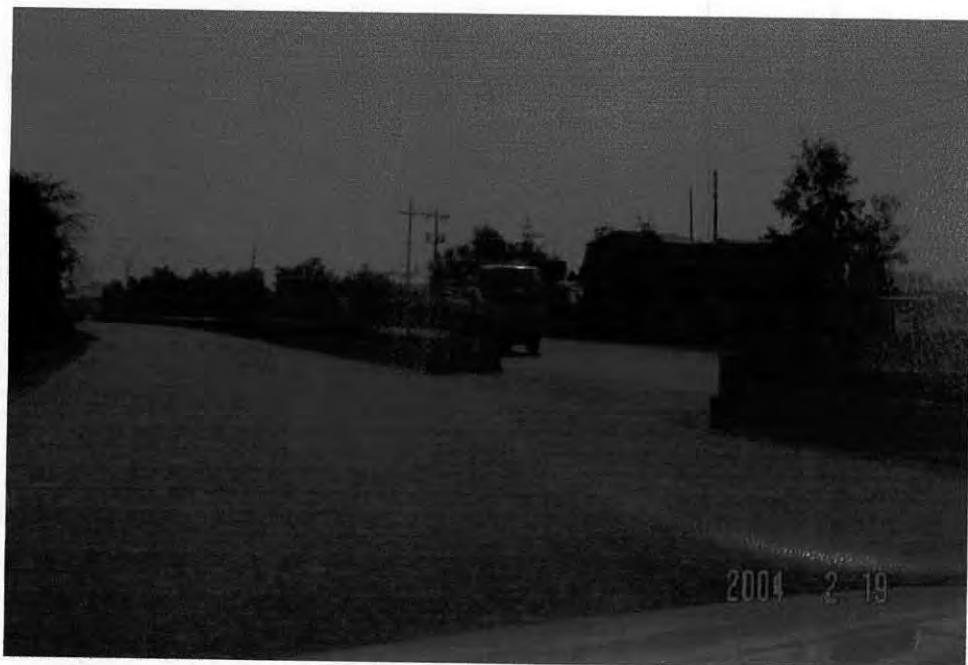
Figure 5.12 Frequent Opening at Median Invites right Angle Collision

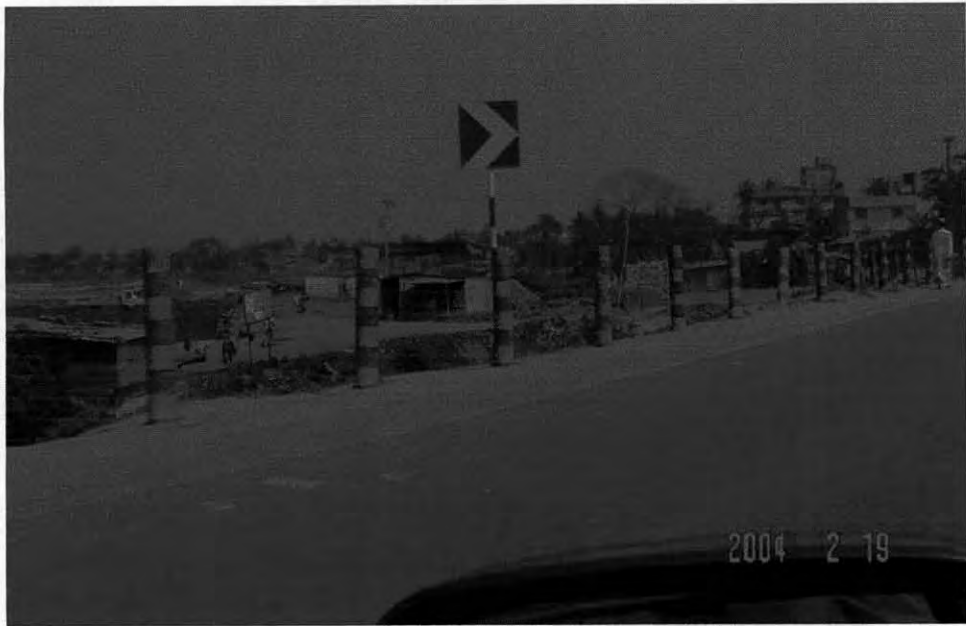
Figure 5.13 Chevron Should be Continuous

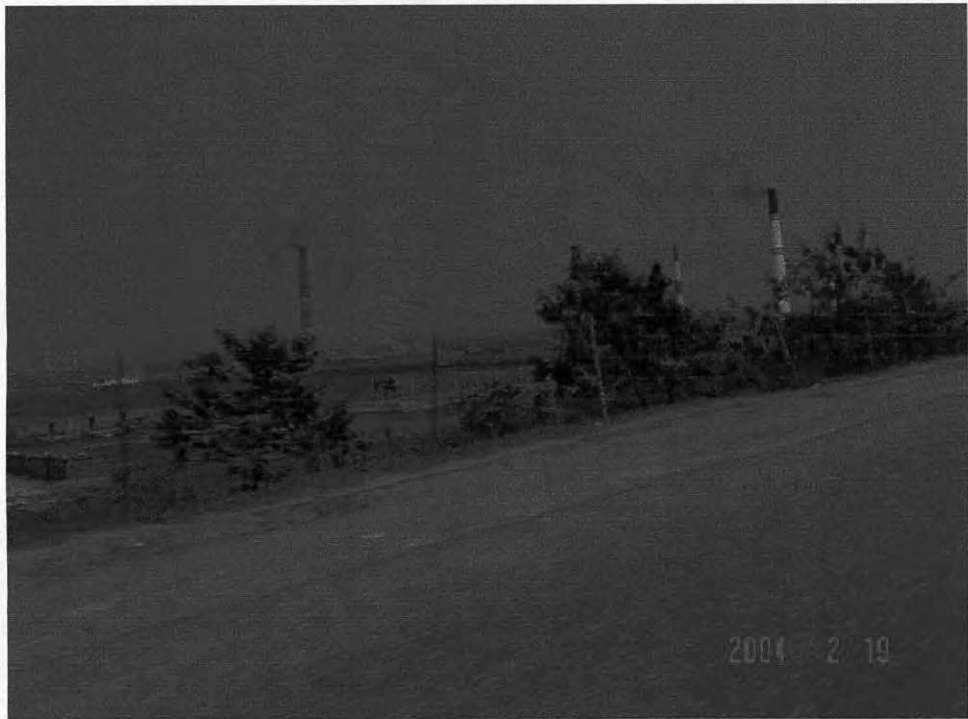
Figure 5.14 High Vertical Drop near Bridge is Hazardous

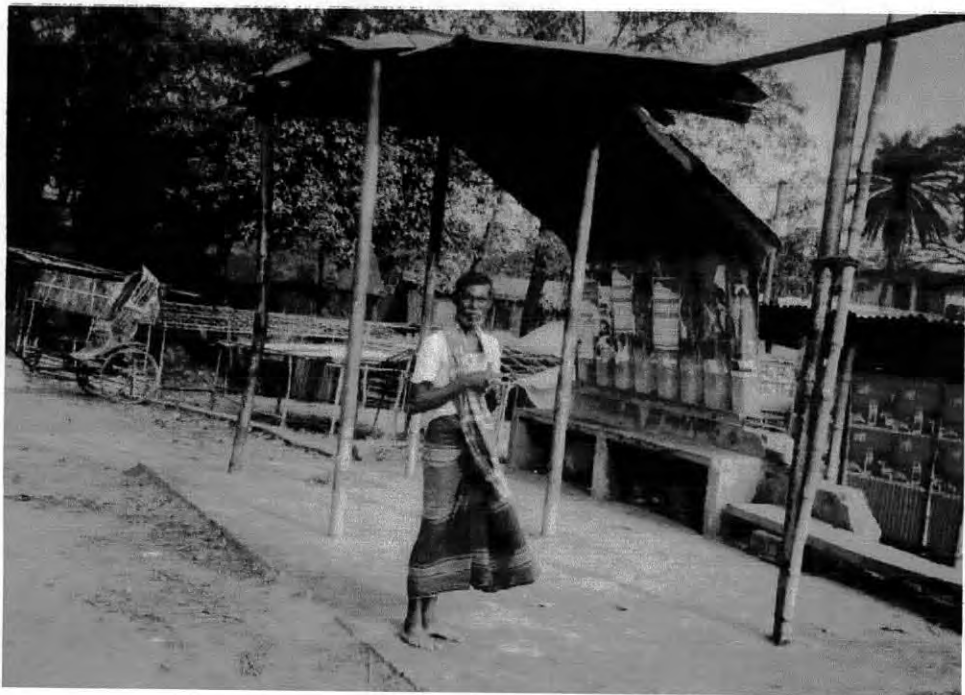
Figure 5.16 Newly Constructed bus shed at Baliha is Already Damaged
