**FLOW AND EROSION PROCESSES AT BENDS AND AROUND RIVER  
TRAINING WORKS IN A SAND BED BRAIDED RIVER**

**MOHAMMAD NAZIM UDDIN**

**DOCTOR OF PHILOSOPHY**

**INSTITUTE OF WATER AND FLOOD MANAGEMENT  
BANGLADESH UNIVERSITY OF ENGINEERING AND TECHNOLOGY  
DECEMBER 2010**

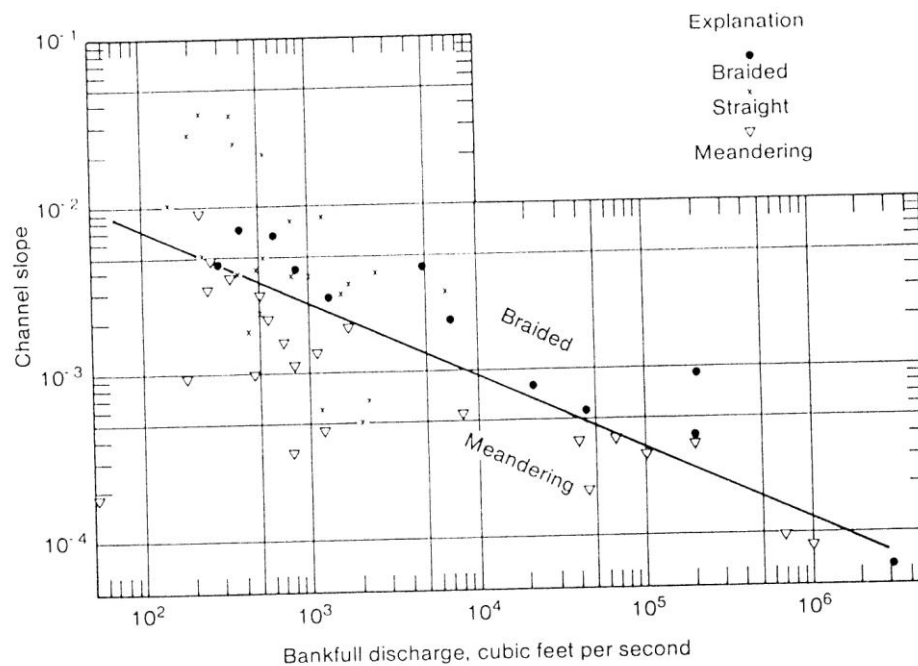
Figure 1.1: Slope discharge relationship as differentiation between meandering and braided (Leopold and Wolman, 1957)

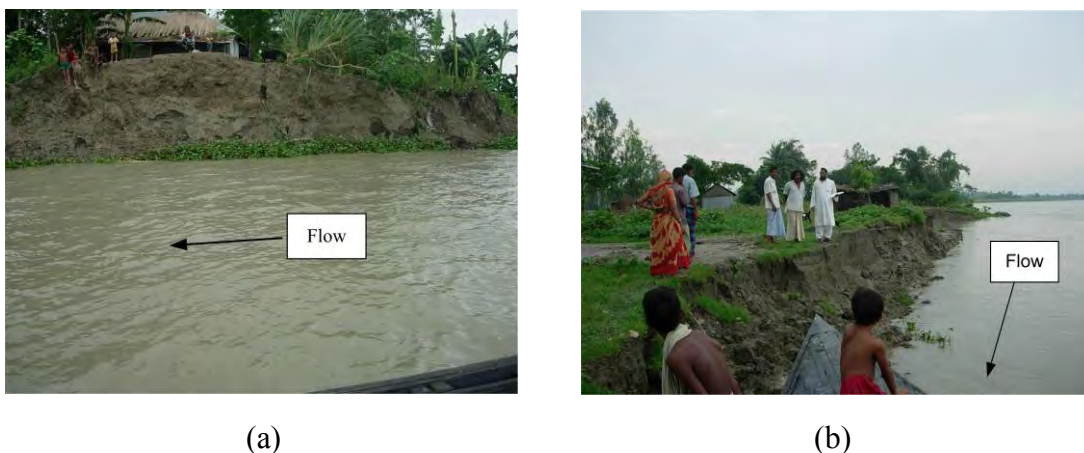
Figure 1.4: Erosion at Shuvogacha bend along the right bank of the Jamuna River

Riverbank erosion is one of the major natural hazards of Bangladesh (Fig. 1.4 a-b). Erosion has rendered millions of people homeless and landless, and has created a major social hazard. Most of the slum dwellers in large urban metropolitan towns and cities are victims of river bank erosion (CEGIS, 2009). Some erosion affected people take shelter on Brahmaputra Right Embankment (BRE) and some live into the char (high sandbar). In 2008, about  $1820 \text{ ha}$  land is eroded by the Jamuna River and about  $18,000$  people are displaced by riverbank erosion. The livelihood strategy of charland people is described by Schmuck-Widmann (2001) and Sarker et al. (2003). Every year, embankments, roads, educational institutions, bazaars, health centers and different government offices are damaged by erosion. Related to river bank erosion, detailed studies were carried out on

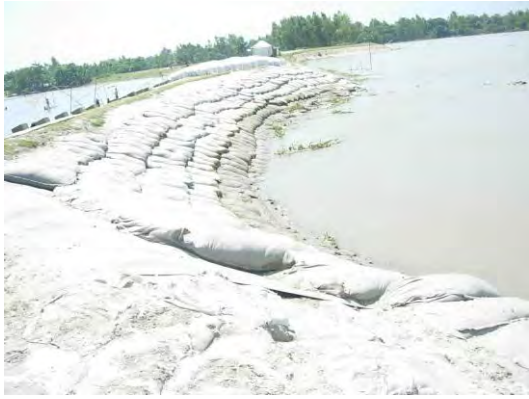
(a) Slip circle failure of the earthen shank of the Chandanbaisha spur (2007)

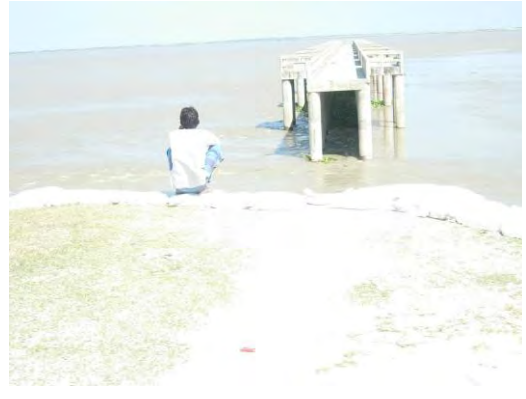
(b) Failure of bellmouth of the Baniajan spur (2007)

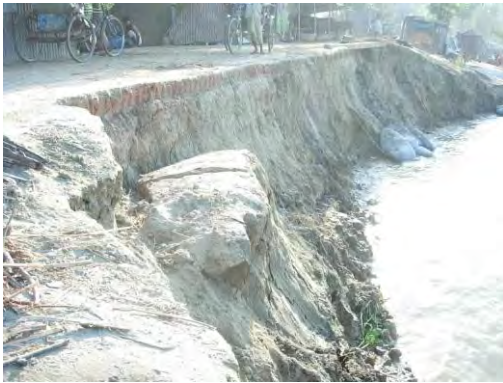
(c) Mass failure of the Ranigram groin (2007)

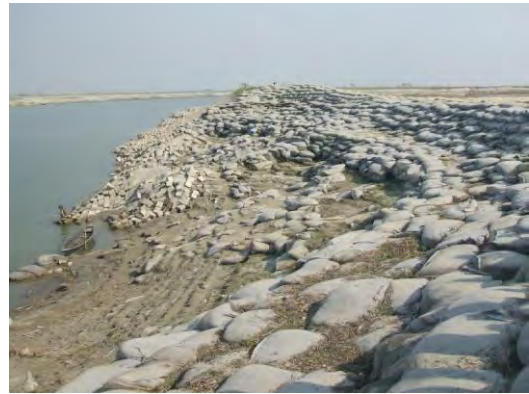
(d) Slip circle failure of the earthen shank of the Enayetpur spur (2007)

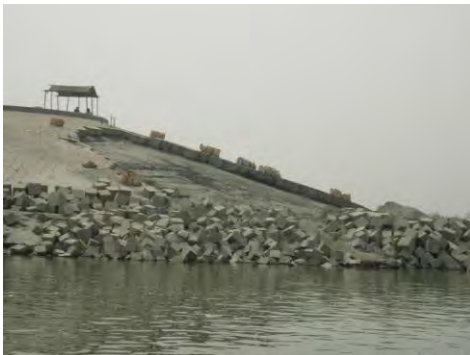
(e) Failure of the Sirajganj hardpoint (2008)

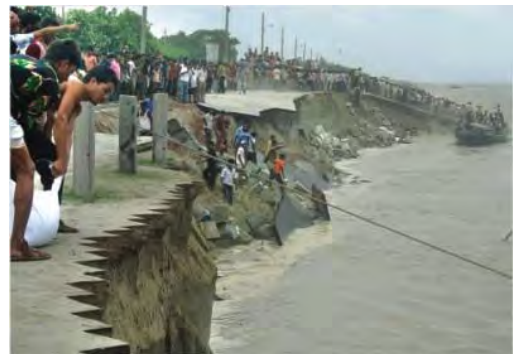
(f) Failure of the Sirajganj hardpoint (2009)

developed deepest scour depth before failure of the hardpoint was higher than -11mPWD. The flow slide is occurred from the revetment side. As a result the hardpoint is failed. The scour hole is filled up by the sliding materials. The catastrophic failure of the hardpoint on 10<sup>th</sup> July, 2009 is shown in Fig. 1.5(f).

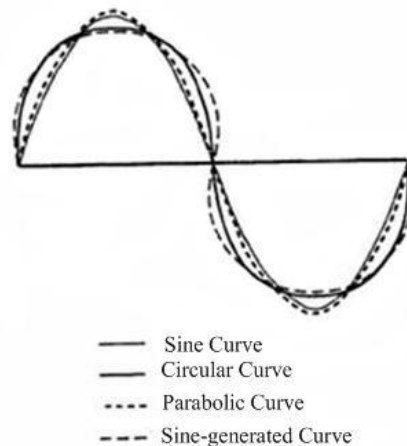
Figure 2.1: Geometric curves investigated by Langbein and Leopold to define meander shape (courtesy: Langbein and Leopold, 1966)

Leopold (1966) attempted to characterize the planform of meanders in terms of a generalized geometrical shape. Fig. 2.1 shows four types of curves proposed by them. They found that the sine-generated curve is an idealized one to represent most of the meandering channels. This curve closely approximates the curve of least work in turning around the bend, and they explained that this is the reason why natural rivers follow the shape of a sine-generated curve.

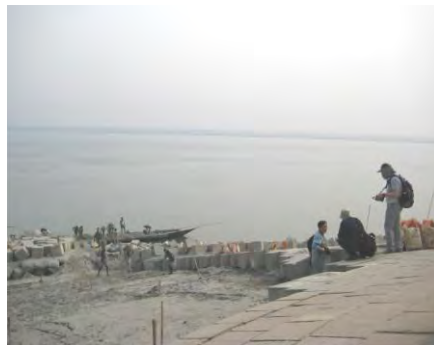
Figure 4.3: Failure part of the Sirajgang hardpoint (March, 2008)

The thickness of the launching apron is 1.93m. Design flow velocity is 3.7m/s. The length of the apron is 1.5 times the scour depth (below the apron setting level). The crest level is (+) 16.75mPWD, whereas approximate ground level is (+) 13.00mPWD. The side slope of the hardpoint is 1V:3.5H. Some design parameters of straight portion and upstream termination of Sirajgang hardpoint are shown in Table 4.1. The length of an apron on upstream termination and thickness are 19.5m and 3.83m respectively. The Sirajgang hardpoint faced the greatest flood in the history of the Jamuna in 1998 just after its construction. Due to unfavorable bathymetric development (common in the Jamuna) at the upstream of the Sirajganj hard point, the scouring rate at the upstream part of the structure was very quick.

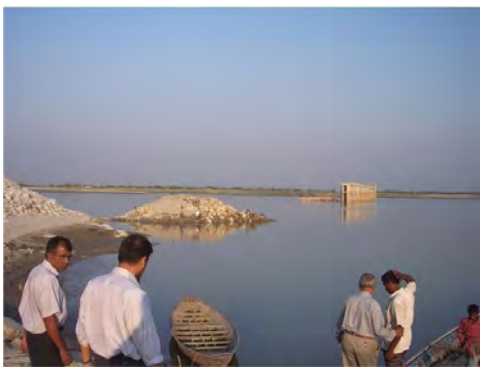
(a) Betil spurs, 2004

During the 2003 flood, a slip circle failure at the earthen shank over a length of 200 m occurred in Enayetpur. In Betil, a slip circle failure of the earthen bell-mouth occurred. The damaged part of the spur was repaired. The earthen bell-mouths and RCC-parts of both spurs were strengthened by the dumping of CC-blocks and geo-bags. Failure of the earthen shank or belmouth (connection of earthen shank and RCC) has occurred at both spurs during the monsoon since their construction. The earthen shank of both spurs was washed away during the flood of 2004. The disconnected RCC part of the Betil spur is shown in Fig. 4.4 (a). The RCC part of the Betil spur was opened and water started to flow beneath the RCC part of the spur. Since then it is working as a permeable spur or to some extent as bandal-like structure. A major rehabilitation programme was implemented in 2006. During rehabilitation work CC blocks were dumped as launching apron at the rate of 25 m<sup>3</sup>/m at the RCC portion and at the rate of 20 to 50 m<sup>3</sup>/m at the earthen shank and the belmouth. Almost every year a portion of the earthen shank is damaged and a huge amount of maintenance budget is required for repairing of the failure part. The failure of the earthen shank of the Enayetpur spur in 2008 is shown in Fig. 4.4 (b).

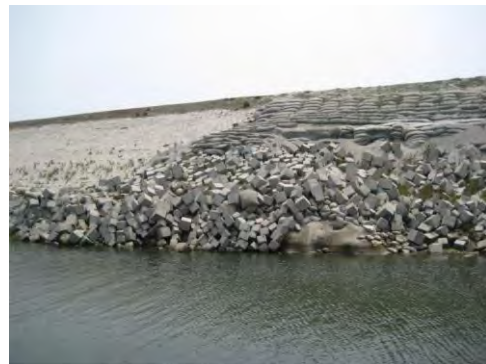
(b) Enayetpur spur, 2008

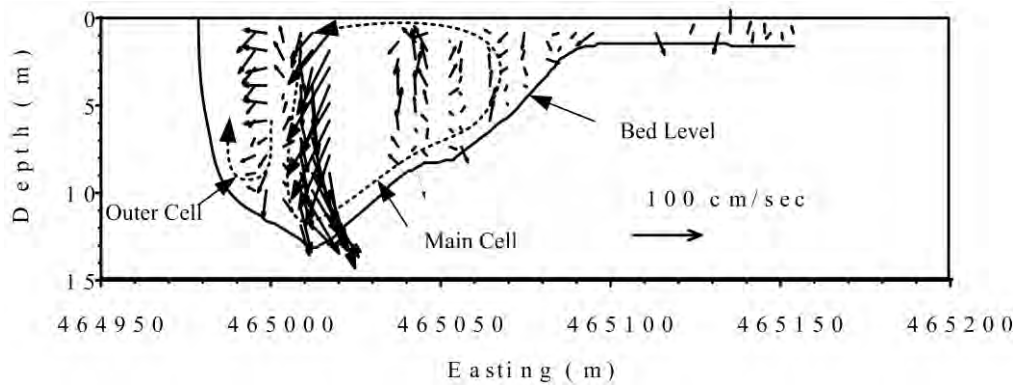
Figure 5.6: Secondary current at section a-a

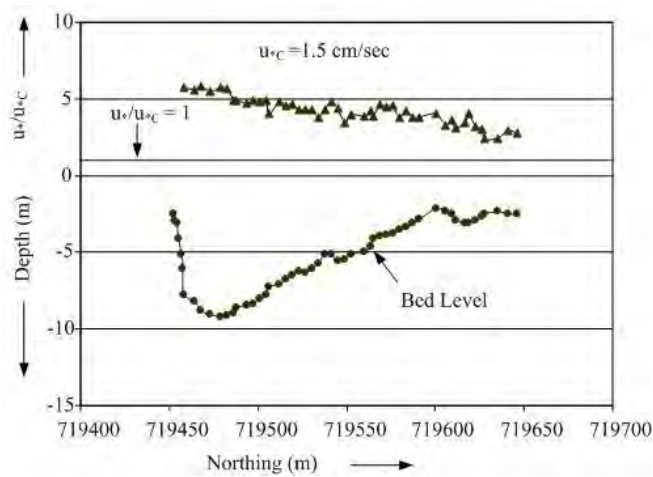
Figure 5.10: Shear velocity along line d-d

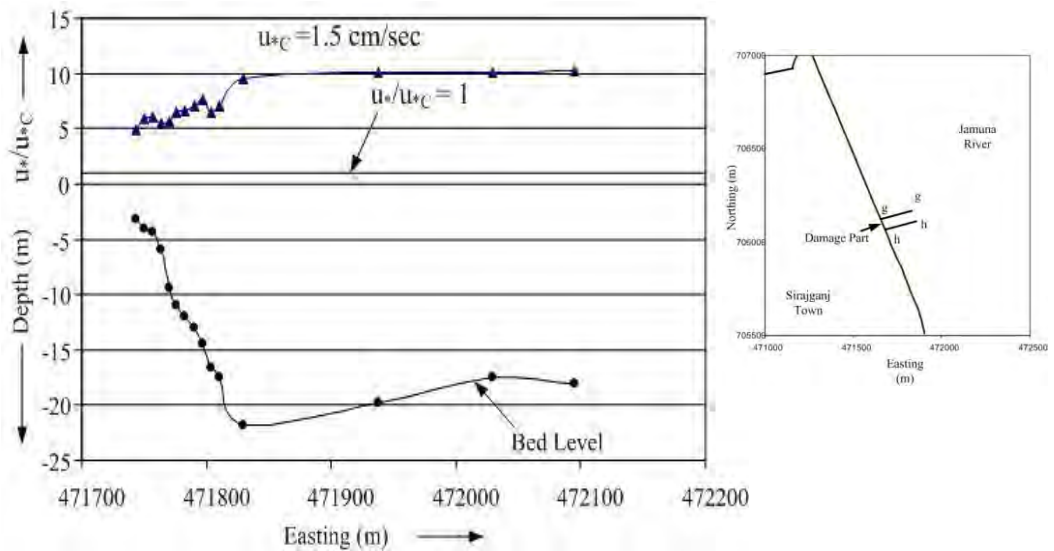
Figure 6.8: Variation of ratio of the shear velocity along vertical section h-h

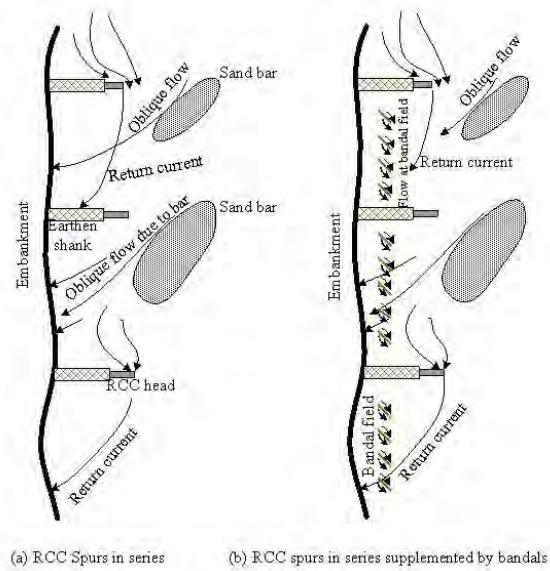
Figure 6.28: Conceptual model of bandal-like structures in between RCC spurs
