**DEVELOPMENT OF CLIMATE RESILIENT SLOPE
PROTECTION FOR DYKES IN SALINE ZONES OF
BANGLADESH**

MASTER OF SCIENCE IN CIVIL ENGINEERING

**BANGLADESH UNIVERSITY OF ENGINEERING AND
TECHNOLOGY**

JUNE, 2015

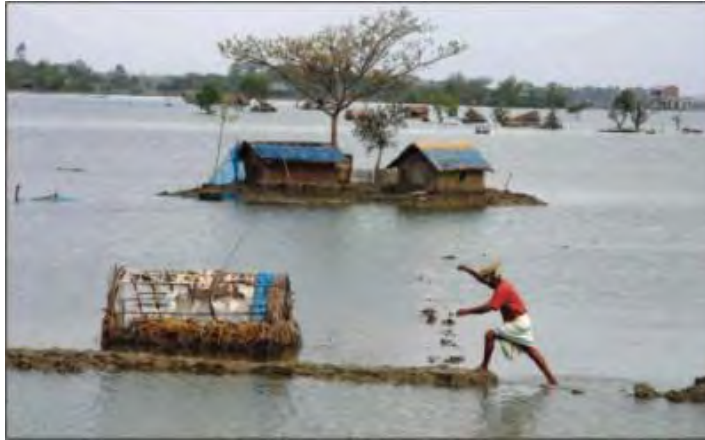
Figure 1.2 Situation of pond dykes during flood. (Source: <http://archive.thedailystar.net>)

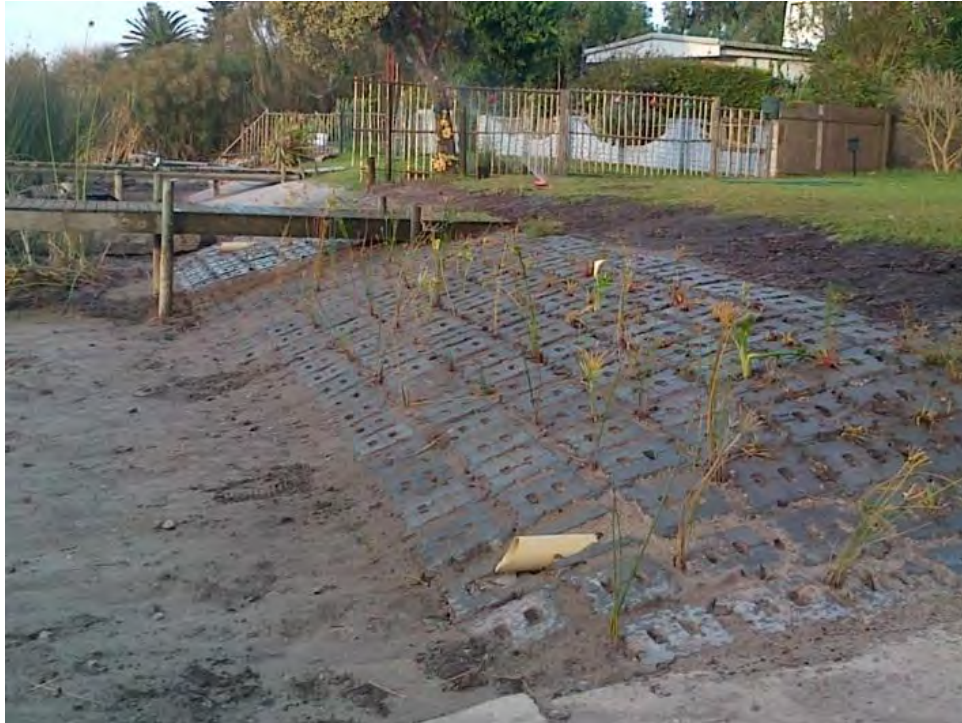
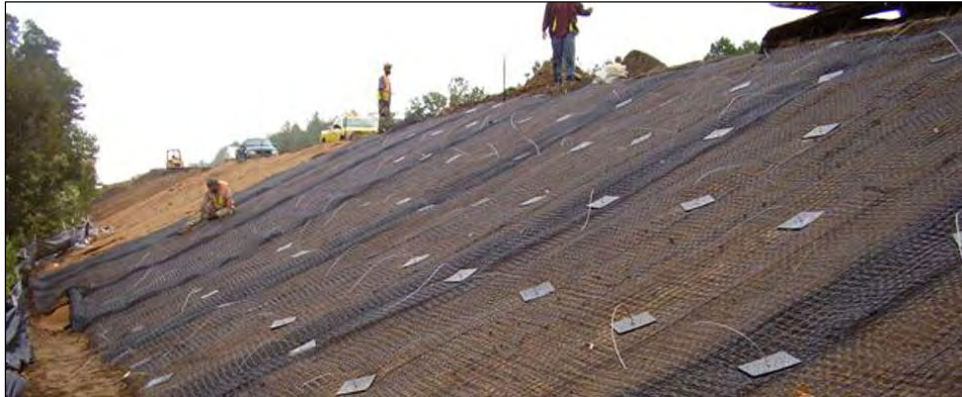
Figure 2.5 View of conventional slope protection methods in Bangladesh (a) CC block with vegetation; (b) geotextile over the embankment.

There are several methods available for slope protection worldwide. In Bangladesh use of RC Wall at the bottom of the slope, driven cantilever wall, reinforced earth wall, CC block, geo-textile over the slope are very common to stabilize the slope. Figure 2.1 shows different slope protection methods used around us which consists driven cantilever wall, reinforced earth wall, RCC wall etc. and these are very useful for protecting large amount of soil at a time. On the other hand Figures 2.2, 2.3 and 2.4 shows some conventional slope protection methods used in Bangladesh by local government engineering department and roads and highways department. Figure 2.5 shows some conventional application view of cc block with vegetation and use of geotextile over embankment slope. Currently these methods are widely used in Bangladesh in rural and urban areas.

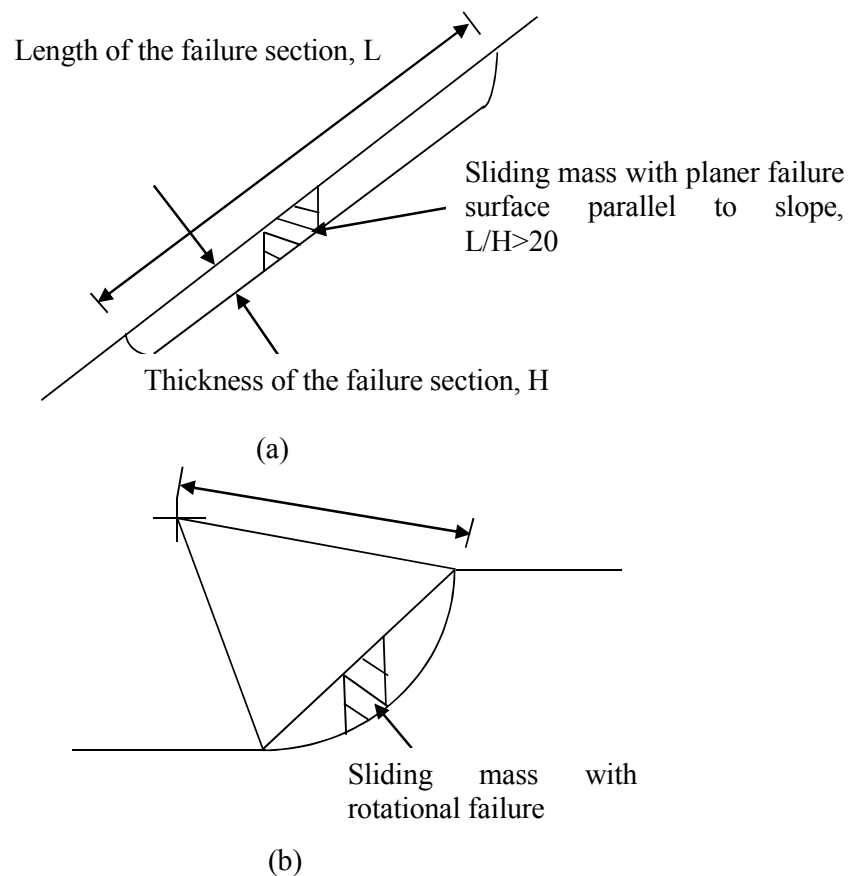
Figure 2.6 Mechanics of slope stability analysis; a) transitional failure; b) rotational failure, circular arc model (after Gray and Sotir, 1996)

Slope stability is evaluated by the factor of safety (FS) which is defined as the ratio of resistance of the soil mass to shear along a potential slip plane to the shear force acting on that plane. Soil failures occurs when the ratio falls to unity.

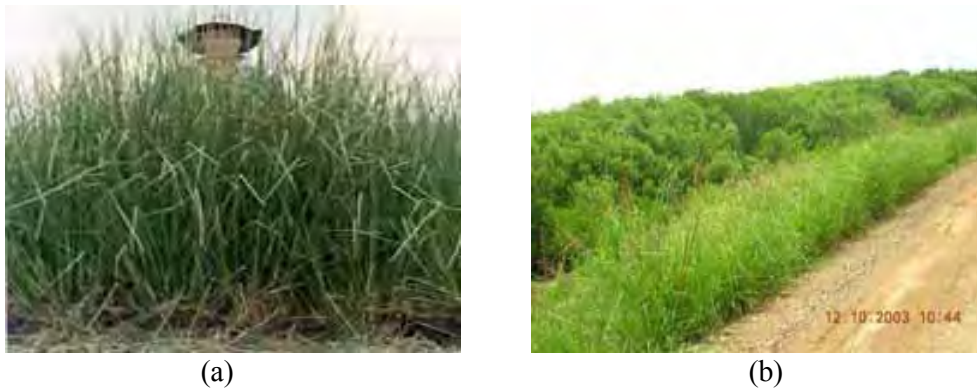
Figure 2.10 Erect and stiff stems form a dense hedge when planted close together (a) close view; and (b) long view

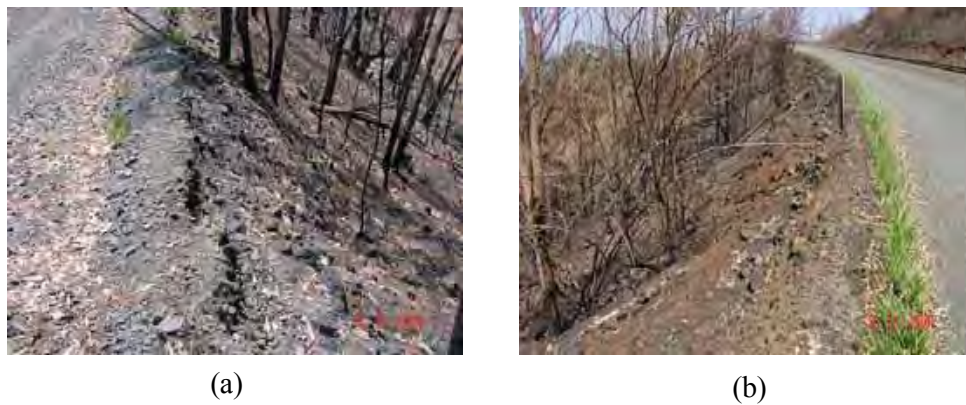
Figure 2.11 View of vetiver grass surviving the forest fire in Australia (a) just after fire; and (b) two months after fire.

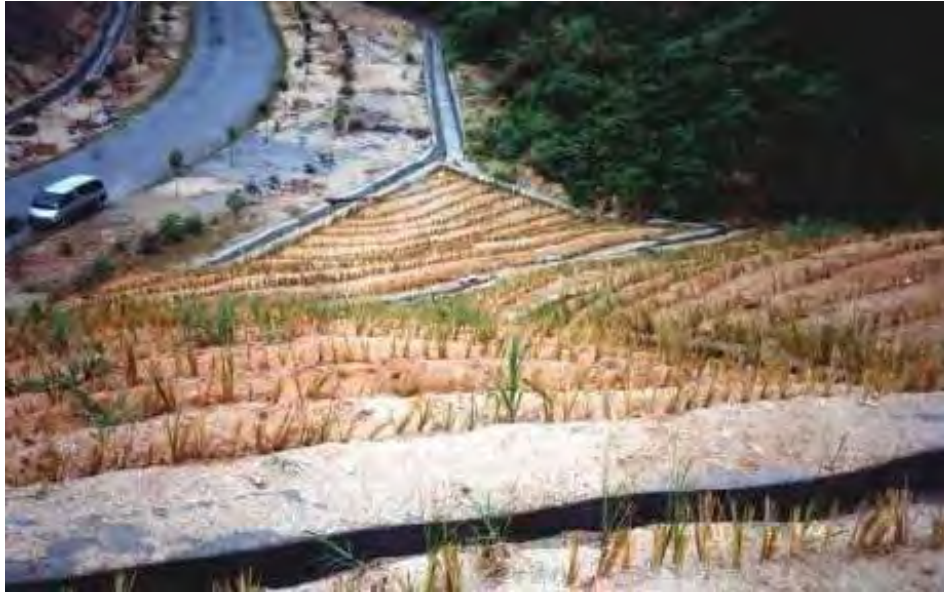
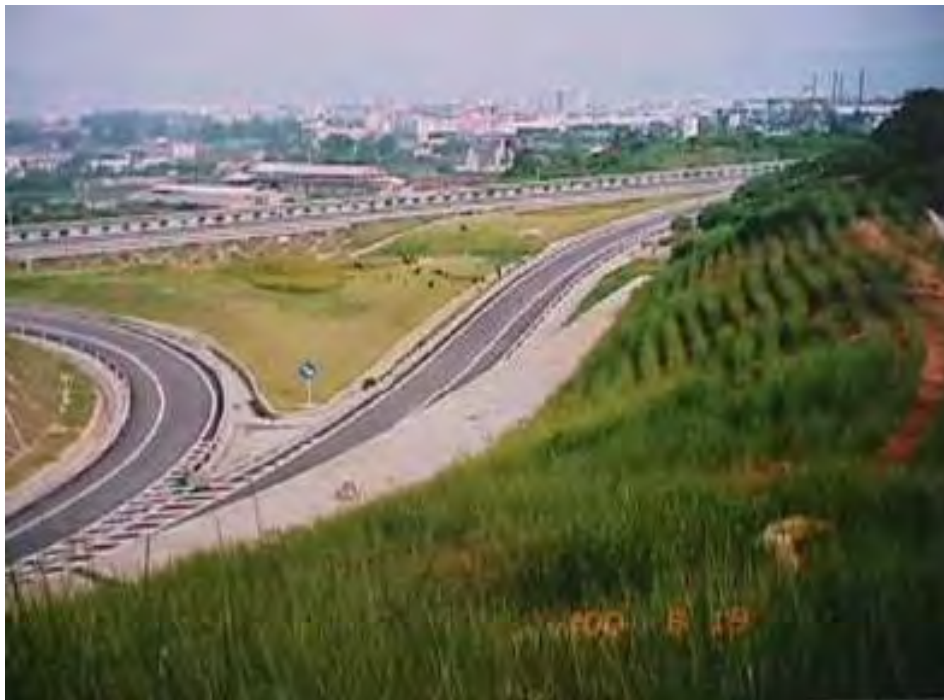
Figure 2.12 Views of vetiver application at highway of Fuzhou, China. (a) before plantation of vetiver; (b) after plantation of vetiver. (Source: http://www.vetiver.org/CHN_Fuzhou_highway.htm)

well there where as performance of concrete protection was not satisfactory. It was planted by Madam Zhang under the finance of World Bank. Figure 2.12 shows before and after condition of vetiver plantation over the slope at Fuzhou, china. Figure 2.13 shows the use of vetiver for river slope erosion control at Guangdong, China. Before application of vetiver this river bank amount of erosion was very high. To mitigate the issue, vetiver was plated on 2001 and it was found that, just after three years of plantation the slope was successfully free from erosion and become highly stable one.

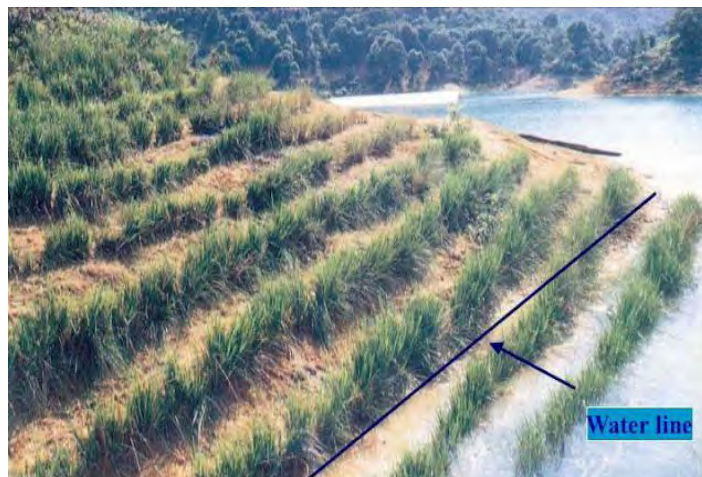
Figure 2.13 River slope erosion control using vetiver at Guangdong, China (a) eroded condition before application, (b) view after two months of vetiver plantation and (c) view of site after three years of plantation. (Source: Truong., 2010)

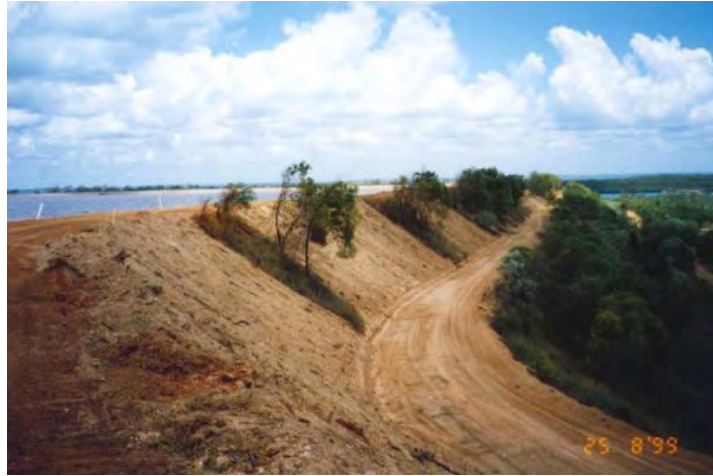
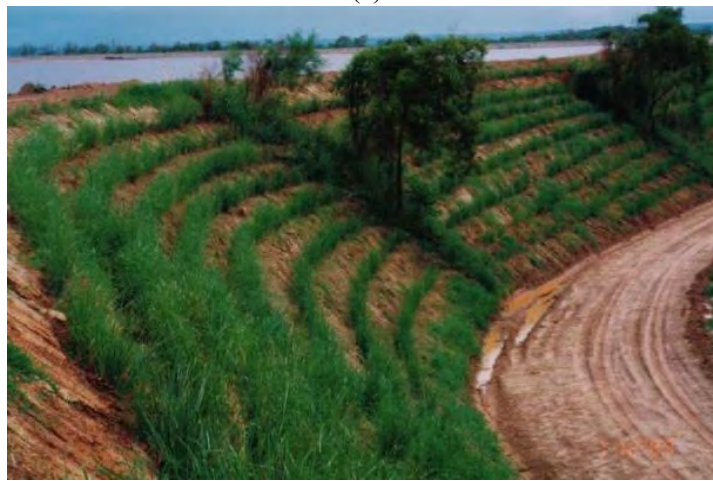
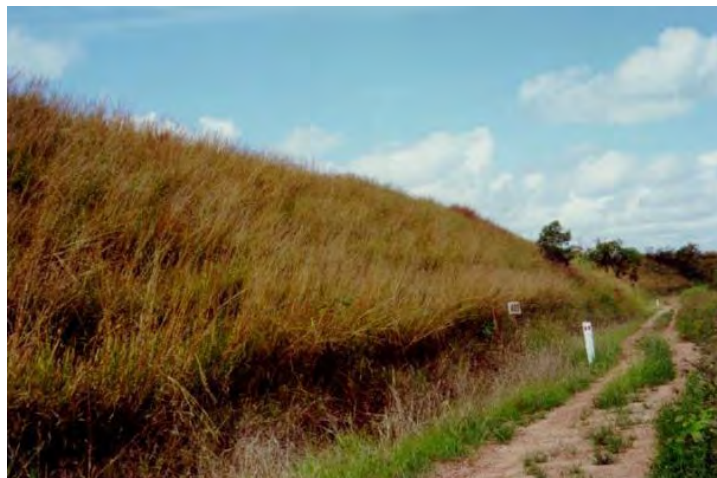
Figure 2.14 Dam wall repair using vetiver grass in Australia (a) before vetiver application, (b) six months after vetiver plantation and (c) two and half years after vetiver plantation. (Source: Truong., 2010)

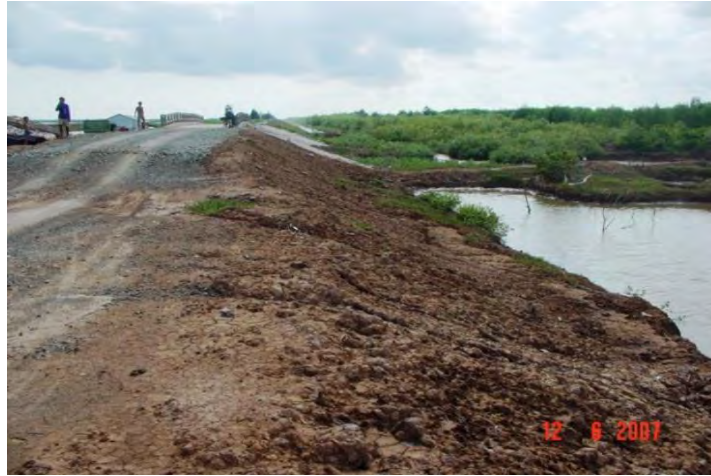
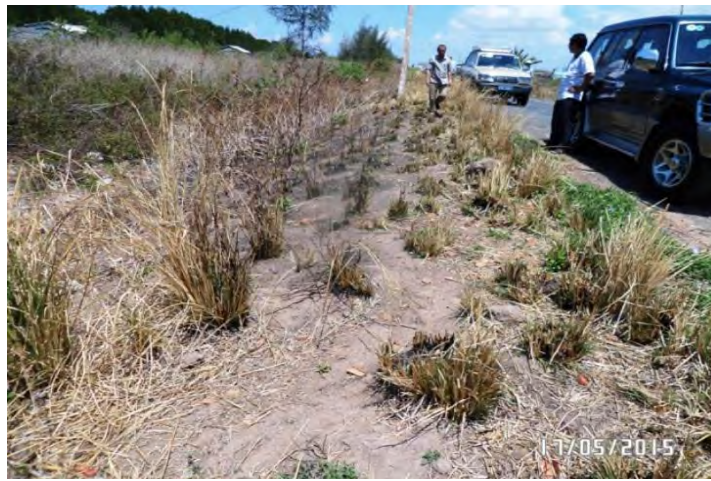
Figure 2.15 shows the application of vetiver grass to protect the dykes of shrimp pond in Mekong Delta, Vietnam. Due to flat topography, those shrimp farming ponds were vulnerable to daily tidal movements, king tides, tidal surge during rainy season and occasional typhoons. Vetiver were planted in 2007 to protect the side slopes and it was found very effective around the year. Figure 2.15(a) shows the slope before plantation of vetiver and Figure 2.15(b) shows the slope condition after eight years in 2015. Vetiver grew very well during this period and protect slopes from natural calamities by all means. Every year during dry season these vetiver burns in fire to protect it from weeds. Figure 2.15(c) shows condition of vetiver grasses after burning. It was found that, vetiver system was very effective in establishing and protecting dykes from adverse elements commonly experienced in coastal zone.

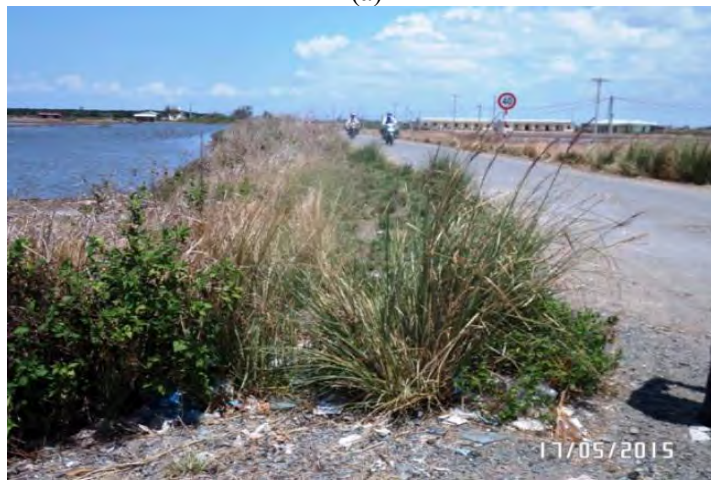
Figure 2.15 Shrimp pond dyke protection in Mekong Delta, Vietnam (a) dyke slope before vetiver application, (b) eight years after vetiver plantation and (c) burning of vetiver in dry season to control weed. (Source: Truong., 2015)

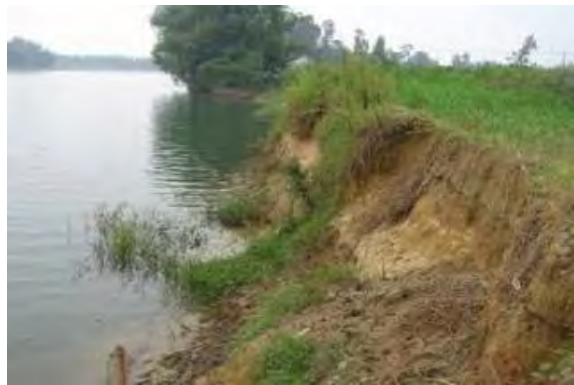
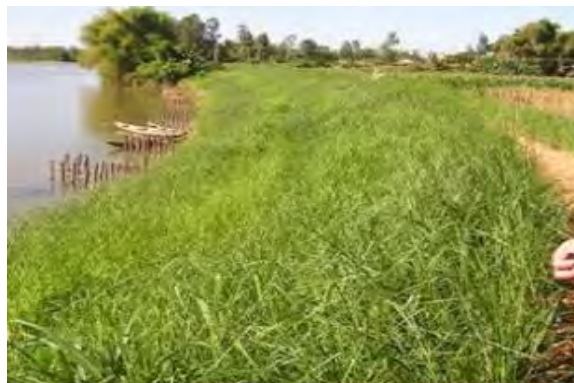
Figure 2.16 River bank slope protection using vetiver grass at Tra Khuc River, Vietnam

(a) before vetiver application, (b) four months after vetiver plantation (Source:

Figure 2.16 shows protection of river bank with vetiver application at Tra Khuc river of Vietnam. Earlier this river bank was erosion prone and after application of vetiver grass by the local community it turns into an intact slope even after flood season.

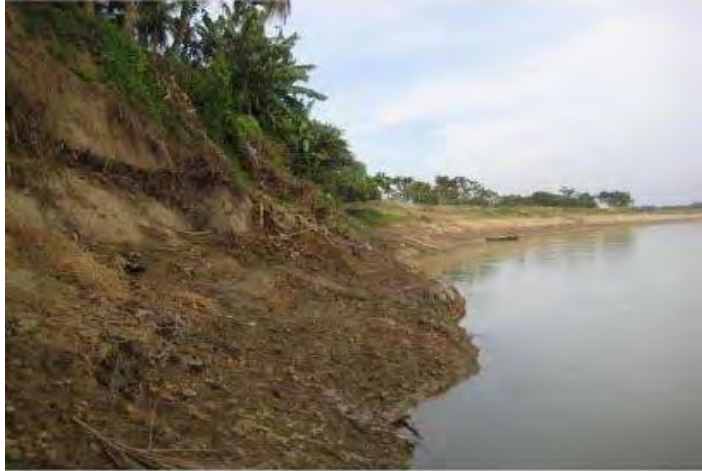
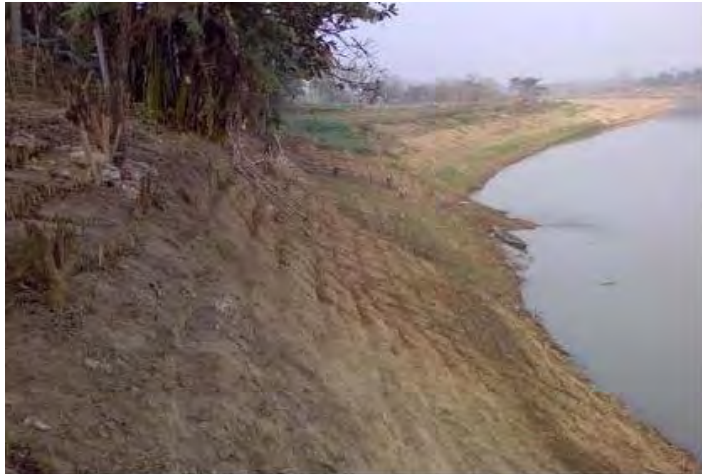
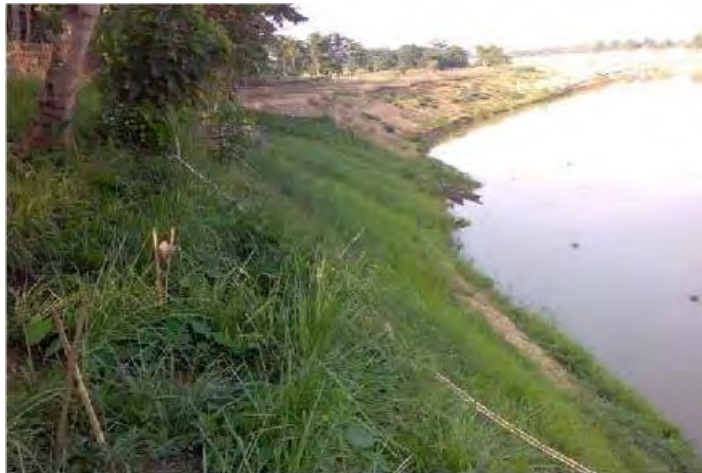
Figure 2.17 River bank slope protection using vetiver grass at Kolong river of Assam, India (a) river bank before vetiver application, (b) vetiver plantation at grid pattern, (c) slope with grown vetiver (Source: Bhattacharyya, 2010).

Vetiver worked very well in Assam for river erosion and slope protection. PWD of Assam used vetiver in many places to assess its potentiality and found that it has great power to control erosion at river bank at other areas. Figure 2.17 shows stages application of vetiver grass at the bank of river Kholong at Assam. Vetiver were planted in row pattern there which helps protecting wave attack directly. Being the tributary of river Brahmaputra river bank soil was silty in condition. Thus it proves that vetiver grows well in silty condition also.

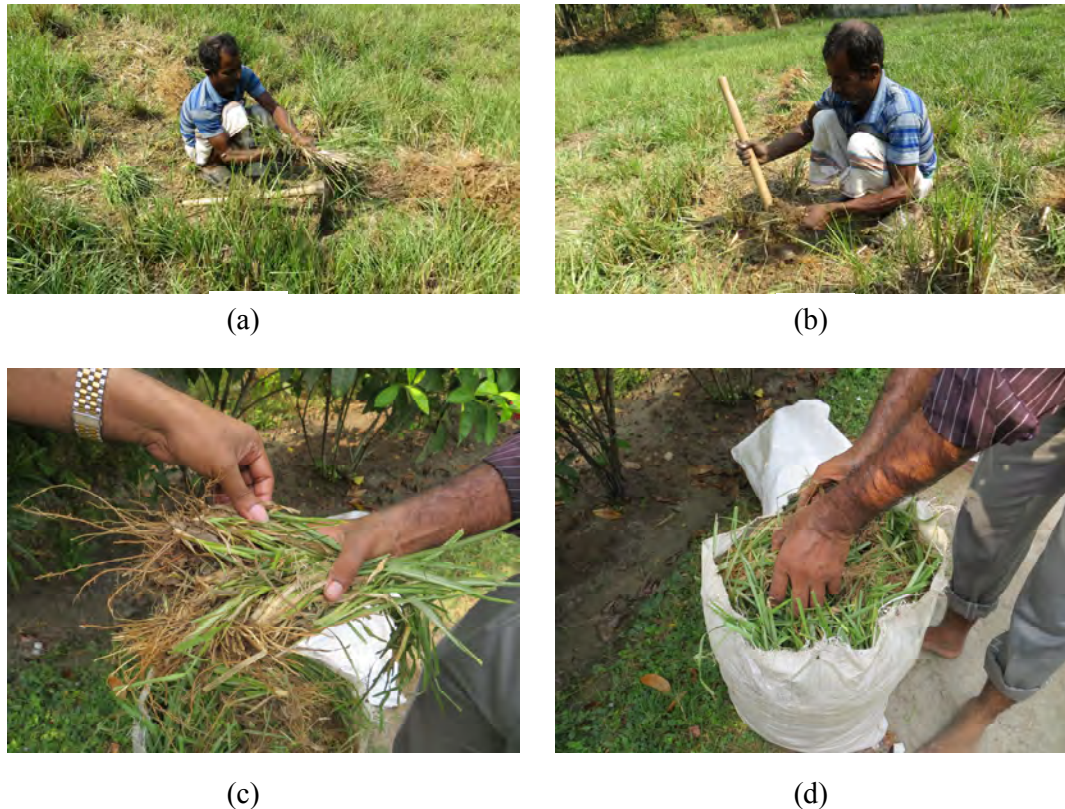
Figure 3.1 Vetiver grass collection procedure: (a) grasses are plucking form grown field; (b) extra soils are putting down from stems; (c) grasses before putting in sacks; (d) vetiver grass in sack bag.

To keep the experiments rational for studying the characteristics of vetiver grass in different level of saline zone, source of these grasses kept same. Plants used in this study had been collected from Pubail of Gazipur area which is situated in North-East side of Dhaka city. A grown field had been chosen as source.

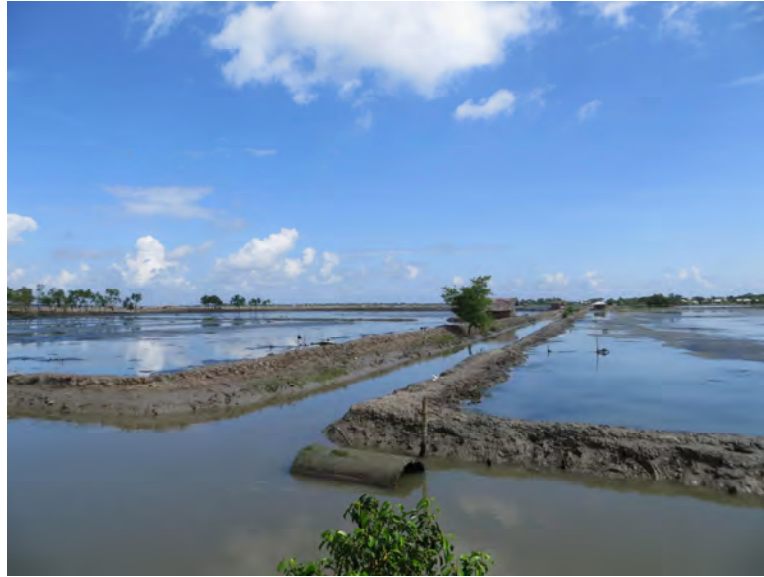
Figure 3.2 View of shrimp pond and dykes in Nildumur.

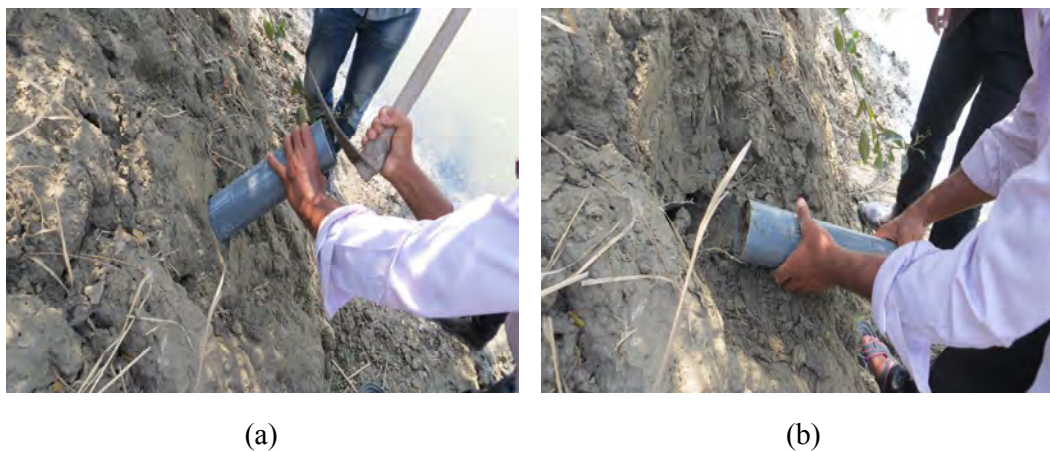
Figure 3.4 Undisturbed soil sample collection procedure (a) insertion of PVC pipe and (b) taking out of PVC pipe with soil sample inside

Two types of soil sample were used to do laboratory tests- disturbed and undisturbed soil samples. Undisturbed soil sample were collected using garden hoe. Polythene bag were used to store those soil sample so that moisture may also retain there. But, collection of undisturbed soil sample were different. To do this, PVC pipe of 7.5 cm diameter and 45 cm length were used. First, pipe was placed perpendicular to the slope and hammered so that it penetrates into the soil up to a at least 40 cm (Figure 3.4a). Then, surrounded soil was dug out to pull up the pipe and undisturbed soils inside (Figure 3.4b). During this pull out procedure proper care were taken so that soil cylinder

does not break inside. Muddy soil and polythene were used to seal the opening of the pipes so that moisture retains as it is.

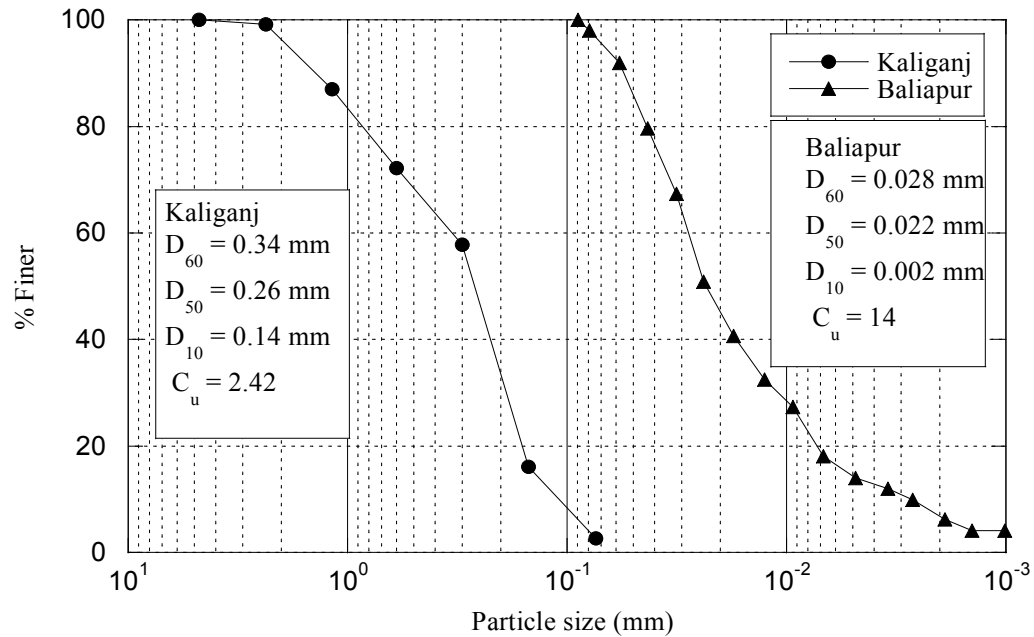
Figure 3.5 Grain size distribution of the soil samples collected from sites

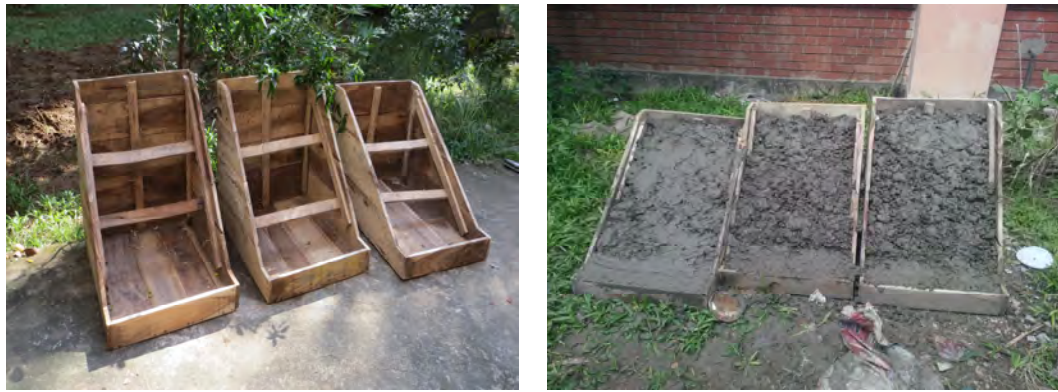
Figure 3.7 Wooden boxes (a) before soil filling and (b) after soil filling

These boxes were filled with soil collected from study area so that growth of grass would represent the saline soil growth. Figure 3.6 shows the measurements of the boxes used in this simulation test and Figure 3.7 shows the wooden boxes at real before and after soil filling. Vetiver grass were planted in these boxes at a distance of 100 mm c/c in both vertical and horizontal direction. At this stage it leave was left for three months. During these three months vetiver used to grow here at it's best level. These boxes were kept in a sunny location so that vetiver grasses could get adequate sunshine. Watering were done for first couple of weeks. Later no external watering were done. During this period weed protection were taken manually. Gardener used to clear the weeds to help it grow smoothly.

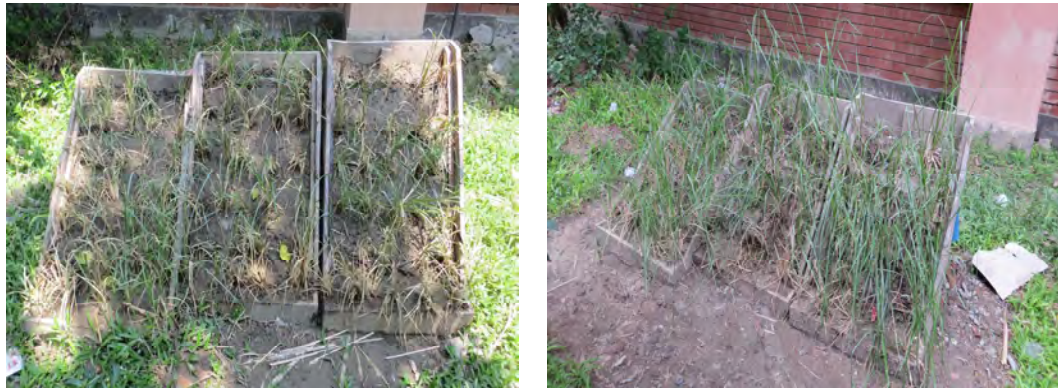
Figure 3.8 Vetiver grass grown on models (a) 15 days after plantation; (b) three months after plantation.

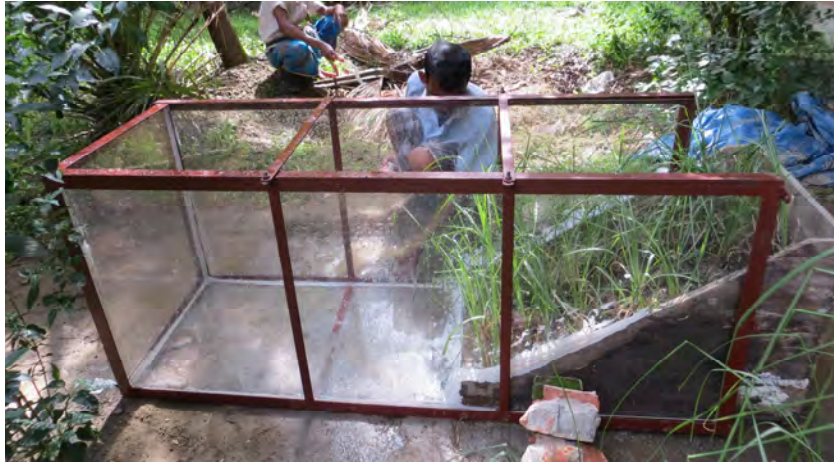
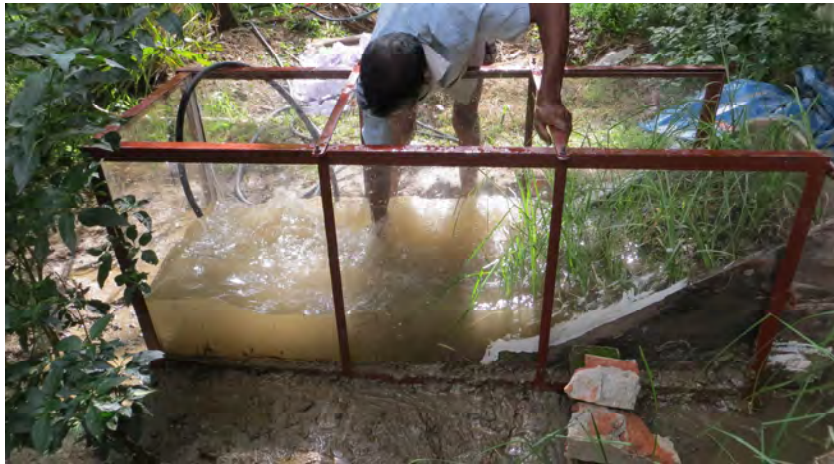
Figure 3.10 Photos of model tests, (a) during water filling and (b) wave generation using hand.

After three months, these boxes with soil were ready for test. An acrylic glass box were made as water container. Figure 3.8 shows wooden box of vetiver 15 days and three months after vetiver plantation. Figure 3.9 shows the schematic diagram of the model setup. Then these two things were attached with angle framing along the outside. After proper waterproofing along the edges, water were poured in the box. This simulates shrimp pond condition. Figure 3.10 shows the actual condition of the model test. After that, hand were used to propagate into the water to generate wave. Those waves were acting as water force along the slope with vegetation. This action were done for 15 minutes. After that, eroded soil were calculated and condition of vetiver grass root were

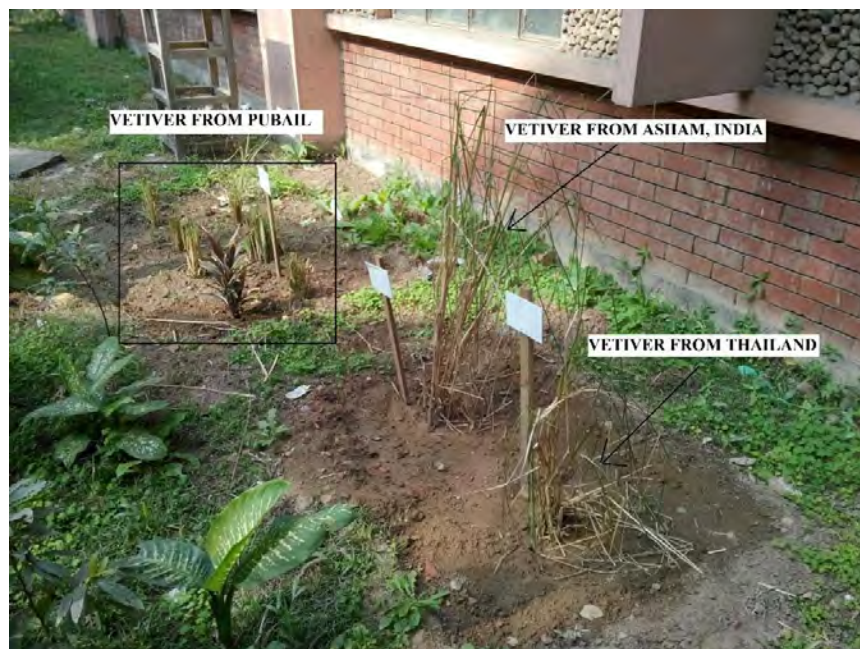
Figure 4.1 Photo showing different grasses planted at BUET premises

Another plant named as *Kans* grass (*Saccharum spontaneum*) which is commonly found in Bangladesh similar to vetiver is also planted in the same place. It was found that among the planted vetiver grasses, the vetiver collected from Pubail grew best.

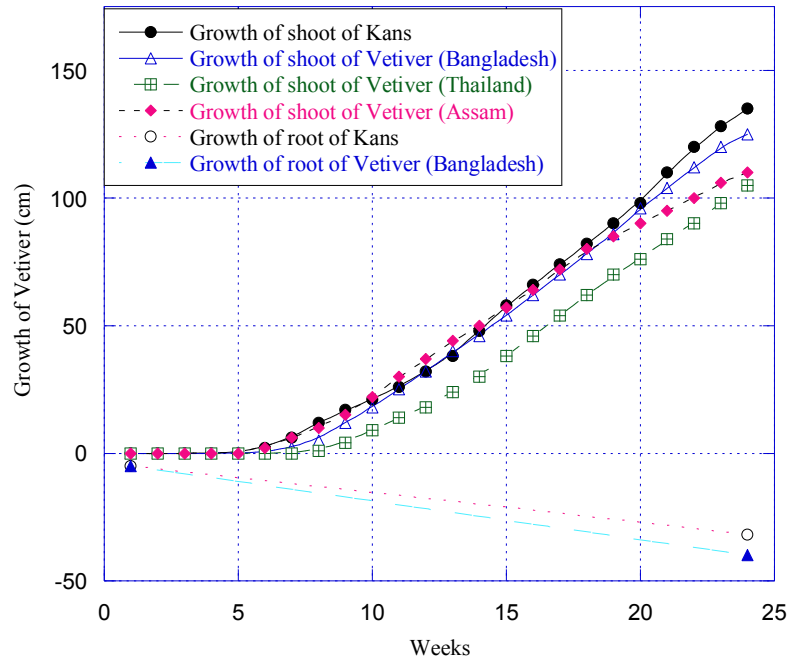
Figure 4.3 Comparative growth chart of root and shoot of different grasses at BUET premises

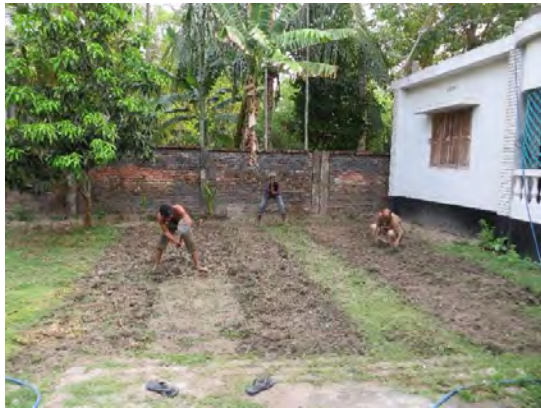
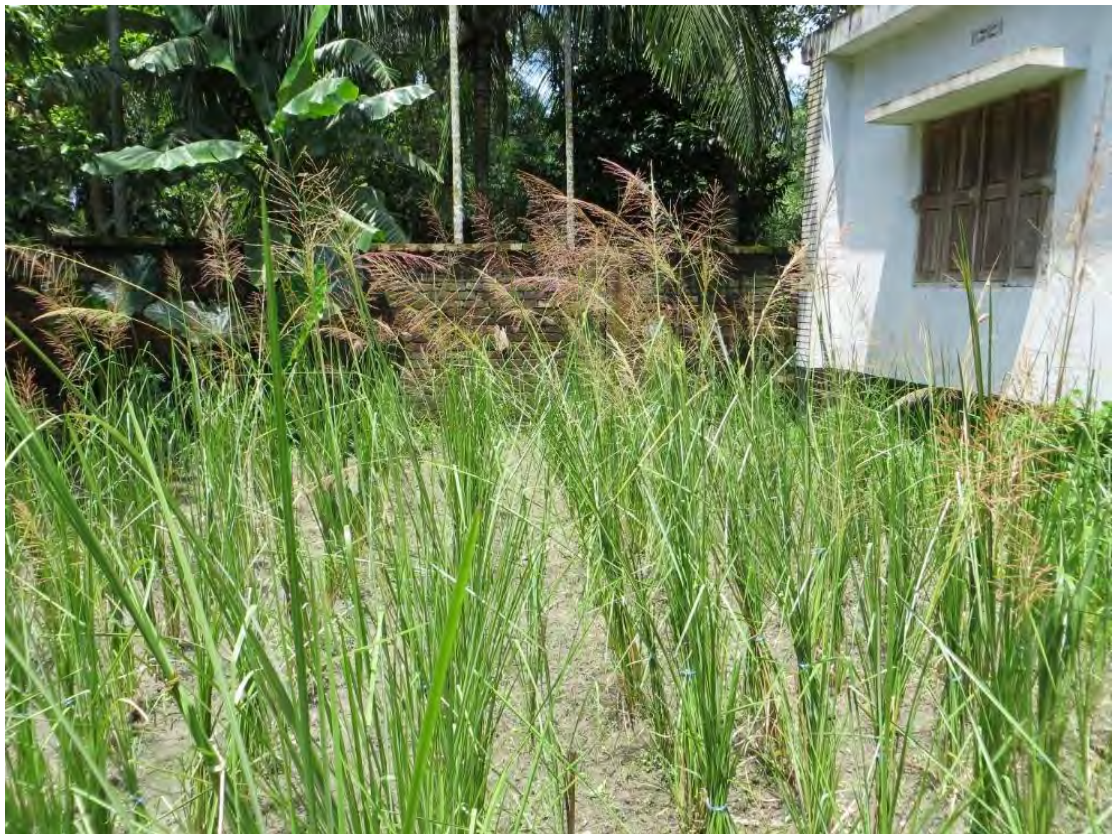
Figure 4.6 Field trials at Kaliganj, Satkhira (a) site preparation; (b) during vetiver plantation and (c) full grown vetiver just after 3 months of plantation.

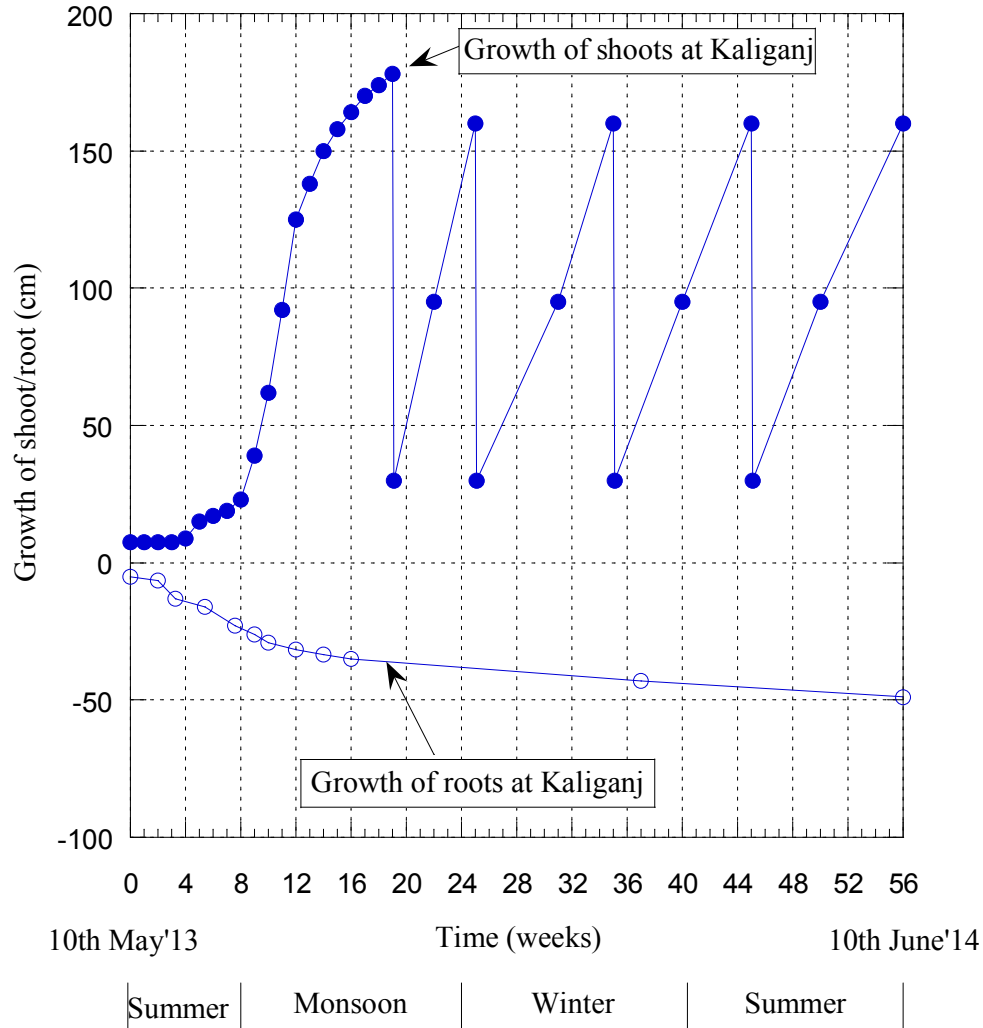
Figure 4.7 Growth chart of vetiver grass at Kaliganj, Satkhira (EC 1.57 ds/m).

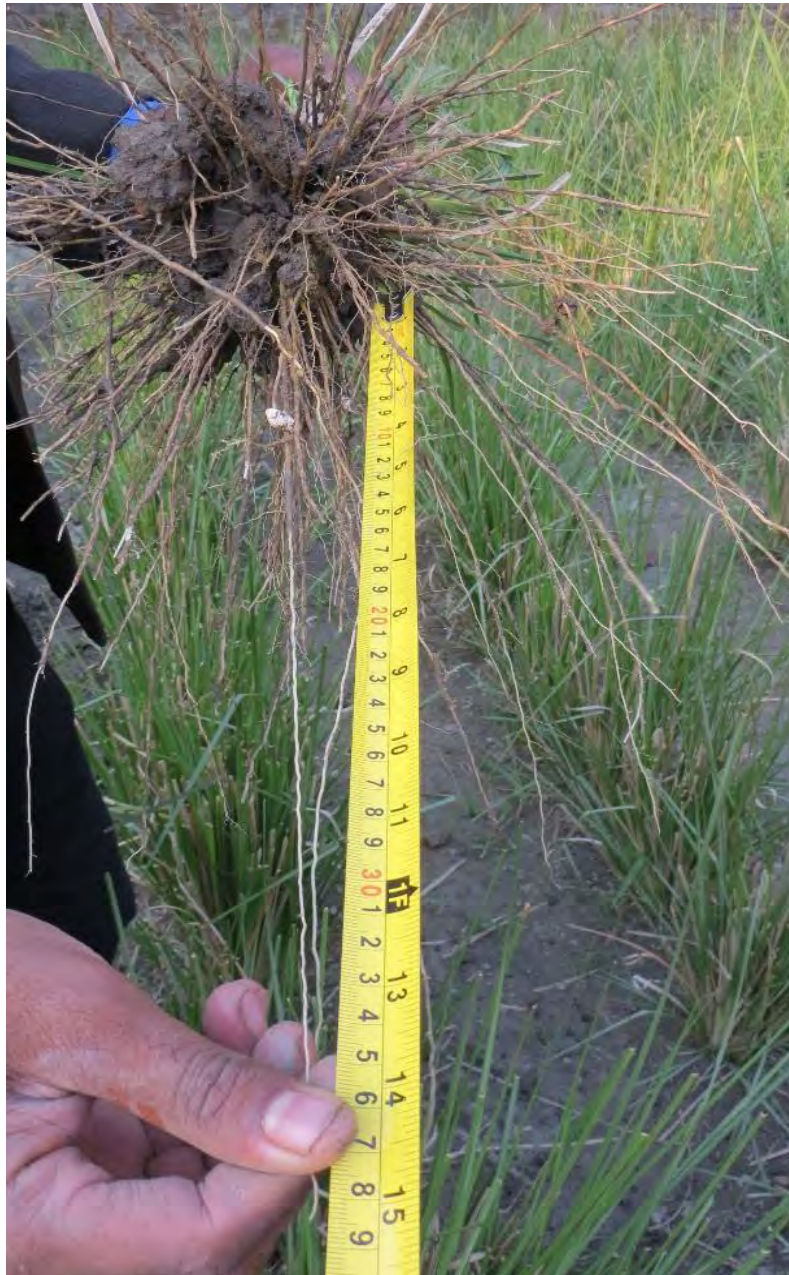
Figure 4.8 Length of vetiver root after 9 months ta Kaligonj, Satkhira.

soild particles to enhance the stability. To get the length of the root of planted vetiver, a round hole were dug around the plant. Then soil were taken out very carefully. As roots of grasses were spread very widely, necessary cautions were taken to take out the whole grass root system with care. Then the longest root were measured for growth measurement.

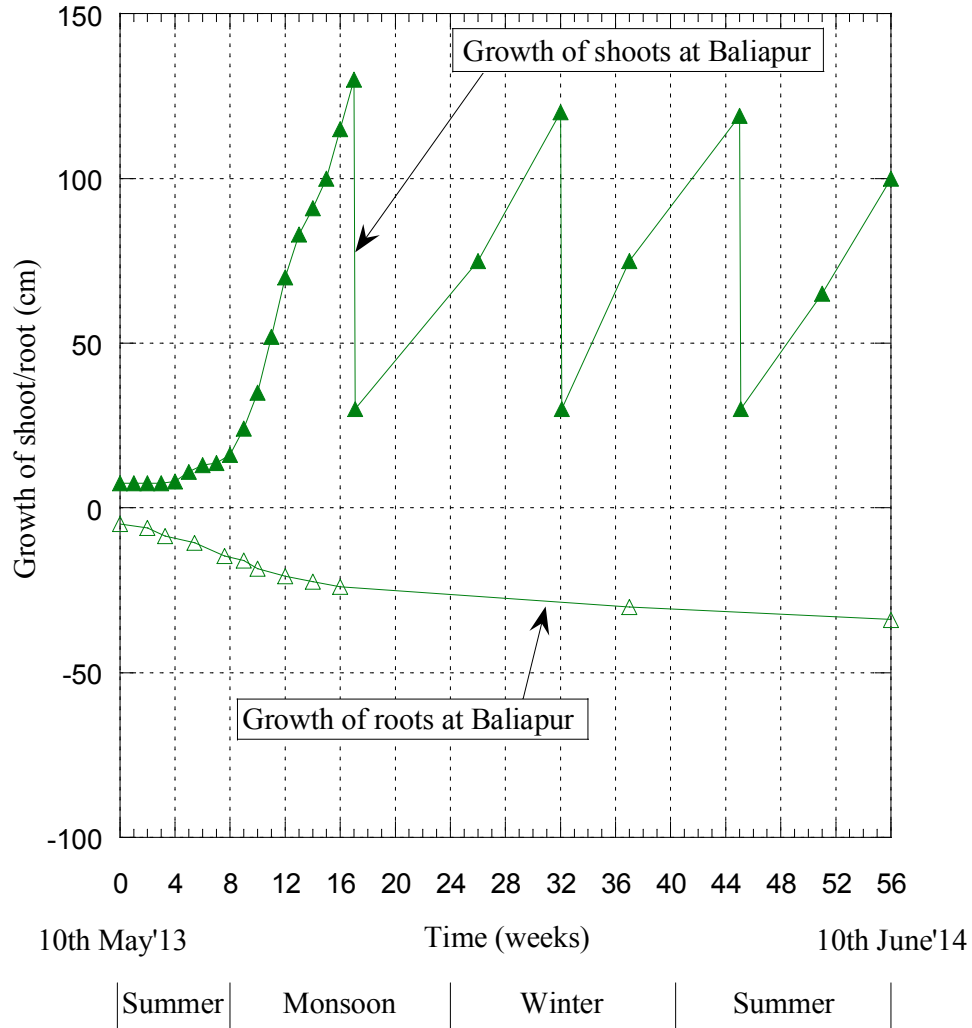
Figure 4.10 Growth chart of vetiver grass at Baliapur, Satkhira (EC 3.93 ds/m)

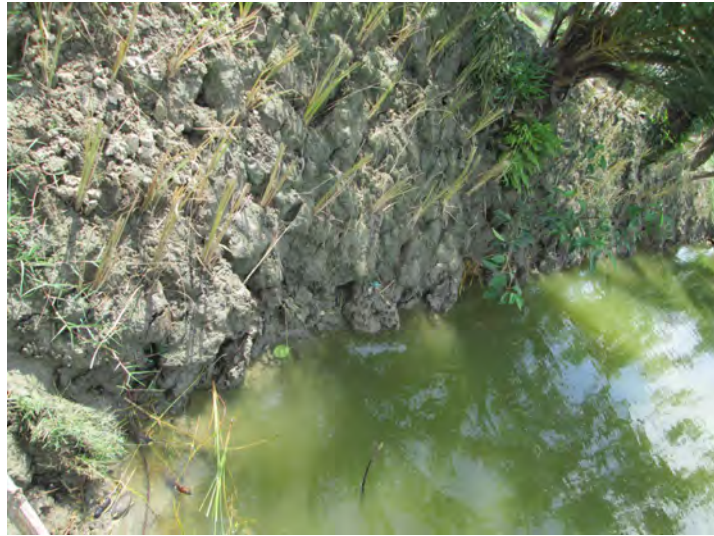
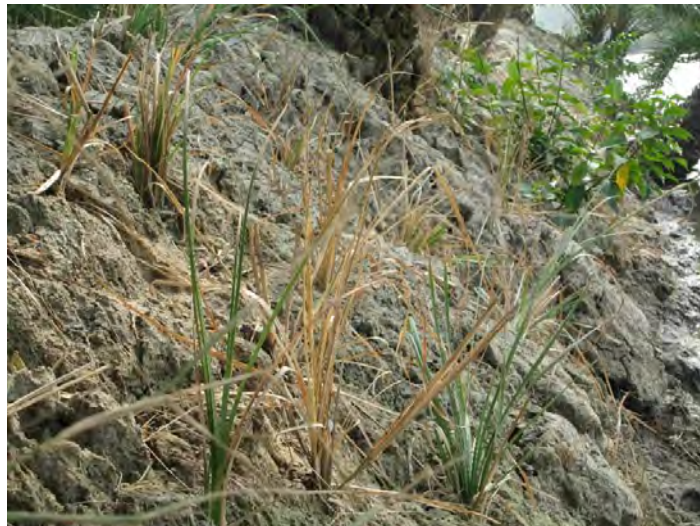
Figure 4.11 Field trial at Nildumur, Satkhira (a) Just after plantation ; (b) Grown vetiver after 5th month (without any trimming)

Among the trial zones Nildumur is the southernmost area and much closer to Bay of Bengal. Thus this area has much salinity than other trial zones. A pond slope were selected for plantation. This time slope of the bank were much steeper and closer to 1:1.5. After plantation proper watering were ensured. Figure 4.11 shows the plantation of vetiver at Nildumur, Satkhira.

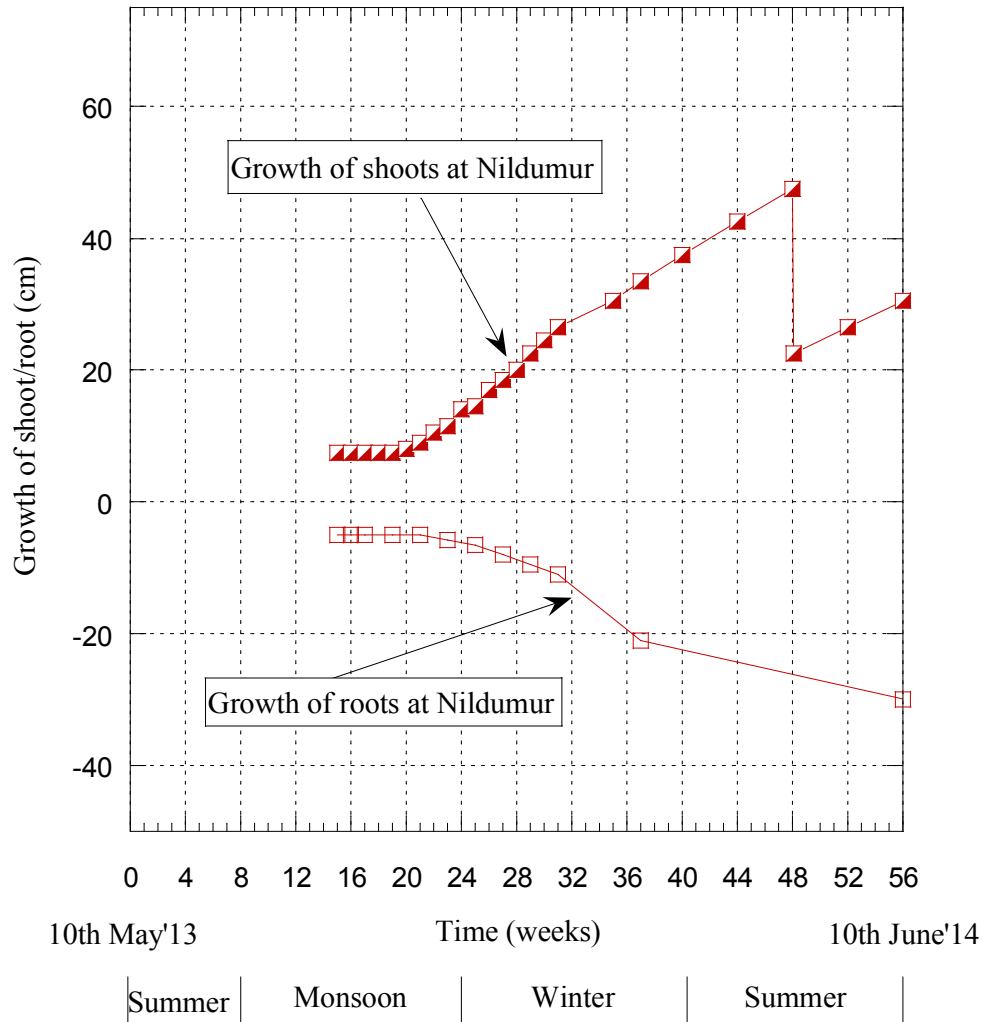
Figure 4.12 Growth chart of vetiver grass at Nildumur, Satkhira

Figure 4.12 shows the growth rate of roots and shoots of vetiver grass at Nildumur site. Rate of growth of roots were much slower than others. It grew only 30cm in 40 weeks. Monitoring of these plantation were done weekly basis. Kaliganj and Baliapur site were monitored for 56 weeks whereas Nildumur site were monitored for 41 weeks. It is here to mention that salinity of this area were 4.19 dsm^{-1} which is highest among the study area. From Figure 4.12 we also can see that initial growth of root were very slow where for other site we found that initial growth rate of roots were fast. Planting during monsoon season also could not help it growing fast. Thus it can be observed that, keeping the other parameters same (like monitoring, maintenance, weed protection) growth of vetiver vastly affected by salinity content of the soil.
