**DEVELOPMENT OF CLIMATE RESILIENT SLOPE
PROTECTION FOR DYKES IN SALINE ZONES OF
BANGLADESH**

MASTER OF SCIENCE IN CIVIL ENGINEERING

**BANGLADESH UNIVERSITY OF ENGINEERING AND
TECHNOLOGY**

JUNE, 2015

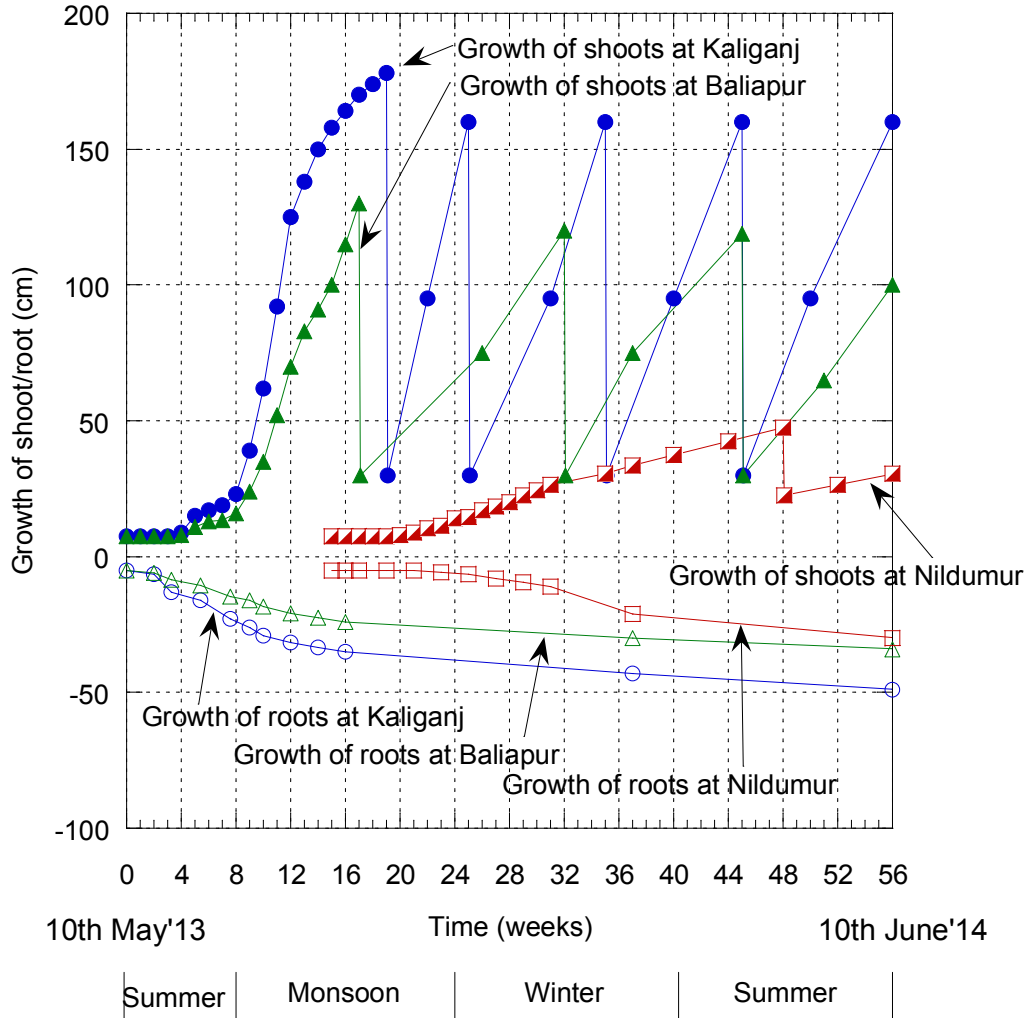
Figure 4.13 Growth of roots and shoots of Vetiver at field trial zones.

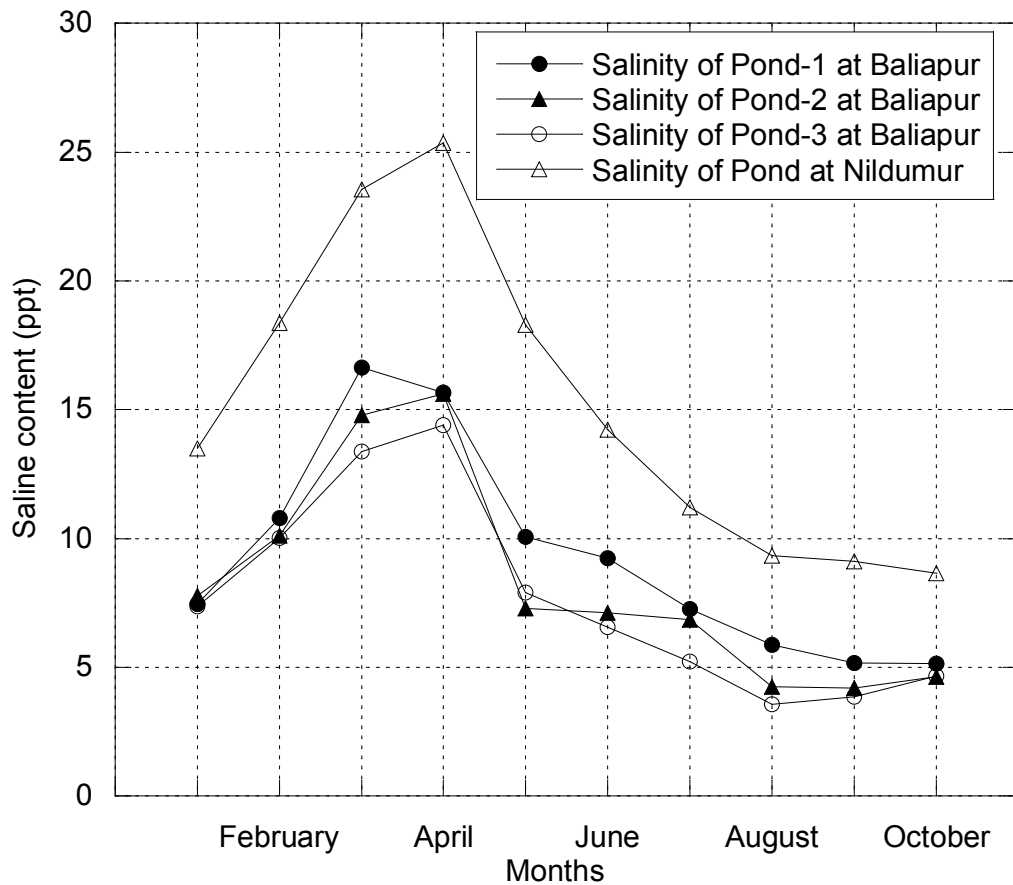
Figure 4.14 Salinity of water at ponds of Baliapur and Nildumur.

To get more information about other factors of growth salinity information of water and soil were gathered. From Figure 4.14 it is found that water salinity concentration become maximum during the month of March-April i.e., at the end of winter season. And salinity remains minimum during the month of August to October i.e. end of monsoon season. Salinity of Nildumur is highest as it locates in the highest saline zone. Salinity in the water of Baliapur area varies between 5 to 17 ppt while the salinity of the water of Nildumur varies between 8 to 25 ppt. Thus seasonal growth can be related from these two graphs that high concentration of saline slower the growth of vetiver grass during winter season.

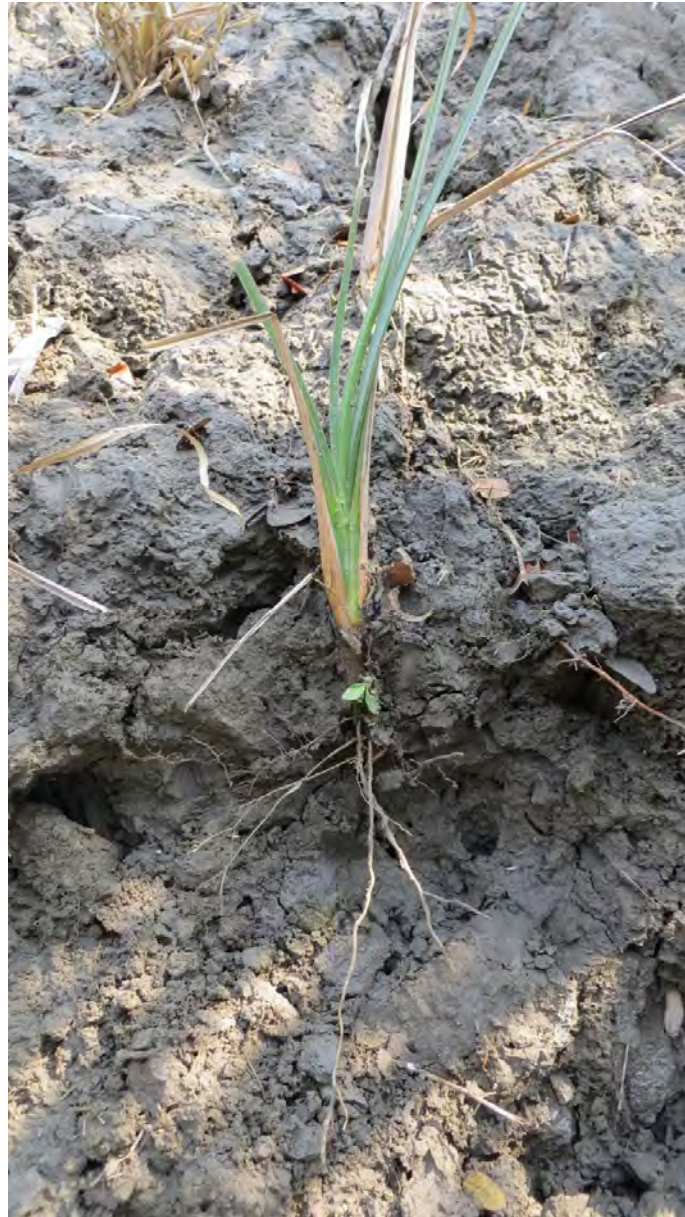
Figure 4.15 Condition of roots at Nildumur after 6 months of plantation (root length is 20 cm).

On the other hand, roots of slow growth area remained same healthy as lower salinity contained area like Kaliganj. Thus, salinity does not affect the capacity of root. Figure 4.15 shows the root of vetiver at Nildumur area, which is alive and healthy.

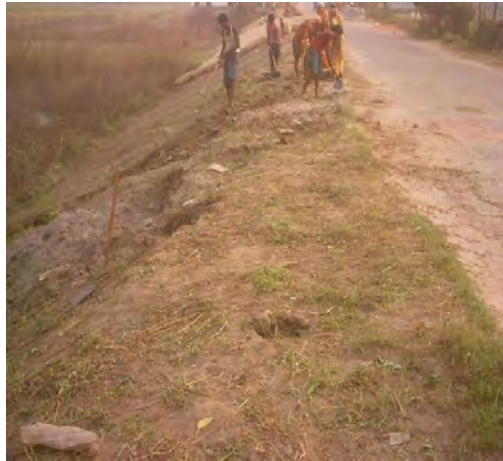
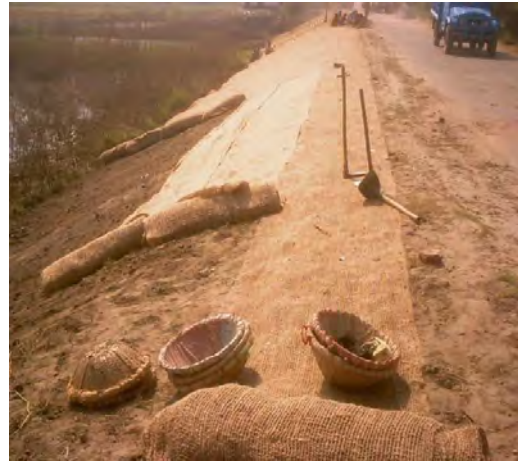
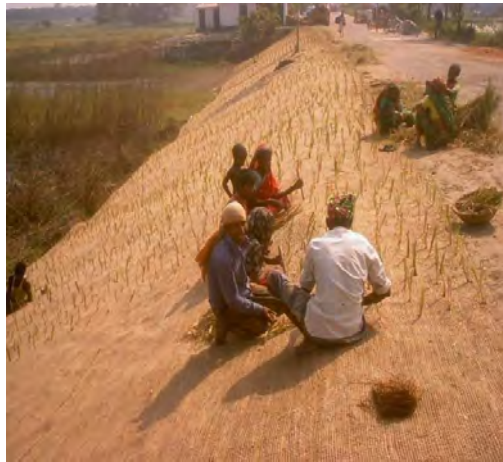
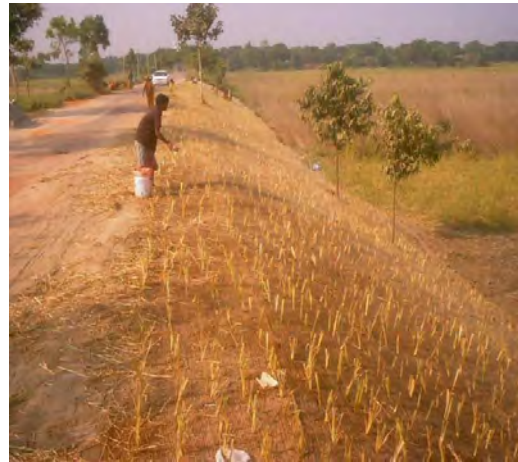
Figure 4.18(a) View of site before plantation; (b), (c) View of site during plantation; (d) View of site after plantation.

Jute geotextile were used during plantation. Spacing of plantation vetiver grass were 200mm c/c both horizontal and vertical direction. Figure 4.18 showing some photos during initial plantation work.

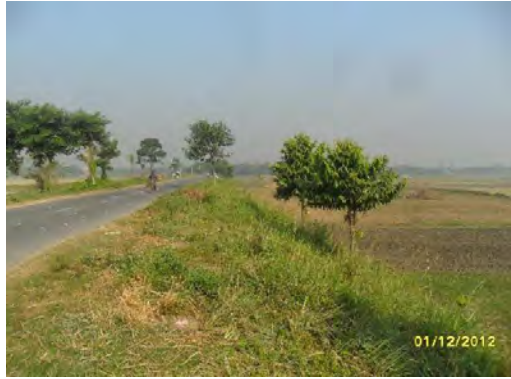
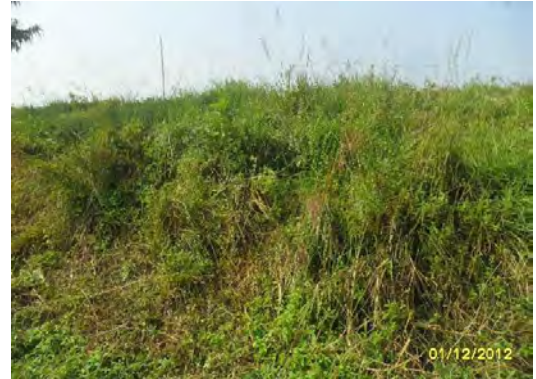
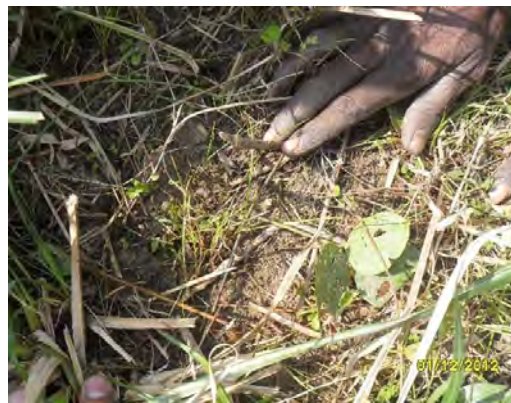
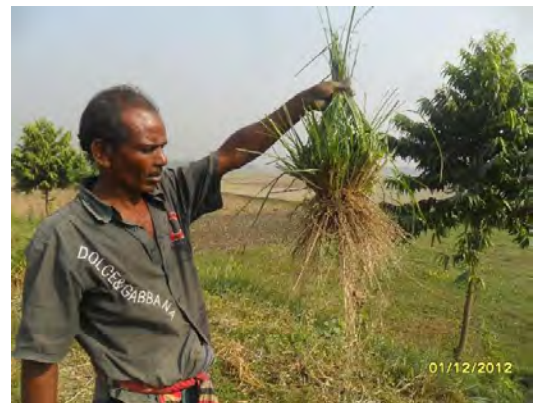
Figure 4.19 (a), (b) View of site on Dec'12; (c) Condition of Jute Geotextile; (d) length of root of vetiver on Dec'12.

After initial plantation watering was ensured for 7 days. Then this site leave for natural growing. Gradually these vetiver grass were kept growing there. Figure 4.19 shows condition of site during Dec'12. There it is found that, vetiver grown very well. Roots become long enough and other vegetation were kept growing along with vetiver. As a bio degradable product, most of the jute geotextiles become degraded. Seeds were started to grown on month of December'12.

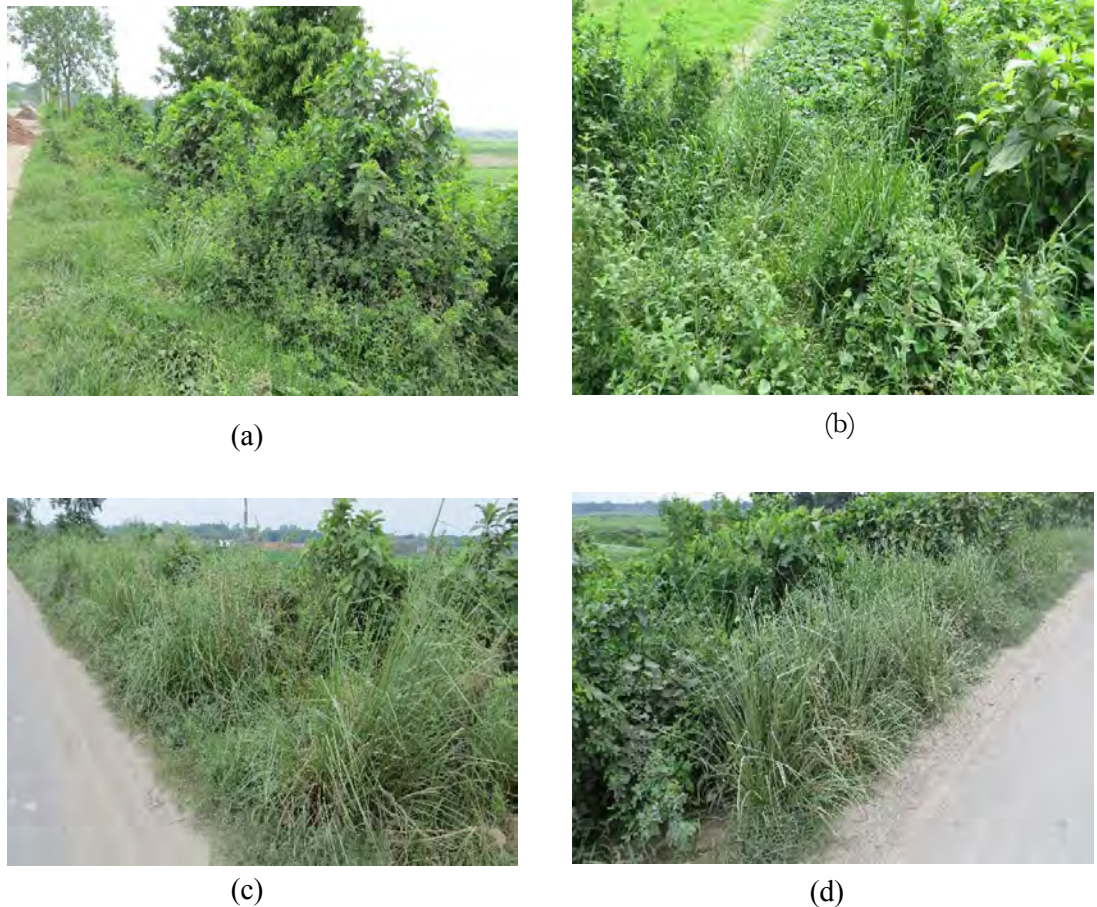
Figure 4.21 (a), (b) Condition of grown vetiver on June'15; (c) Naturally grown vetiver on West side, (d) Naturally grown vetiver on East side of keraniganj, Savar.

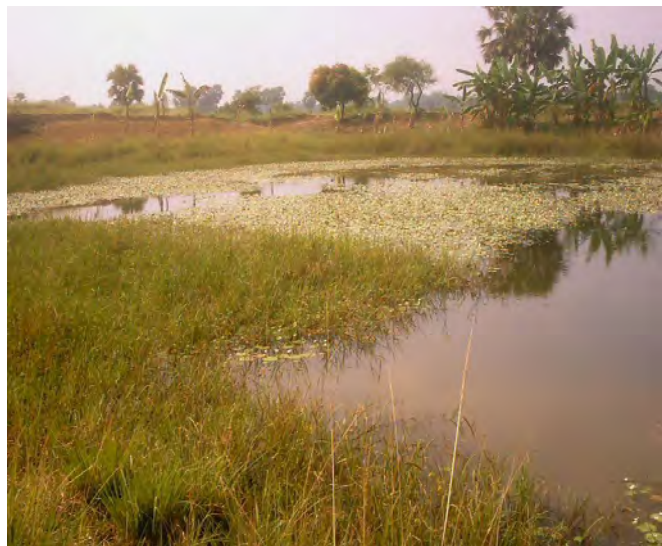
Figure 4.22 Vetiver plantation at Godagari, Rajshahi.

A pond was selected to evaluate the growth and effectiveness of vetiver grass to control erosion of pond bank soil. The pond was situated at Godagari Upazilla in Rajshahi District. The region consists of *Barindtract*, *Diara* and *Char* lands. Annual average temperature ranges between 11.2°C and 37.8°C. Average annual rainfall is 1862mm. Specific gravity of the slope soil is 2.64. Sand, silt and clay content of the soil are 13%, 75% and 12%, respectively. Mean grain size, D_{50} and coefficient of uniformity, C_u is 0.016mm and 7.4, respectively. According to percentage of contents the soil is sandy silt. It seems that the soil is erodible as well. Figure 4.22 shows the vetiver plantation work at Godagari, Rajshahi.

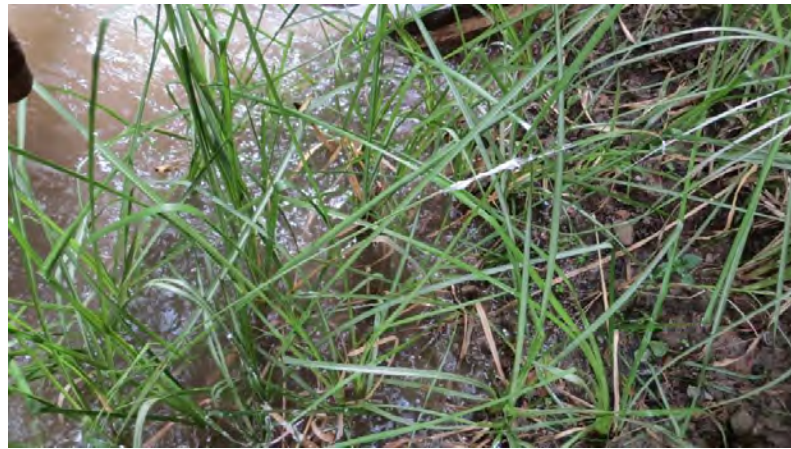
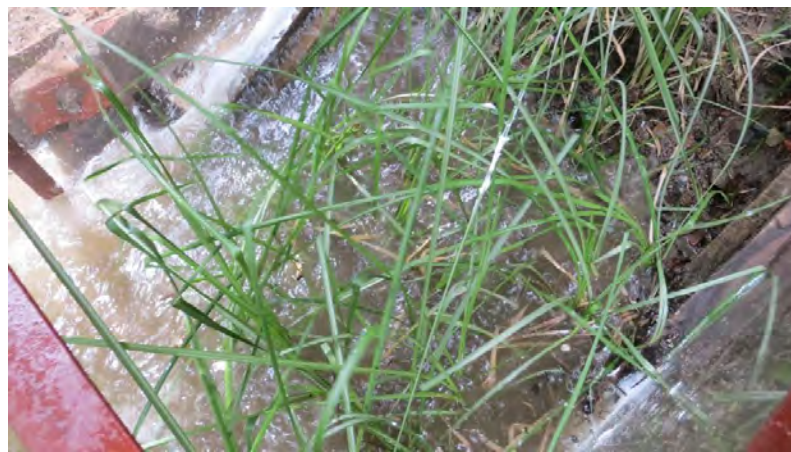
Figure 4.23 Condition of slope against wave attack; (a) before wave attack, (b) after wave attack.

Model study had been conducted at BUET premises to study the behavior of slope with vegetation against wave action. Three types of slope were used for this purpose 1:1, 1:0.75 and 1:1.5. these slopes were made at wooden boxes. After completing the experiment it was found that, each slopes acted differently. Figure 4.23 shows the model setup with wave propagation.

From the model study it was found that, vetiver grass at slope ratio 1:1.5 remained as it was before wave attack and eroded soil amount was very negligible. Same happened for slope ratio 1:1 though amount of eroded soil was a bit higher than 1:1.5 slope. But, amount of soil erosion for vetiver at slope 1:0.75 was higher than remaining two. Few tillers became displaced after wave attack in this slope. This result shows that, vetiver

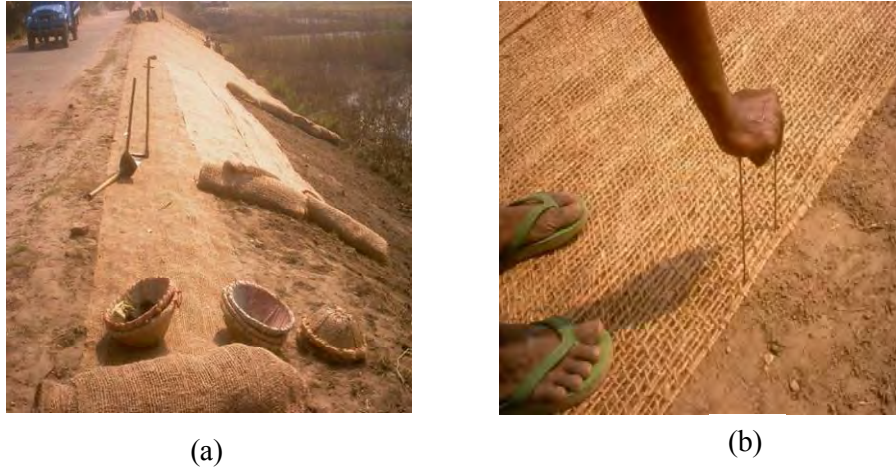
Figure 4.29 Geo-jute laying; (a) roll placing at site, (b) attaching geo-jute with U hook

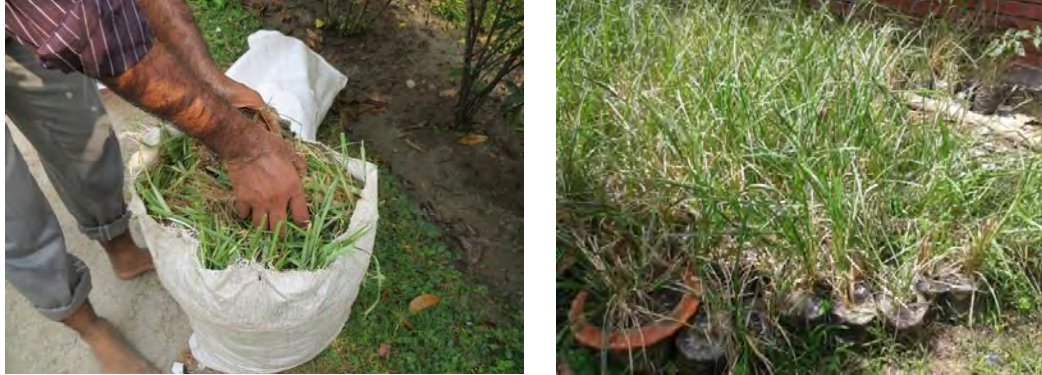
Figure 4.31 Vetiver transportation and storing, (a) Carrying vetiver grasses in bag (b) grown vetiver grasses in nursery

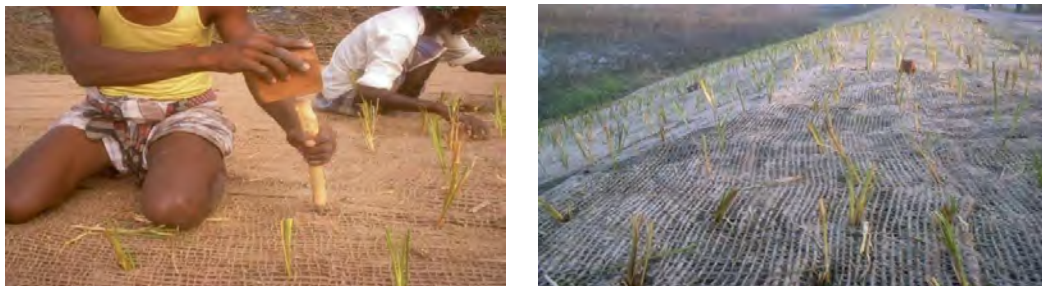
Figure 4.35 Vetiver plantation at embankment slope: plantation procedure and newly planted vetiver (right)

If the embankment is vulnerable to rain cut erosion then vetiver plantation to be done as per Figure 4.34 horizontal and vertical distance for top rows of the embankment would be 200 mm c/c. rest of the plantation to be done at a spacing of 400 mm c/c distance. Figure 4.35 shows the plantation procedure at embankment slope.
