**FLOW AND EROSION PROCESS AND ITS LOCAL IMPACT ALONG A  
DEVELOPING BEND BETWEEN TWO RIVER TRAINING STRUCTURES IN  
A BRAIDED RIVER**

**INSTITUTE OF WATER AND FLOOD MANAGEMENT  
BANGLADESH UNIVERSITY OF ENGINEERING AND TECHNOLOGY**

**APRIL 2011**

In partial fulfillment of the requirement for the degree of  
**MASTER OF SCIENCE IN WATER RESOURCES DEVELOPMENT**

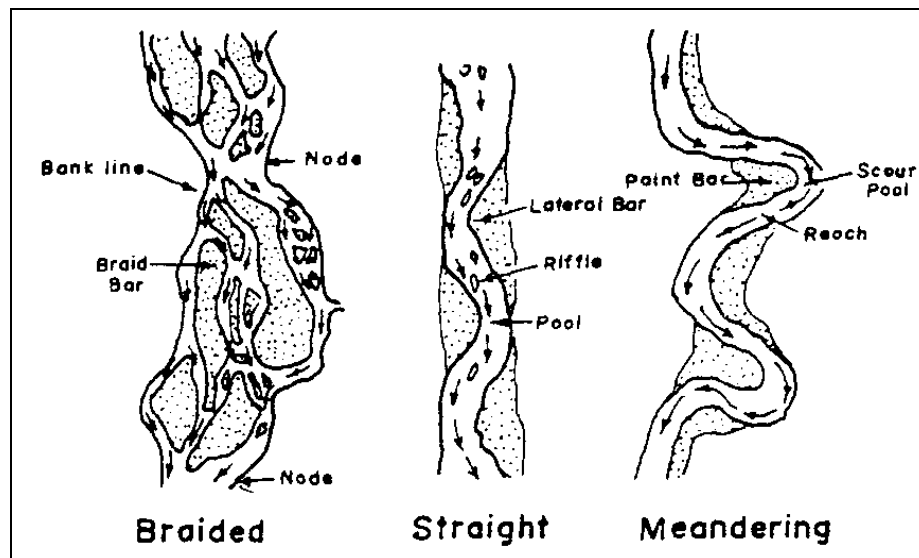
Figure 2.1: Definition diagram of the channel pattern (FAP 24, 1996)

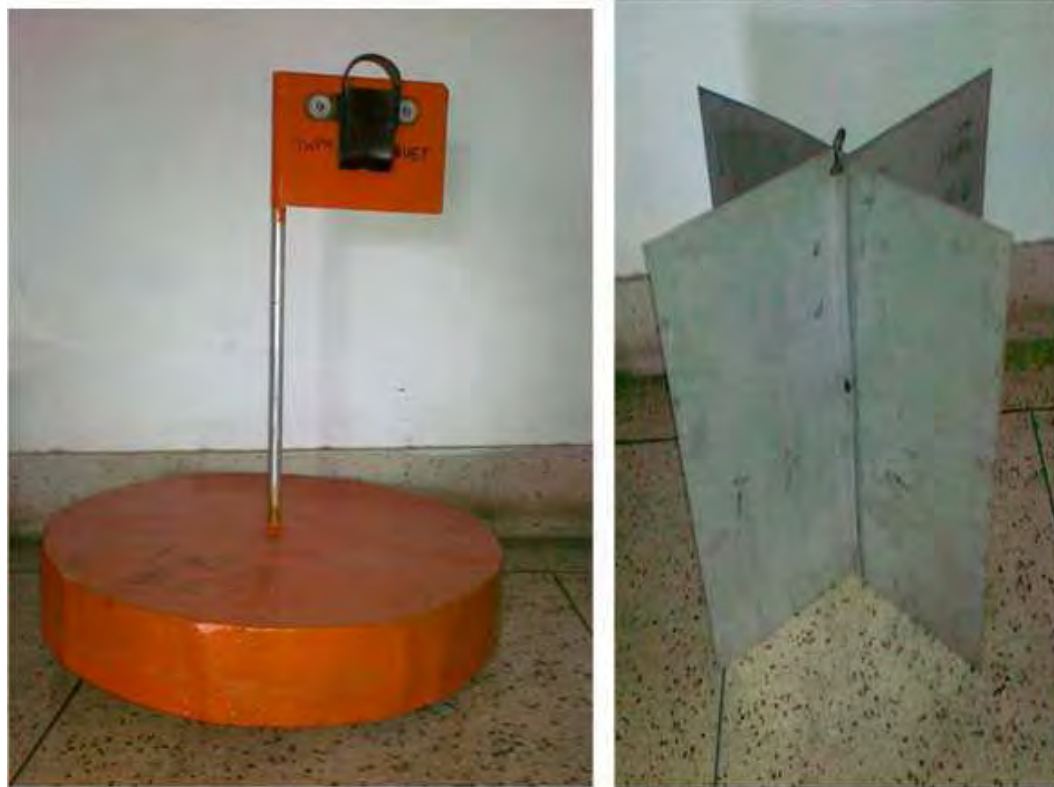
Surface float

Bottom fin

**Float tracking data:** Surface floats mounted with hand GPS were used to track surface stream lines. Floats track the surface stream lines and its convergence characteristics towards bank line. The method permits an immediacy of visual assessment of water movements and explores a reproducible and reliable technique for monitoring surface and subsurface current patterns (Duck et al., 1985). Total four floats were used to track surface stream lines within the developing channel. The flow tracker is a floating buoy having a fixed steel fin (Figure 4.2) hanging beneath the float. Fin works as propeller to keep the float stable in the wavy and windy condition during measurement. The mounted GPS is programmed for collecting data every 20 seconds continuously. The data was collected on the basis of increasing water level data. Approximately around 15 days of interval, data was collected so that the change of water level, change of flow hit point and active erosion point at bank is also clearly identified.

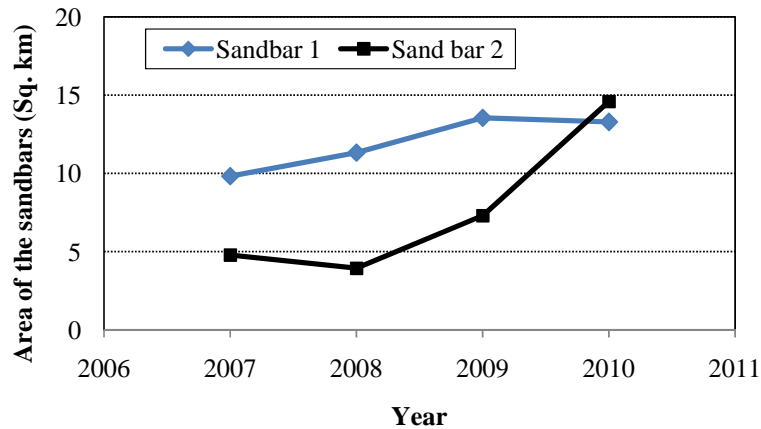
**Figure 5.8: Changes in area of the sandbars over time**

Year	Area (Sq. km)		Ratio of width to length	
	Sandbar 1	Sandbar 2	Sandbar 1	Sandbar 2
2007	9.83	4.79	0.39	0.14
2008	11.33	3.94	0.36	0.32
2009	13.56	7.31	0.32	0.35
2010	13.29	14.61	0.53	0.47

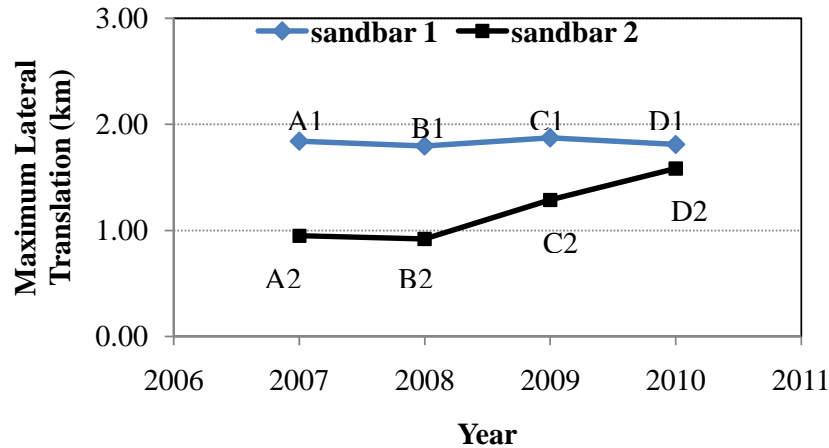
**Figure 5.12: Maximum lateral translations of sandbar 1 and sandbar 2**

The maximum lateral translation of sandbar 1 during 2007 and 2008 was at A1 and B1 (Figure 5.11 left) which was just upstream of the upstream termination of Sirajganj Hardpoint. The flow was guided by the sandbar and diverted towards the upstream termination which caused undermining in 2007 and damage in 2008 (Uddin and Rahman, 2009). The maximum point C1 of 2009 bar and D1 of 2010 bar (Figure 5.11 and 5.12) translated downstream from the upstream termination which caused damages of the hardpoint downstream from the termination. During 2009 the maximum translated point was just upstream of northing 706000 and the damage was also near northing 706000, which clarify the bar effect (Uddin, 2010). The west ward translation of the sandbar 1 diverted the flow towards the Hardpoint structure and caused undermining and damages during different years.

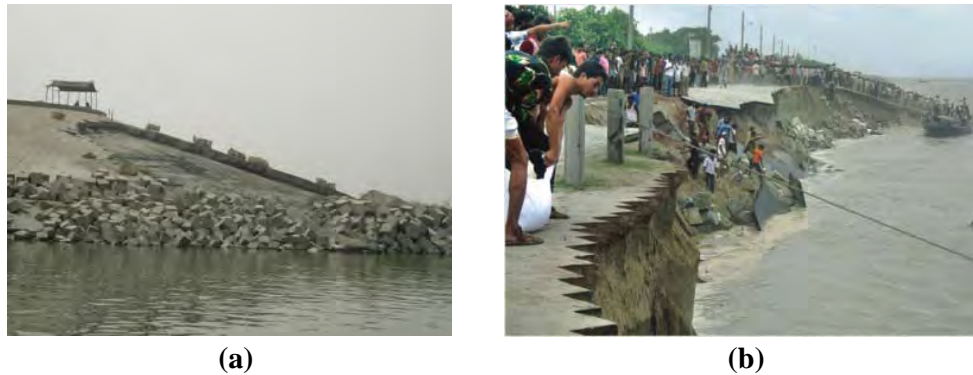
(a) (b)

**Figure 5.16: Failure of Sirajganj hardpoint structure at different locations,  
 (a) Failure of the Sirajganj hardpoint near upstream termination in 2008,  
 (b) Failure of the Sirajganj hardpoint near northing 706000 in 2009, Uddin (2010)**

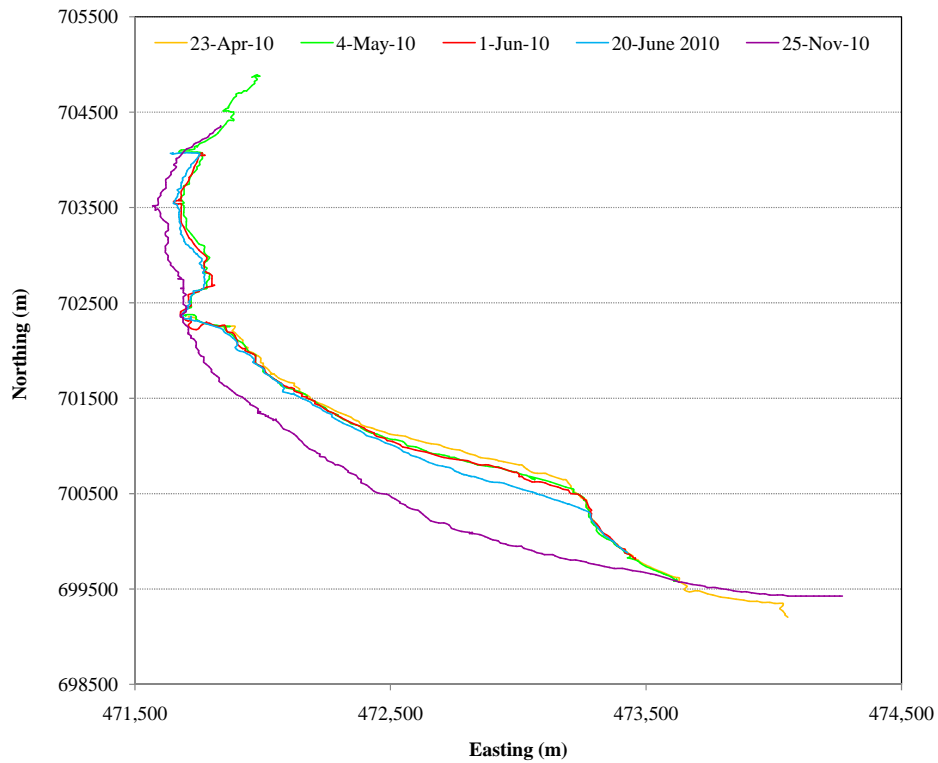
**Figure 5.22: Spatial and temporal variation of bankline shifting along the study bend**

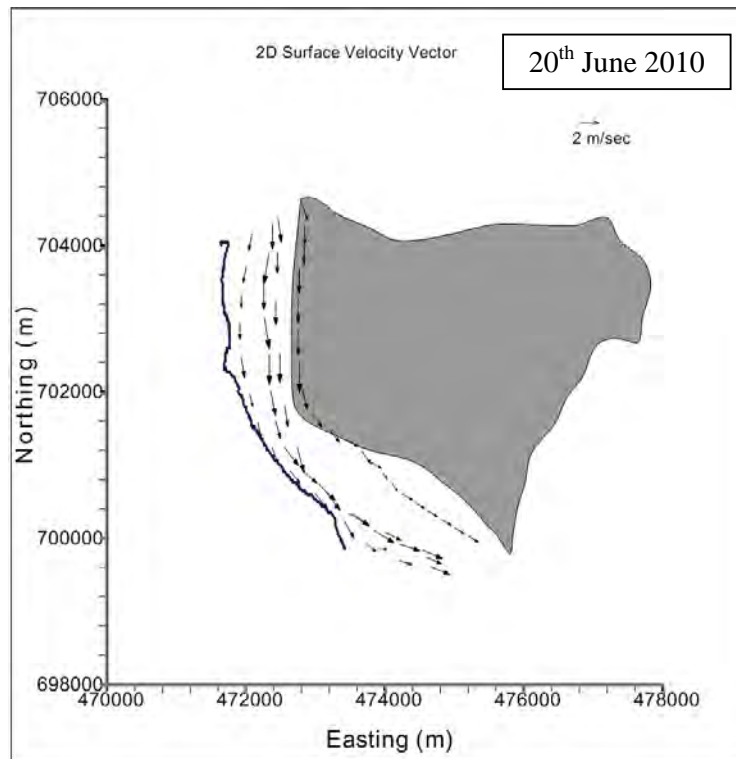
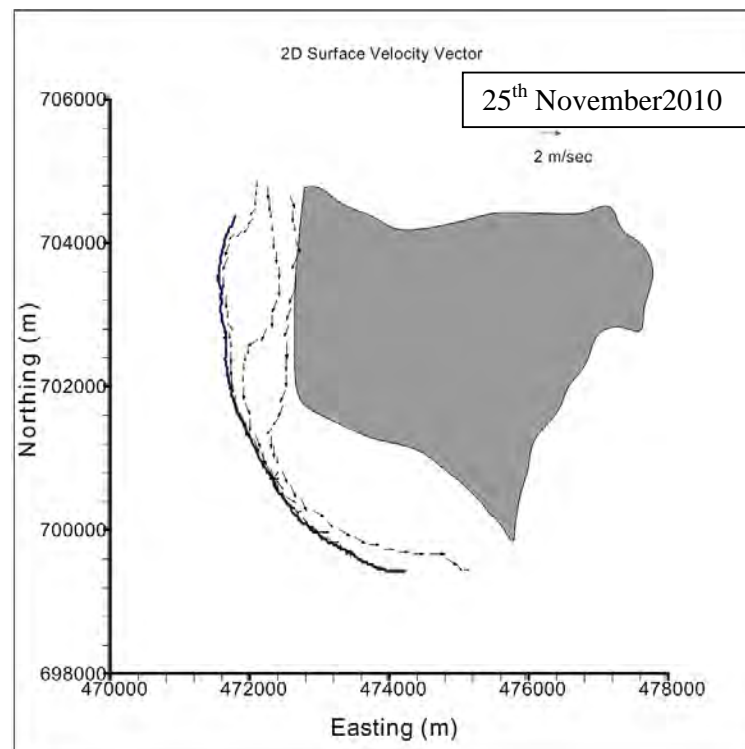
**Figure 5.23: Two dimensional (2-D) surface flow velocities estimated from float movement**

From the above observation it can be concluded that the convergence point of streamlines in a bend channel within a braided river move gradually downstream with the increase of water level.

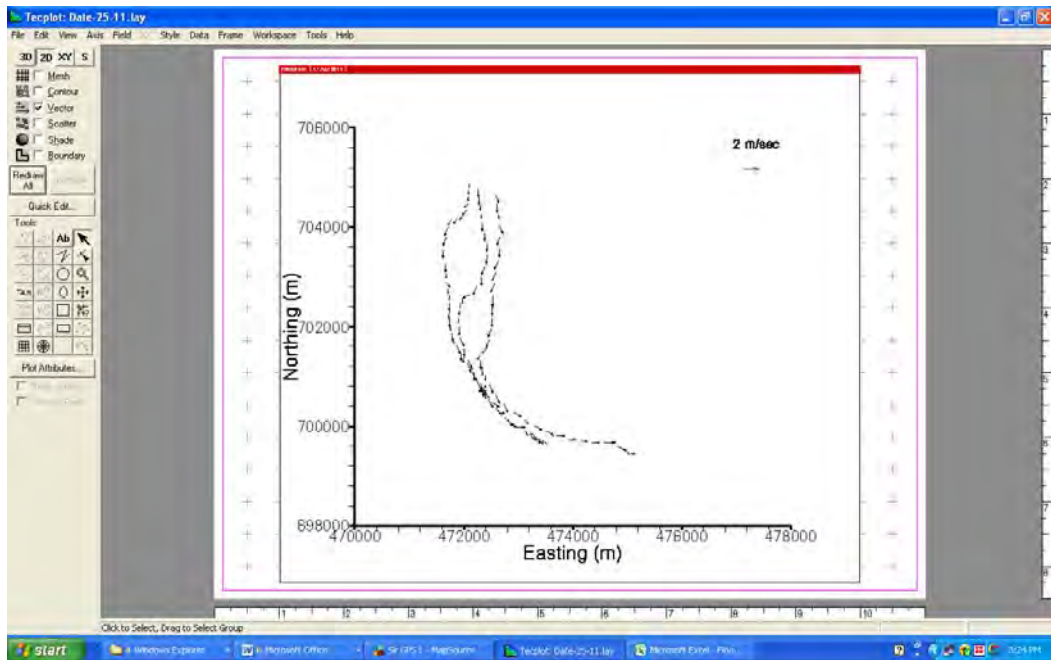
Figure A4: 2-D Surface velocity vector generated by TecPlot 7.5 software

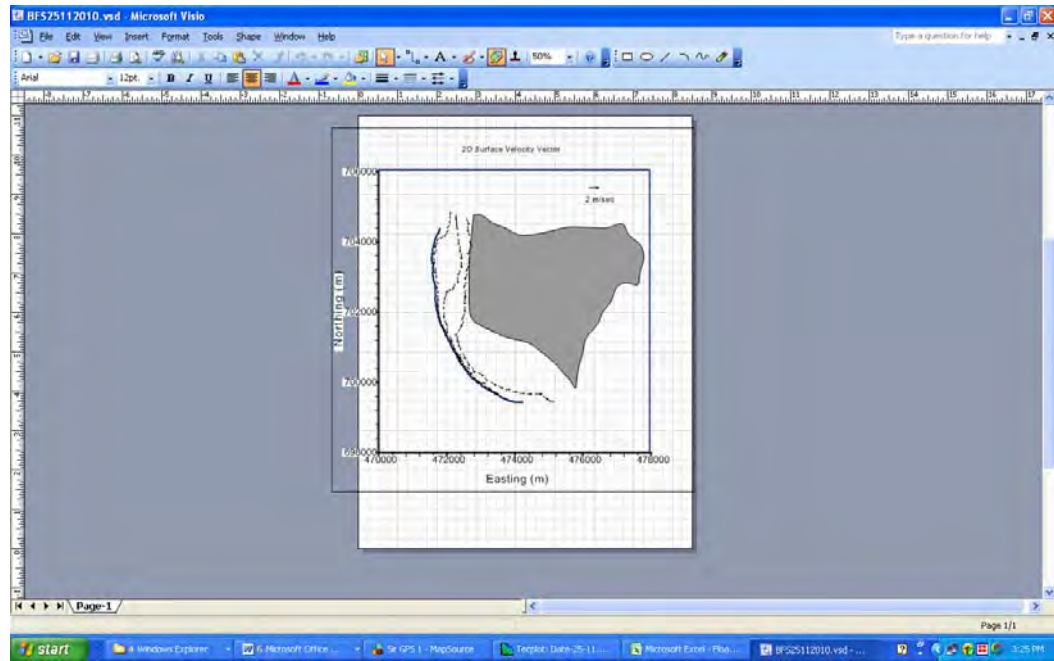
**Figure A5: Sandbar drawn with the generated velocity vector with Microsoft Visio 2003**

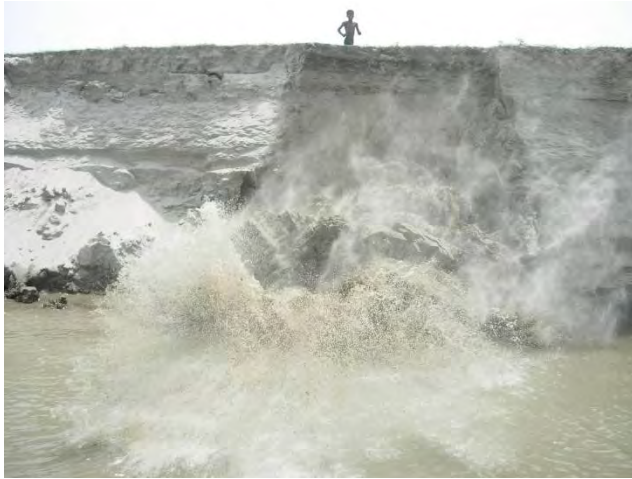
**Fig C1: Sudden bank failure on 23<sup>rd</sup> April 2010**
