**Assessment of Biophysical Factors for Storm Surge Hazard and their
Implications for Food Security**

MASTER OF SCIENCE IN WATER RESOURCES DEVELOPMENT

**INSTITUTE OF WATER AND FLOOD MANAGEMENT
BANGLADESH UNIVERSITY OF ENGINEERING AND TECHNOLOGY**

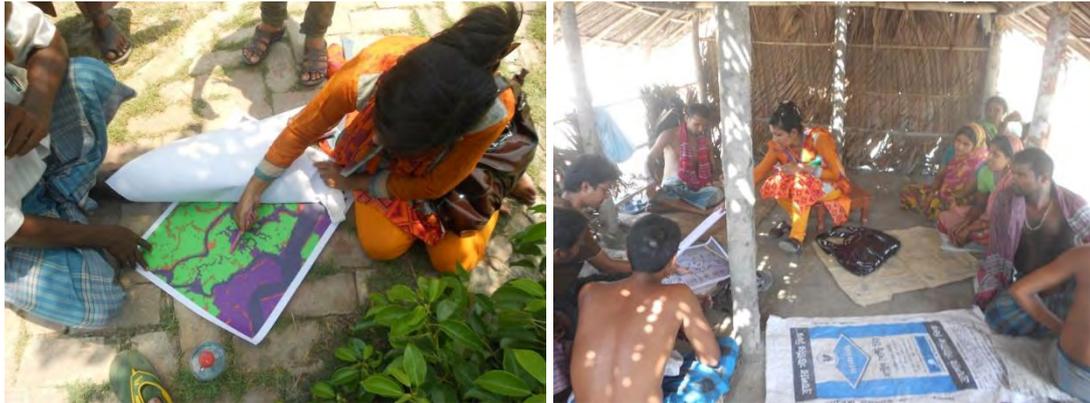
Photo 4.1: PGIS exercise carried out in polder 32 to map inundation depths and durations

In PGIS mapping process there is a need for some forms of base maps that help to provide background details necessary to facilitate the data collection process from the local community using those maps. The Google earth image of the study area, the land use map collected from ESPA Deltas project of IWF, BUET, the LGED Upazila map showing the ward/units of the study area have been used as base maps which participants used as a reference to derive information about the depth and duration of storm surge. Also participants were allowed to draw on the maps to describe about the storm surge scenario in the study area, to locate the breaching locations together along embankment with the areas subjected to prolonged inundation. Photo 4.1 shows the PGIS exercise carried out in the field.

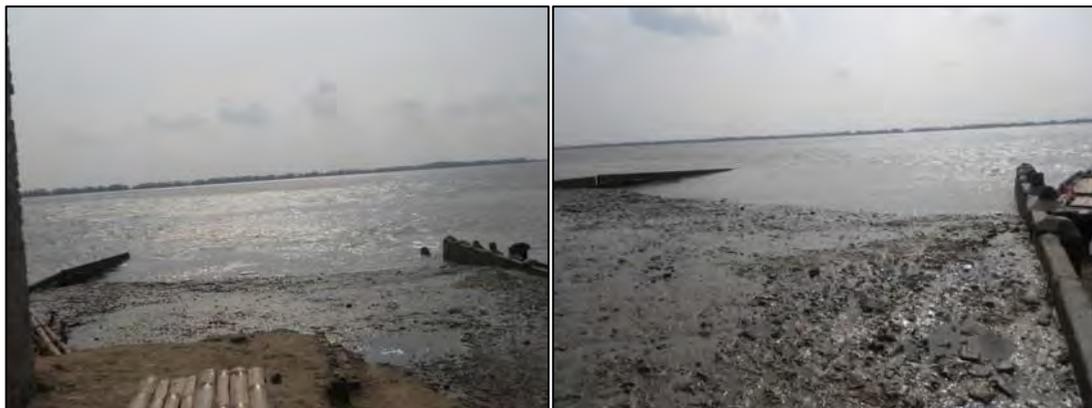
Photo 5.4: Location of 8-vent regulator which was washed away at Nalian

coastal embankment rehabilitation programme by World Bank at 2009. Polder rehabilitation i.e. the repairing of the broken embankment and the reconstruction of the sluice gate started in November of 2009. An eight vent regulator was washed away due to the breach at the mouth of the Nalian river, with rapid widening of the opening in the embankment (original location of the regulator can be seen in Photo 5.4. Construction of the sluice gate or regulator at that place was not immediately possible due to creation of deep depression at the breaching locations. From key informant interviews, it was learnt that construction of 3.2 km of retired embankment at the mouth of Nalian river was done in the first phase of the rehabilitation programme in 2009. However, by the time the retired embankment was in place, the breach location had widened 6 times the original breaching width. So having the area free from water was too difficult a task at that time. BWDB then went for constructing ring embankments at both sides of the Nalian river.
