**DETECTING NONLINEARITY IN CONCRETE BEAMS
USING BI-COHERENCE OF VIBRATION DATA**

MASTER OF SCIENCE IN CIVIL ENGINEERING (STRUCTURAL)

**DEPARTMENT OF CIVIL ENGINEERING
BANGLADESH UNIVERSITY OF ENGINEERING AND TECHNOLOGY**

June, 2016

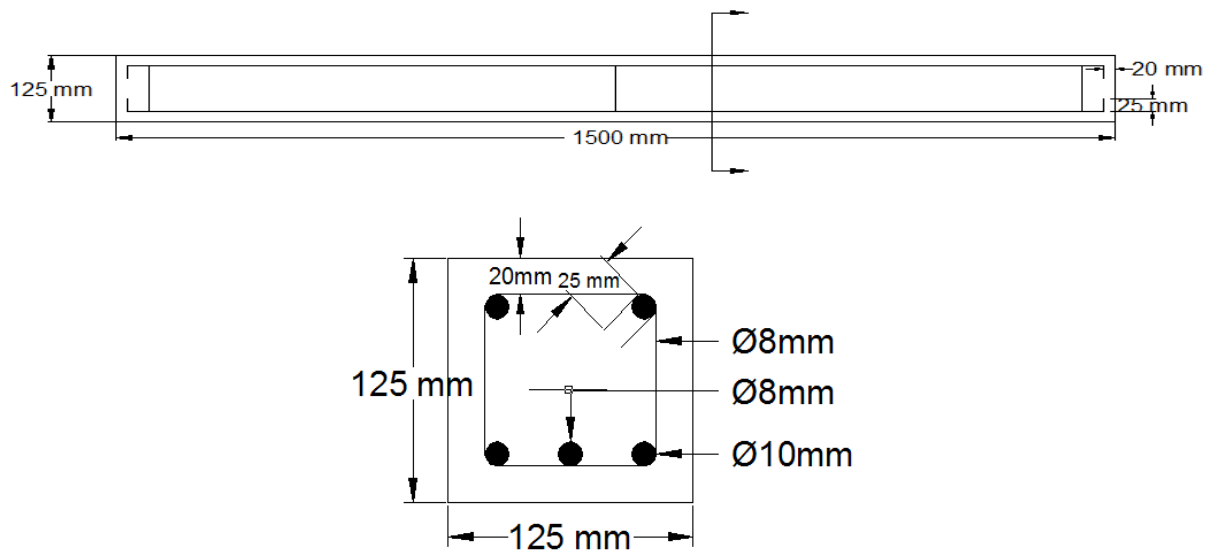
The shear control beam had cross sectional area of 125 x 125 mm and a longitudinal length of 1500 mm. it had 2- ϕ 10 mm top bar with 2- ϕ 10 mm and 1- ϕ 8 mm bottom bar. To control the shear crack only three shear reinforcement of ϕ 8 mm are provided, one in the middle and other two in two end support point. All the shear reinforcement had 135 degree hook. Three shear control beams were prepared in the laboratory. Fig.3.1 shows dimension sand detailing of shear control beams. The Flexural moment capacity of the beam was 209 N-m and shear capacity of the beam was 15kN. The following Fig. 3.1 shows the detailing of flexure control beam.

Figure 3.1: Dimensions and Detailing of Shear Control Beam

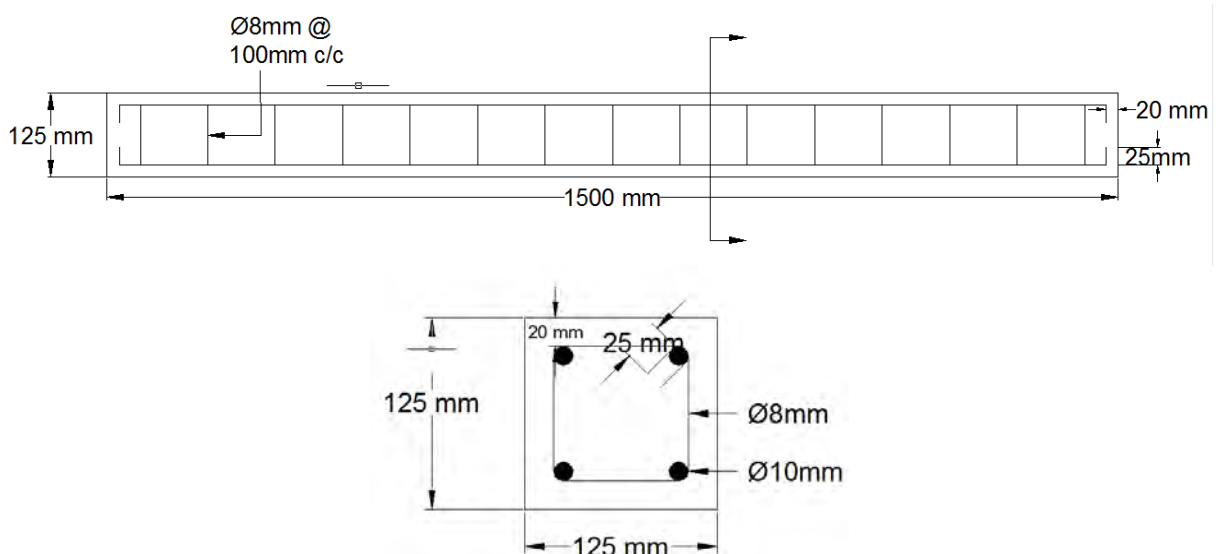
The flexure control beam had cross sectional area of 125 x 125 mm and a longitudinal length of 1500 mm. it had 2-φ 10 mm top and bottom bar. To control the flexure crack shear reinforcement of φ 8 mm are provided @ 100mm spacing with 135 degree hook. Three flexure control beams were prepared in the laboratory. It was estimated that the moment capacity of flexure control beam was 140 N-m, corresponding to a single point loading of 13.24 kN at mid span of the beam. Fig 3.2 shows the reinforcement detailing of the flexure control beam.

Figure 3.2: Dimensions and Detailing of Flexure Control Beam

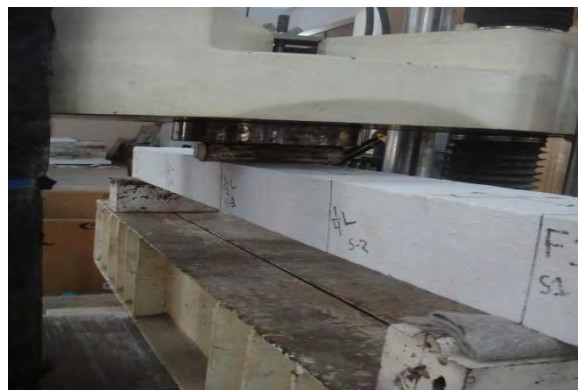
The beam was damaged using single point loading at mid span of the beam. The damage levels were in steps of 5 kN. Failure was defined as the point where the beam could sustain no further increase in load. The load was applied using a Universal Testing Machine. To measure the deflection at mid span of the beam a dial gauge was used. This data is used to develop load deflection curve of the beam. The following Fig. 3.4 shows the load applying mechanism.

Figure 3.4: Load Application Mechanism in RC Beam

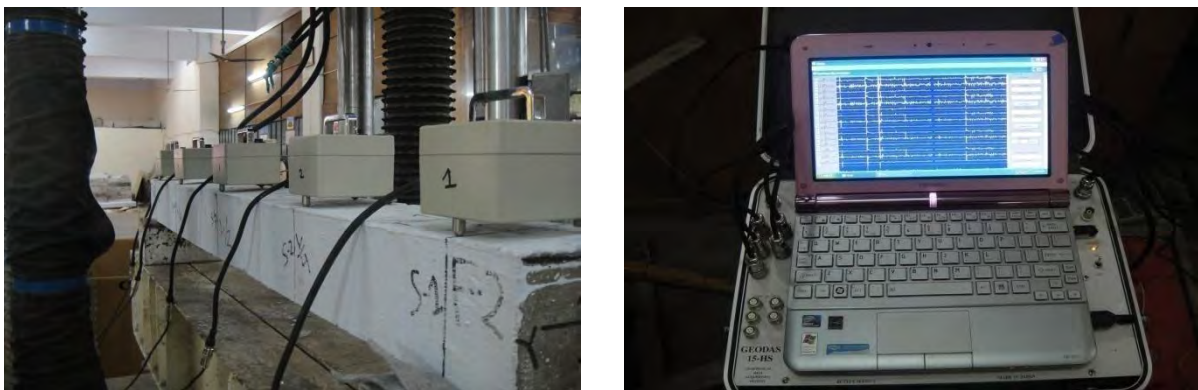
Once the beam was unloaded, the vibration of the beam was recorded for four different conditions: Ambient Vibration, Vibration after one impact, Vibration at certain interval impact and vibration at continuous impact. The vibration was recorded using a Microtremor (MT) with 5 sensors in it. Each sensor had three channels for measuring vibration in three direction (x,y and z). Sampling frequency of the MT was 200 Hz and total data recording time was 42 sec. the velocity data was recorded in micro meter/s and time was in second. The following Fig. 3.5 shows the MT sensor arrangement and data logger.

Figure 3.5: sensor and Data Acquisition System of MT

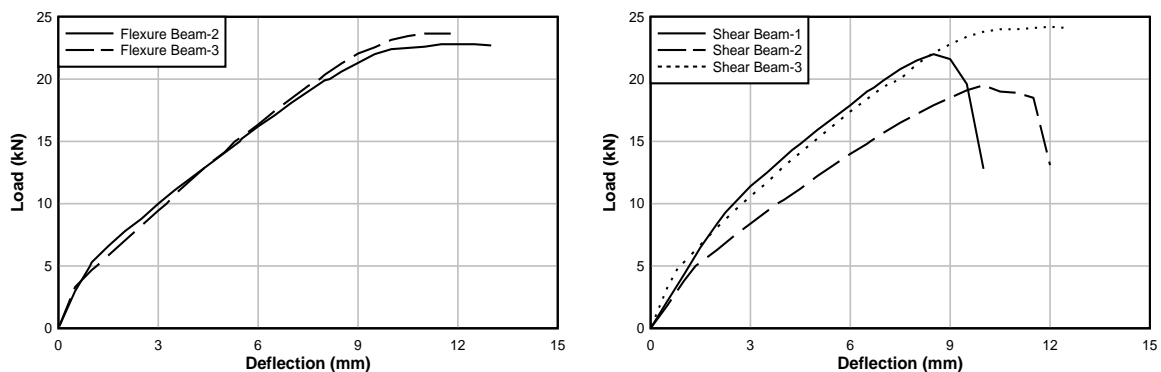
Fig. 4.6 shows deflection at mid span of beam where maximum load was applied. Deflection was measured using a dial gauge. Deflection at each damage level was with respect to the initial undamaged condition. In addition to deflection crack locations were also identified cracks were located almost exclusively between sensor -2 and 4 (ch06 and ch12).

Figure 4.6: Load Deflection Curve of Flexure and Shear Control Beams

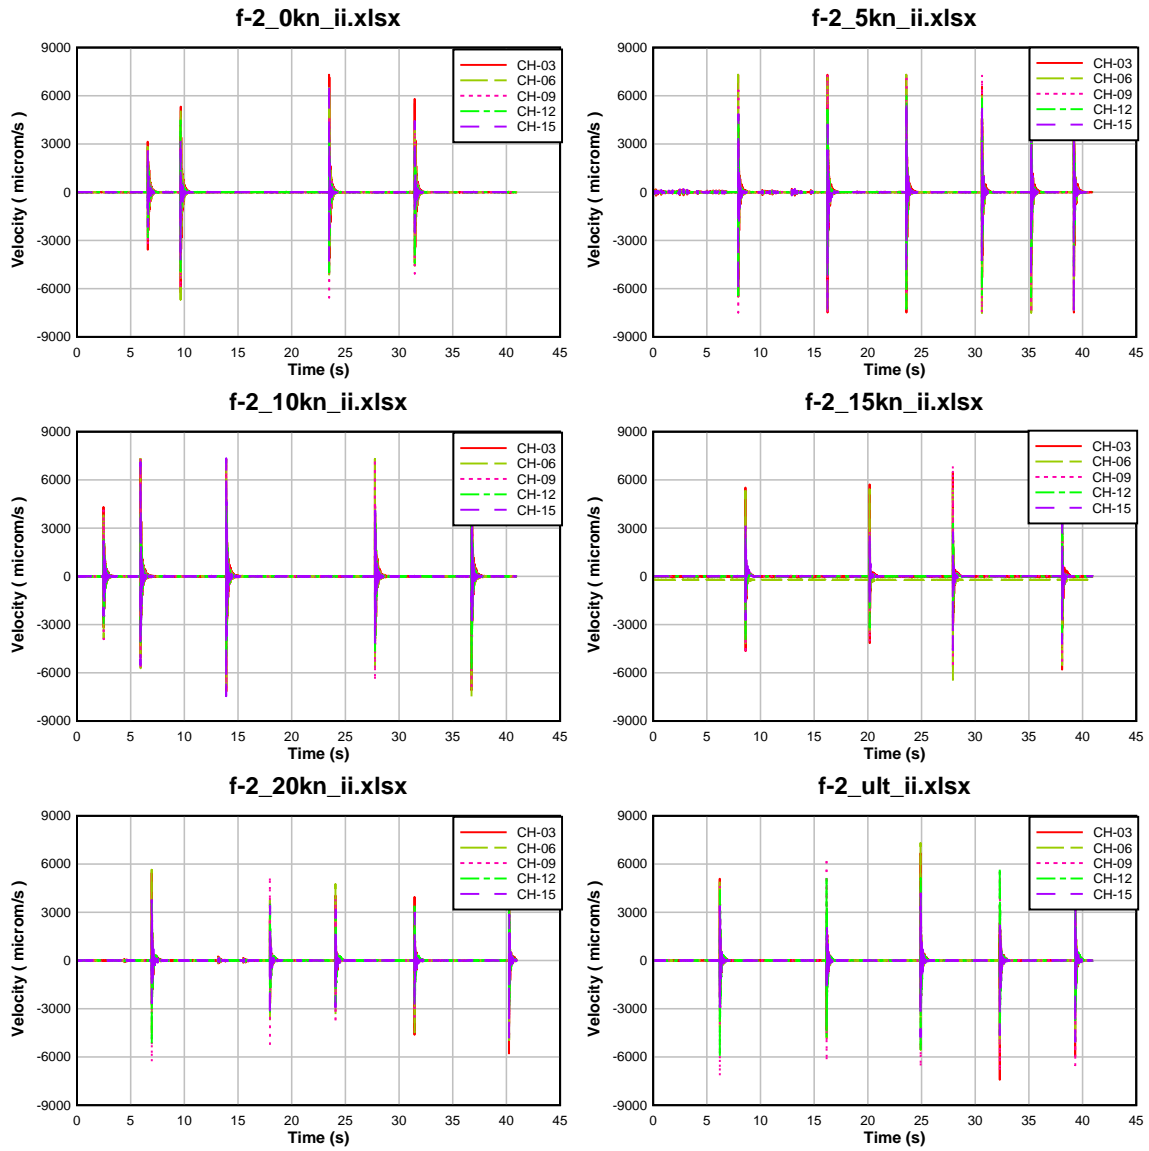
recording of interval impact excitation of the flexure beam. For other beams time series data is provided in Appendix-A.

Figure 4.13: Interval Impact Time History Recording for Flexure Control Beam-2

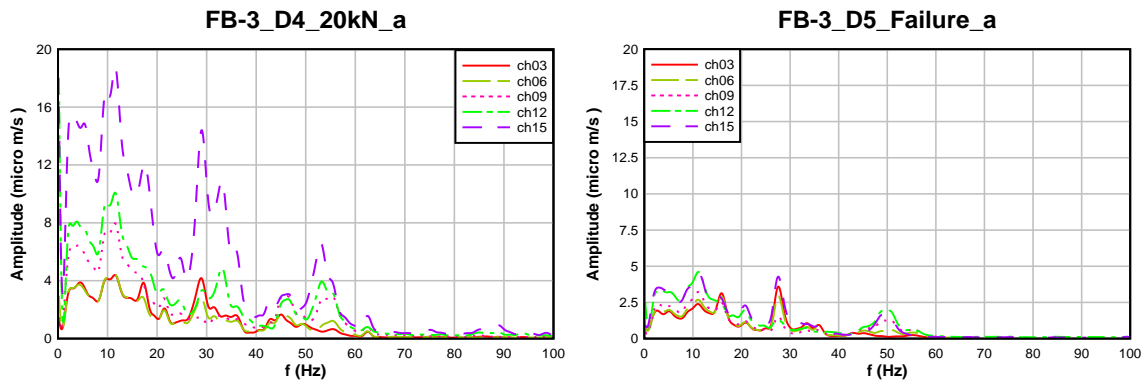
At damage level D5 (Failure) no new cracks appeared only previous cracks propagated in length and width. And FFT plot shows jump in all channels as cracks were increasing with applied load but the jump is lower than the previous damage level. The beam was not taking any load which was clear from load-displacement curve in the Universal Testing machine (UTM) as displacement of the load cell was increasing without increasing load reading and thus indicated the failure stage of the beam. It is also clear from load-deflection curve of the beam that FB-3 was not taking any load after 23.65 kN.

Figure 4.20: Normalized FFT Curve of Flexure Control Beam-3 (FB-3)

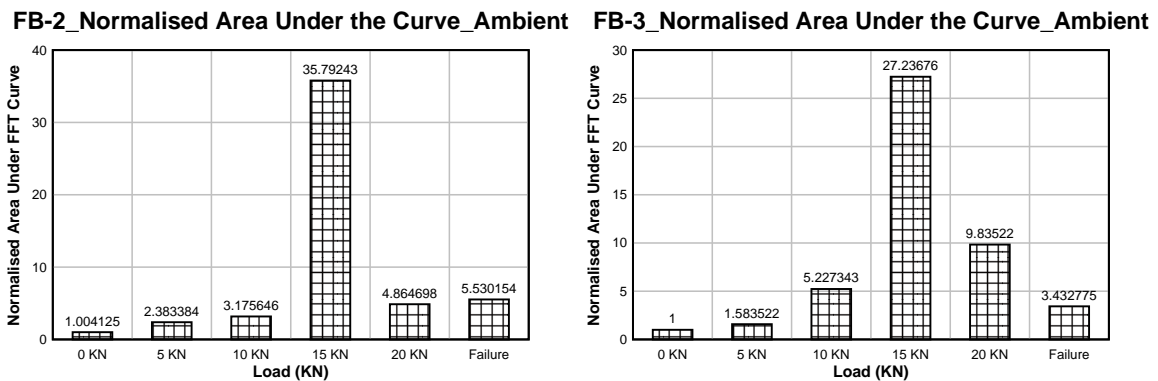
The following Fig. 4.21 shows the average area under the FFT curve, normalized with respect to undamaged state UD (0kN). For both of the flexure beams it is clear that there is a gradual increase in FFT area up to theoretical load capacity of the beam. And there is a gradual decrease in FFT area after the maximum theoretical load capacity. It is also clear from the Fig. 4.21 that FFT area is maximum when the beam works at its maximum capacity level and at failure stage RC flexure control beams does not disintegrate suddenly.

Figure 4.21: Area under the FFT Curve of Flexure Control Beam at Ambient Excitation

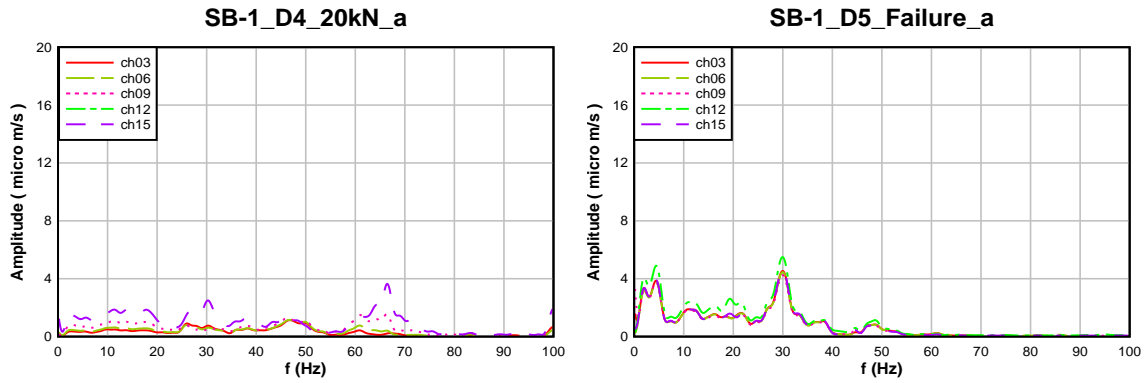
At damage level D5 (Failure) two new cracks appeared below sensor-2 (ch06). In FFT plot all the channels showed same level of jump there was no distinguished difference between them. In this stage the beam was not taking any load which was clear from load-displacement curve in the Universal Testing machine (UTM) as displacement of the load cell was increasing without increasing load reading and thus indicated the failure stage of the beam. It is also clear from load-deflection curve of the beam that SB-2 was not taking any load after 22 kN.

Figure 4.22: Normalized FFT Curve of Shear Control Beam-1 (SB-1) at Ambient Excitation

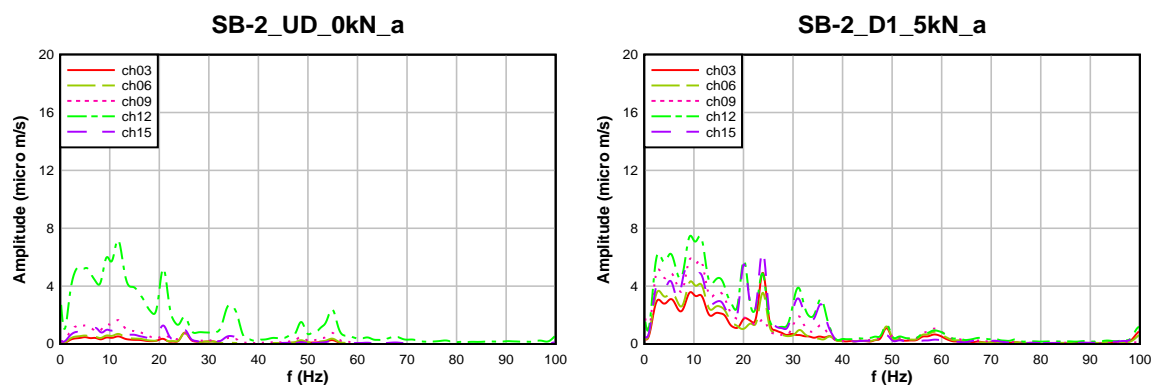
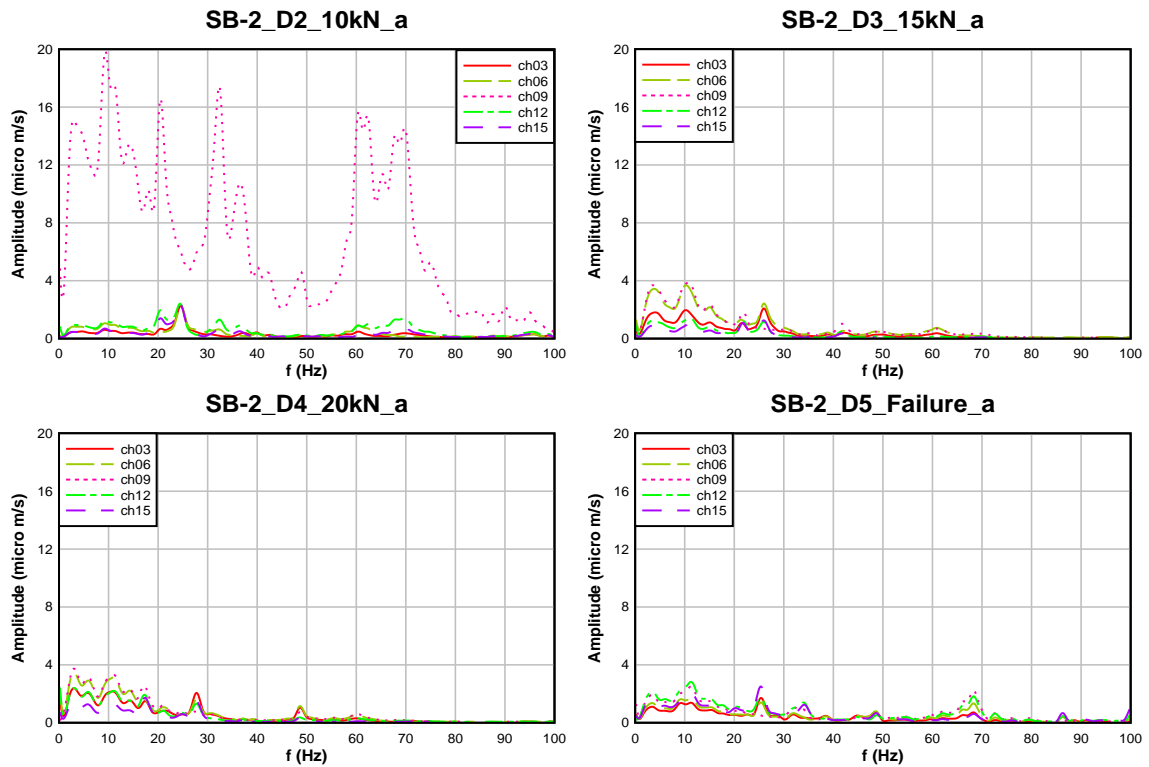
At damage level D5 (Failure) no new cracks appeared only previous cracks were propagated. In FFT plot all the channels showed same level of jump, no distinguished peak was observed. In this stage the beam was not taking any load which was clear from load-displacement curve in the Universal Testing machine (UTM) as displacement of the load cell was increasing without increasing load reading and thus indicated the failure stage of the beam. It is also clear from load-deflection curve of the beam that SB-2 was not taking any load after 21.5kN.

Figure 4.23: Normalized FFT Curve of Shear Control Beam-2 (SB-2)

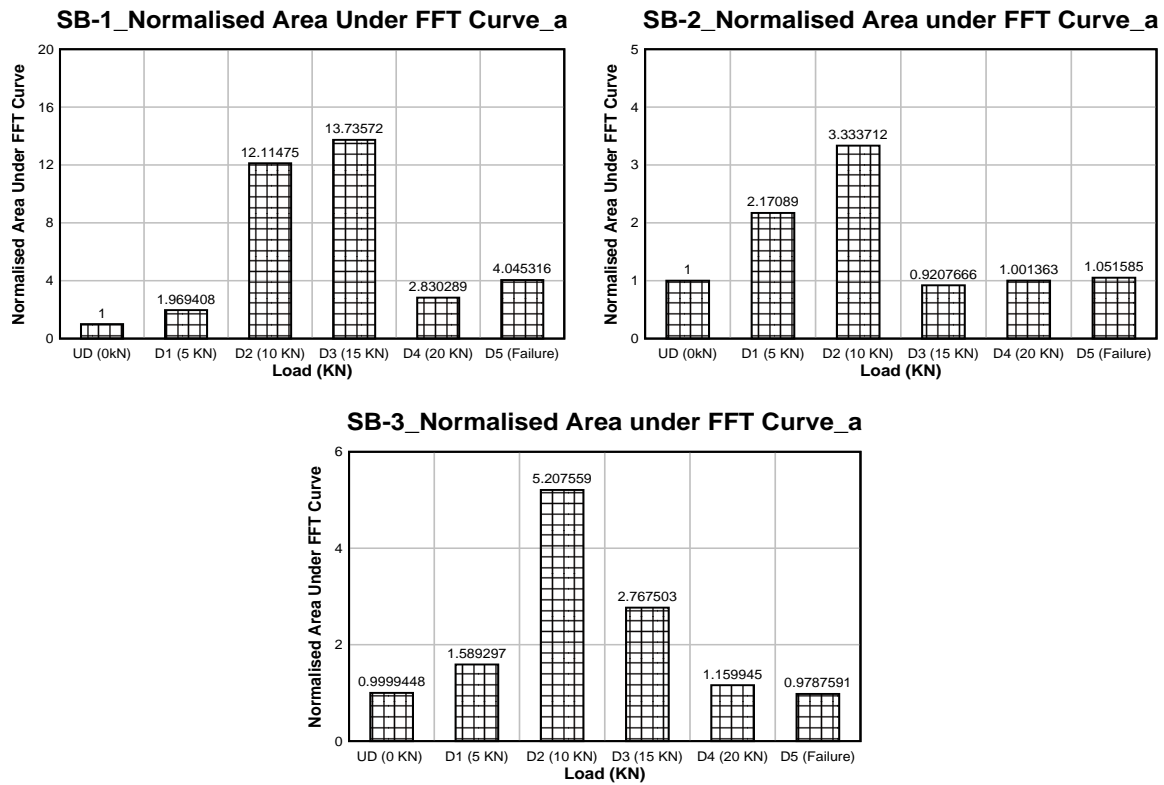
The following Fig. 4.25 shows the average area under the FFT curve, and they were normalized with respect to undamaged state UD (0kN) state. From the figure it is clear that there is a no definite pattern in increasing the area under FFT curve. For SB-1 highest area was achieved at damage level D3 (15kN) but for SB-2 & 3 showed highest area for damage level D2 (10kN). For higher damage level SB-1&2 showed no definite pattern in decreasing areas. Only SB-3 showed a definite pattern in decreasing areas. It is also clear that a for shear control beams failure occurred in a random way after achieving the maximum load.

Figure 4.25: Area under the FFT Curve of Shear Control Beam at Ambient Excitation

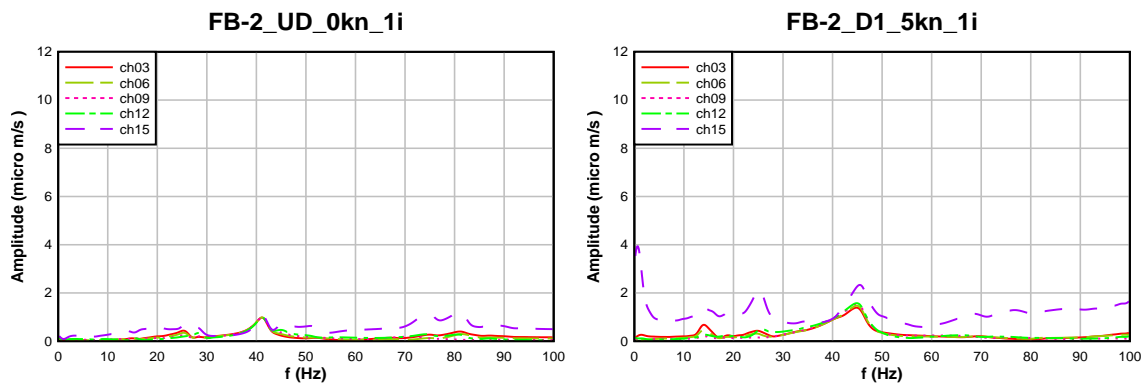
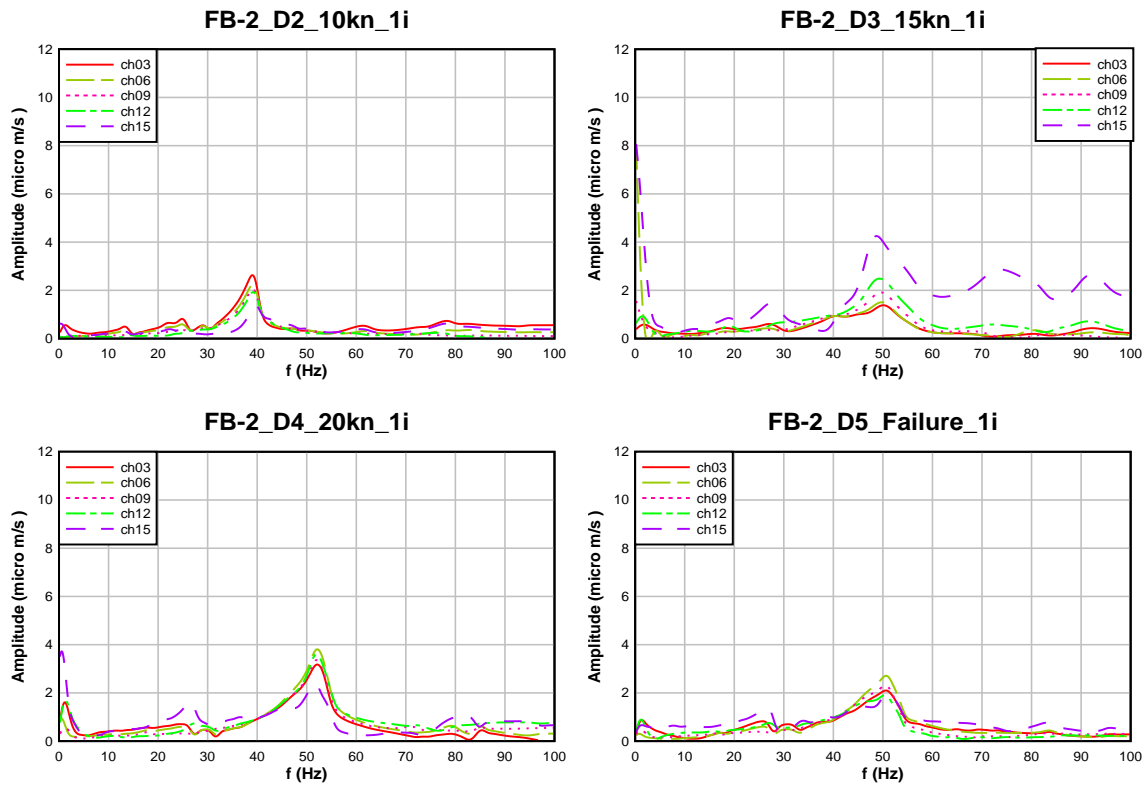
At damage level D5 (Failure) no new cracks appeared only previous cracks propagated in length and width. And FFT plot shows jump in all channels as cracks were increasing with applied load. The beam was not taking any load which was clear from load-displacement curve in the Universal Testing machine (UTM) as displacement of the load cell was increasing without increasing load reading and thus indicated the failure stage of the beam. It is also clear from load-deflection curve of the beam that FB-2 was not taking any load after 22.8 kN.

Figure 4.26: Normalized FFT Curve of Flexure Control Beam-2 (FB-2)

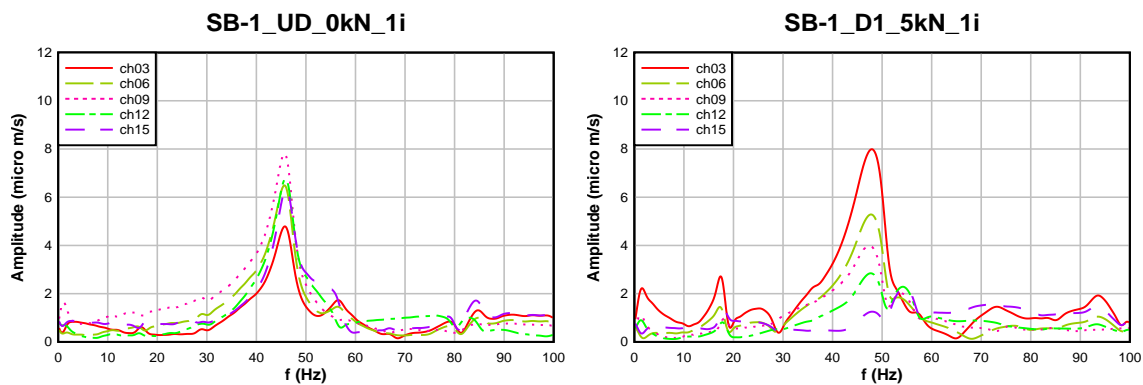
At damage level D5 (Failure) two new cracks appeared below sensor-2 (ch06). In FFT plot we found that all the channels showed abrupt and scattered peaks without any pattern. Here highest peak was shown by sensor-4 (ch-12).In this stage the beam was not taking any load which was clear from load-displacement curve in the Universal Testing machine (UTM) as displacement of the load cell was increasing without increasing load reading and thus indicated the failure stage of the beam. It is also clear from load-deflection curve of the beam that SB-1 was not taking any load after 22 kN.

Figure 4.29: Normalized FFT Curve of Shear Control Beam-1 (SB-1) at One Impact Excitation

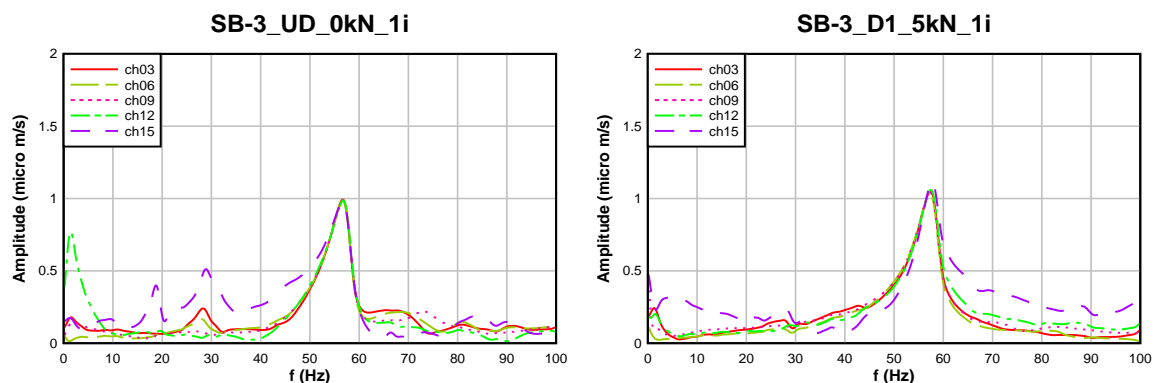
At damage level D5 (Failure) no new cracks appeared only previous cracks were propagated. In FFT plot sensor-5(ch15) showed highest level of jump, followed by sensor-4 (ch12). All other channels showed same level of jump without any distinguished peak value. In this stage the beam was not taking any load which was clear from load-displacement curve in the Universal Testing machine (UTM) as displacement of the load cell was increasing without increasing load reading and thus indicated the failure stage of the beam. It is also clear from load-deflection curve of the beam that SB-3 was not taking any load after 24.2 kN.

Figure 4.31: Normalized FFT Curve of Shear Control Beam-3 (SB-3) at One Impact Excitation

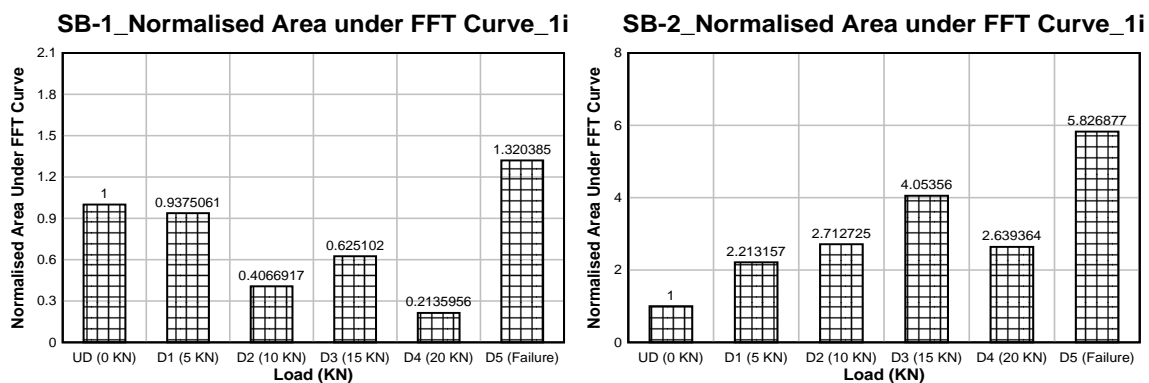
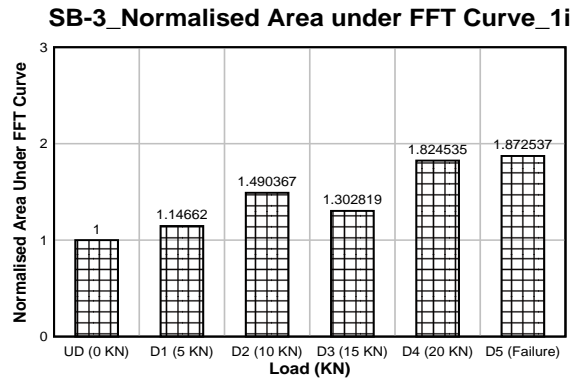
The following Fig. 4.32 shows the average area under the FFT curve normalized with respect to undamaged state UD (0kN) state. From the figure it is clear that there is a no definite pattern in increasing the area under FFT curve. It is clear from the figure that maximum area of FFT curve was achieved in damage level at failure D5 (Failure).

Figure 4.32: Area under the FFT Curve of Shear Control Beam at One Impact Excitation

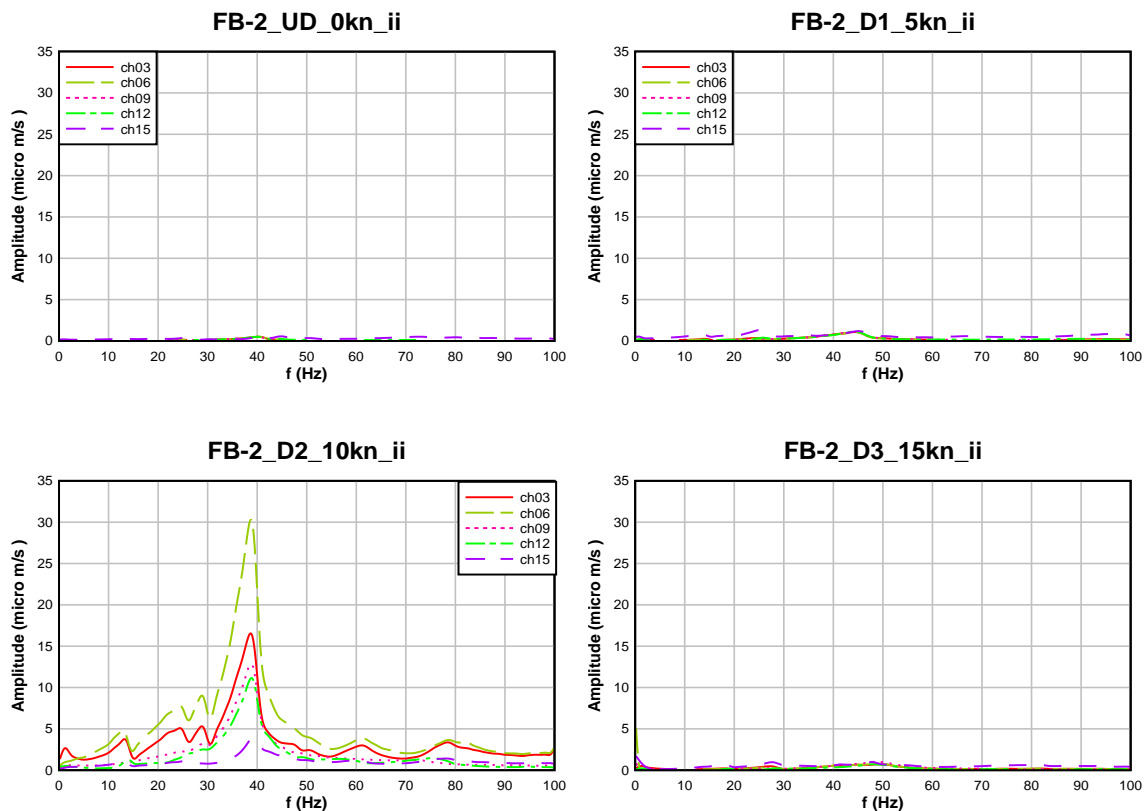
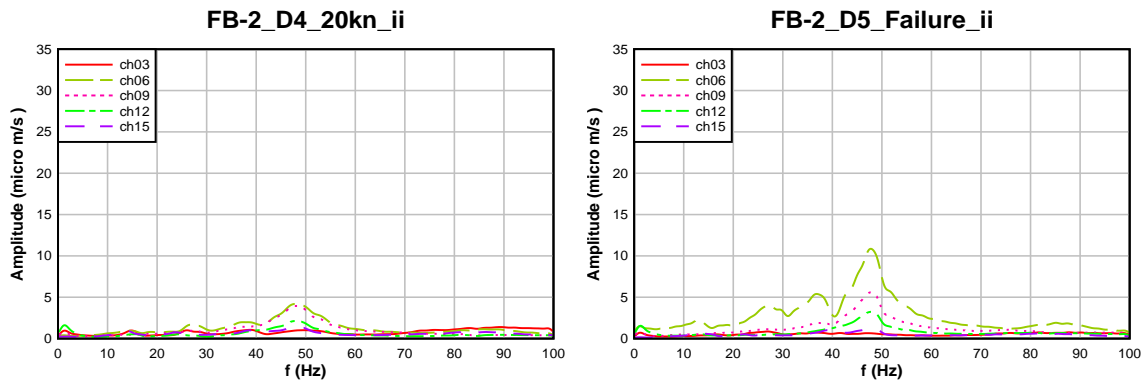
At damage level D5 (Failure) no new cracks appeared only previous cracks propagated in length and width. And FFT plot shows jump in all channels as cracks were increasing with applied load. The beam was not taking any load which was clear from load-displacement curve in the Universal Testing machine (UTM) as displacement of the load cell was increasing without increasing load reading and thus indicated the failure stage of the beam. It is also clear from load-deflection curve of the beam that FB-2 was not taking any load after 22.8 kN.

Figure 4.33: Normalized FFT Curve of Flexure Control Beam-2 (FB-2)

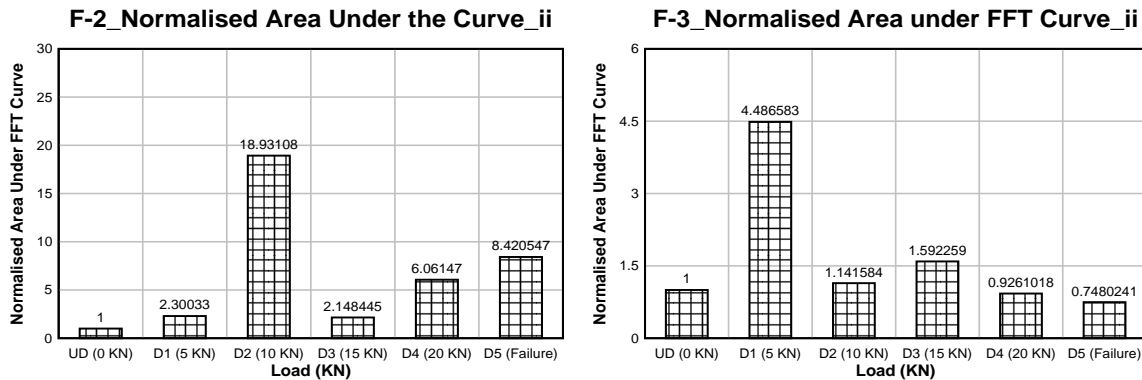
highest area in D1 (5kN). Moreover there was no definite pattern in increasing the FFT area of both the beams for Interval Impact Excitation.

Figure 4.35: Area under the FFT Curve of Flexure Control Beam at One Impact Excitation

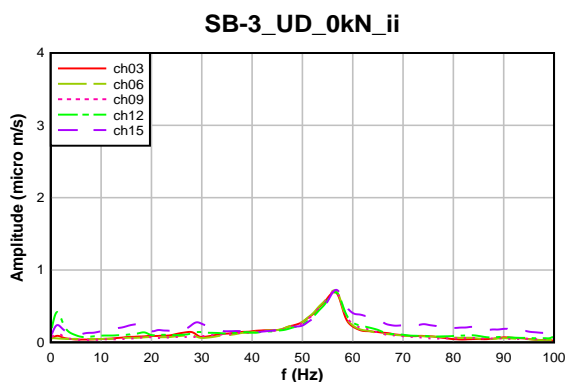
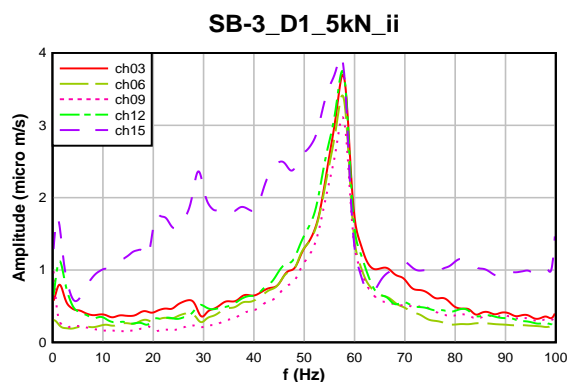
At damage level D5 (Failure) no new cracks appeared only previous cracks were propagated. In FFT plot sensor-2(ch06) showed highest level of jump, but peak was lower than previous damage level. All other channels showed same level of jump without any distinguished peak value. In this stage the beam was not taking any load which was clear from load-displacement curve in the Universal Testing machine (UTM) as displacement of the load cell was increasing without increasing load reading and thus indicated the failure stage of the beam. It is also clear from load-deflection curve of the beam that SB-3 was not taking any load after 24.2 kN.

Figure 4.38: Normalized FFT Curve of Shear Control Beam-3 (SB-3) for Interval Impact Excitation

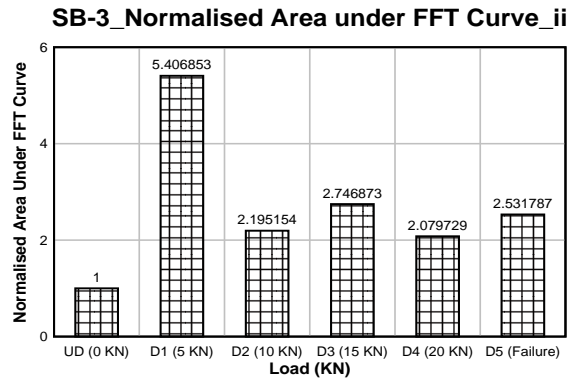
The following Fig. 4.39 shows the average area under the FFT curve normalized with respect to undamaged state UD (0kN) state. From the figure it is clear that there is a no definite pattern in increasing the area under FFT curve. For SB-1 highest area was achieved at damage level D3 (15kN) and damage level D5 (Failure) apart from these, SB-2 showed highest area for damage level D5 (Failure). On the other hand SB-3 showed highest area for damage level D1 (5kN), at the start of the loading.

Figure 4.39: Area under the FFT Curve of Shear Control Beam at Interval Impact Excitation

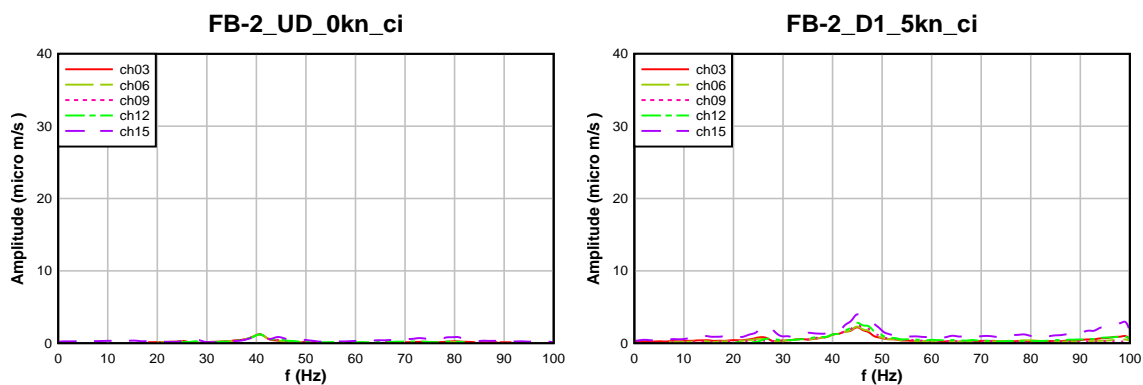
At damage level D5 (Failure) no new cracks appeared only previous cracks propagated in length and width. And FFT plot shows jump in all channels specially channel 9, as cracks were increasing with applied load. The beam was not taking any load which was clear from load-displacement curve in the Universal Testing machine (UTM) as displacement of the load cell was increasing without increasing load reading and thus indicated the failure stage of the beam. It is also clear from load-deflection curve of the beam that FB-2 was not taking any load after 22.8 kN.

Figure 4.40: Normalized FFT curve of Flexure Control Beam-2 (FB-2) for Continuous Impact Excitation

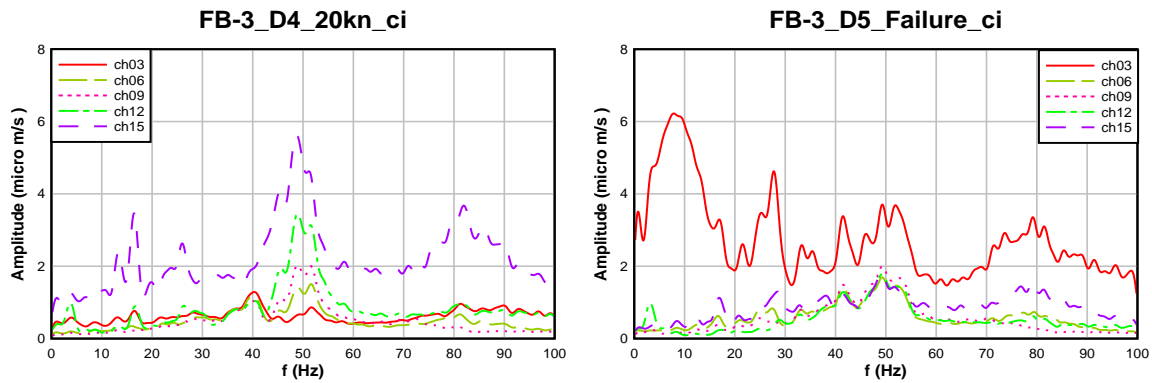
Figure 4.41: Normalized FFT Curve of Flexure Control Beam-3 (FB-3) for Continuous Impact Excitation

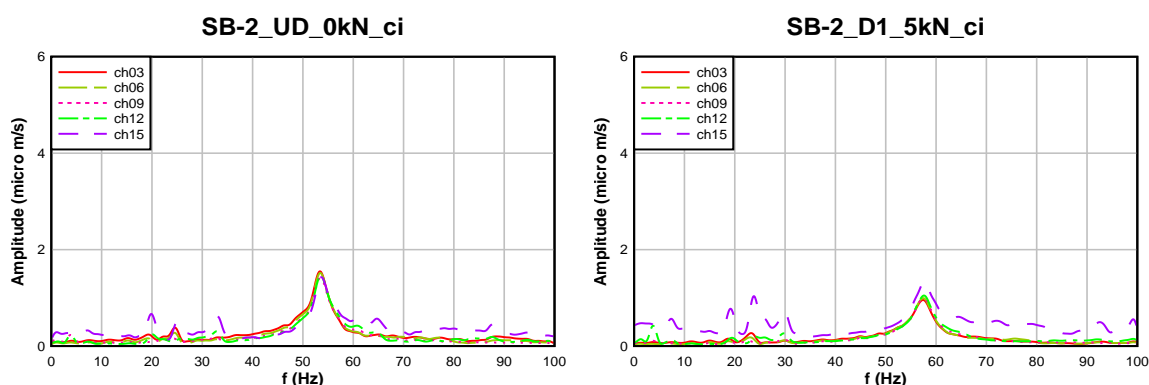
Figure 4.44: Normalized FFT Curve of Shear Control Beam-2 (SB-2) for Continuous Impact Excitation

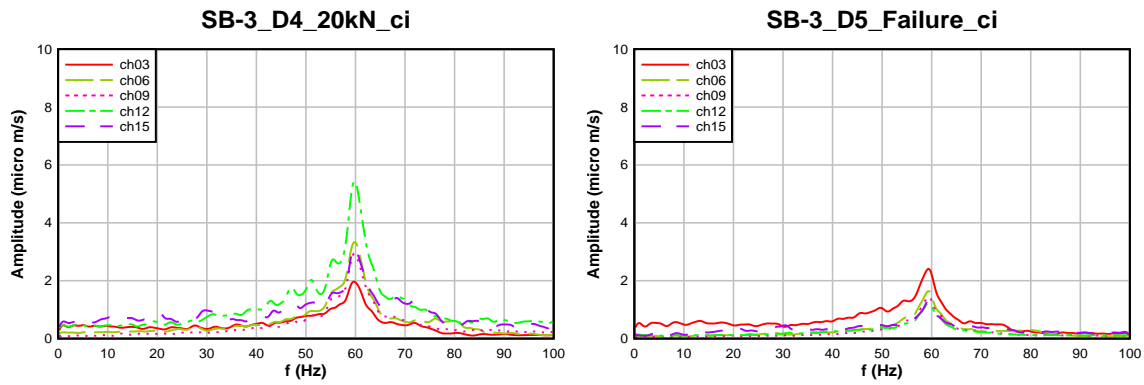
Figure 4.45: Normalized FFT Curve of Shear Control Beam-3 (SB-3) for Continuous Impact Excitation

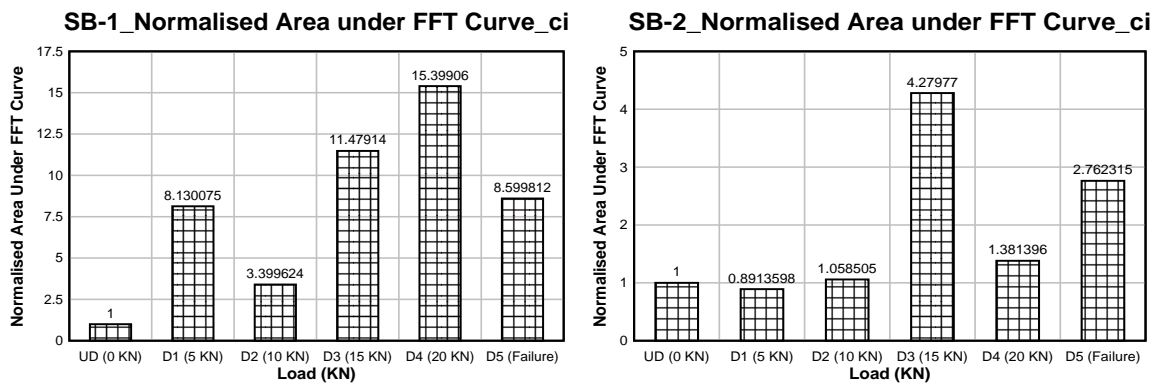
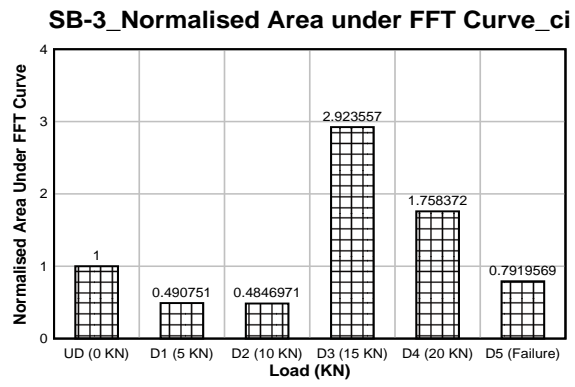
Figure 4.46: Area under the FFT Curve of Shear Control Beam at Continuous Impact Excitation
