**STORM SURGE PROPAGATION AND CROP DAMAGE ASSESSMENT IN  
A COASTAL POLDER OF BANGLADESH**

**MASTER OF SCIENCE IN WATER RESOURCES DEVELOPMENT**

**INSTITUTE OF WATER AND FLOOD MANAGEMENT  
BANGLADESH UNIVERSITY OF ENGINEERING AND TECHNOLOGY**

**JUNE 2016**

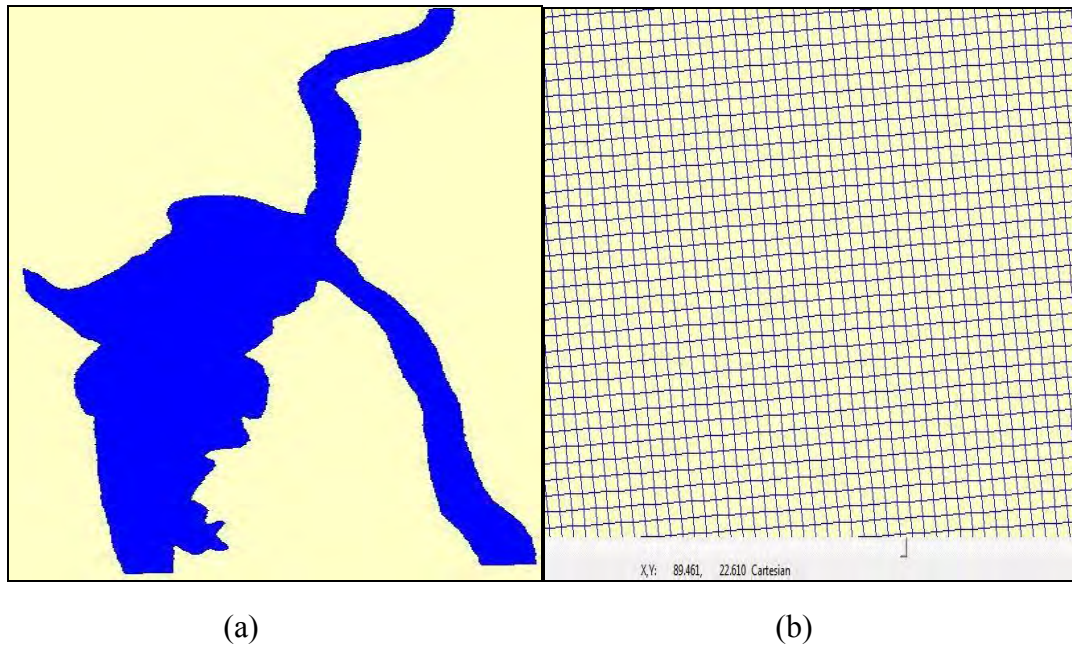
Figure 4.2 : Grid components of the model area, (a) Full area and (b) Partial area.

To set the model for simulation components, including grid, bathymetry and boundary of the domain were specified. The concept of staggered grid was applied in Delft3D-FLOW. In a staggered grid not all quantities, such as the water level, the depth, the velocity components or concentration of substances, are defined at the same location in the numerical grid. The domain of the study area may be divided into some rectangular grids e.g. 30 m x 30 m, 60 m x 60 m and so on. In this specific study, 30 m x 30 m grids were used (Figure 4.2).

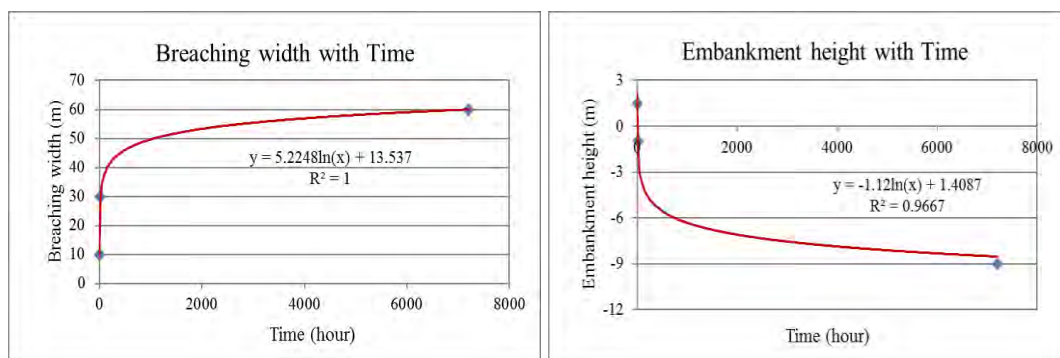
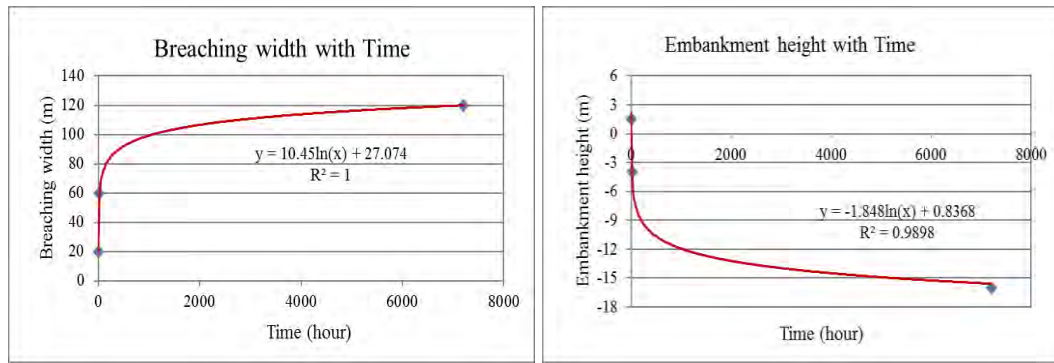
Figure 5.3: Breaching and scouring process (a) Nalian (b) Jaliakhali (c) Vitevanga  
(data source: field information).

Aila, the polder was breached at three locations. The initial breaching width identified by the local observers was about 10 m, 60 m and 20 m at Nalian, Jaliakhali and Vitevanga respectively, within the first half an hour of Cyclone Aila. The breaching width increased very rapidly after first few hours of the event. Even after Aila, during daily high tide and low tide the breaching width increased until the polder was reconstructed. Not only the breaching width, but also the bed level at the point of the embankment breaching became deeper with time. The bed level dropped down to (-) 16 m (PWD) at some locations where the previous bed level was (-) 2 m to (-) 3 m (PWD). Our analysis was based on the information gathered from local people and technical personnel from BWDB. The progressive breaching width and embankment height in the short and long term showed that the breaching and scouring approximately followed logarithmic trends (Figure 5.3). However, this analysis would be more accurate and reasonable if it was done based on hydraulic theories that include head difference, flow velocity, scouring rate, etc. A Major portion of the breaching width and scouring depth occurred within the early few hours of Aila (Figure 5.3 and Figure 5.4). Almost 50% of the total breaching took place within the first 6 hours of the event. After a certain period the breaching and scouring processes became steady which is represented by the flatter portion of the Figure 5.3.

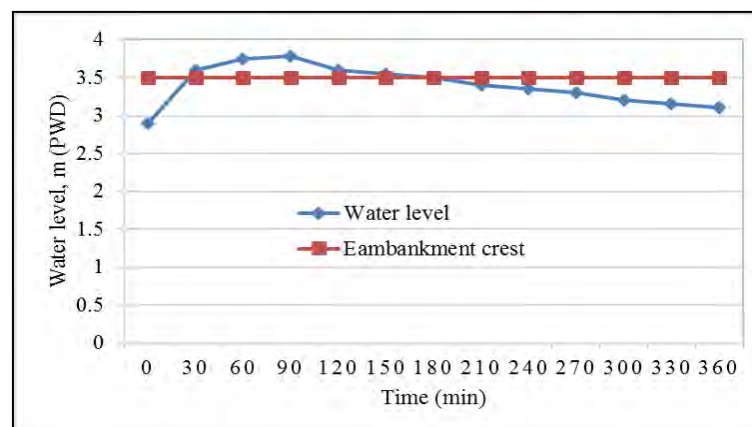
Breaching is a complex process; whereas overtopping is a quite simple process occurred by a significant rise in water level. Overtopping occurs when the water level in the vicinity of the embankment exceeds the crest level of the embankment. Polder 32 was overtopped at some points during Cyclone Aila among which three overtopping locations were identified during this study, namely L-1, L-2 and L-3 as mentioned earlier in Figure 5.1. At those locations the embankment crest was 3.65 to 3.70 m (PWD). The water level rose to almost 3.80 m (PWD) at those points during Aila. The detailed overtopping process has been illustrated in Figure 5.5. In the figure water level for the first six hours immediately after Aila has been plotted against time and summarized in Table 5.3.

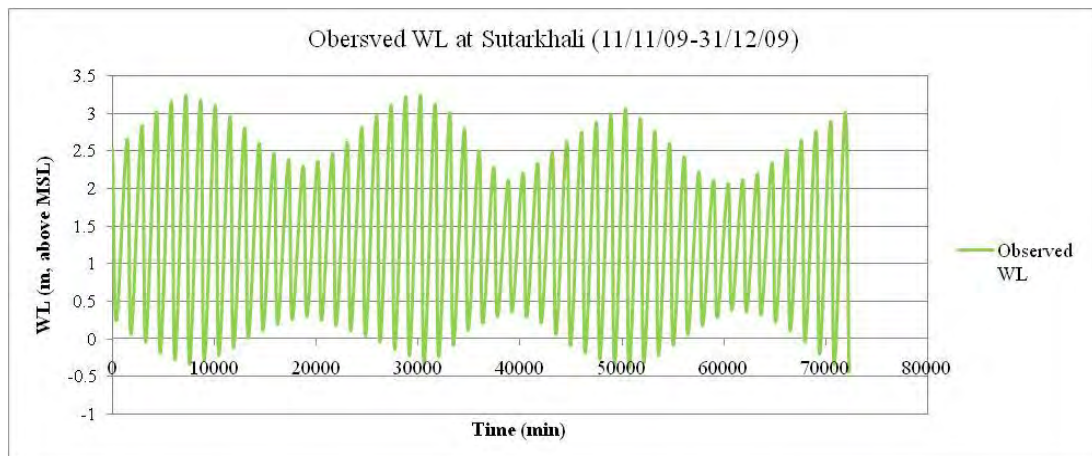
Figure 5.6: Observed water level hydrograph at Sutarkhali station during 11-11-2009 to 31-12-2009 (*source*: BWDB).

a number of values for Manning's  $n$ . Comparisons were made between the model results and the known water level at Sutarkhali point for calibrating the model. Observed water level and model results of November and December of 2009 were used for calibrating the model. Then the model was tested for a gradual change in the values of Manning's  $n$ . The observed water level hydrograph at Sutarkhali is shown in Figure 5.6. A series of hydrographs were developed for different values of  $n$  ranging from 0.02 to 0.08 and the best calibration was found for  $n$  value of 0.025 which has been used in this study as final calibration and shown in Figure 5.7. It was observed that the model conveyed better results as the Manning's  $n$  value was decreased and the results became more congruent with the observed values. After setting a value for Manning's  $n$  the model was validated with the water level of the Sutarkhali river (Figure 5.8). Observed water level and model results of October, 2009 were used for validation of the model.

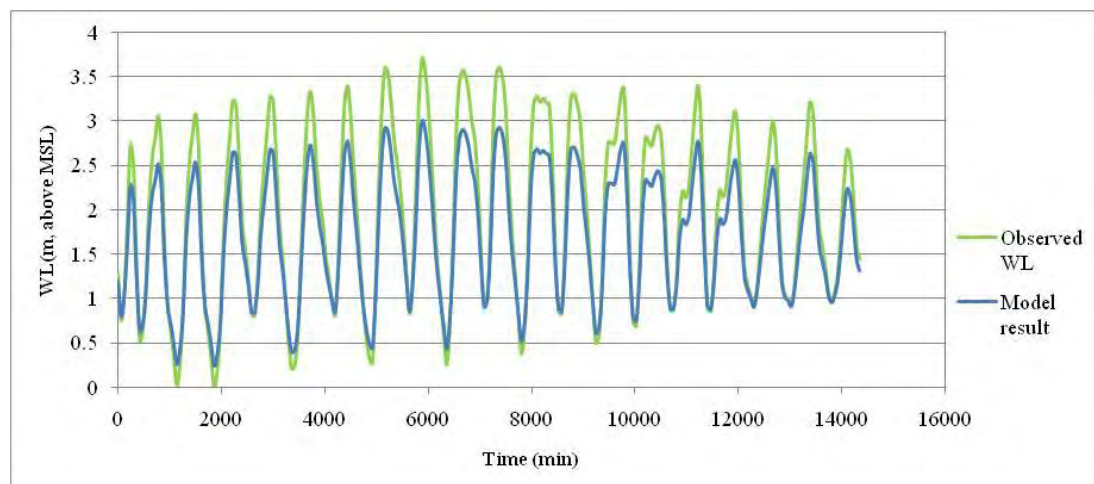
Figure 5.8: Model generated water level hydrograph from 01-10-2009 to 10-10-2009 (validation plot).

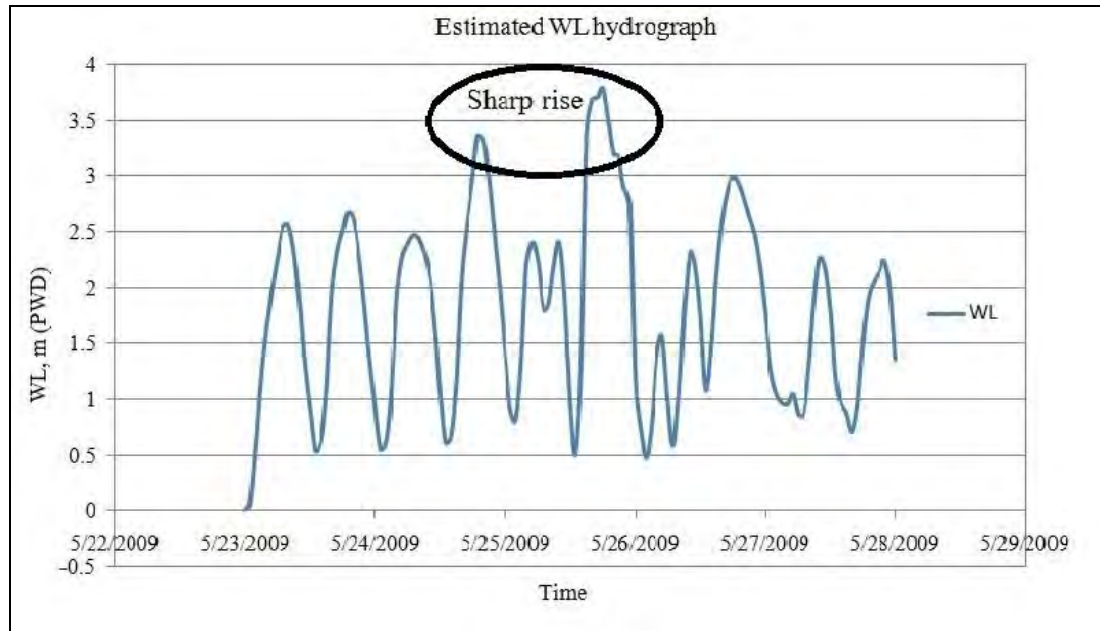
Figure 5.9: Estimated water level hydrograph during Aila (*source*: model result).

to 6 PM, the water level exceeded the embankment crest which made it to overtop the embankment. A similar scenario was observed in a number of places where overtopping of polder took place.

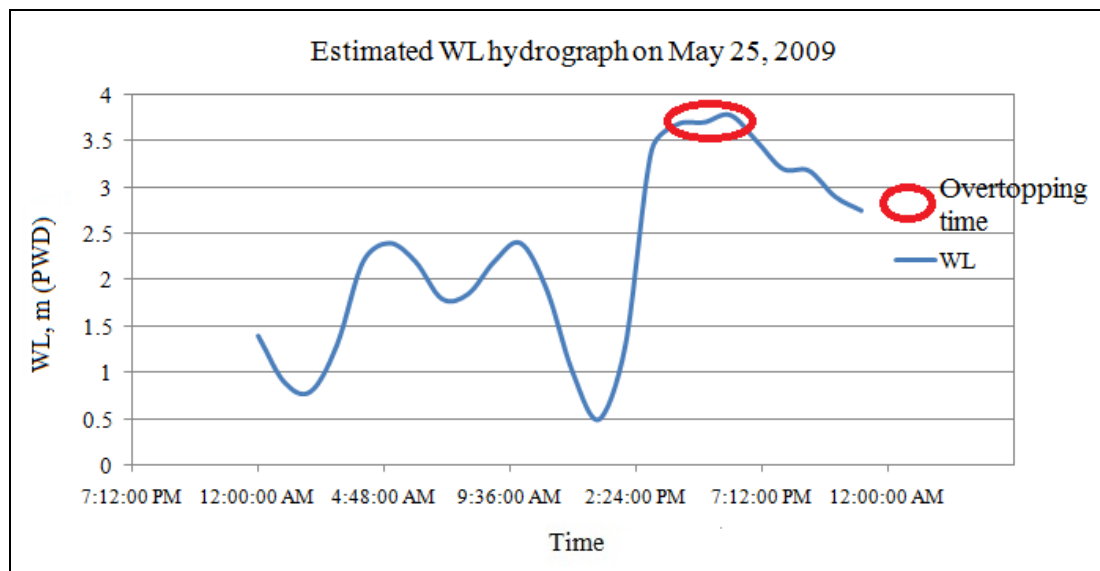
Figure 5.10: Estimated water level hydrograph on May 25, 2009 (*source*: model result).

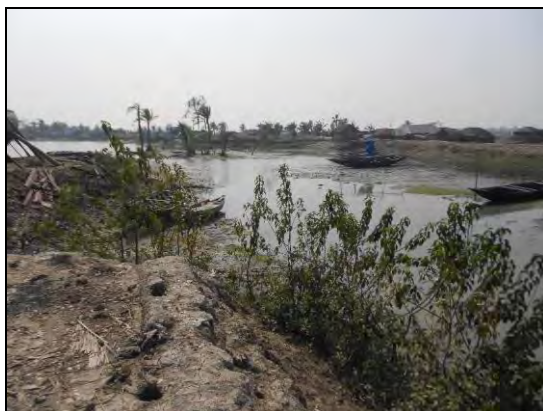
Photo B1: Damages to embankment by Aila.

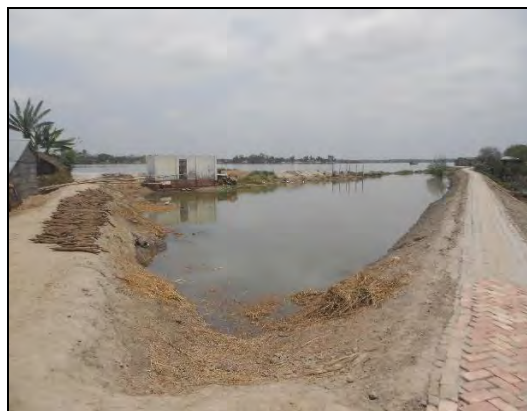
Photo B2: Ring embankments undergoing rehabilitation after Aila.

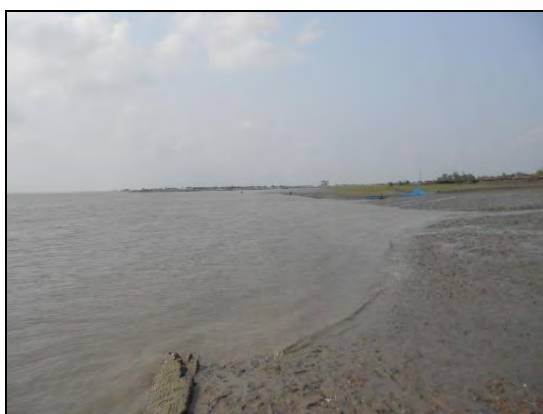
Photo B3: Breaching caused by Aila at Nalian sluice.

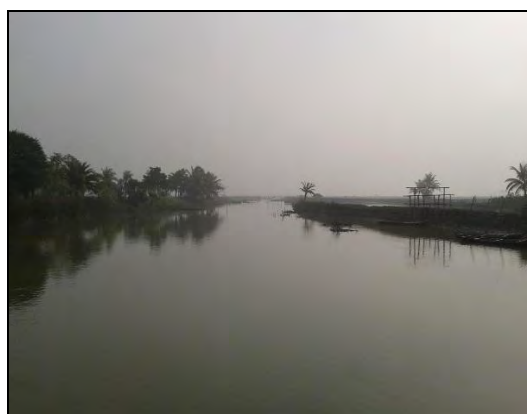
Photo B4: A small canal turned into a river by Aila.

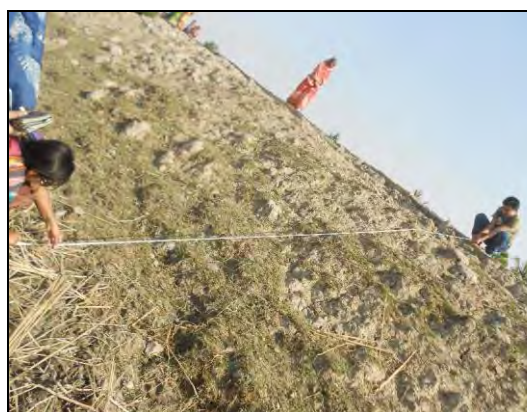
Photo B6: Measurement of Polder height during field visit.
