**PERFORMANCE EVALUATION PARAMETERS FOR SIGNALIZED
ROAD INTERSECTIONS UNDER HETEROGENEOUS
TRAFFIC CONDITION**

**By
M.M.A. KADER CHOWDHURY**

**MASTER OF SCIENCE IN ENGINEERING
(CIVIL AND TRANSPORTATION)**

**BANGLADESH UNIVERSITY OF ENGINEERING AND TECHNOLOGY
DHAKA, BANGLADESH.**

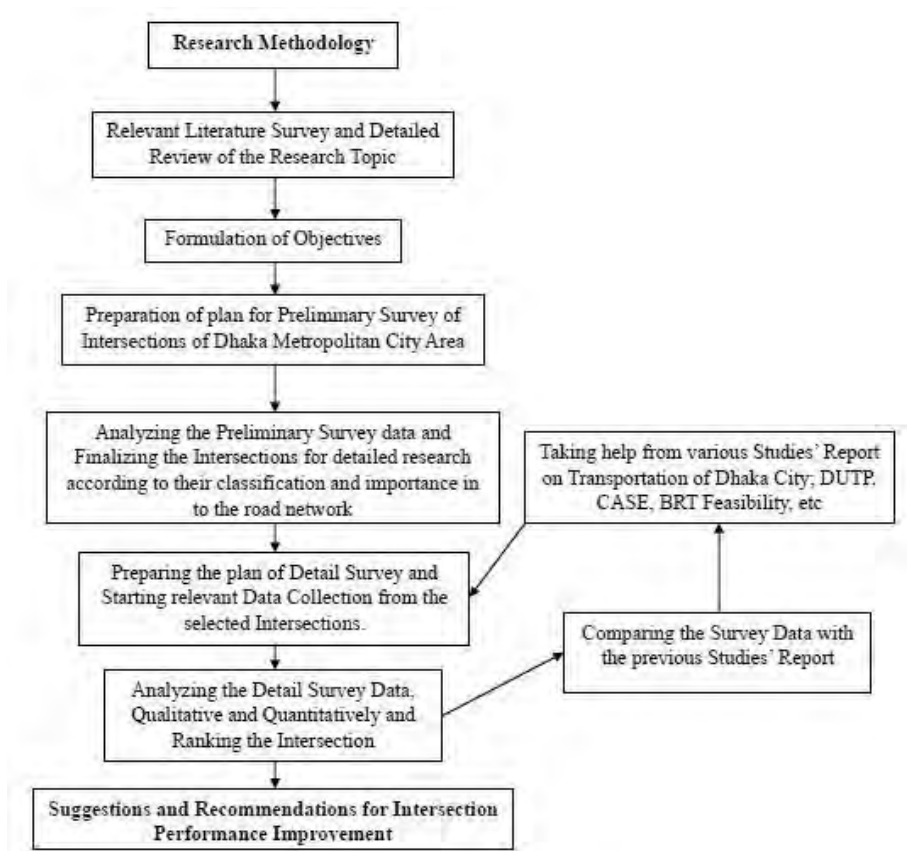
The methodology followed is outlined in the Figure 3.2.1 and described subsequently. The relevant review on previous literature from home and abroad have been carried out before conducting detailed review and study to identify the relevant sectors and field. These also pointed out the required study area and from where data or information will have to be collected. The literature review also assist to select the type and nature of data required for this study, to outline the method of data collection and time for data collection also. Data or information has been collected, formatted and analyzed to identify the performance of intersections of Dhaka Metropolitan City.

Figure 3.2.1: Flow Chart of the Research Methodology.

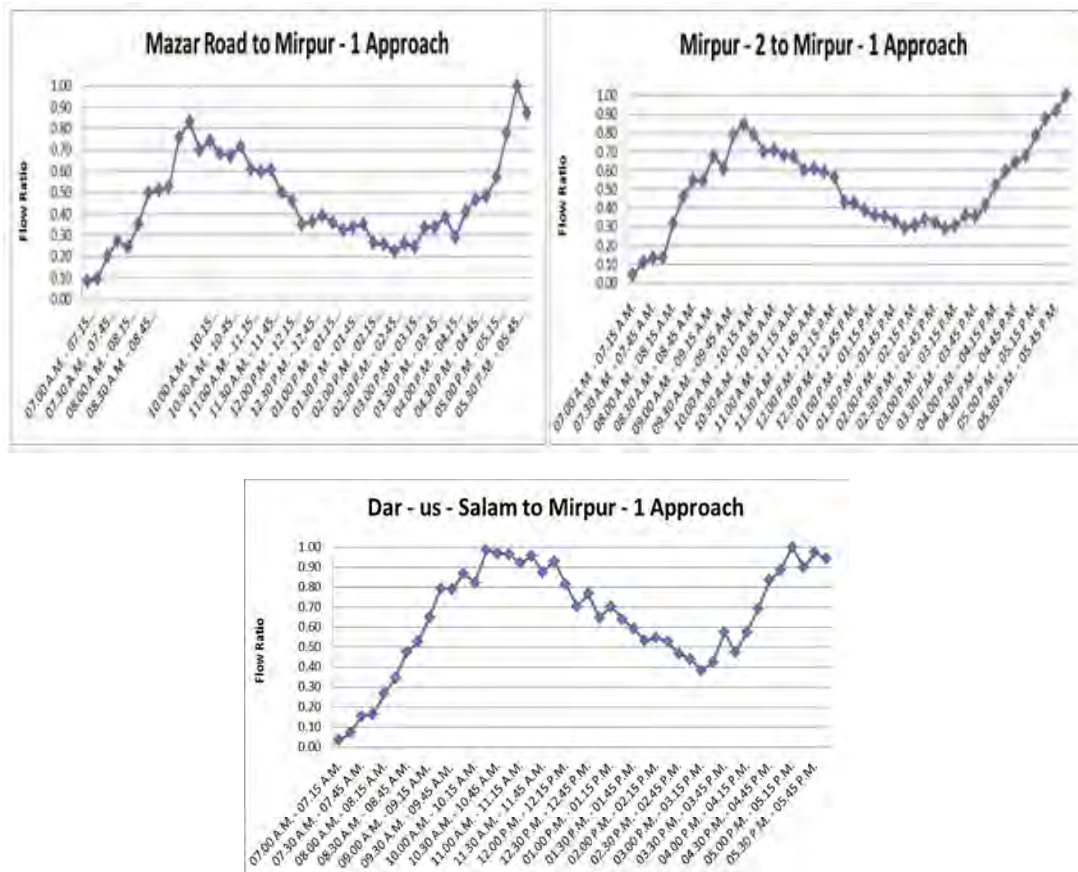
Later, the usages of road space of every approaches of this intersection were calculated. The result of this calculation is presented here through Figure 4.6.4 a), b), and c) with individual general graph, which is expressing the flow ratio with respect to saturation flow of the every individual approach of this intersection of 11 hours (from 07.00 A.M. to 06.00 P.M.).

Figure 4.6.4: a) Flow Ratio of Mazar Road to Mirpur 1 Approach; b) Flow Ratio of Mirpur 2 to Mirpur 1 Approach; c) Flow Ratio of Dar us Salam to Mirpur 1 Approach.

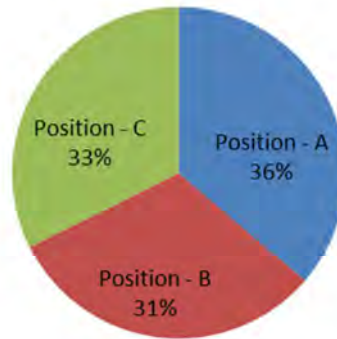
Figure 4.6.5: a) Pedestrian Survey Position inside Mirpur-1 Intersection; b) Pedestrian Flow; c) Pedestrian Flow Contribution among three (3) Positions.

From the preliminary survey, the three (3) positions were selected for detail field survey according to the availability of pedestrian in these points. The positions of those three (3) points are shown here in Figure 4.6.5 a). From Figure 4.6.5 b) at grade pedestrian flow through this intersection is presented, two (2) peak hours were found, one in the morning from 09.30 A.M. to 11.00 A.M. and other in the evening from 04.30 P.M. to 06.00 P.M. Among the three (3) positions, maximum at grade pedestrian flow was observed in position A, which is at the front of Mukto Bangla Shopping Complex, 36% percent of entire at grade pedestrian flow took place in this position which is presented here in Figure 4.6.5

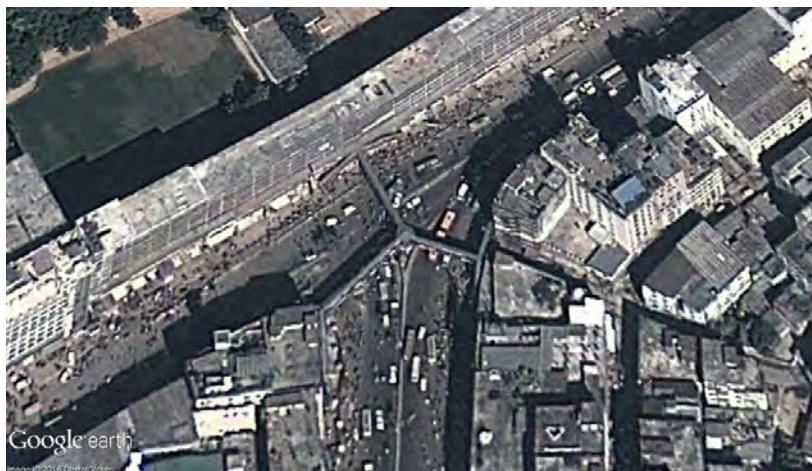
A three (3) legged over bridge is situated inside this intersection as a grade separated crossing facilities for pedestrian. For finding out the scenario of grade separated pedestrian crossing facility of this intersection, an 11 hours (from 07.00 A.M. to 06.00 P.M.) pedestrian crossing survey was organized in this over bridge. After analyzing the result of this pedestrian survey, it is presented here in Figure 4.6.6 a), b) and c), through a general graph accompanying with a Google map and pie chart.

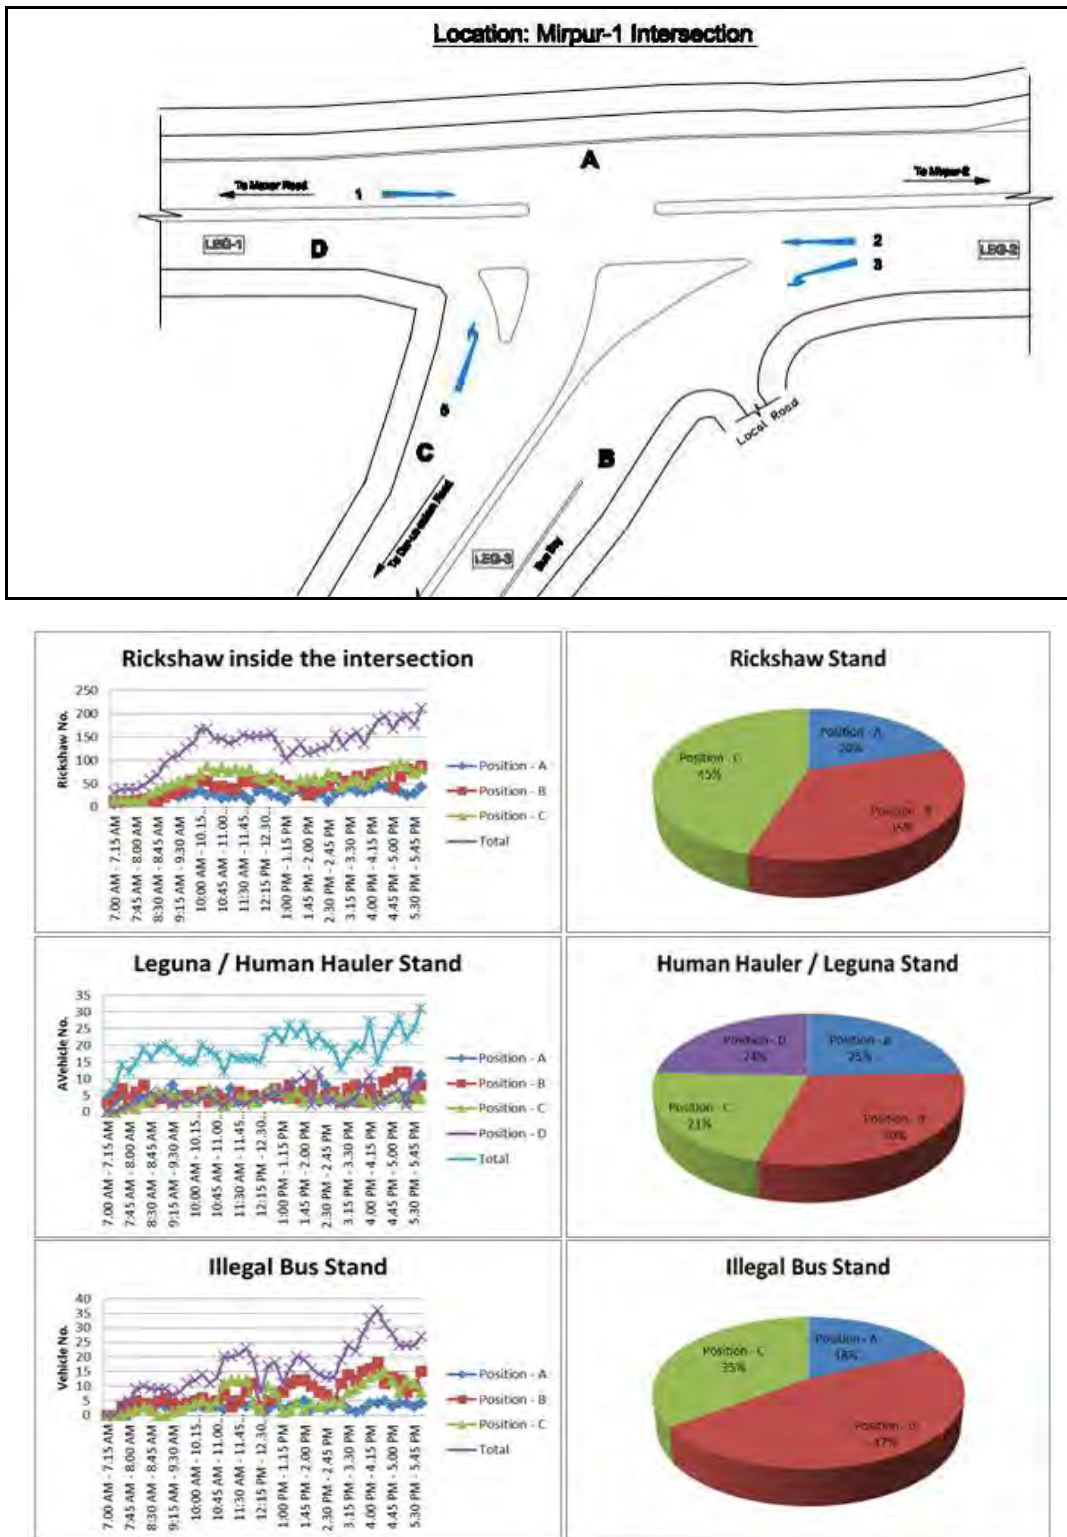
here in Figure 4.6.7 a), b), c) and d).

Figure 4.6.7: a) Side Friction Survey Position inside the Mirpur-1 Intersection; b) Contribution of Illegal rickshaw Stand; c) Contribution of Illegal Human Hauler Stand; d) Contribution of Illegal Bus Stand.

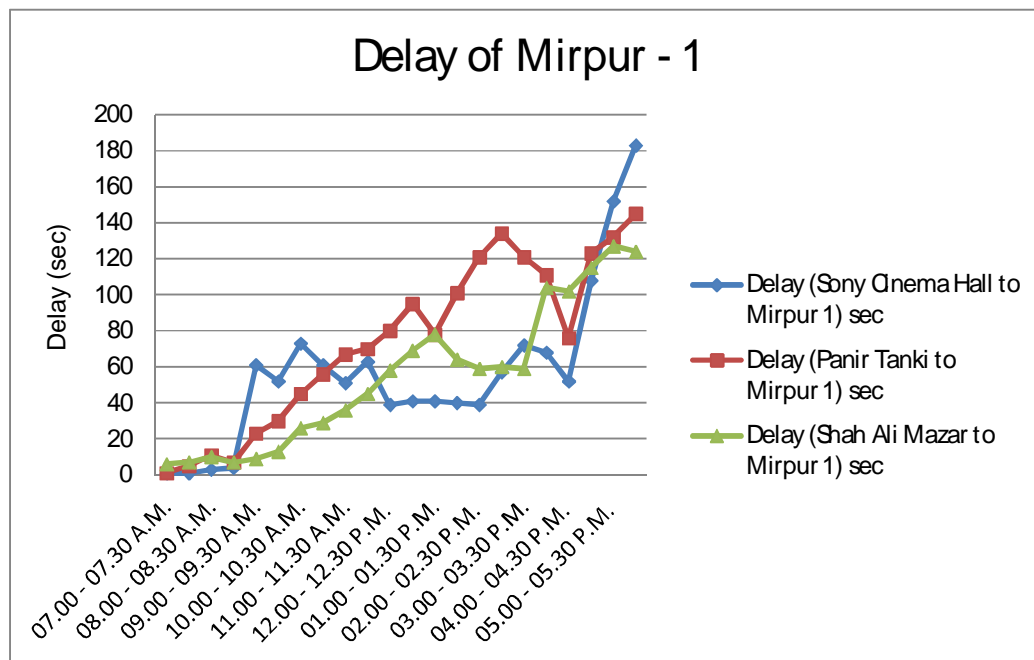
Analyzing the Table 4.6.10, the delay at different approach of Mirpur 1 intersection was found increased as the progress of the day time. Approach wise comparison of delay time is shown in Figure 4.6.9 below.

Figure 4.6.9: Comparison of Delay at Different Approach of Mirpur 1 Intersection.

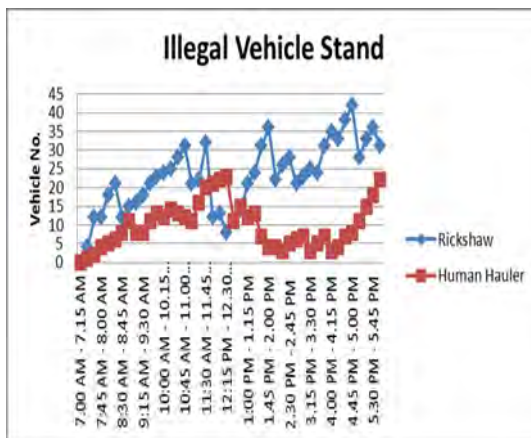
Figure 4.7.6: a) Contribution of Rickshaw Diversion; b) Contribution of Illegal Vehicle Stand; c) Contribution of Illegal Bus Stand.

Analyzing Figure 4.7.6 a), b) and c); For Rickshaw diversion, two (2) points were found inside this intersection, beside Shishu Mela Park and on the mouth of Khilji road. Among the two places, 63% diversion of total diverted rickshaw was done beside the Shishu Mela Park. For this diversion, a huge jam was created on the mouth of the Agargaon to Shishu

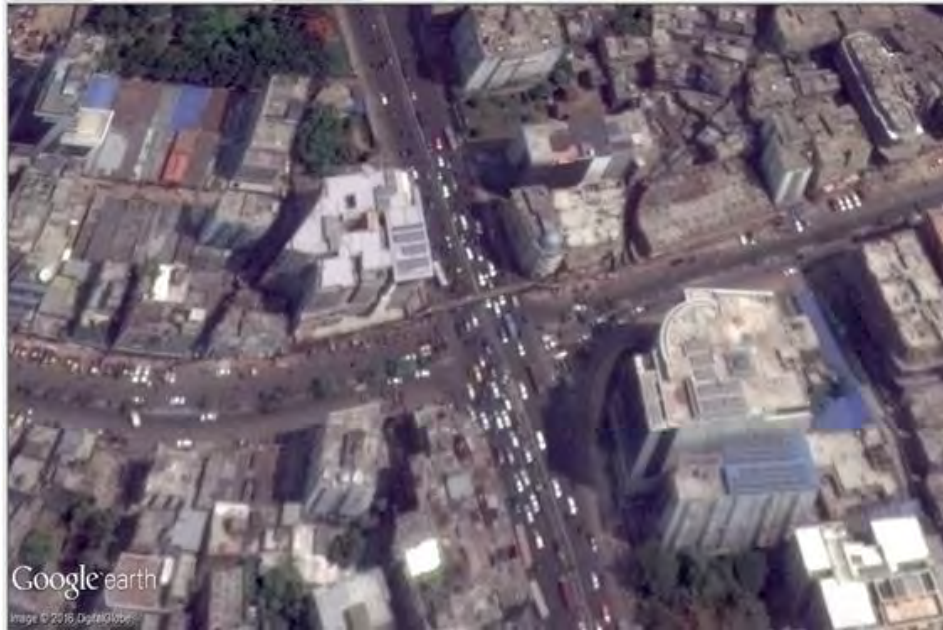
A two (2) legged over bridge is situated inside this intersection as a grade separated crossing facilities for pedestrian. For finding out the scenario of grade separated pedestrian crossing facility of this intersection, an 11 hours (from 07.00 A.M. to 06.00 P.M.) pedestrian crossing survey was organized in this over bridge. After analyzing the result of this pedestrian survey, it is presented here in Figure 4.9.6 a), b) and c), through a general graph accompanying with a Google map and pie chart.

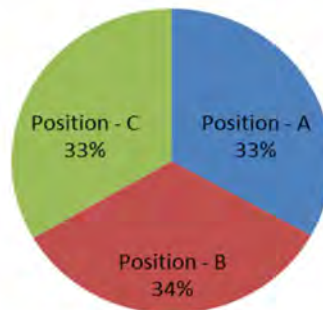
Figure 4.11.5: a) Pedestrian Survey Position inside Shapla Chattar Intersection; b) Pedestrian Flow; c) Pedestrian Flow Contribution among three (3) Positions

From the preliminary survey, the three (3) positions were selected for detail field survey according to the availability of pedestrian in this intersection. The positions of those three (3) points are shown here in Figure 4.11.5 a). From Figure 4.11.5 b) at grade pedestrian flow through this intersection is presented, two (2) peak hours is found from it, one in the morning from 10.00 A.M. to 01.00 P.M. and other in the evening from 03.30 P.M. to 06.00 P.M and further beyond the survey time. Among the three (3) positions, maximum at grade pedestrian flow was occurred in position B, which is at the front of Sonali Bank 34% percent of entire at grade pedestrian flow took place in this position which is presented here in Figure 4.11.5 c).

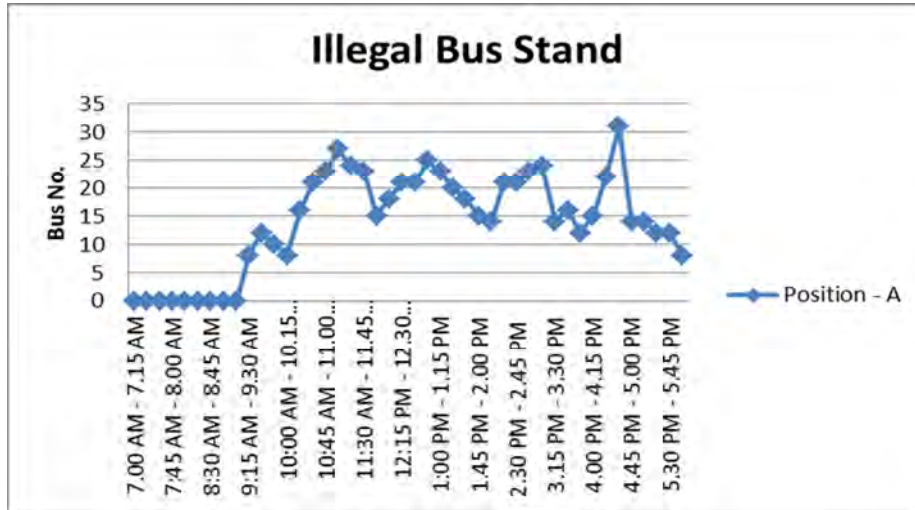
Figure 4.11.8: a) Position of Illegal Bus Stand inside Shapla Chattar Intersection; b) Illegal Bus all throughout the Day.

From the above Figure 4.11.8 a) and b); analyzing the 11 hours survey result, a huge amount of bus stood this point on the main approach of this intersection. Around 621 nos. of buses were found in this place. As usually they were created obstacle in the circulation of vehicle inside this roundabout intersection. It stopped the flow of vehicle through this intersection intermittently.

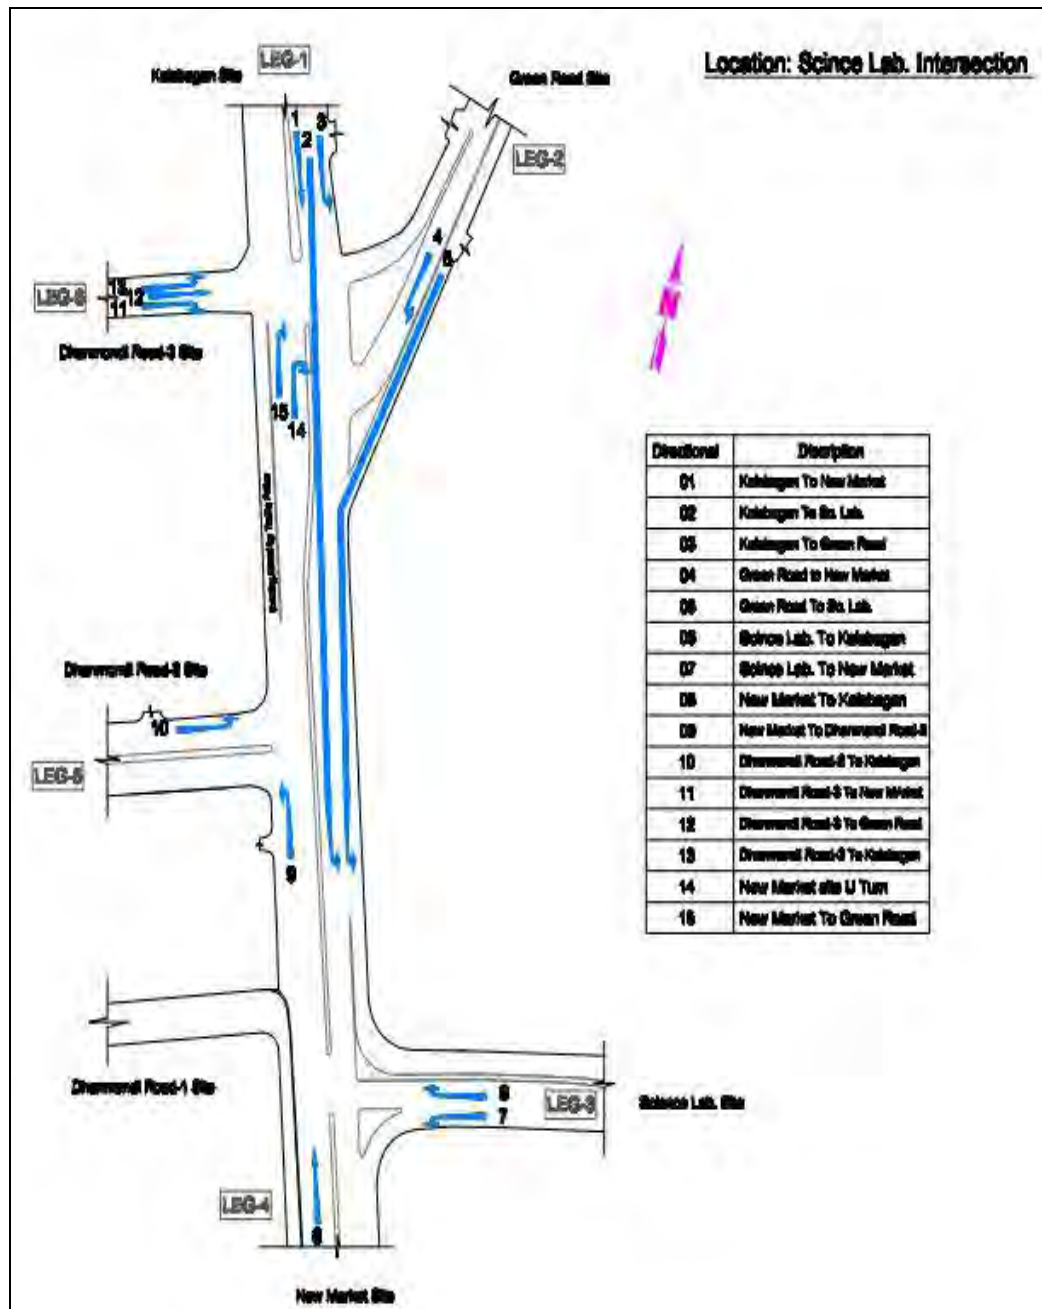
Figure 4.12.1: Layout of Science Laboratory intersection.

to classification of intersection; the Science Laboratory Intersection is a multi - legged compound intersection. In this intersection, there is a combination of one four (4) legged / cross junction, two (2) Tee intersection.

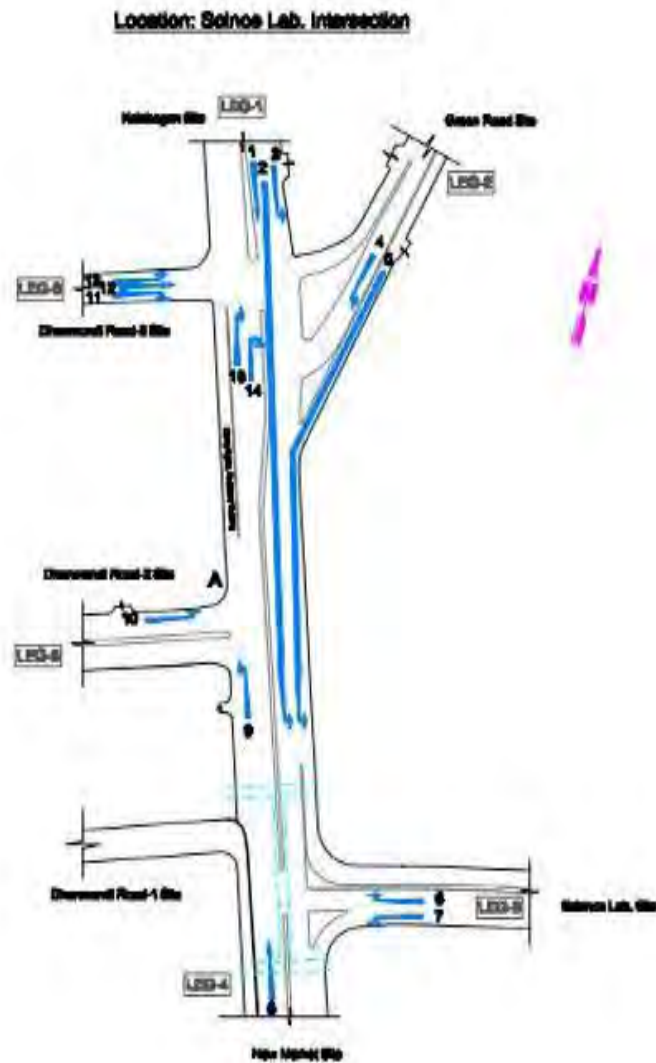
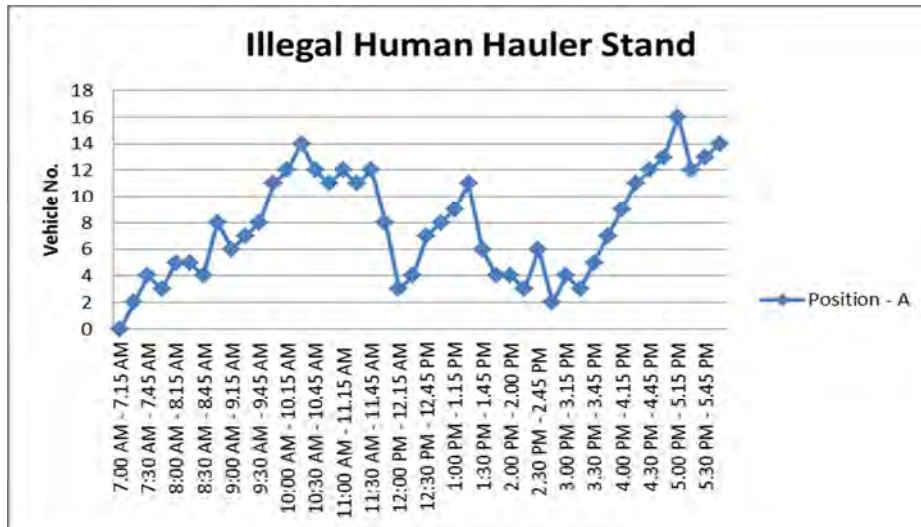
Figure 4.12.8: a) Position of Illegal Human Hauler Stand of Science Laboratory Intersection; b) Counting Survey of Human Hauler Stood Inside the Intersection.

From the above Figure 4.12.8 a) and b) analyzing the 11 hours survey result, a huge amount of human hauler were stood this point on the main approach of this intersection, on the mouth of Dhanmondi Road 2 to Science Lab approach. It disturbed the smooth flow of the vehicle through this intersection.

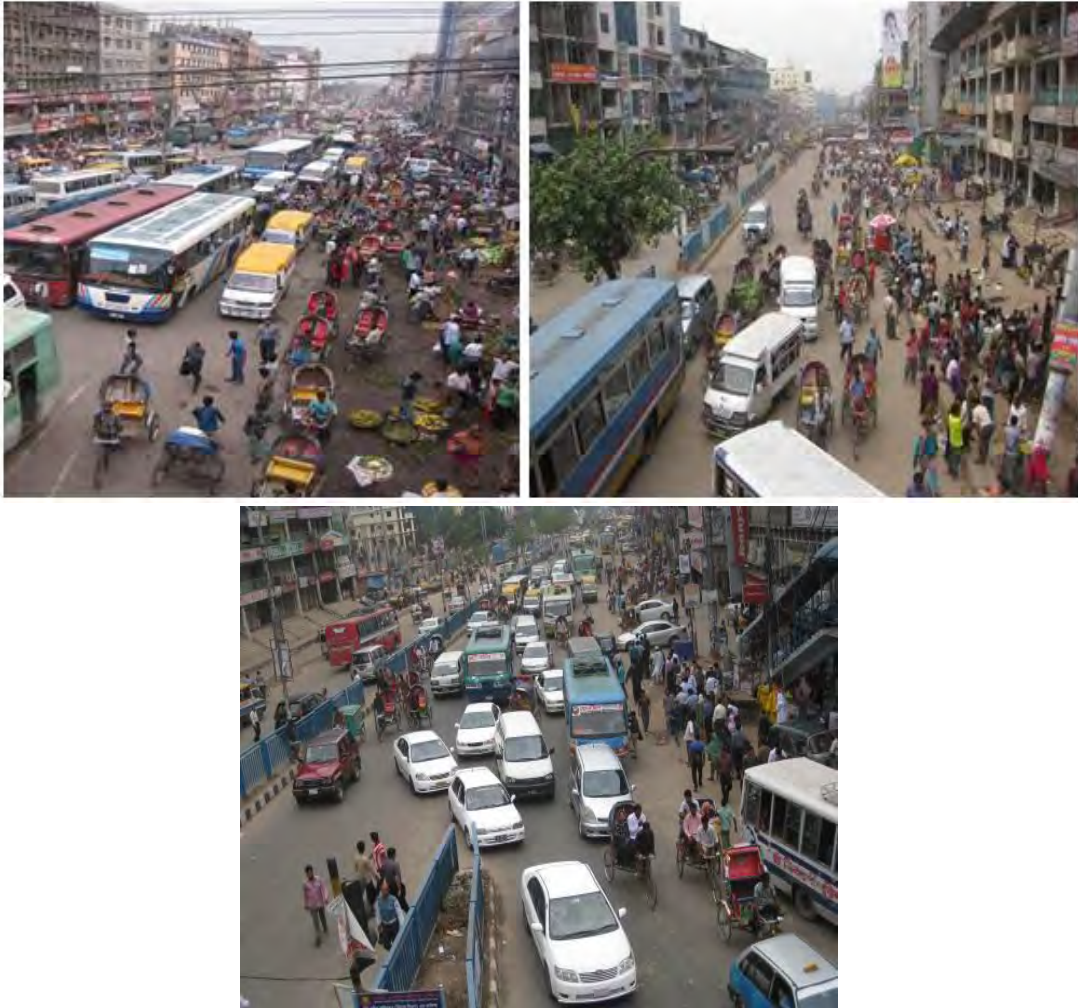
Figure 1.1.3: Approach Road: (a) Mazar Road, (b) Dar-us-Salam Road and(c) Mirpur 10 Road.

- a) Mazar Road 2 Lane both directions.
- b) Dar-us-Salam Road 2 lane both directions.
- c) Mirpur 10 Road 2 lane both directions.

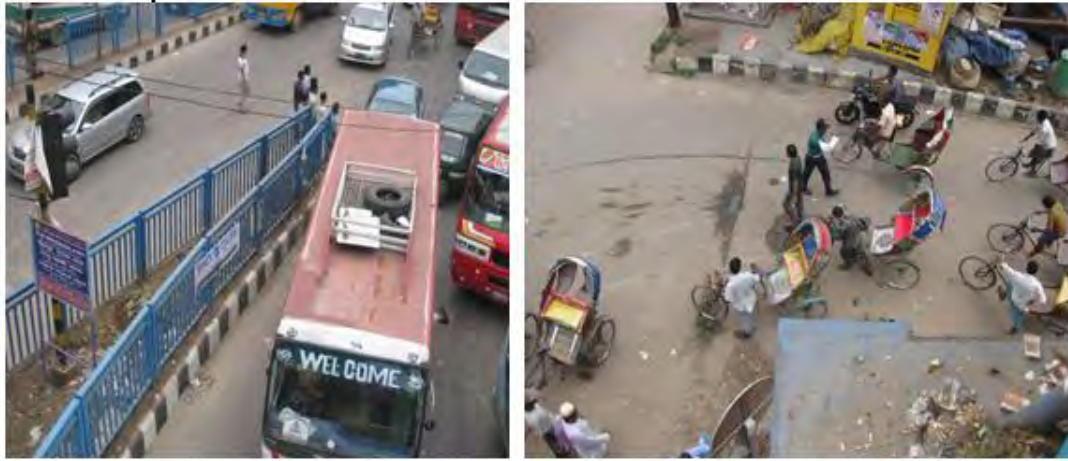
Figure 1.1.4: Inside Intersection: Channelization on Dar-us-Salam Road.

There is exclusive left turn in Mirpur Road and Dar-us-Salam Road. Some roads contain the provision of channelization. The pictures are given below

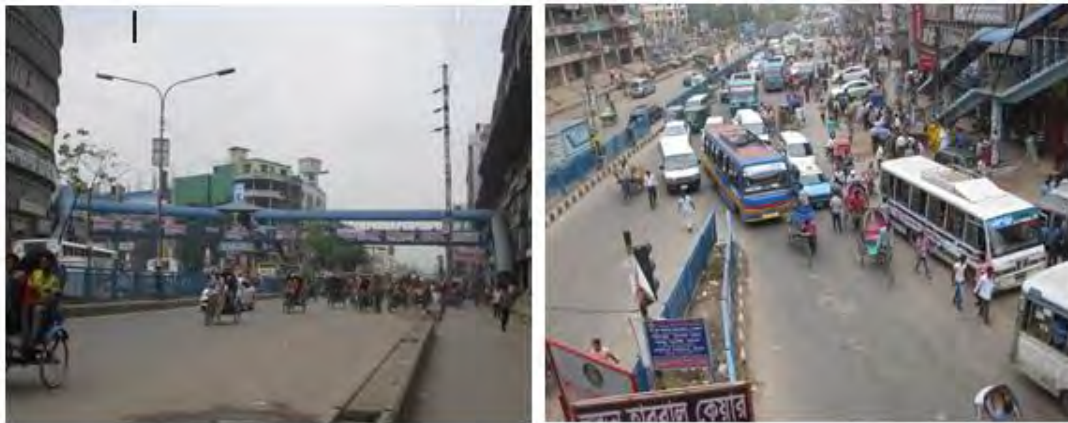
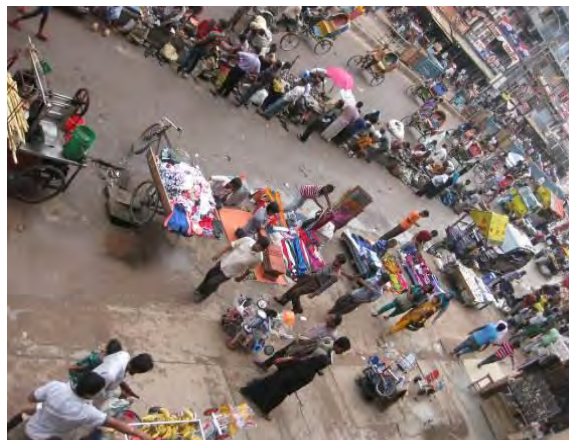
Figure 1.1.5: Inside the Intersection: (a) Over Bridge, (b) Median Barrier and (c) Footpath Occupied by Vendor.

Some of the links contain Median with or without picket barrier, Marking, Sign, etc. In this intersection, there are some facilities of pedestrian crossing, such as over bridge, pedestrian movement facilities, such as footpath. Pedestrian cross the road illegally also. They usually cross the median barrier for crossing movement.

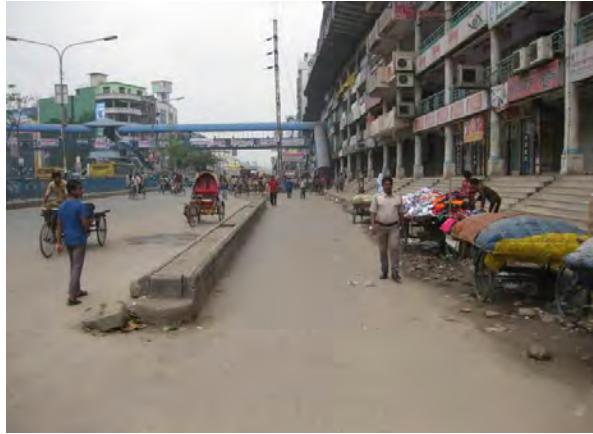
For movement of Non Motorized Vehicle, there is separate lane for this; it is located in front Mukto Bangla Shopping Complex. But it is not properly used by NMV.

Figure 1.1.6: Separated NMV Lane.

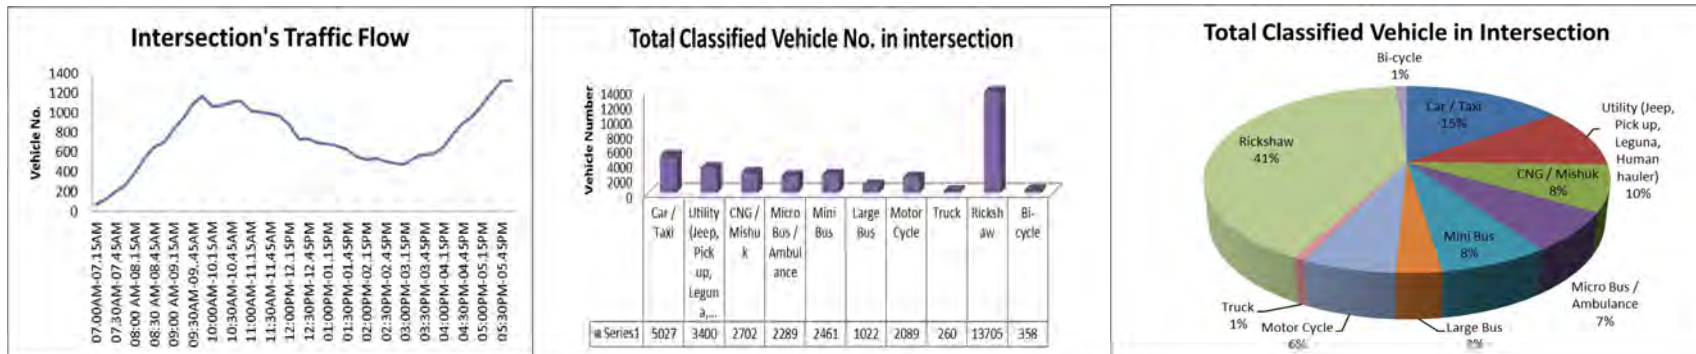
After finishing the vehicular survey, the analyzing of vehicular flow data was done. The result of this analysis are given below. From the analysis it was found that Movement 4 (Dar us Salam to Mirpur 2) contains maximum traffic flow of this intersection. Non-Motorized Vehicle rickshaw is dominant in this intersection.

Figure 1.1.7: Traffic Flow through Mirpur 1 Intersection.

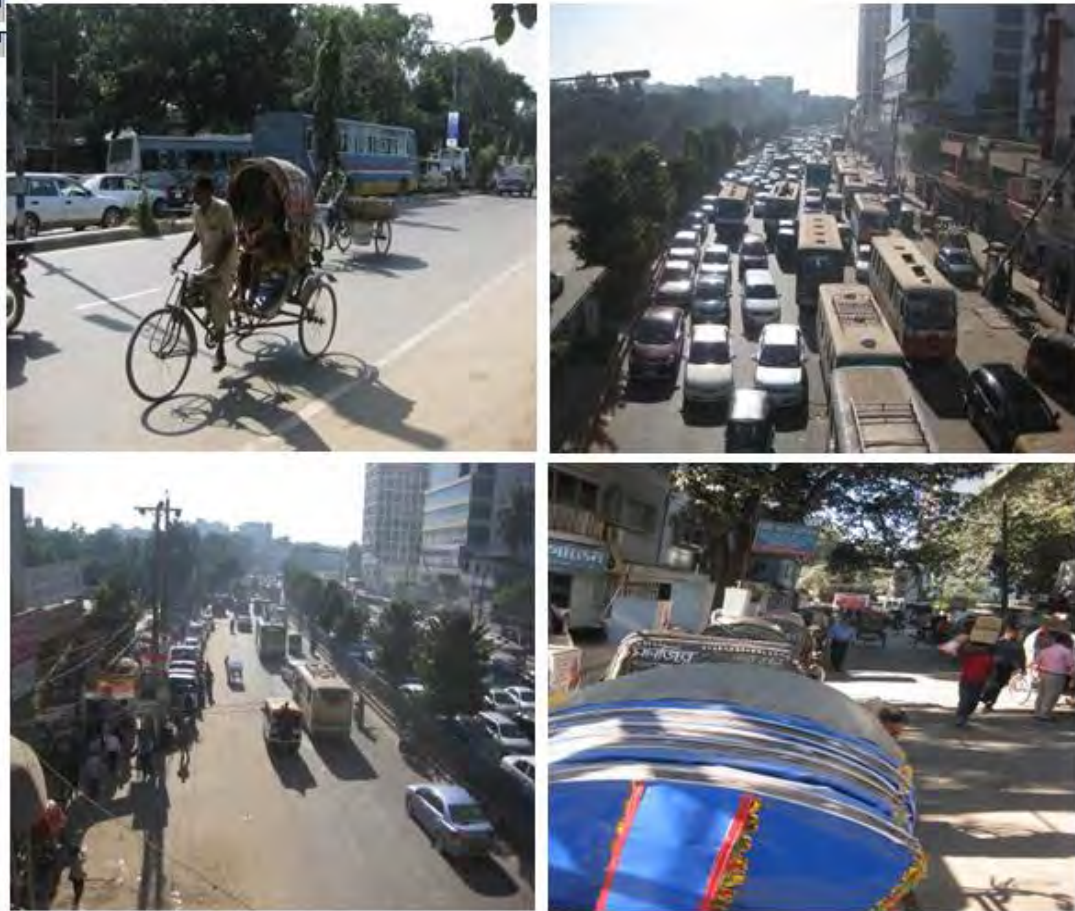
Figure 1.2.3: Approach Road: (a) Agargaon Road, (b) Shyamoli Road, (c) College Road and (d) Khilji Road.

- a) Shyamoli Road 3 lanes both directions,
- b) Agargaon Road 2 lanes both directions,
- c) College Gate 3 lanes both directions, and
- d) Khilji Road (Minor Local road) No lane division.

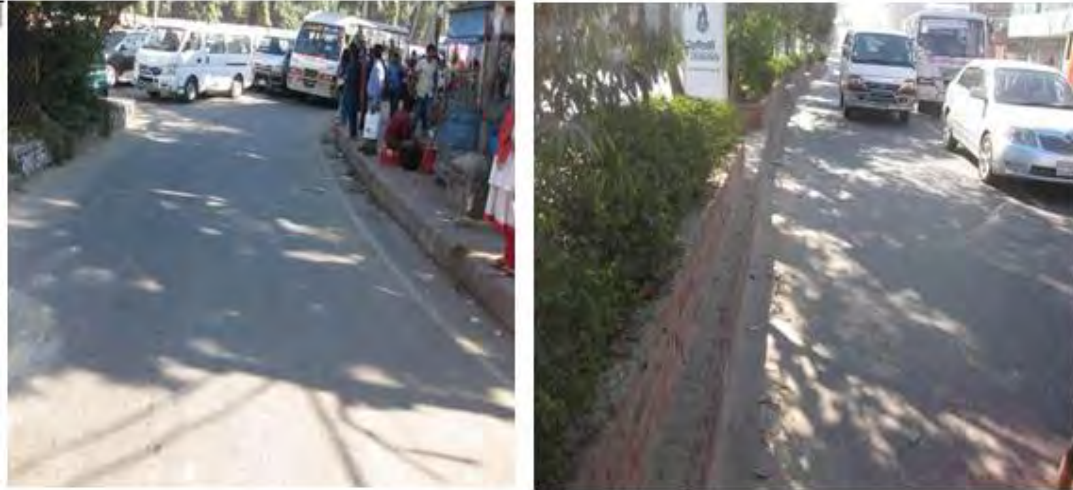
Figure 1.2.4: Inside the Intersection: (a) Left Turning Lane and (b) Right Turning Lane.

There is exclusive left turn lane on the mouth of Agargaon road. There is right turning lane on Mirpur road.

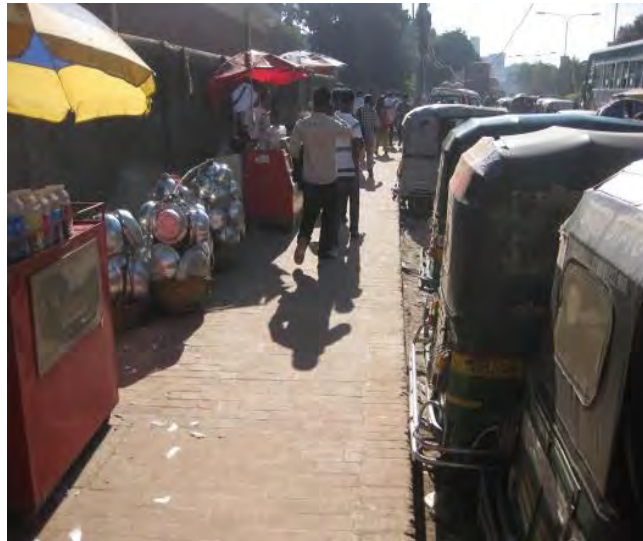
Figure 1.2.5: Illegal Footpath Occupy of Shishu Mela Intersection.

Some of the links contain Median with or without barrier, Marking, Sign, etc. On the mouth of Agargaon road contains the provision of channelization. Unfortunately there is no facility for pedestrian crossing in this intersection. So pedestrians have to cross the road with risk through the road. Footpath area is illegally occupied by the hawkers.

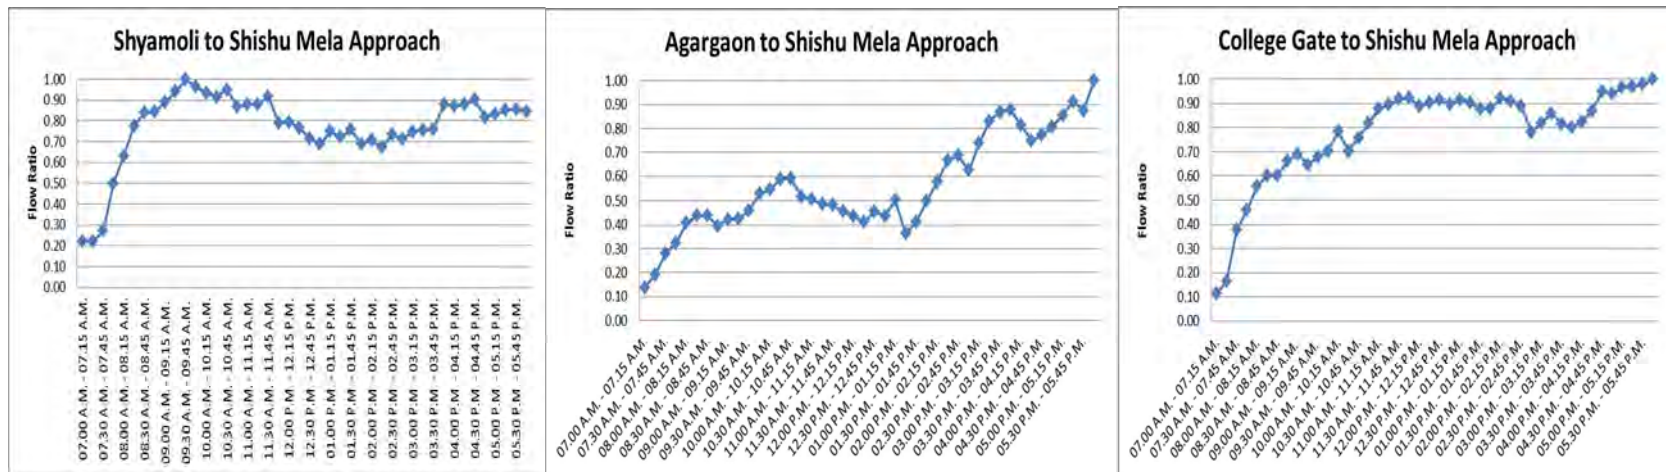
Figure 1.2.8: a) Flow Ratio of Shyamoli to Shishu Mela Approach; b) Flow Ratio of Agargaon to Shishu Mela Approach; c) Flow Ratio of College Gate to Shishu Mela Approach.

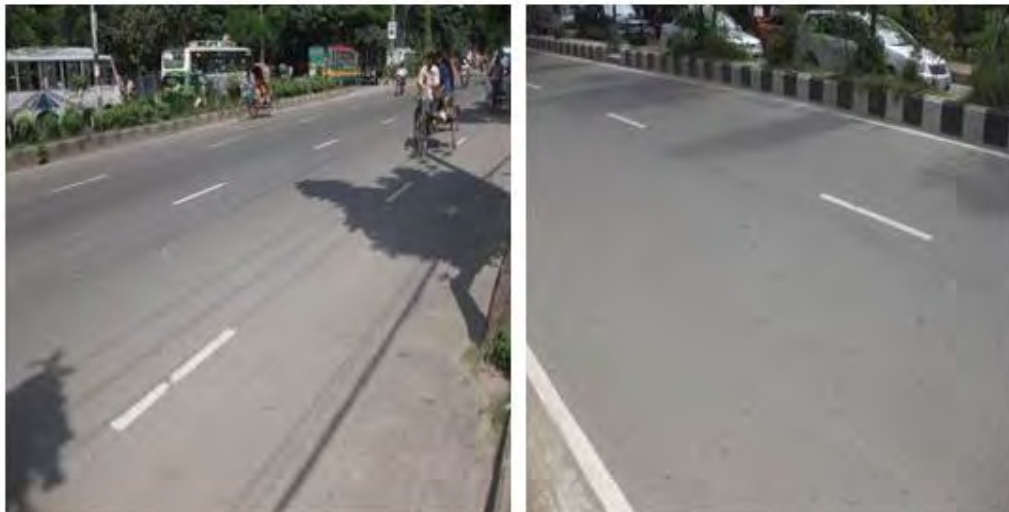
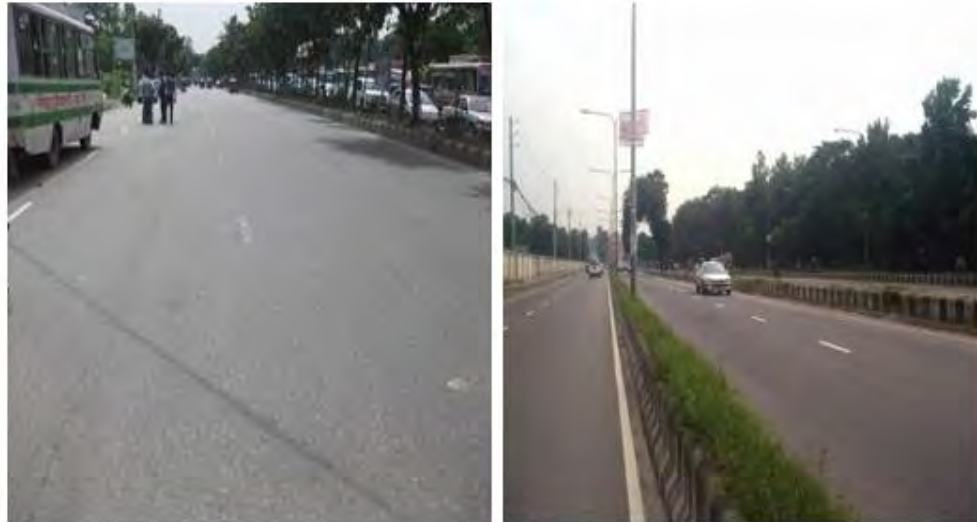
Figure 1.3.3: Approach Road (a) Mirpur Road, (b) Agargaon Shyamoli Road, (c) Farmgate Road and (d) New Link Road (to Prime Minister Office).

There are four links in this intersection. They are Mirpur Road, Shyamoli Road, Farm gate Road and New link road (to Prime Minister Office).

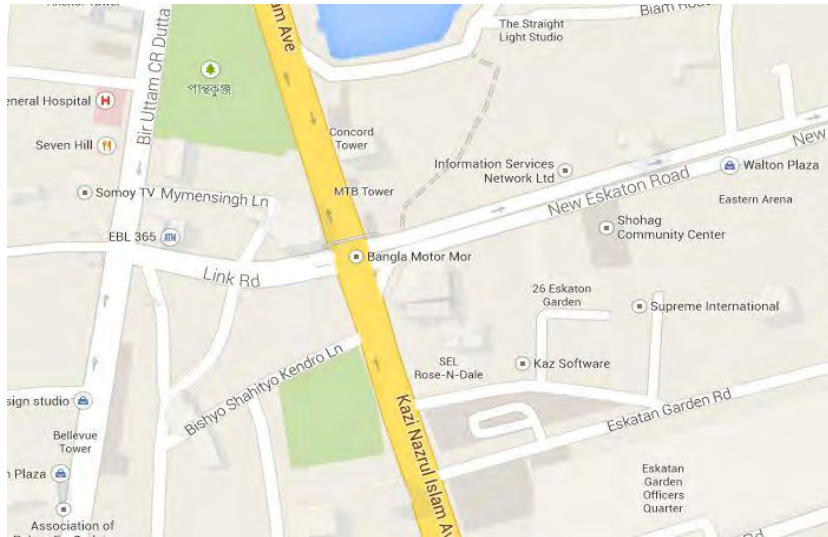
Figure 1.4.2: Bangla Motor Intersection

Bangla Motor intersection is situated in the middle part of Dhaka city. It is in the VIP road. This is a crossed intersection. It consists of two (2) major links and two (2)

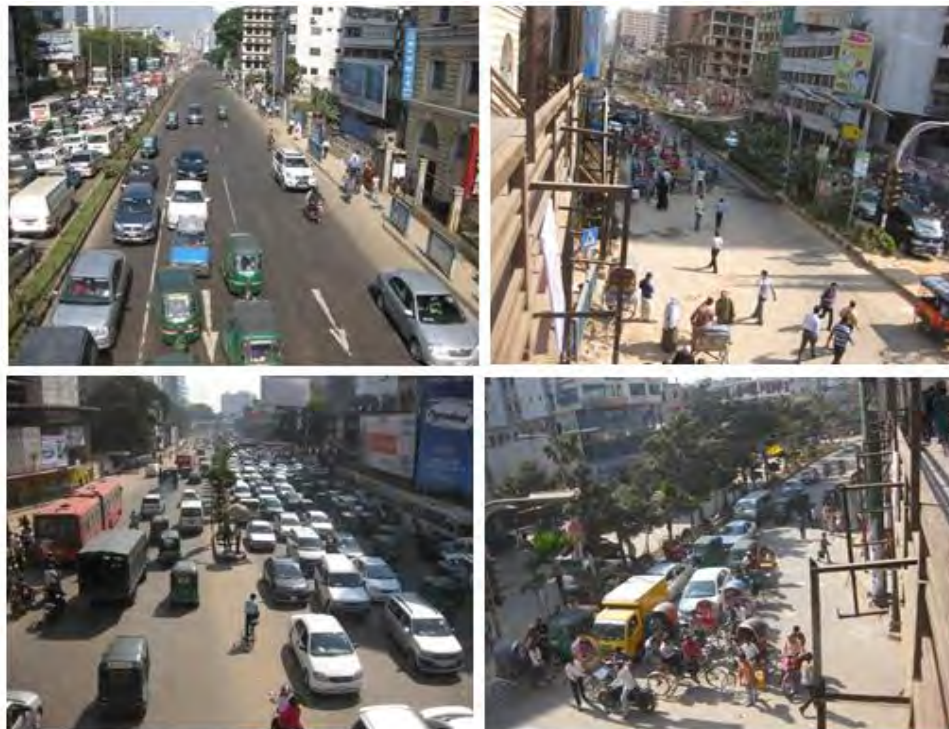
Figure 1.4.3: Approach Road (a) Road from Farmgate, (b) Road from Moghbazar, (c) Road from Shahbag, (d) Sonargaon Link Road.

Bangla Motor contains the flexible pavement as road structure. The road is marked with lane sign, marking, etc. The condition of lane at different approaches of this intersection is

- a) Road from Farmgate 3 lanes both direction,
- b) Road from Moghbazar 2 lanes both direction,
- c) Road from Shahbag 3 lanes both direction and
- d) Sonargaon Link Road 2 lanes both direction.

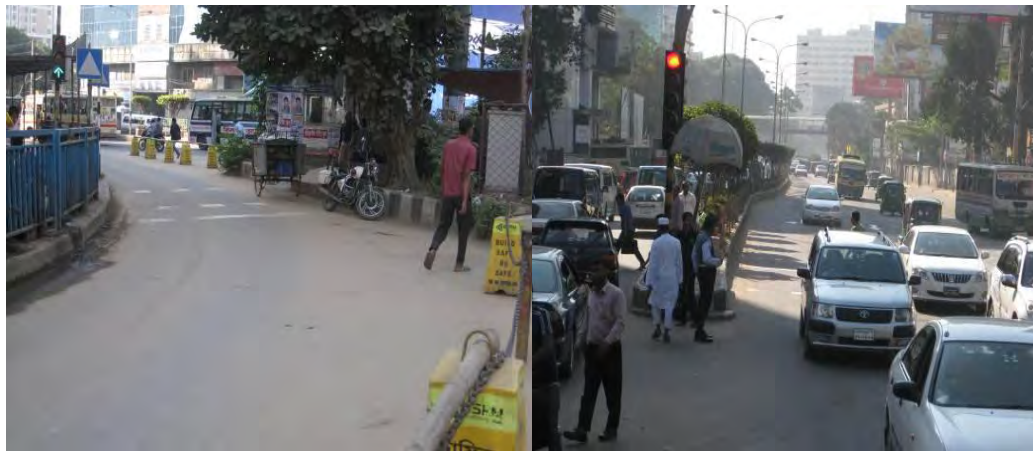
There is exclusive left turn in Moghbazar Road. There is right turning lane in Road from Shahbag. Some of the links contain Median with or without barrier, Marking, Sign, etc.

Figure 1.4.4: Inside the Intersection: (a) Left Turn Lane on Moghbazar (b) Right Turn Lane on Shahbag Approach.

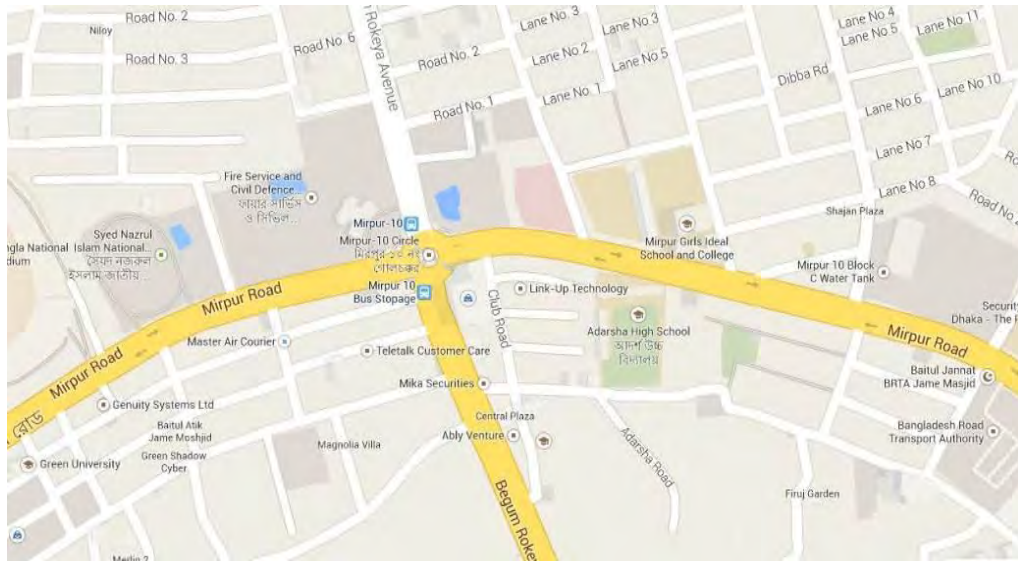
Figure 1.5.2: Mirpur 10 Intersection.

the junction matching with their desire paths under risk. Pedestrian would hardly find the suitable gaps within the moving traffic stream to perform the crossing maneuver. At the vicinity of the roundabout approaches, almost all the approaches are provided with illegal stoppage, where the vehicles stands haphazardly create jam. There by reduces the effective width of the road. It is a signalized junction, but it is operated by traffic police manually. Roundabout often quickly become block if circulating traffic is not given right of way. Although the safety record of roundabout is generally good, but it creates problem with slow moving vehicle.

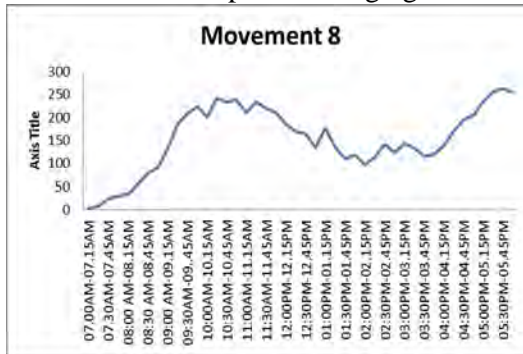
Movement: 8 Mirpur 12 to Agargaon.

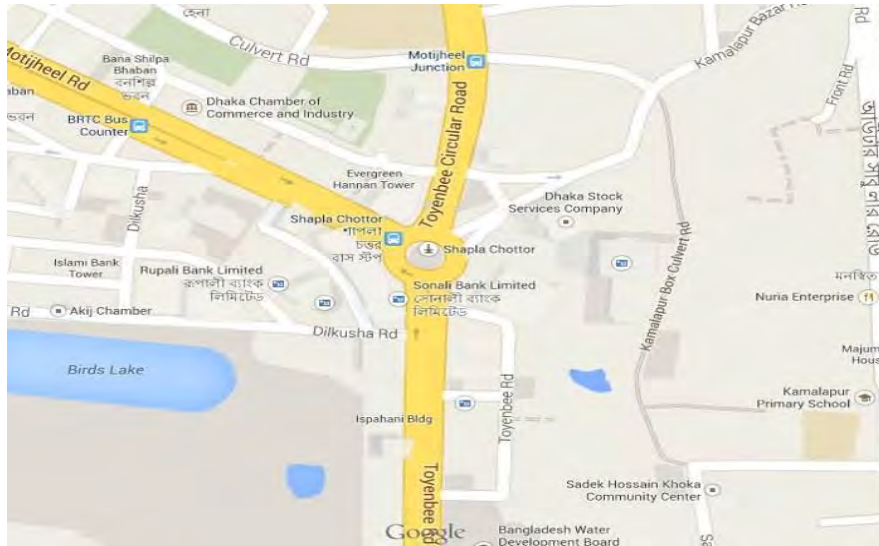
Figure 1.6.2: Shapla Chattar Map.

Shapla Chattar intersection is situated in the Central Business District (CBD) in Dhaka Metropolitan City area. It is situated in Motijheel area. A lot of offices are around in this intersection. Very important educational institute are near about from this intersection, such as Notre Dame College. This intersection keep link with Kamalapur Railway Station, Banga Vaban, Bangbandhu National Stadium, Baitul Mukarram and many other places. It ensures the traffic flow from CBD. This is a commercial place indeed. Three government bank is situated in this intersection is very closely, they are

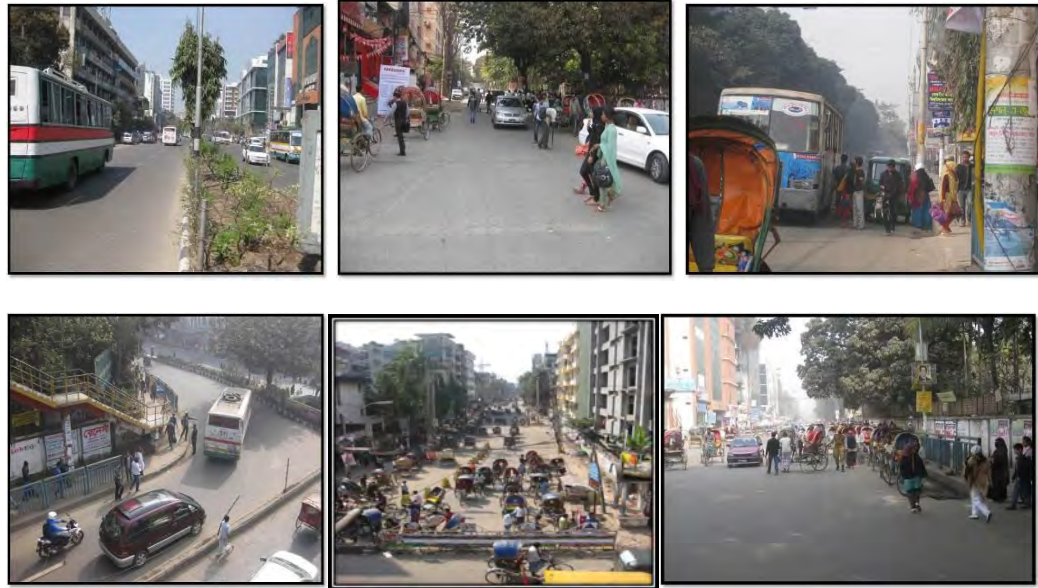
Figure 1.7.2 Various Position of Science Laboratory Intersection.

In every approach of this intersection contain markets, shopping mall, offices, schools, colleges, restaurants, private universities, etc. So this intersection has to carry huge load of vehicles and pedestrians. Non-motorized vehicle is not allowed in this intersection. A separate lane is provided in this intersection. This is a central business district of Dhaka city. This intersection has an over bridge for safe pedestrian crossing. But a negligible amount of pedestrian uses this crossing facility. Pedestrians cross the junction matching with their desire paths under risk. Pedestrian would hardly find the suitable gaps within the moving traffic stream to perform the crossing maneuver. All the approaches of this intersection contain motorized traffic flow. The footpath facilities for pedestrian movements are completely blocked by the street hawkers, forcing pedestrian on to the roadway. Parts of the road space always remain block with parked vehicle. At the vicinity of this intersection approaches, almost all the approaches are provided with illegal stoppage, where the vehicles stand haphazardly create jam by reducing the effective width of the road. It is a signalized junction, but it is operated by traffic police manually.

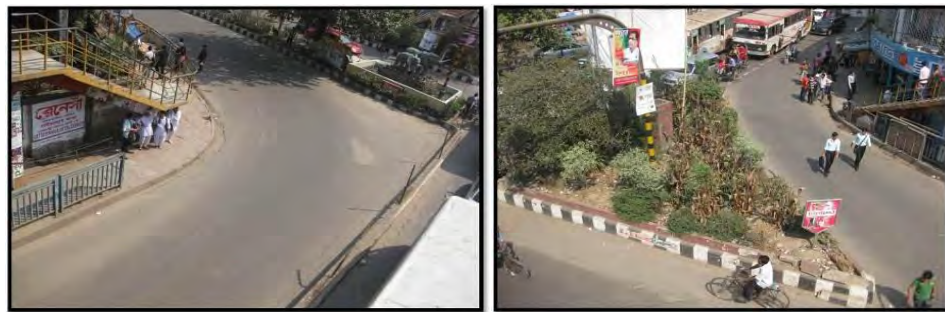
On the mouth of Elephant road, left turning lane and on the Mirpur road there are right turning lane, the researcher team found those in this intersection.

Figure 1.7.3: Inside the Intersection: Left Turning Lane.

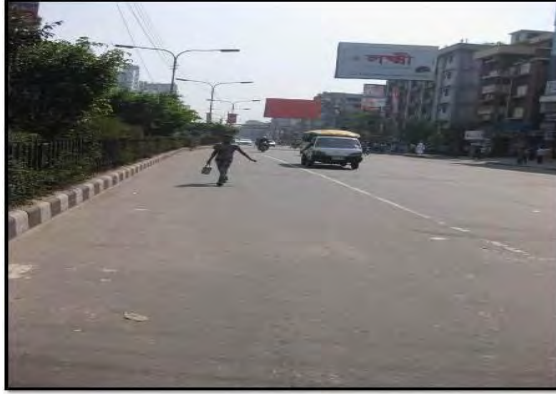
Figure 1.7.4: Inside the Intersection: Exclusive Right Turn Lane
