**PERFORMANCE EVALUATION PARAMETERS FOR SIGNALIZED
ROAD INTERSECTIONS UNDER HETEROGENEOUS
TRAFFIC CONDITION**

**By
M.M.A. KADER CHOWDHURY**

**MASTER OF SCIENCE IN ENGINEERING
(CIVIL AND TRANSPORTATION)**

**BANGLADESH UNIVERSITY OF ENGINEERING AND TECHNOLOGY
DHAKA, BANGLADESH.**

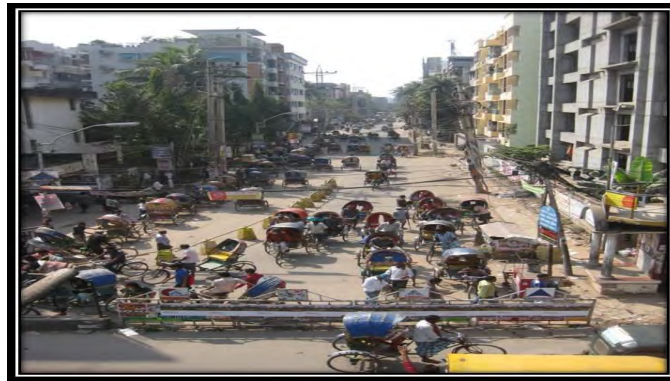
For NMV movement, in this intersection, there was a separate rickshaw lane from Dhanmondi Road 1 to New Market Road.

Figure 1.7.5: Separate Lane: Rickshaw Lane (Dhanmondi Road 1).

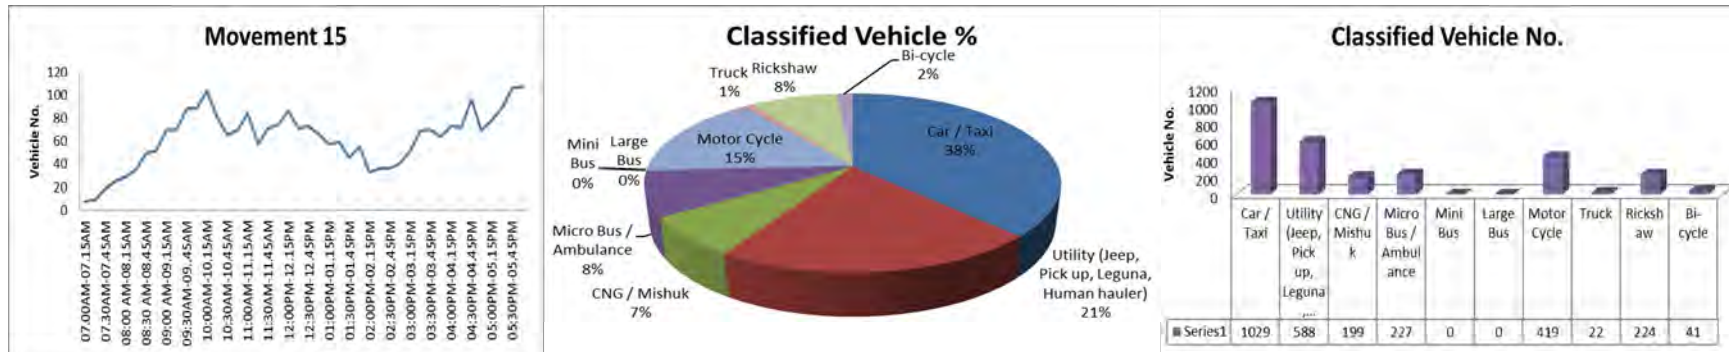
Movement: 15 New Market to Green Road.

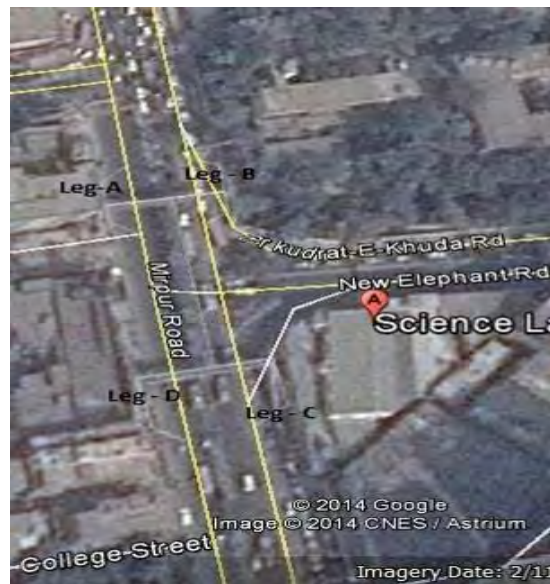
Figure 1.7.8: Foot Over Bridge User

In this intersection, there is an over bridge having four legs. A very few amount of pedestrian use it for road crossing. A counting survey was arranged for finding out the pedestrian amount from this survey. The survey data is given here under.
