**DYNAMIC BEHAVIOUR OF UNREINFORCED
MASONRY BUILDING**

MASTER OF SCIENCE IN CIVIL ENGINEERING (STRUCTURAL)

DEPARTMENT OF CIVIL ENGINEERING
BANGLADESH UNIVERSITY OF ENGINEERING AND TECHNOLOGY
DHAKA-1000, BANGLADESH

DECEMBER 2018

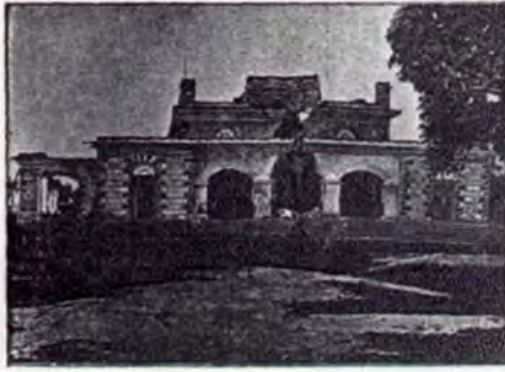
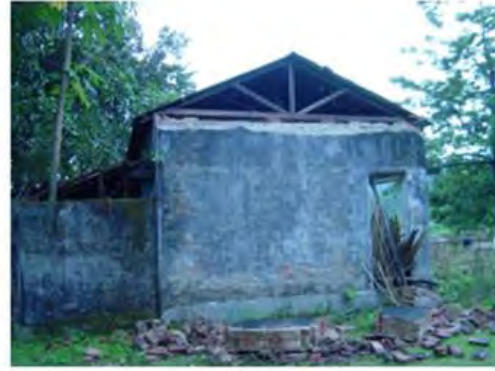
a) Damage at Rangpur, 1897 earthquake

b) Damage due to 2003 Rangamati Earthquake

Figure 1.1 Common Failure of Unreinforced Masonry Building

One of the prime causes of mass casualties in an earthquake around the world is collapse of the non-engineered structures (Macabuag et. al., 2012). Many advanced researches have been conducted in the field of earthquake engineering; yet non-engineered structures often remain outside the scope. Along with many architectural heritage structures, there are many residential buildings in Bangladesh, which are non-engineered unreinforced masonry (URM) buildings. Those buildings are vulnerable due to lack of lateral load resisting system. Figure 1.1 shows some common failure of URM in Bangladesh. Rather than demolishing those URM buildings, we need to seek a favorable option for the improvement of their seismic performance. However, before adopting any retrofitting or rehabilitation technique, it is essential to understand the seismic behavior of URM buildings. A number of experimental researches e.g. In-plane tests (Elgwady et. al., 2002; Russwill et. al., 2007; Fam et. al., 2002; Capozucca, 2011), out of plane tests (Derakhshan and Ingham, 2008; Simsir et. al., 2004) and shake table tests (Elgwady et. al., 2002; Simsir et. al., 2004; Hanazato et. al., 2008; Ersubasi and Korkmaz, 2010) were conducted in different countries using their indigenous materials and testing equipment. In these researches, particular construction technique, aspect ratio, boundary condition, brick-mortar interface and axial loading have been focused. Findings from the researches reveal that use of improper masonry units, formation of inappropriate wall cross sections, inadequate or no connection of crossing walls, irregular wall openings, improper roofing and lack of continuity in seismic load path are the main cause of damage of URM buildings.

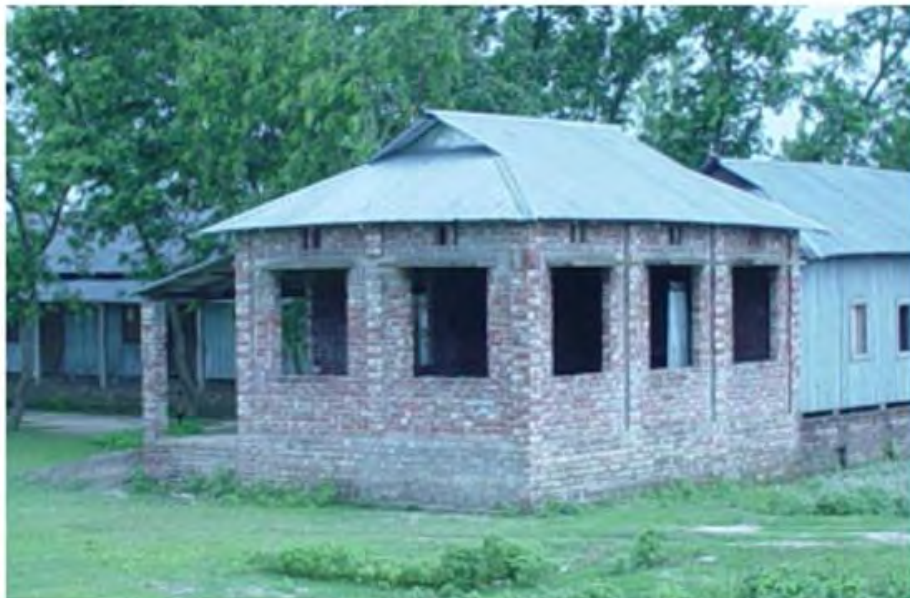
Figure 2.5 Typical Construction of Unreinforced Masonry Building
(Ansary, 2003)

The most common type of unreinforced masonry building in the Bangladesh is constructed of brick walls, shown in Figure 2.5. The masonry walls around the exterior, and sometimes similar walls in the interior, bear up under the weight that is delivered to them by floor or roof beams. For this reason, they are called bearing walls.

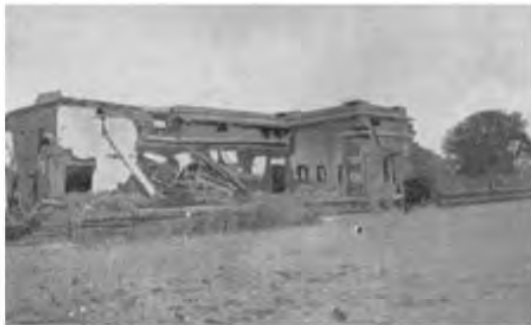
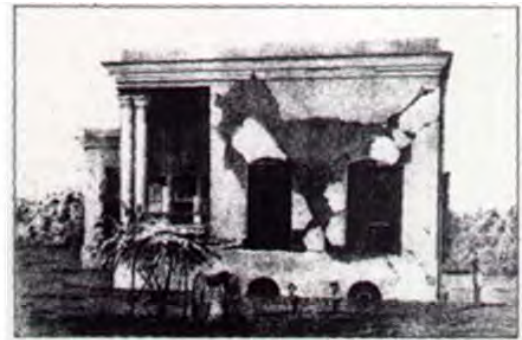
a) Sub-Divisional Officer's Bangalow, Kishorganj (Sreemangal Earthquake of July 8th, 1918)

b) Damage at Sirajganj, 1897 Earthquake

Figure 2.6 Damage of Unreinforced Masonry Building in Bangladesh
(Ansary, 2003)

Figure 2.6 illustrates the damage in masonry buildings in Bangladesh due to earthquake. During the 1897 Assam earthquake, almost 90% of masonry structure suffered some kind of damage (Ansary, 2003).

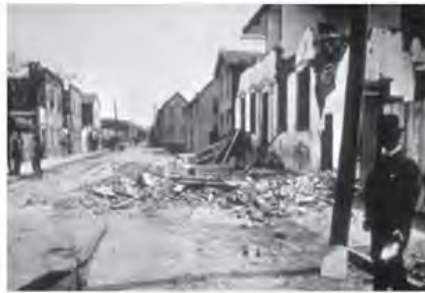
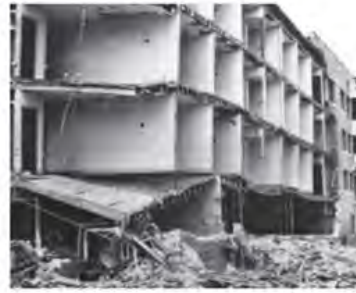
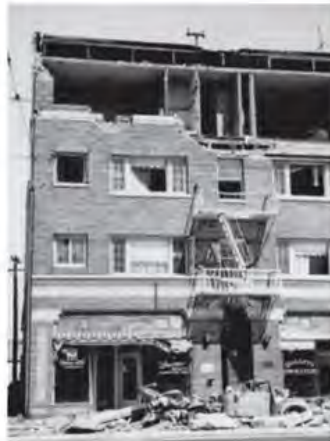
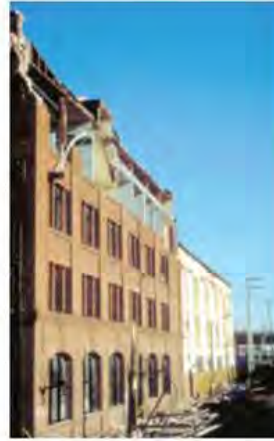
a) Debris resulting from the 1886 Charleston, South Carolina Earthquake

b) Heavily damaged Hotel Californian, 1925 Santa Barbara, California earthquake.

c) URM building damage, 1933 Long Beach, California earthquake

d) Upper story wall collapse, with resulting fatalities

Figure 2.7 URM damage in USA (FEMA P-774, 2009)

experienced damage severe enough to require that they be vacated. Figure 2.7 illustrates the debris from collapsing second story masonry walls in USA.

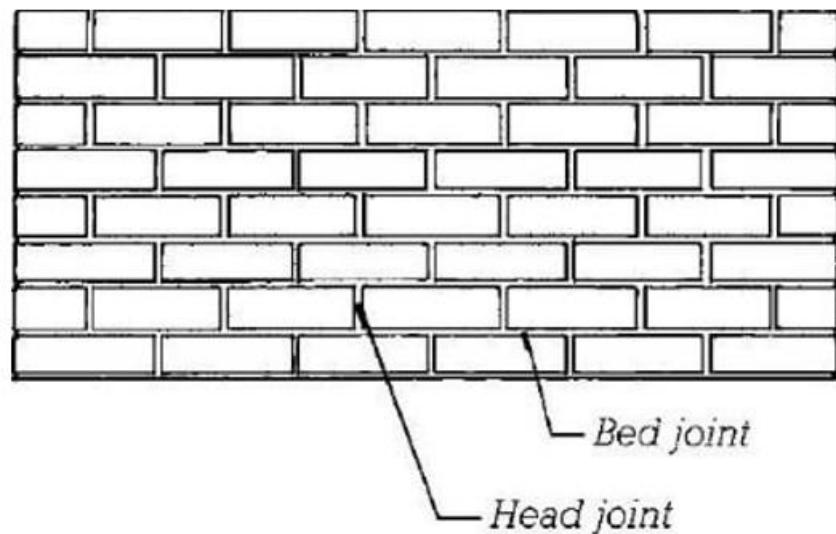
Figure 2.9 Joints in brick wall

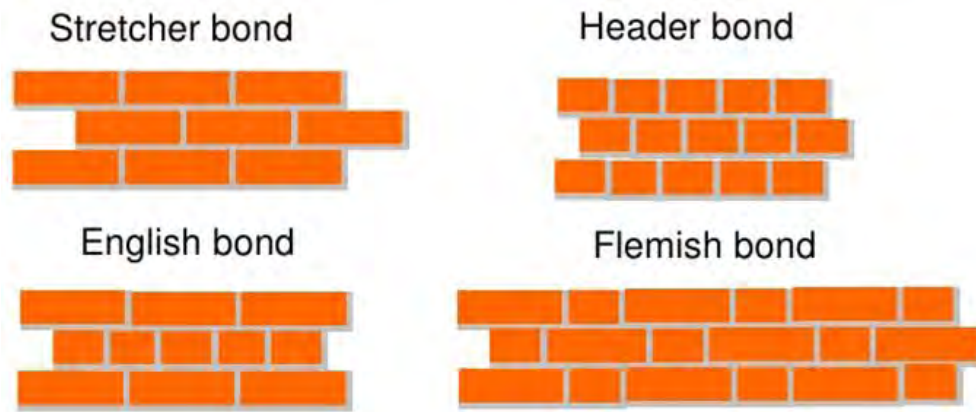
Figure 2.10 Different type of bond in brick wall

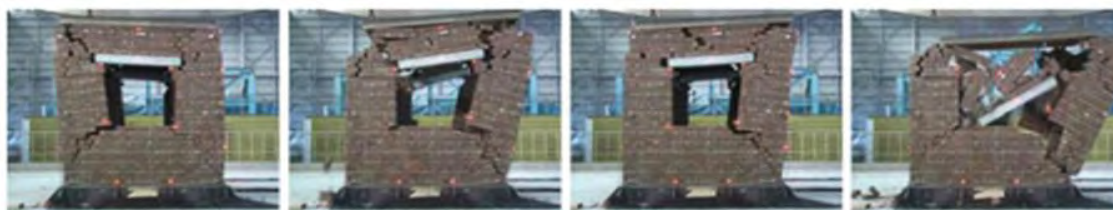
Figure 2.11 Process of specimen collapse in the shaking table test
(Nakagawa et.al., 2012)

A dynamic collapse test was conducted on 3m x 3m brick masonry house using Pakistani bricks (Nakagawa et. al., 2012). The test was performed in a one-direction horizontal large-scale shaking table. The model structure exhibited a sufficient horizontal resistance to withstand the Bam and JMA Kobe earthquake excitations without developing cracks. A large pulse shock loading with a velocity of 40 cm/s and an acceleration of 1.7g, the structure develop cracks. Figure 2.11 shows the model building collapse. The tested structure was very strong compared to the structures in the developing countries. Therefore, it was anticipated that good workmanship could reduce the levels of damage of masonry-based houses in developing countries.

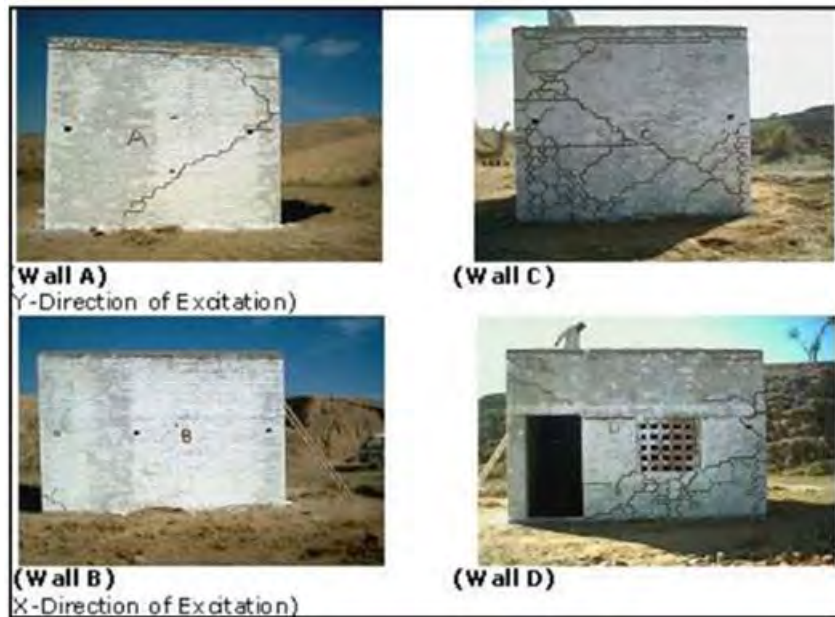
Figure 2.12 Damage Mechanism of Tested Building Model (Ali et. al., 2012)

In situ dynamic testing of masonry building model was conducted by means of underground explosions simulating earthquake ground motions (Ali et. al., 2012) for evaluating the seismic behavior (damage pattern and failure modes) and performance (lateral resistance capacity) of building models. Three different explosions were used with a peak ground acceleration of 0.15g, 0.48g and 0.70g. Figure 2.12 depicts the damage mechanism of tested building. Good performance of the structure was due to the good quality construction materials. Special type of constituent, which was used in mortar, called khaka. Which renders mortar with high strength, causing increase in the shear strength and tensile strength of masonry. Good behavior was also seen due to the global rocking.

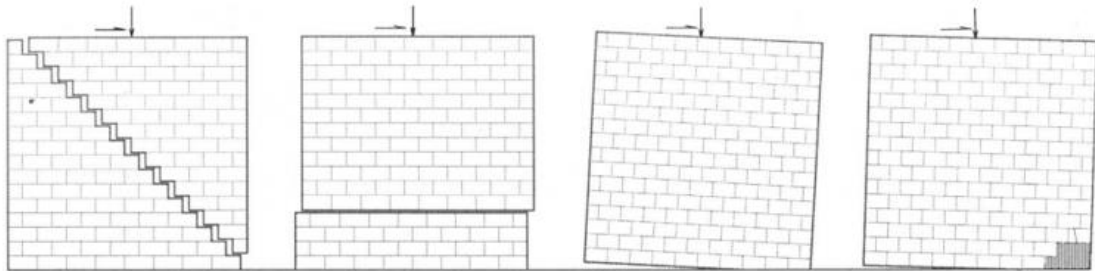
Figure 2.13 In-plane failure modes of a laterally loaded URM wall

Shear failure: This kind of failure will occur in the walls with low aspect ratios and high axial loads. Diagonal cracks developed in the wall either follow the path of the bed

Sliding failure: In this kind of failure, the upper part of the wall will slides on the lower part of the wall. In the case of low vertical loads and/or low friction coefficient, which may be due to poor quality mortar, horizontal cracks in the bed joints can form a sliding plane extending along the wall length.

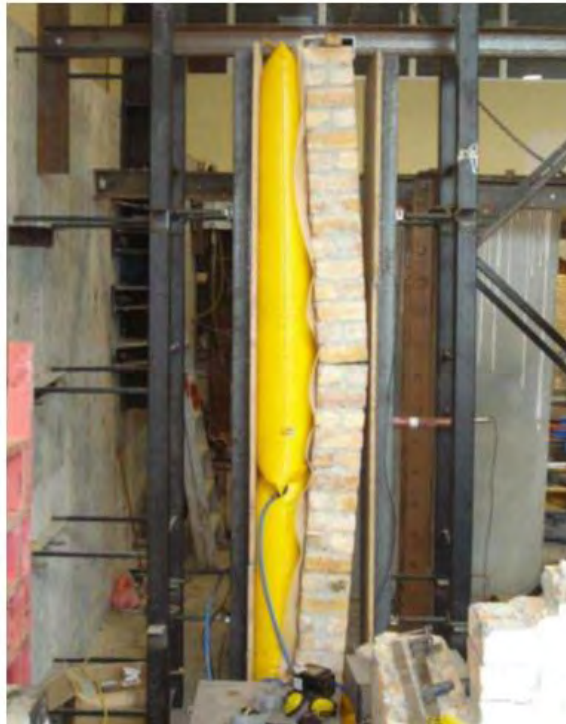
Figure 2.14 Test Setup for out of plane test of masonry wall
(Derakhshan and Ingham, 2008)

Uniform out-of-plane loading on New Zealand unreinforced masonry (URM) walls were applied to see the performance (Derakhshan and Ingham, 2008). The test was done on a full-scale URM wall with a slenderness ratio (h/t) of 16 with different levels of pre-compression (0 kPa, 20 kPa, 40 kPa). The tested simply supported wall is shown in Figure 2.14.

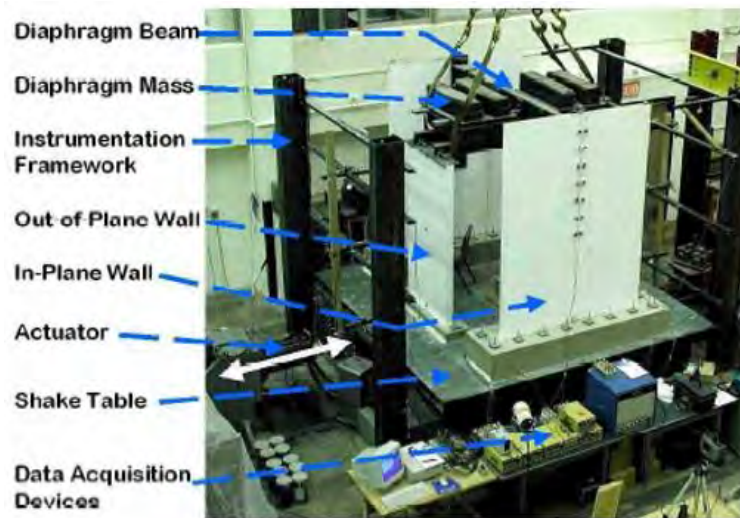
Figure 2.15 Specimen on the shake table for out of plane test (Simsir et.al., 2004)

Pseudo static out of plane tilting test was carried out on dry masonry blocks with frictional behavior to study the out of plane behavior of masonry wall with different corner connection (Shi et.al., 2008). The comparison of the experimental results with the analytical predictions from the program FaMIVE was done. Figure 2.16 shows the collapse behavior of different out-of-plane damage mechanisms of dry masonry wall.

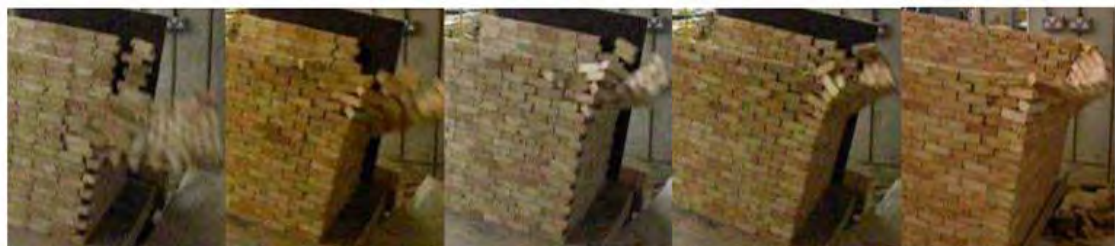
(a) Mechanism A (b) Mechanism D (c) Mechanism B1 (d) Mechanism B2 (e) Mechanism G

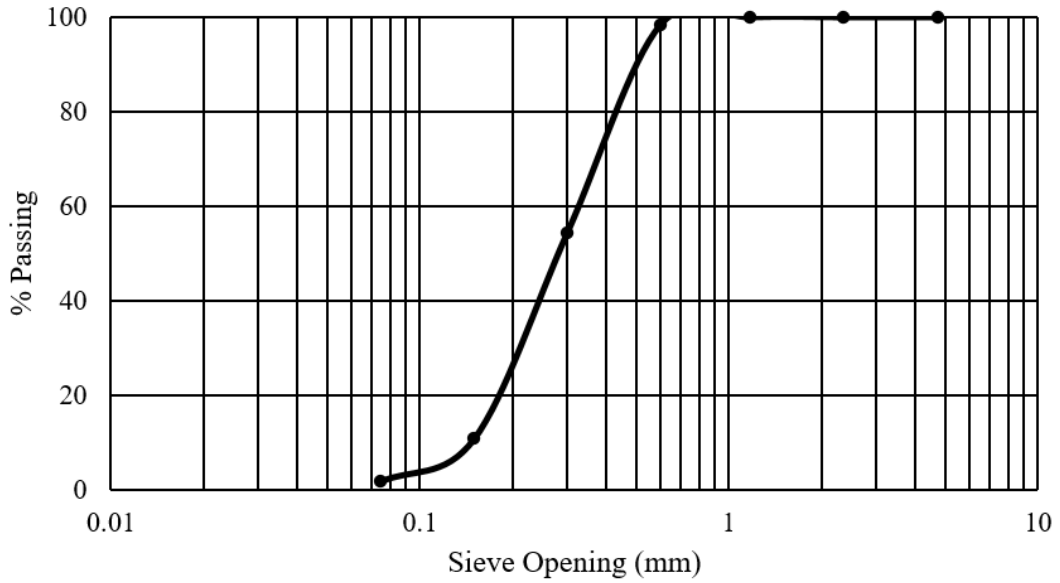
Figure 3.2 Gradation curve of Local Sand

gradation curve of local sand and Sylhet sand respectively. Table 3.2 shows the properties of sand used in the construction of slab, base and in joining of bricks. Local sand was used for the construction of wall (brick joining) and Sylhet sand was used for base and slab construction.

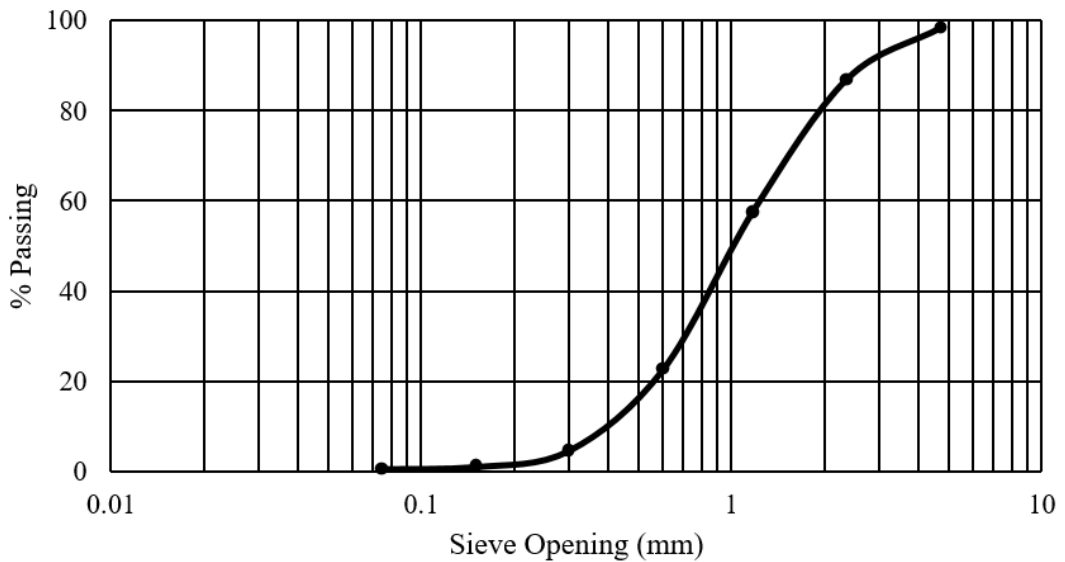
Figure 3.3 Gradation curve of Sylhet Sand

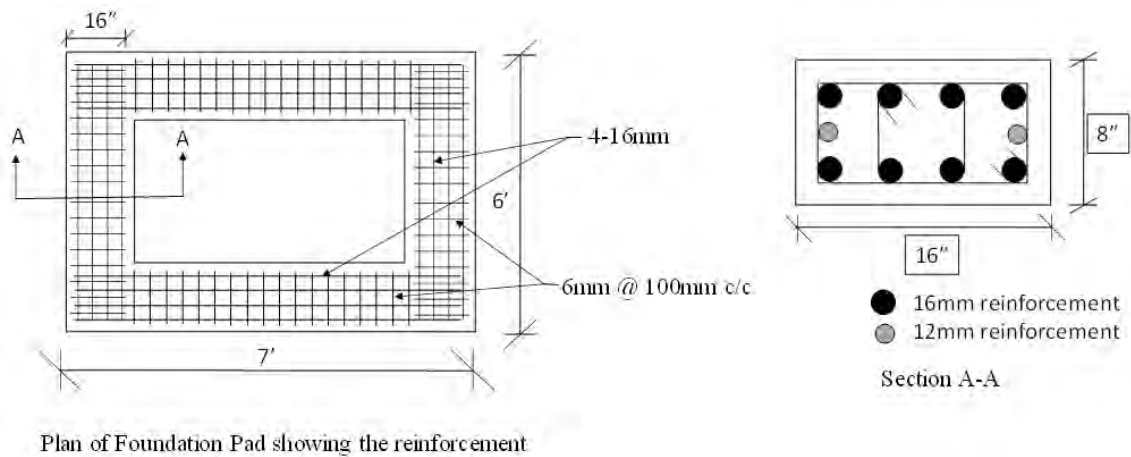
Figure 3.4 Detailing of foundation pad and cross section

total 24 holes in staggered position to anchor (to provide precise positioning) the foundation pad to the shake table. Six 12 mm loops positioned near the inside corners provided means for lifting. Figures 3.4 shows the foundation pad detailing and cross section and Figure 3.5 shows the foundation pad on shake table. Total weight of the foundation pad is 1.24 ton.

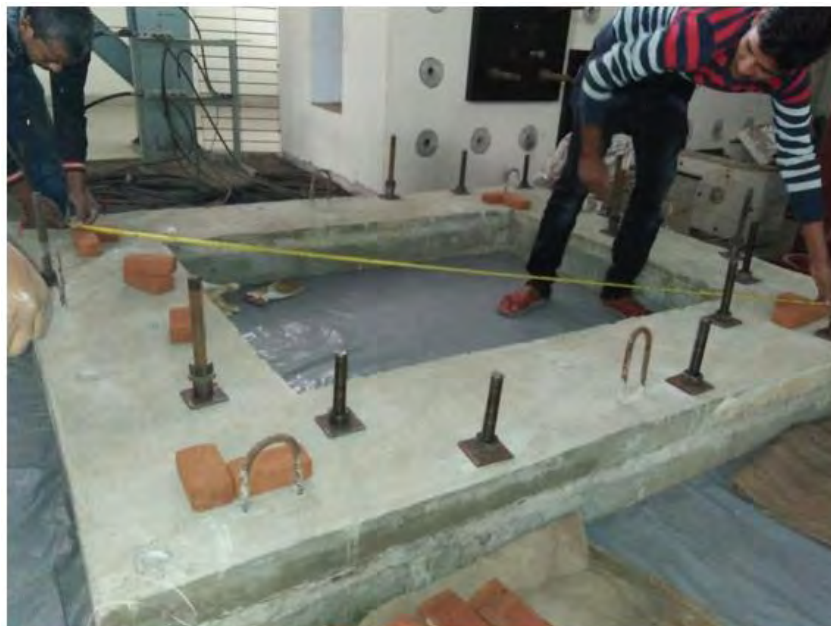
Figure 3.5 Foundation pad on shake table

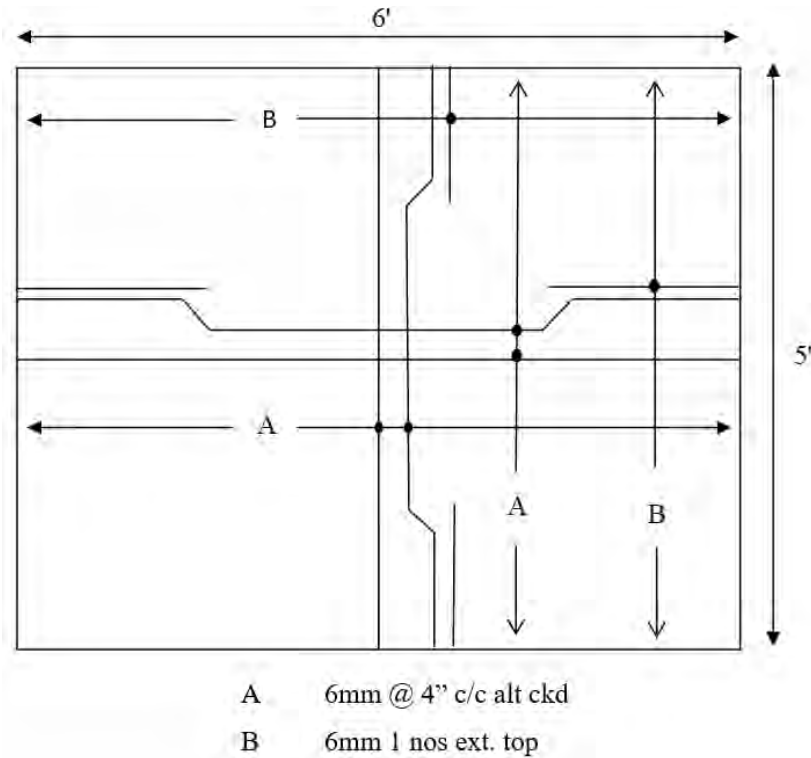
Figure 3.7 Reinforcement in Slab

Figure 3.7 shows the reinforcement detailing of the slab. 6 mm reinforcement was provided at 4" c/c in both direction. This reinforcement is more than calculated reinforcement as per the rules of scaling. This is because, the purpose of this test is to see the performance of masonry building not the slab. The reinforcement is cranked at L/4 distance from the edge of the slab. The extra top is 6" more than the calculated length. Total weight of the slab is 0.52 ton.

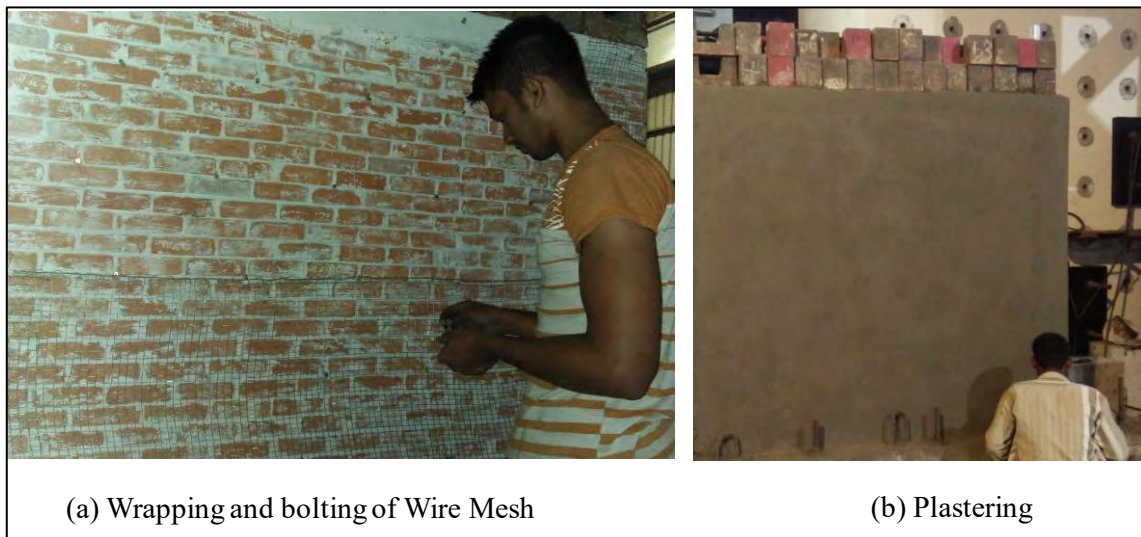
Figure 3.8 Retrofitting Procedure

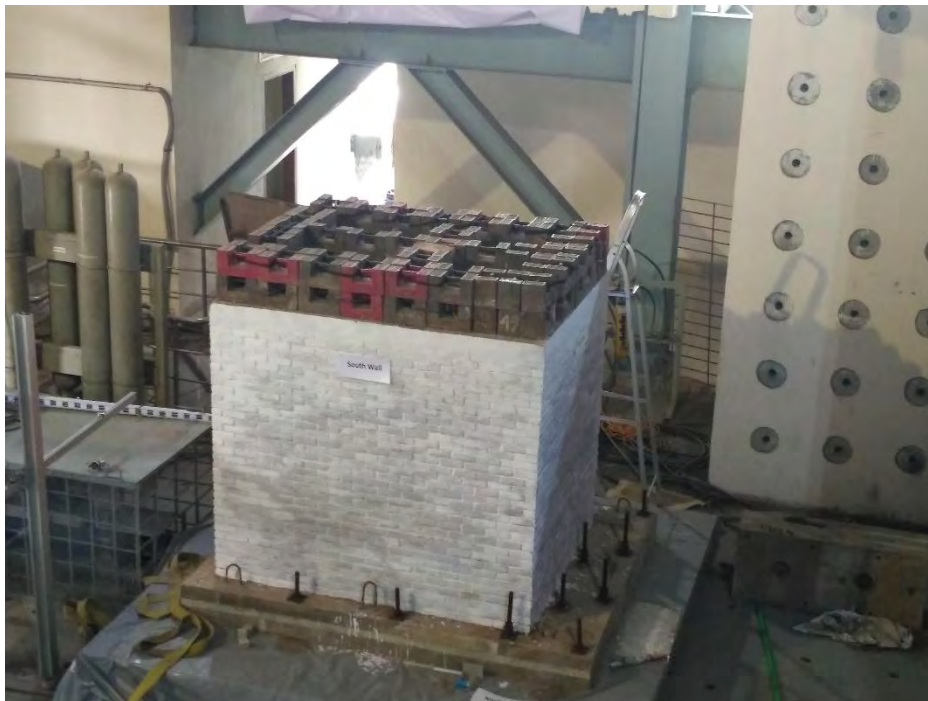
Figure 3.9 Weights on the slab

Same amount of weight was used for both reference model and for retrofitted model. Therefore, total weight acting on the shake table is 5.08 ton. Figure 3.9 shows the weights used in the slab. A rope was used to tight the weights together. Four anchors of the slab were used for stronger tightening so that those weights cannot fall during the test. Despite this, a rectangular box made by wood was used around the weights so that those weights cannot fall. The model is anchored to the shake table with 20mm bolt. Total 12 bolt is to anchor the model to the table. After every test run all bolts were tighten so that no shear failure of the bolt can occur.

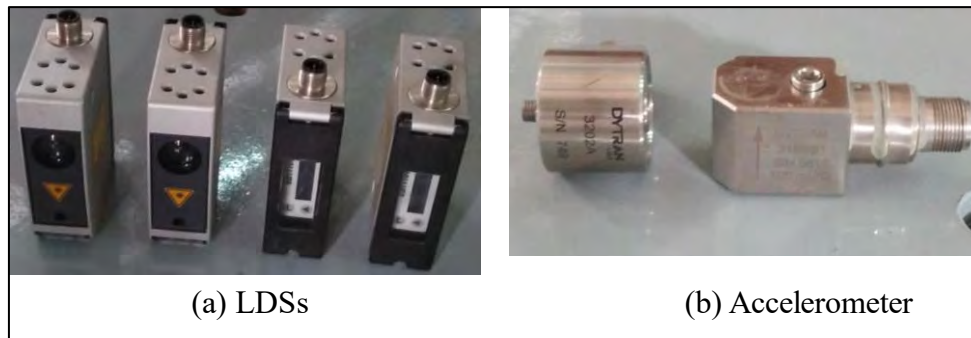
Figure 3.11 Instruments used in the test

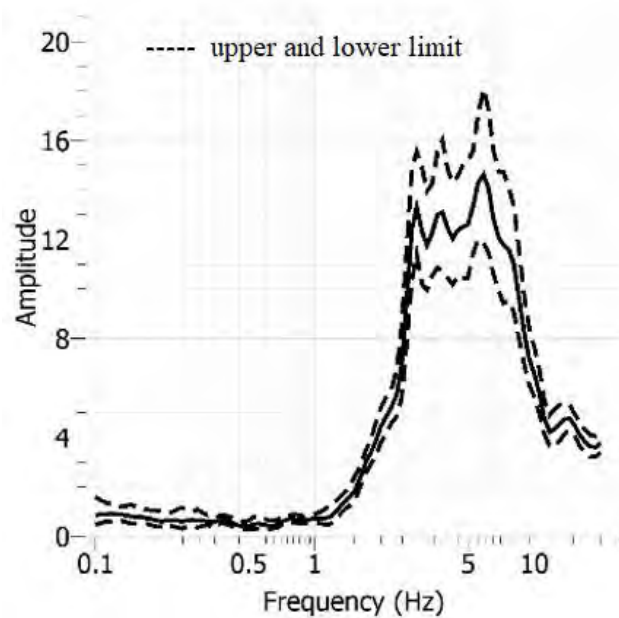
Figure 3.12 Pre-Dominant Frequencies of model structure

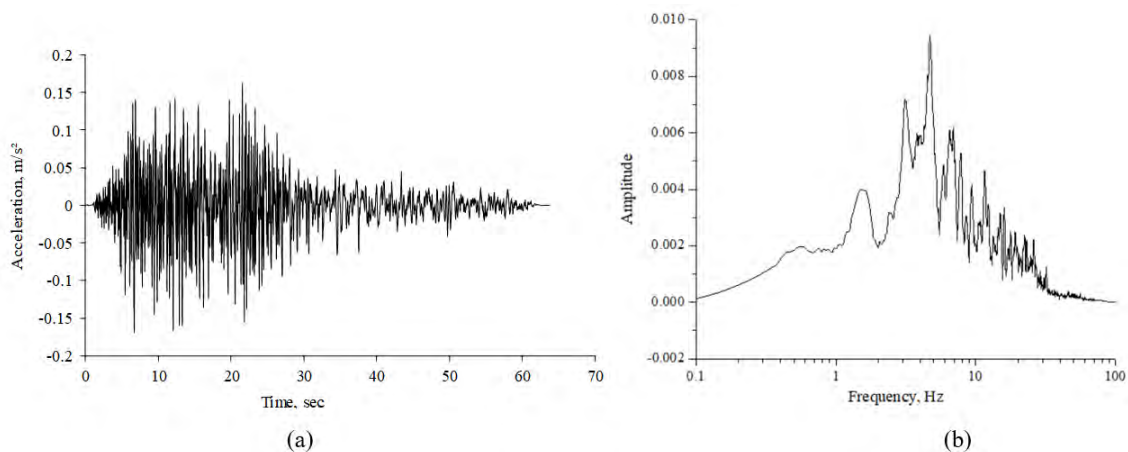
Figure 3.13 time history and Pre-Dominant Frequencies of scaled Imperial Valley earthquake

similitude law, the artificial accelerograms should be compressed in time by a factor of 2 and the acceleration should also be multiplied by the scale factor 2. The standard response spectrum and response spectrum obtained from the compressed artificial accelerograms are shown in Figure 3.13.

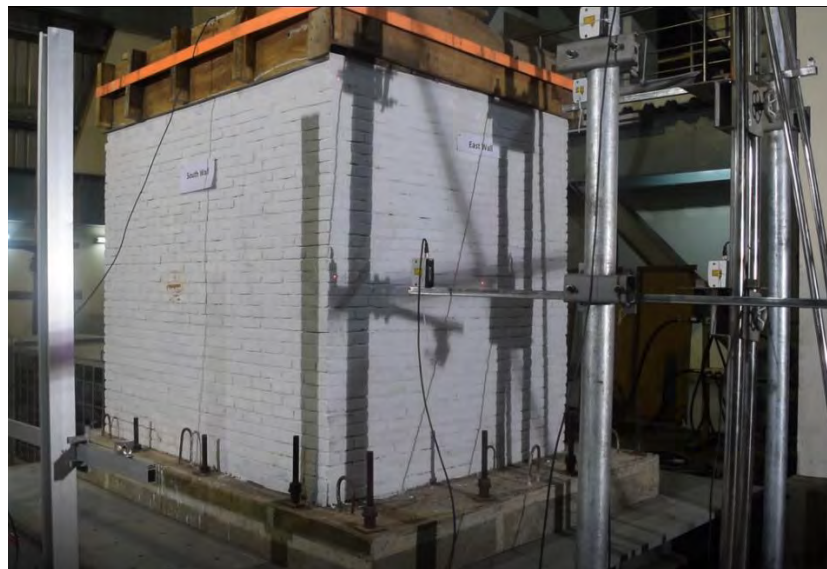
Figure 3.14 Complete Experimental Setup

The complete experimental setup for model structure is shown in Figures 3.14. A total of twelve earthquake simulations were performed for reference model. The first three runs were sine wave with low frequency (1Hz, 2Hz, 3Hz) and low acceleration (0.05g) which were run without damaging the structure. Then the test was conducted with incremental acceleration ranging from 0.27g to 1.05g using Imperial Valley Earthquake. Between each earthquake simulation, visible damage was noted and recorded. Prior to their testing, model structure was painted white to facilitate crack identification and marking. Cracks were marked with colored pens, with a different color used for each run that induced new cracks. These crack patterns are discussed in Section 4.2.2. A large number of photographs were taken between tests to record characteristics such as dislodged bricks, missing mortar, misalignment across cracks etc.

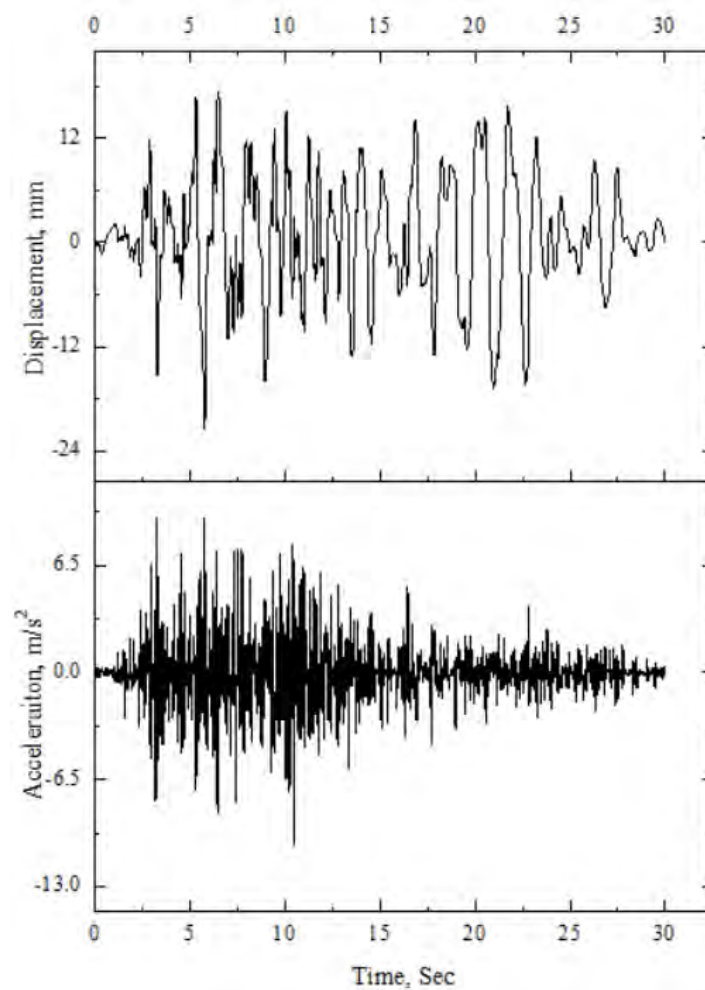
Figure 4.1 Input Motion in Reference Model (1.05g)

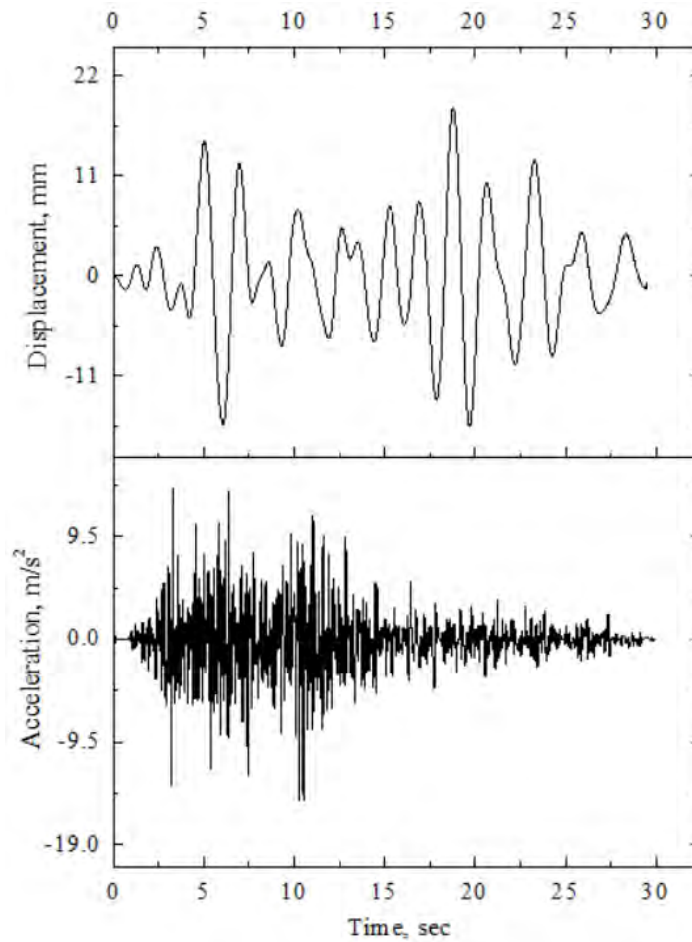
Figure 4.2 Input Motion in Retrofitted Model (1.49g)

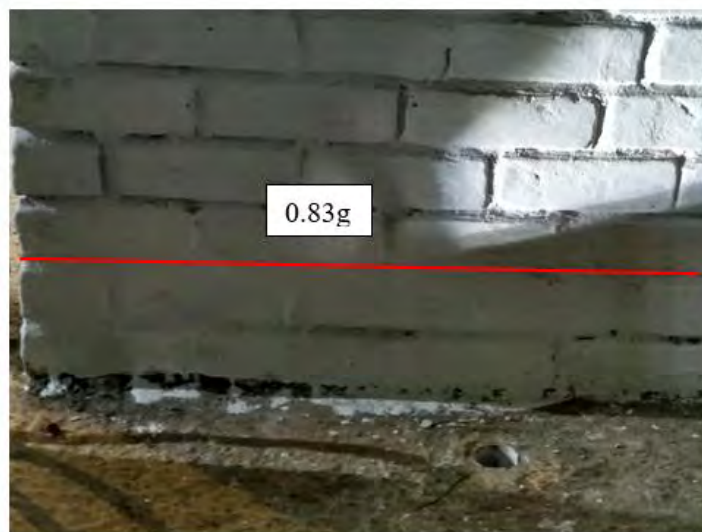
Figure 4.3 First crack develop at 0.83g in east wall (out of plane wall)

was along the same course as was at 0.83g. At north-east corner, cracks were developed along the head joint in north wall as well as along the bricks which indicate that mortar

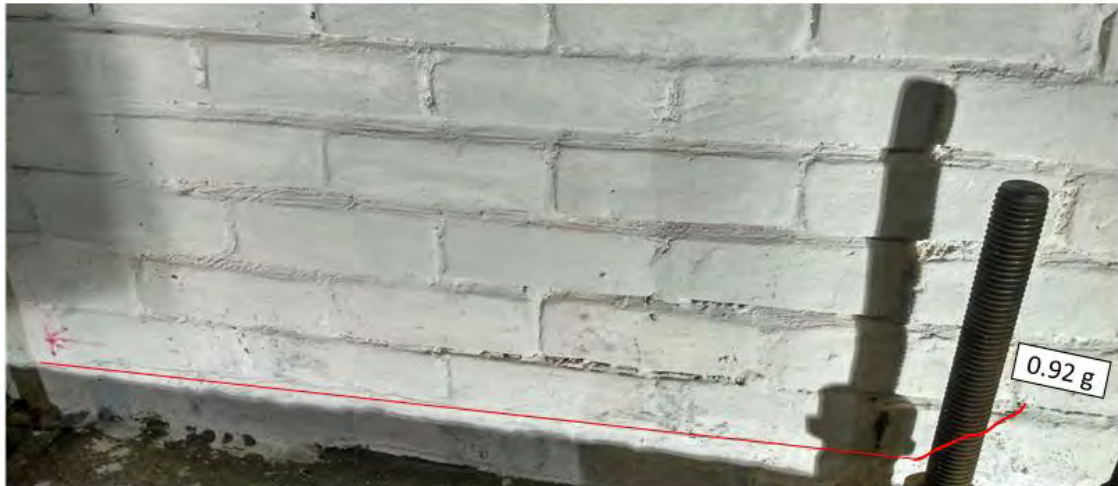
Figure 4.5 Horizontal Cracks develop at 0.92g (south wall)

stepped cracks are localized in the corner of the walls. At this stage, the cracks developed in east, west, north and south walls covering the whole lower half of the walls.

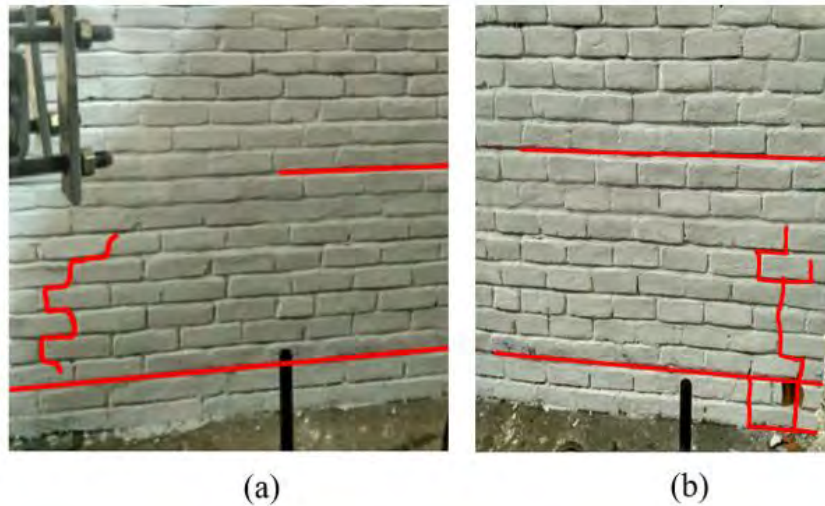
Figure 4.6 Cracks developed at 1.05g in east wall (out-of-plane wall)
 ((a) south-east face (b) north-east face)

of 6mm in the east-north corner. It can be inferred that the global condition of the model was much notorious and did not collapsed, in spite of heavy damage. It will not be able to sustain any of acceleration after this final run. The model is not intended collapsed because of further testing.

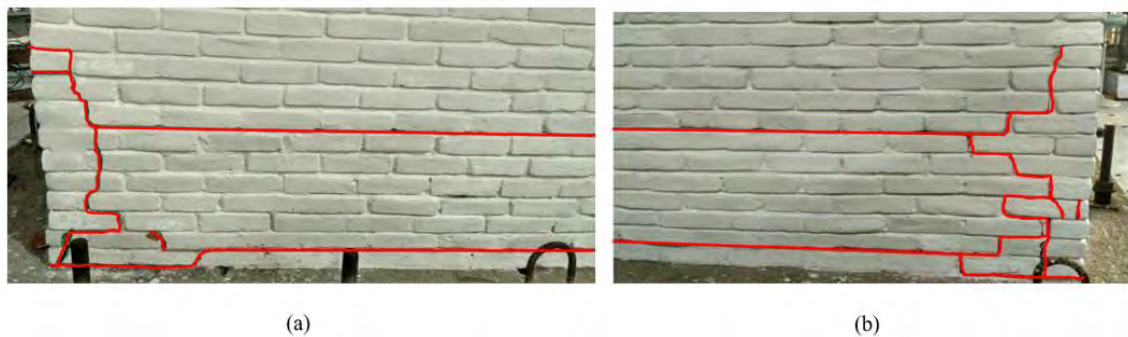
Figure 4.7 Cracks developed at 1.05g in north wall (in-plane wall)
 ((a) north-east face (b) north-west face)

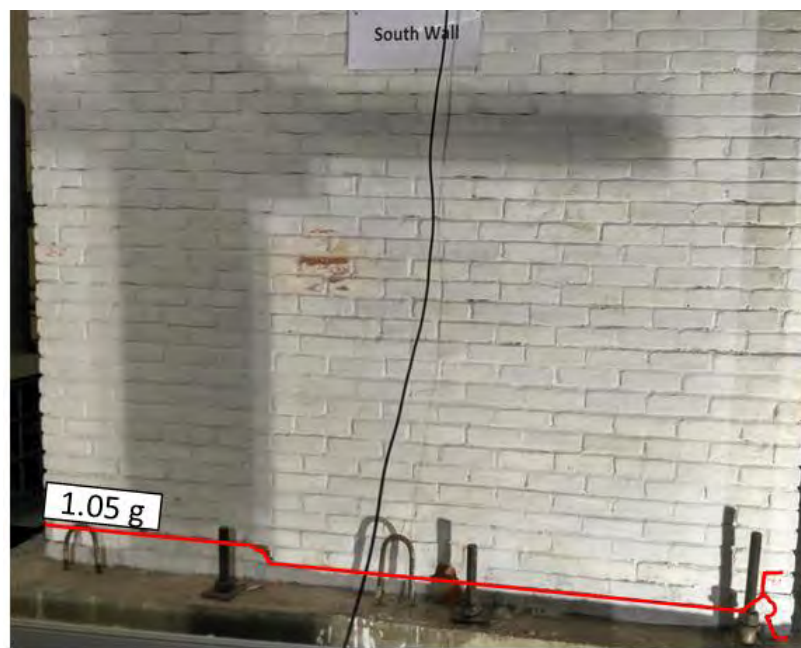
Figure 4.8 Cracks developed at 1.05g in south wall (in-plane wall)

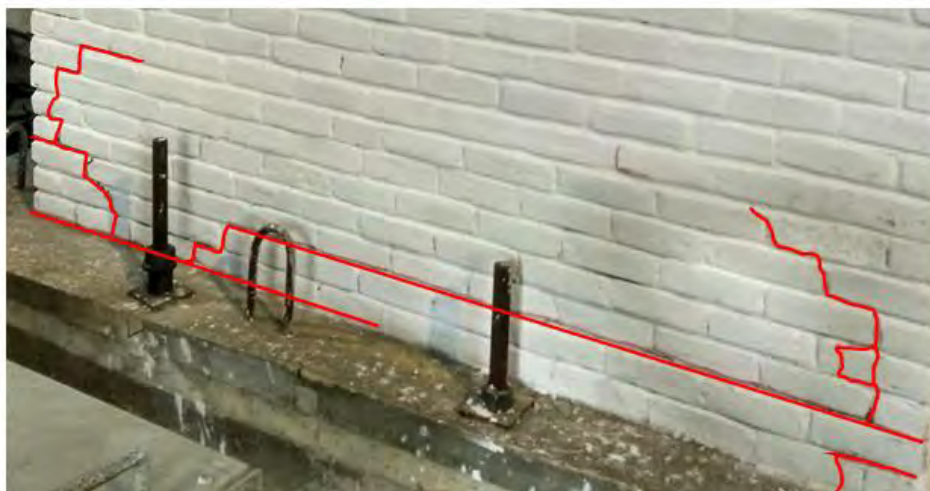
Figure 4.9 Cracks developed at 1.05g in west wall (out of plane wall)

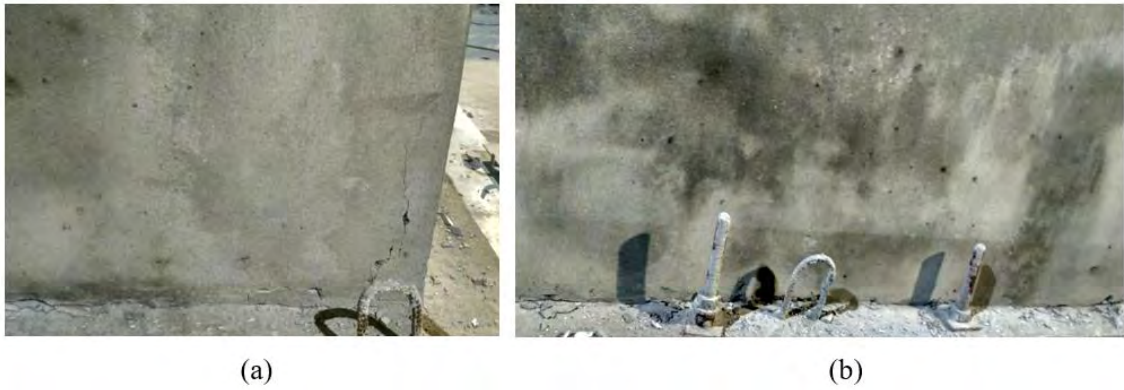
Figure 4.10 Crack developed in Retrofitted Model ((a) vertical crack in north wall
(b) separation of wall from base)

Total fourteen seismic motion were run and no visible cracks were observed in the wall for the first eleven run in which acceleration range was from 0.27g to 1.45g. In twelve run at an acceleration of 1.49g, which is the maximum acceleration, cracks develop at the base of the model in all wall. This is due to the sliding of the wall. After retrofitting, model become stiff- this stiffness as well as low vertical compression accelerate the sliding of the wall. In the next following run, a vertical crack developed at the bottom of north-west corner of the north wall and no other visible cracks were observed in any other wall. The cracks along the base was further extended and the model was totally separated from the base. In Figure 4.10, crack in base and crack in north wall are shown.

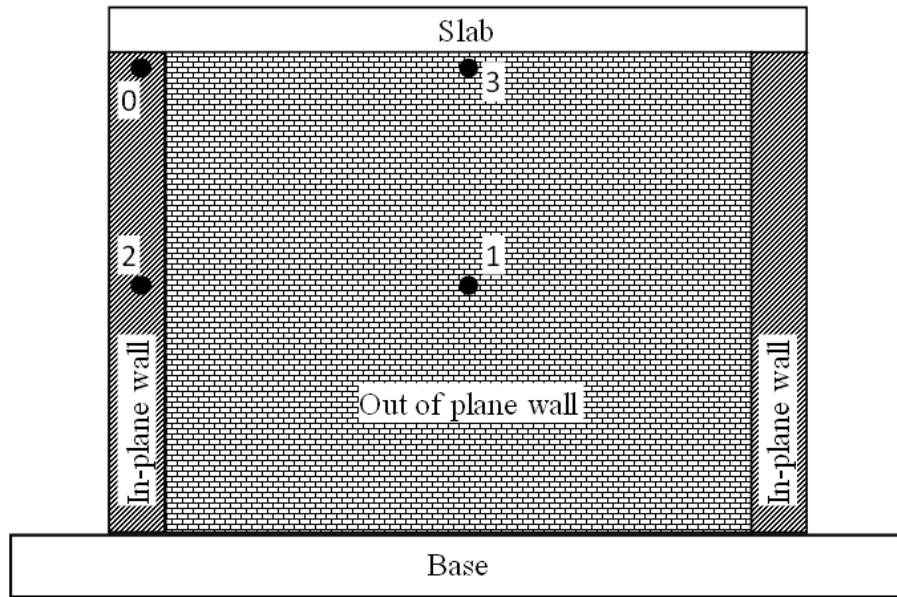
Figure 4.11 Position of Sensors measuring displacements of walls

However, due to presence of equipment's capable of taking not more than two readings along the height of the walls the displacements of points other than the two measured cannot be estimated.

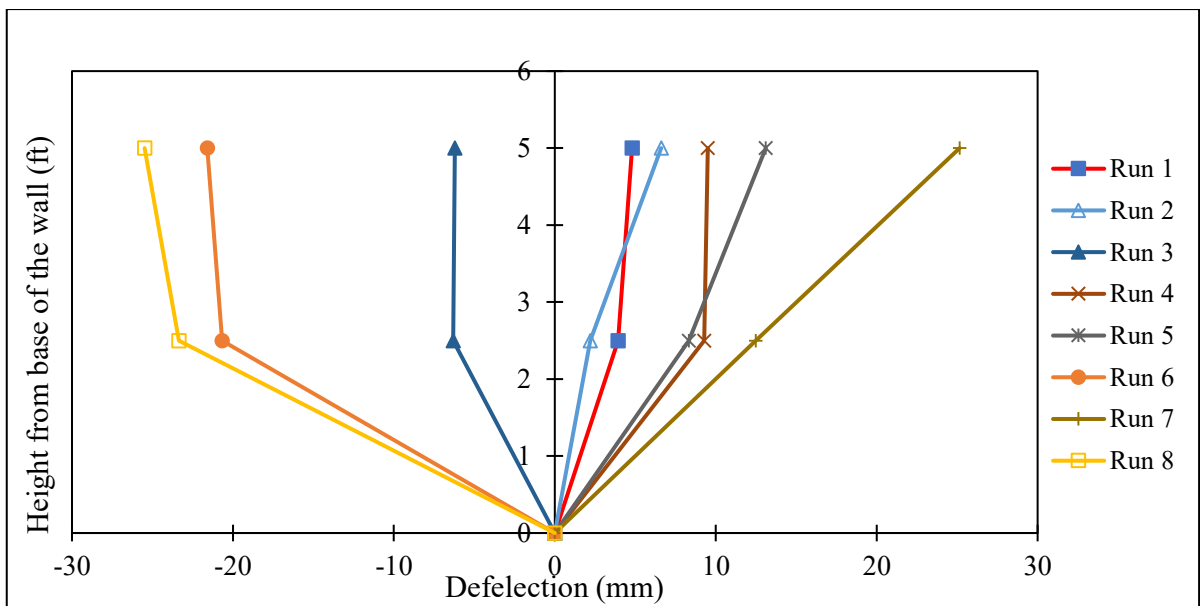
Figure 4.12 Approximate deflected shape of In-Plane wall for maximum top deflection

Table A.2 in Appendix A lists the two largest displacement peaks recorded for each laser sensor and at the table during Test Runs 1-10, along with their occurrence times. It is seen that displacement increase as the acceleration of the excitation increases for the in-plane, out of plane and table displacement. Only for the last excitation when the acceleration was maximum, the displacement decrease. Out of place wall experienced more displacement, which is 34.7 mm for the excitation of 0.92g (Run 8). At the same excitation, in-plane wall also experienced maximum displacement, which is 25.5mm.

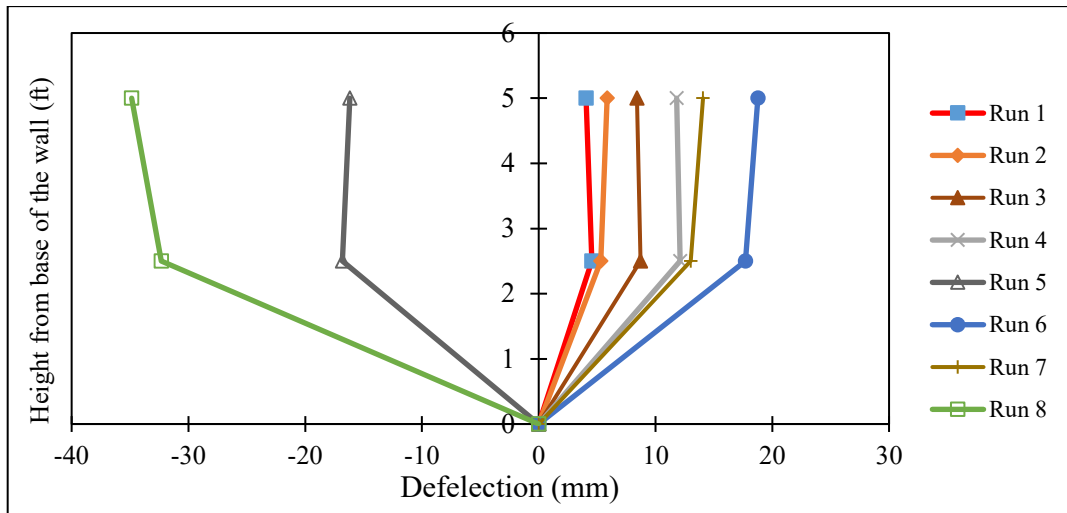
Figure 4.13 Approximate deflected shape of Out-of-Plane wall for maximum top deflection

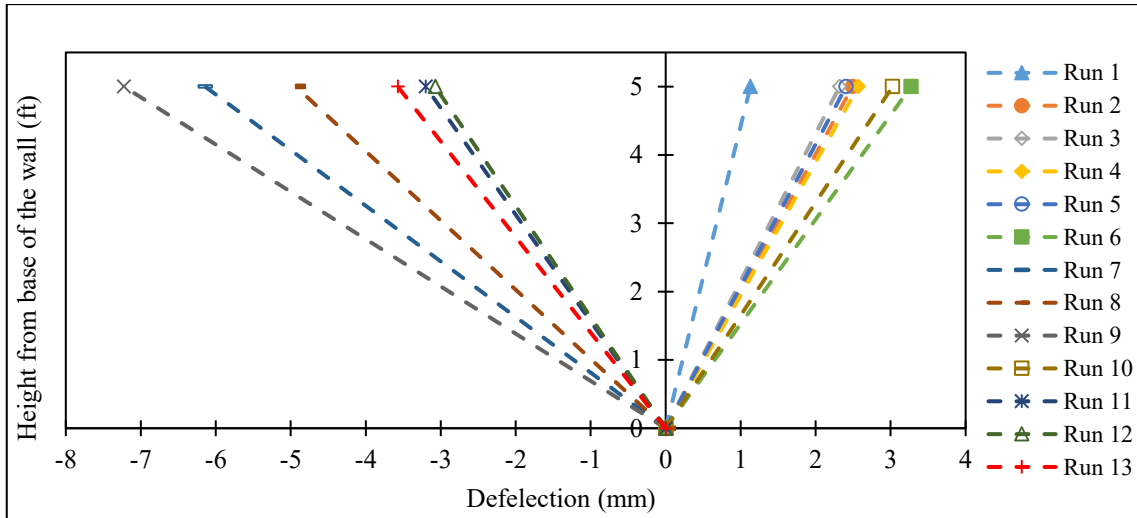
Figure 4.15 Approximate Deflected shape of Out-of-Plane wall for maximum top deflection

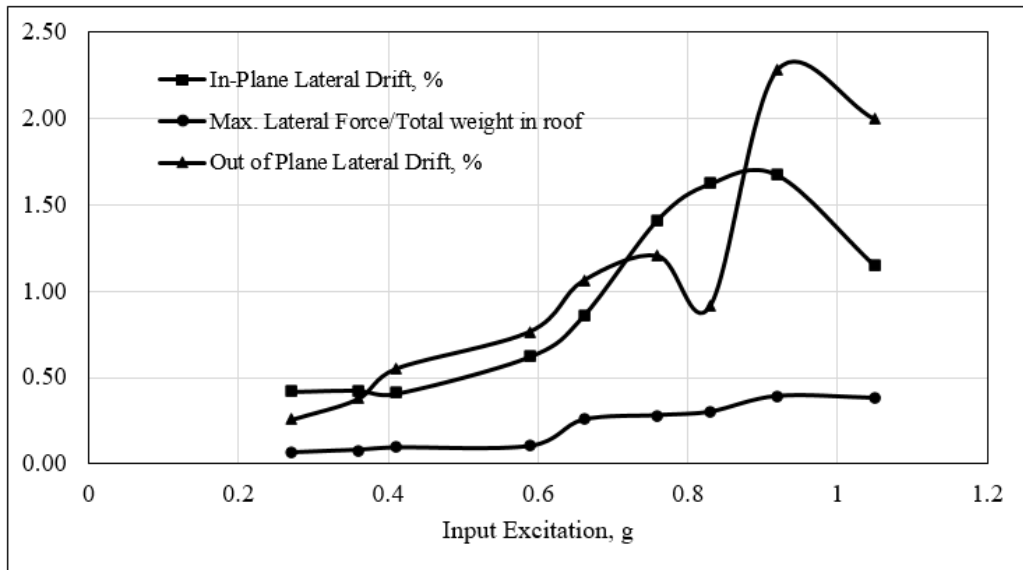
Figure 4.16 Input acceleration vs normalized lateral force and displacement of Reference Model

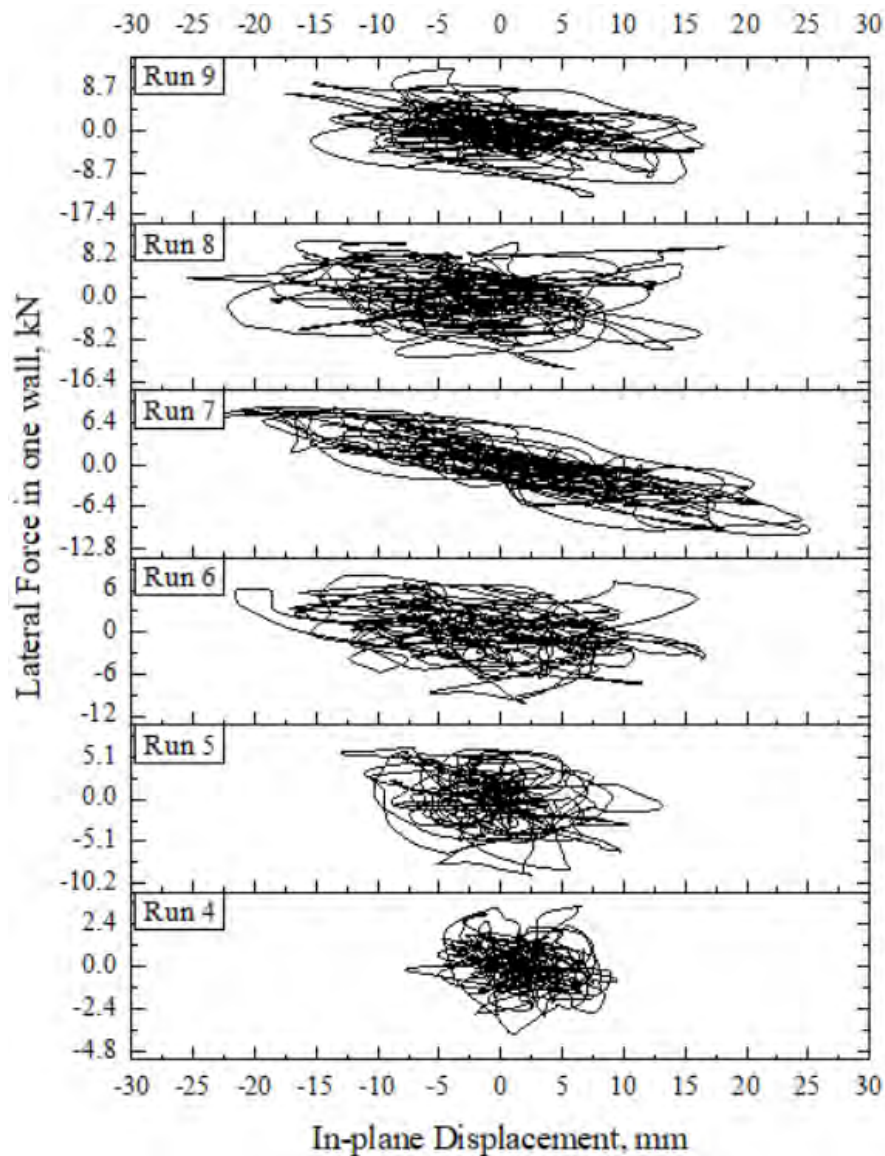
Figure 4.17 Lateral Force vs. Relative Lateral Displacement of in-plane wall for different input acceleration
