**DYNAMIC BEHAVIOUR OF UNREINFORCED
MASONRY BUILDING**

MASTER OF SCIENCE IN CIVIL ENGINEERING (STRUCTURAL)

DEPARTMENT OF CIVIL ENGINEERING
BANGLADESH UNIVERSITY OF ENGINEERING AND TECHNOLOGY
DHAKA-1000, BANGLADESH

DECEMBER 2018

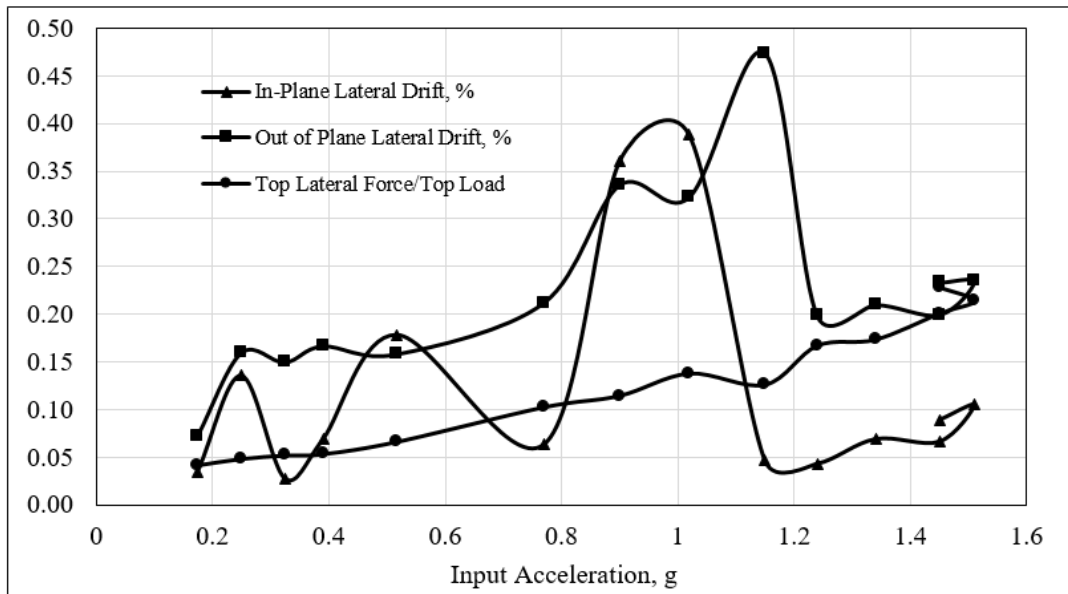
Figure 4.19 Input acceleration vs normalized lateral force and displacement of Retrofitted Model

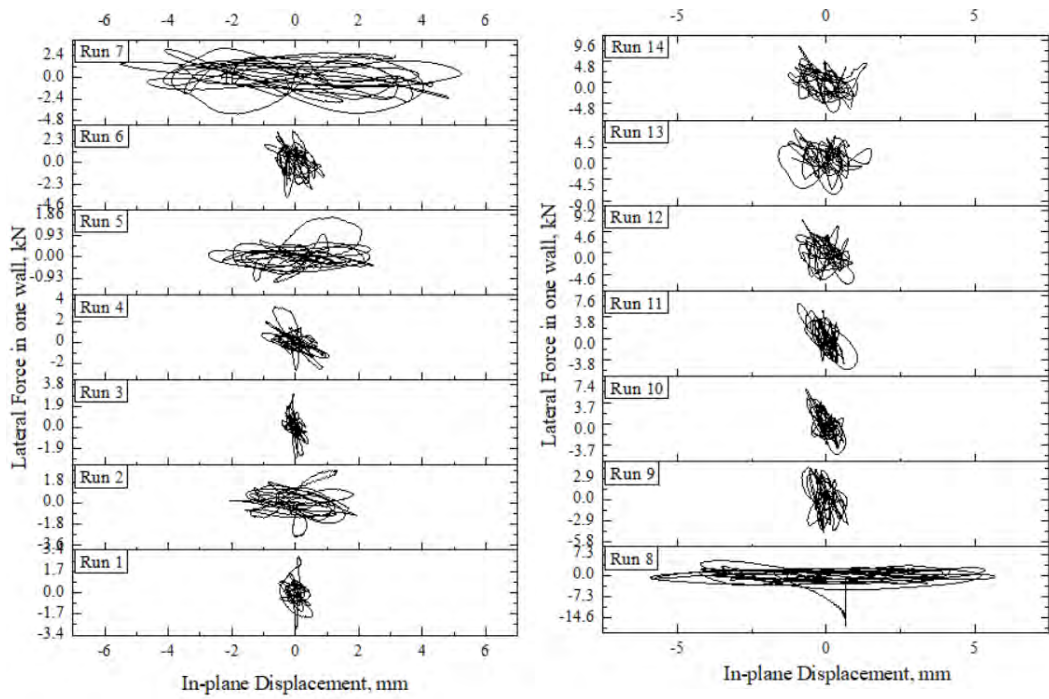
Figure 4.20 Force-Displacement relationship for in-plane wall of Retrofitted Model

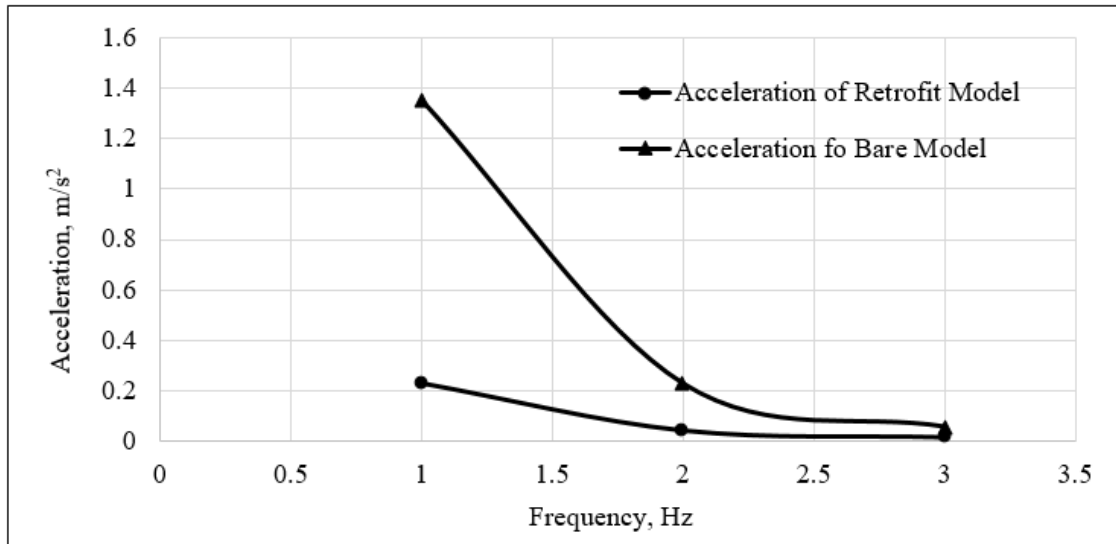
Figure 4.22 Acceleration at Roof Level for Sine Wave Excitation

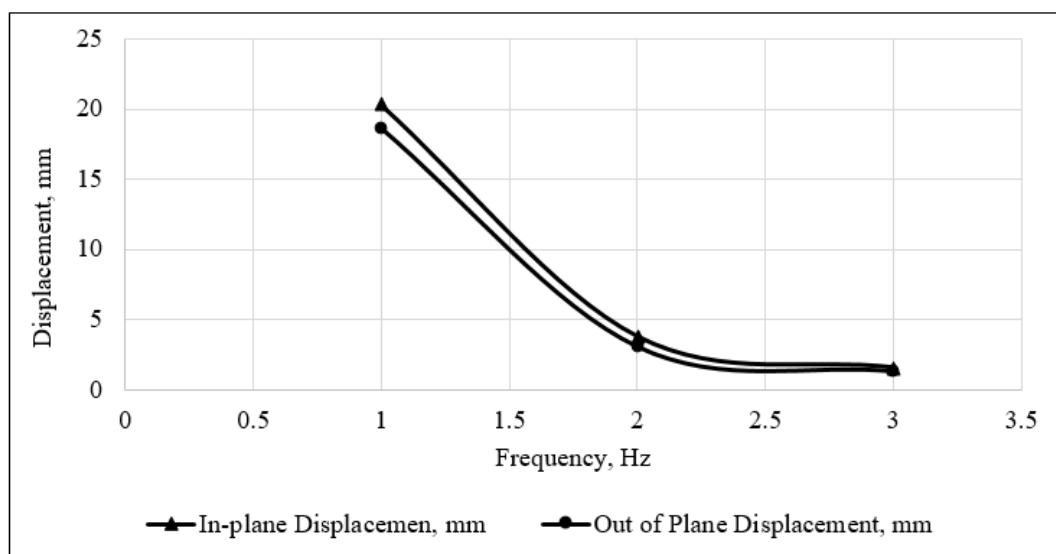
Figure 4.23 In-plane and Out of plane displacement of Reference Model for Sine wave excitation

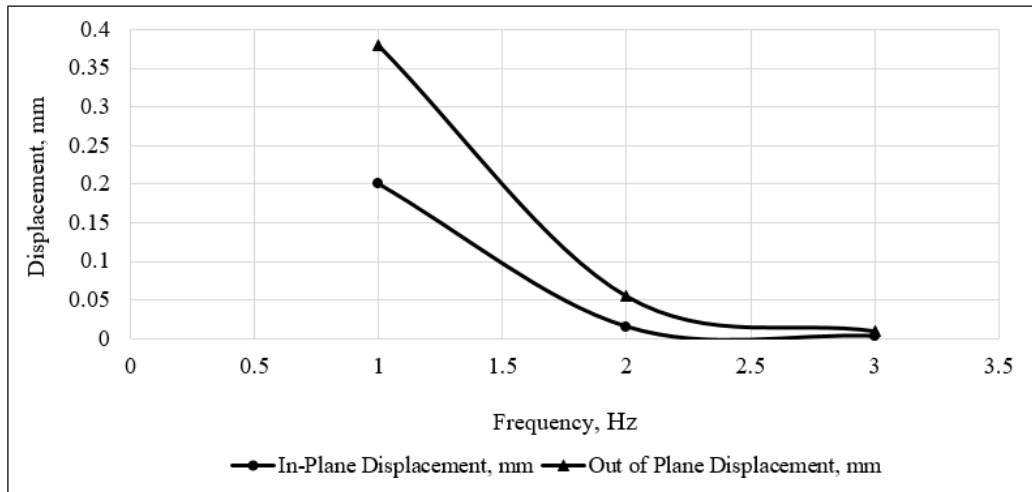
Figure 4.24 In-plane and Out of plane displacement of Retrofitted Model for Sine wave Excitation

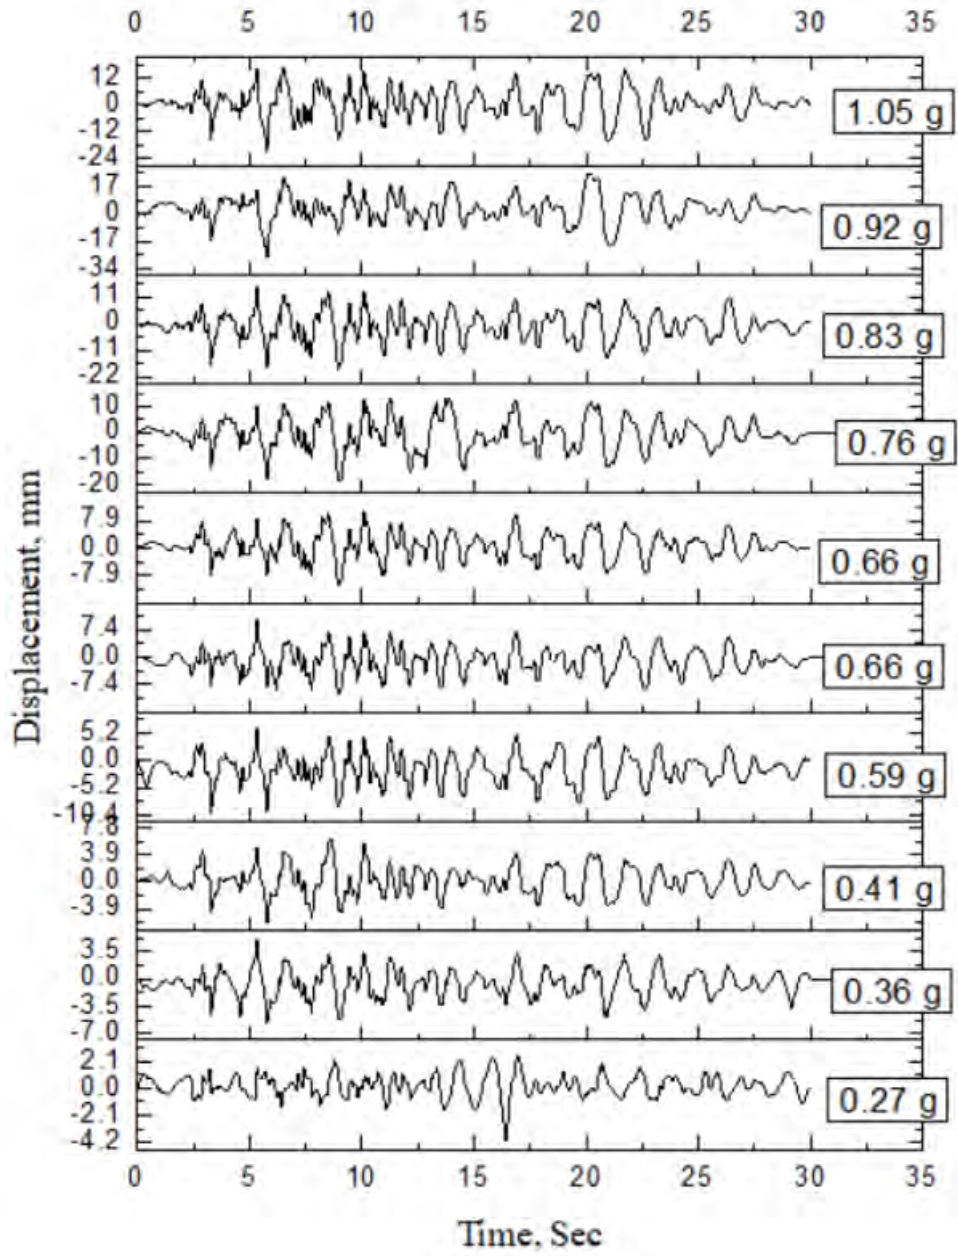
Figure A.2: Corresponding Displacement value of Input Motion for Reference Model

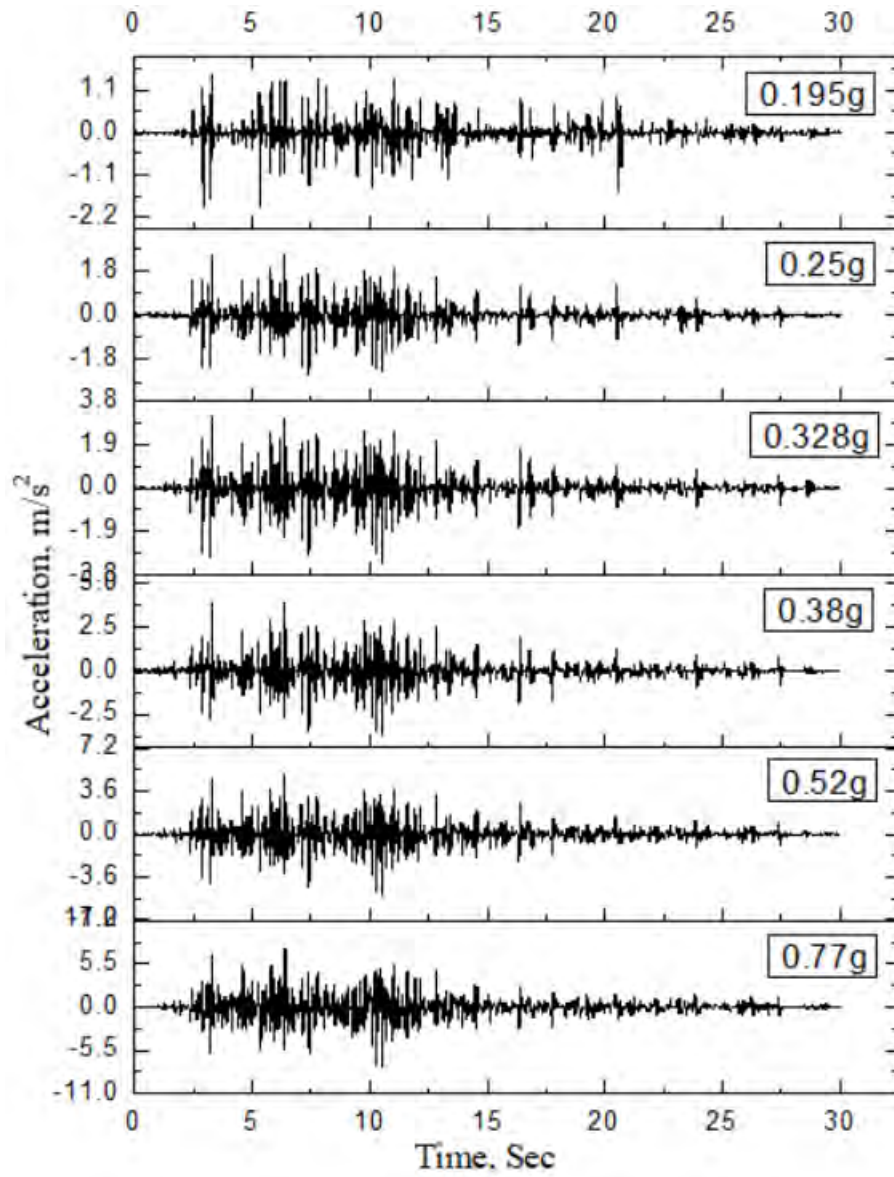
Figure A.4: Input Motion for Retrofitted Model

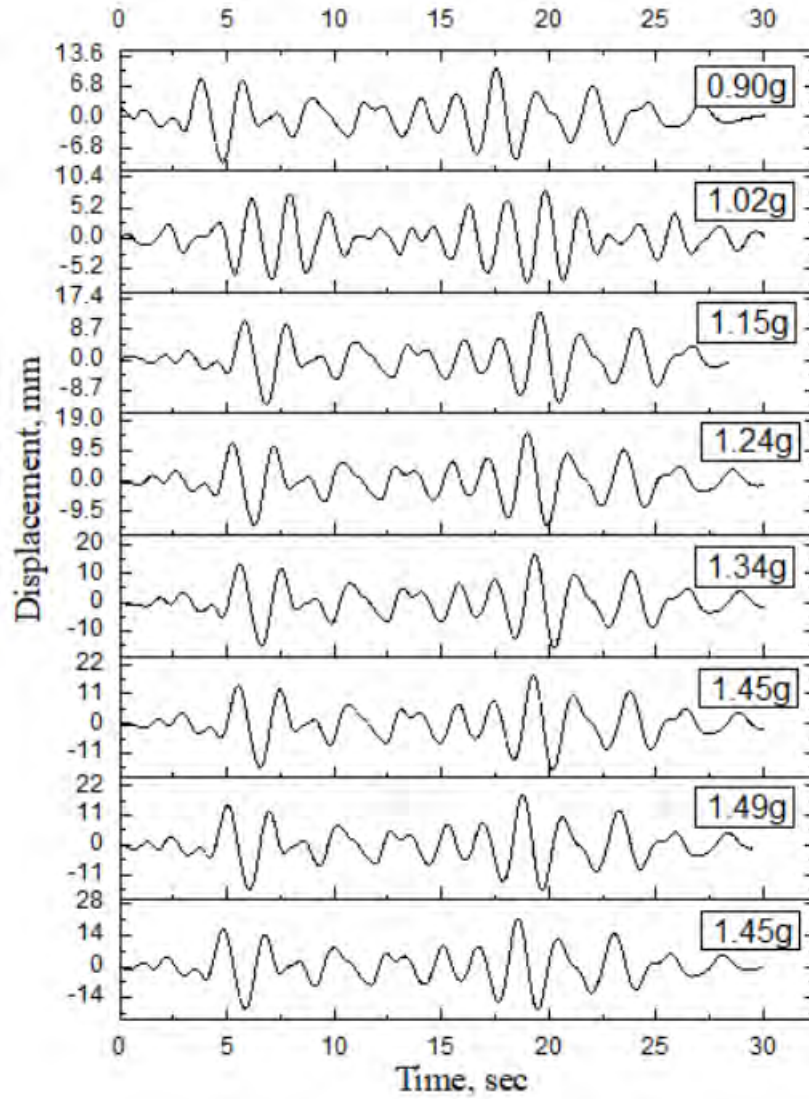
Figure A.5: Corresponding Displacement of Input Motion for Retrofitted Model

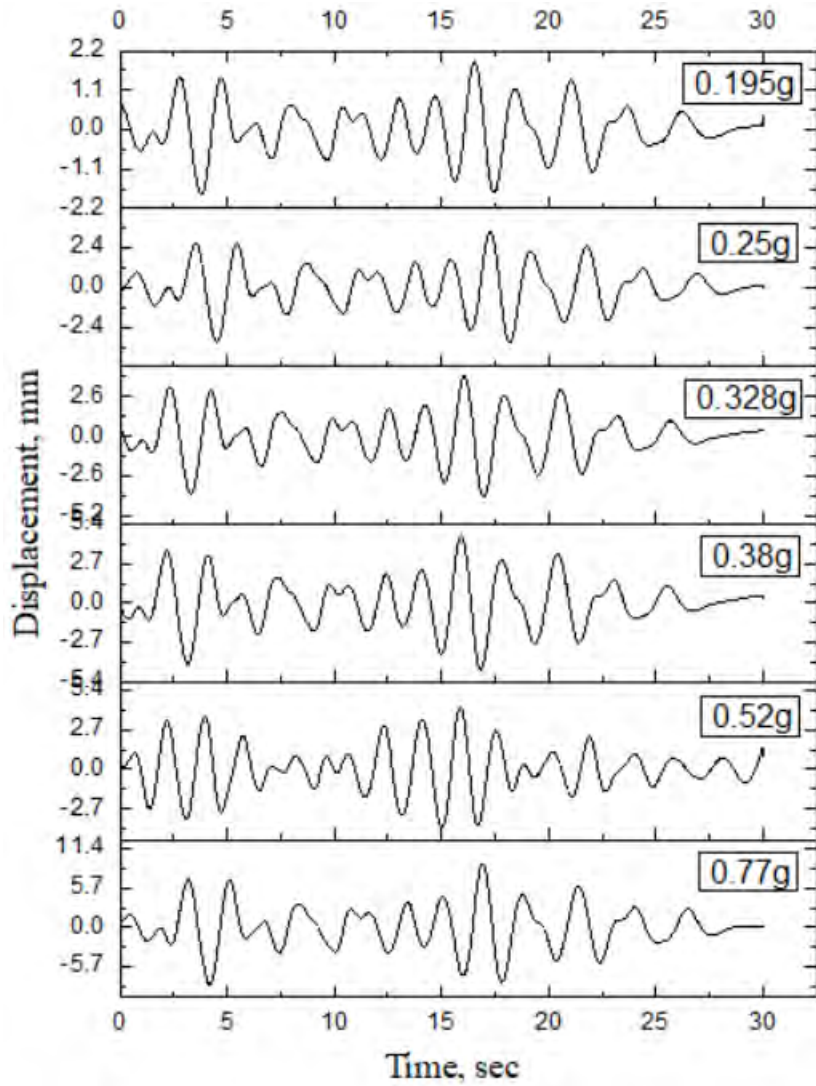
Figure A.6: Corresponding Displacement of Input Motion for Retrofitted Model
