PERFORMANCE OF ECOLOGICAL REVETMENT IN HAOR AREAS OF BANGLADESH

DEPARTMENT OF CIVIL ENGINEERING
BANGLADESH UNIVERSITY OF ENGINEERING AND TECHNOLOGY
Dhaka, Bangladesh

A Thesis Submitted to the Department of Civil Engineering in
Partial Fulfillment of the Requirements for the Degree of
Master of Science in Civil and Geotechnical Engineering

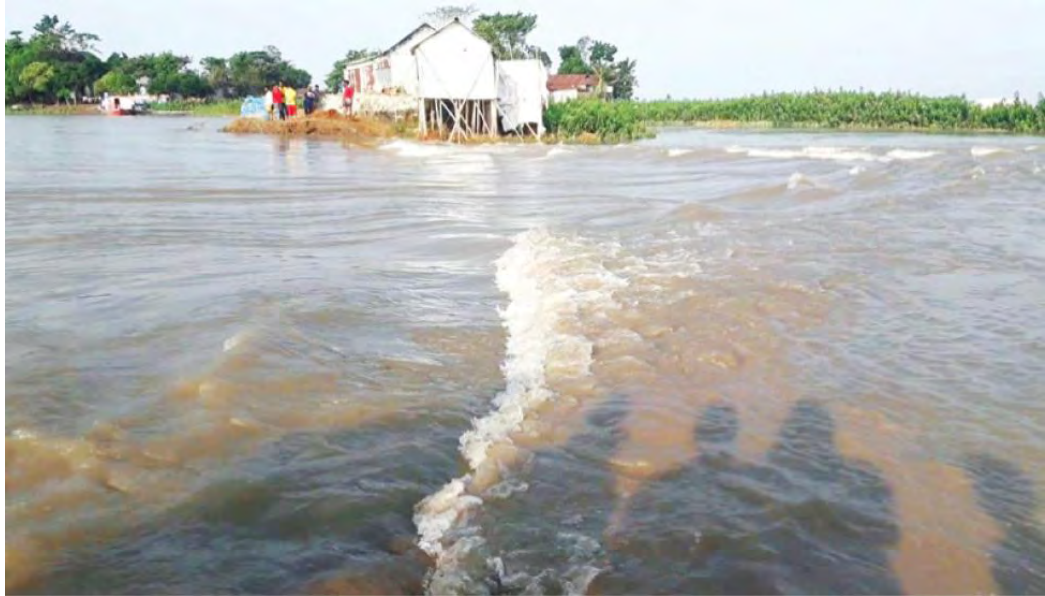
Figure 2.7: Floodwater from the Hills Overflows into Villages of Halir *Haor* under Jamalganj, Sunamganj in 5th May 2019 (New Age Bangladesh, 2019)

Extremely severe cyclonic storm ‘Fani’ originated from a tropical depression that formed west of Sumatra in the Indian Ocean on 26 April 2019. People in the *haor* region in started facing flash flood on 28 April 2019 because of heavy rainfall more than 50 mm caused by cyclone Fani inside Bangladesh and upstream in neighboring India. Thousands of hectares of cropland in south-western Bangladesh went under water as the weakened cyclone crossed Bangladesh on Saturday affecting 8,500 km protection embankment with high wind and tidal surges (New Age Bangladesh, 2019). On 28 April 2019, vast *haor* areas went under water after embankments were breached by rapidly rising rivers in five upazilas of Sylhet, Sunamganj and Netrakona districts. Flash flood situation at two upazilas in Netrakona was reported to be deteriorating by the flood forecasting center in the afternoon. Overflowing Sarigowain River caused flash flood at Gowainghat upazila. The flood forecasting center said that rivers in the *haor* region, including Kangsha, Jadukata, Sarigowain and Someshwari, rose up to over three meters in 24 hours. Figure 2.7 shows an affected village in Sunamganj during the flash flood of April 2019. It also shows the tremendous wave action during *afal*.

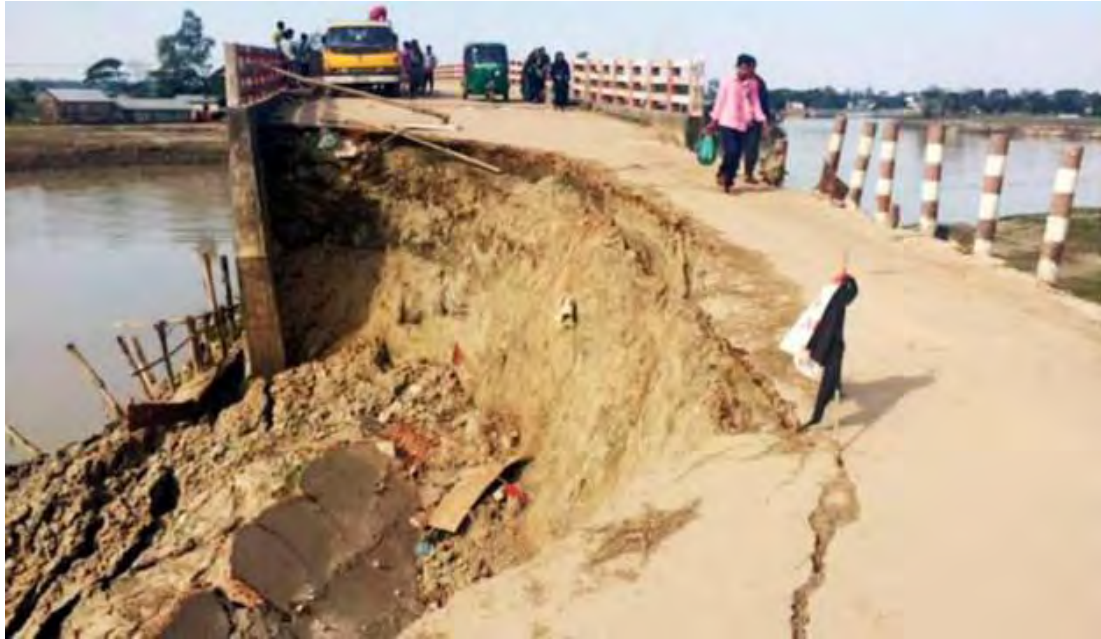
Figure 2.13: Road Slope Damage by Flood on 6th December 2017 in Jagannathpur Upazila, Sunamganj (The Daily Star, 2018)

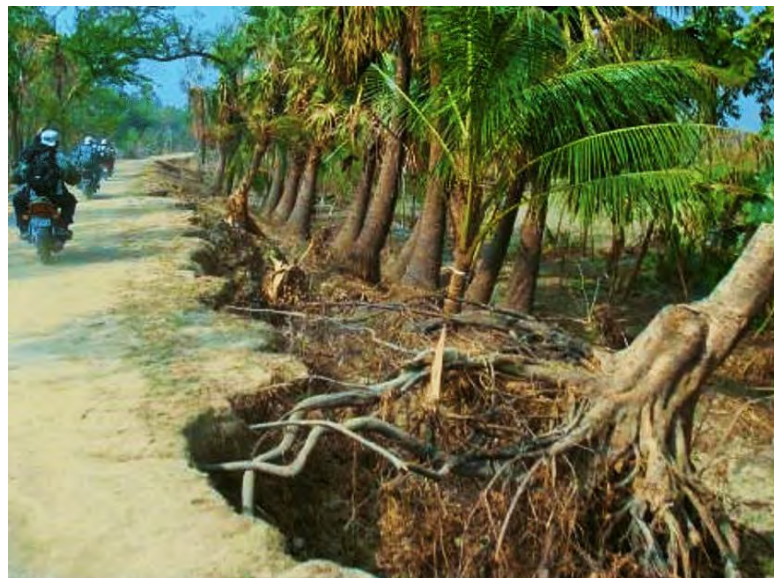
Figure 2.15: Failure of Embankment due to Overturning or Uprooting of Trees during Cyclone (Mohammad Shariful Islam, BUET)

Figure 2.15 indicates that only vegetation cannot protect the embankment, rather than topple in high winds and cause problem after disaster. So, it is essential to select long

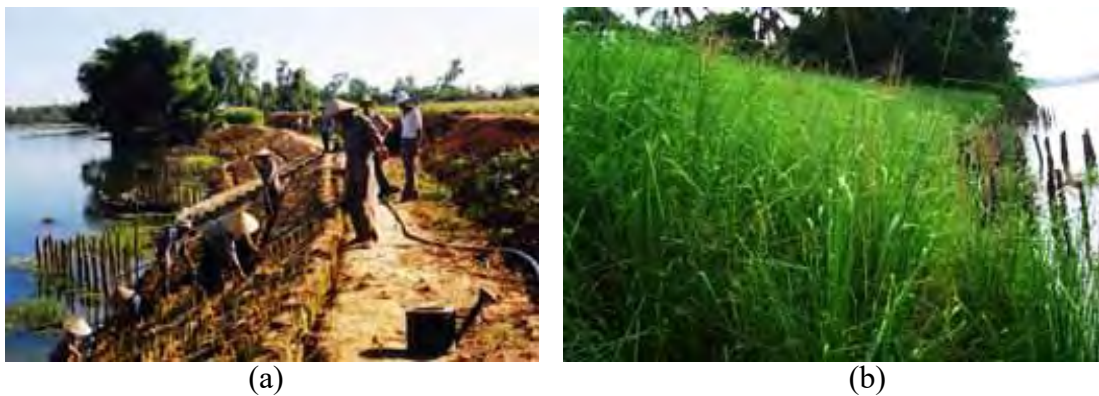
Figure 2.19: (a) Community Members Planting Vetiver; and (b) Bank Remains Intact Following the Flood Season in Quang Ngai Province, Vietnam (November 2005, funded by AusAid)

Figure 2.19 to Figure 2.21 (Truong et al., 2008) show the efficacy of vetiver plantation in case of slope protection in different places all over the world.

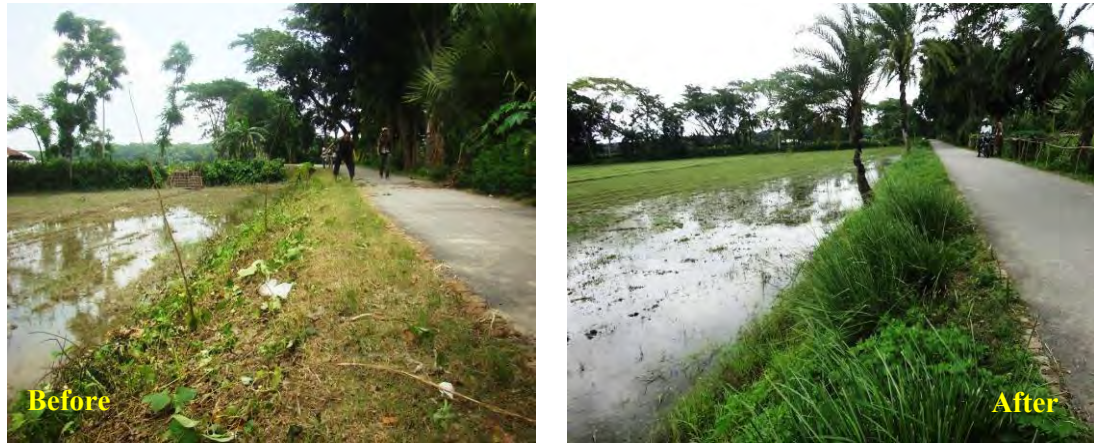
Figure 2.22: Road Slope Protection by Vetiver at Barisal, Bangladesh under CCRIP (Islam and Hoque, 2020)

Figure 2.22 to Figure 2.24 show some implantation of vetiver in field in Bangladesh in different sectors. Chattogram City Corporation has been established a ‘‘Vetiver Grass Display Center’’ at Tiger Pass, Chattogram (Figure 2.25) with the joint collaboration of Bangladesh and Thailand government. At 30th May 2019 Thai Princess, Her Royal Highness Maha Chakri Sirindhorn inaugurated the display center. Professor Dr. Mohammad Shariful Islam worked as the advisor of this work.

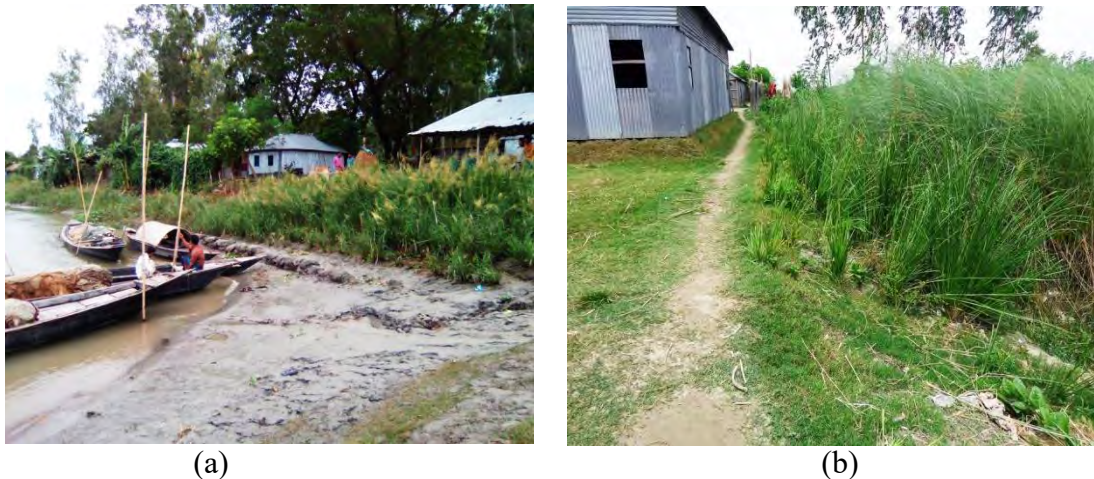
Figure 2.23: Charland Protection under UNDP with Vetiver at (a) Nageswari, (b) Chilmari, Kurigram, Bangladesh (2017) (Islam and Hoque, 2017)

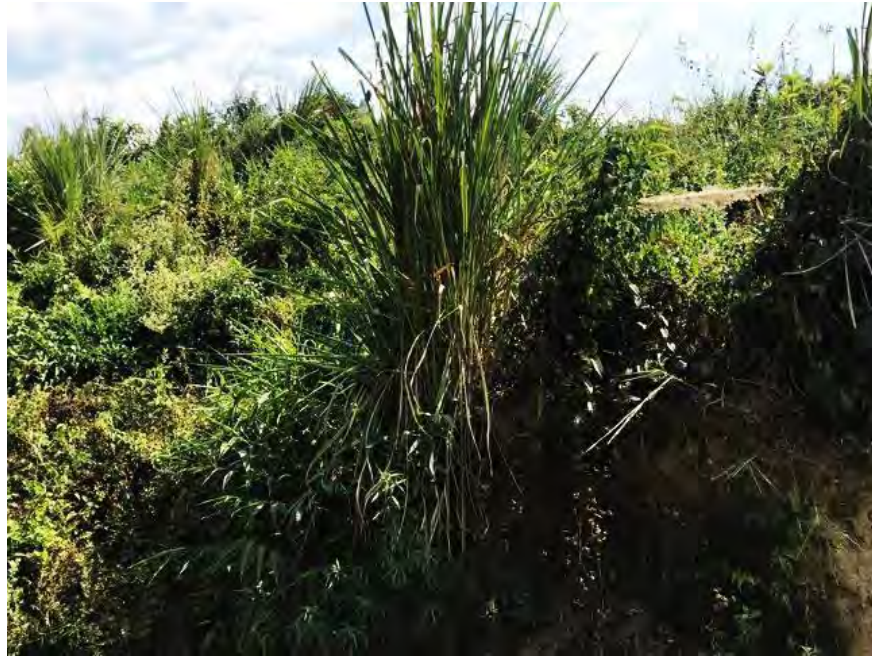
Figure 2.24: Hill Protection at Ukhia, Cox’s Bazar (Mohammad Shariful Islam, BUET)

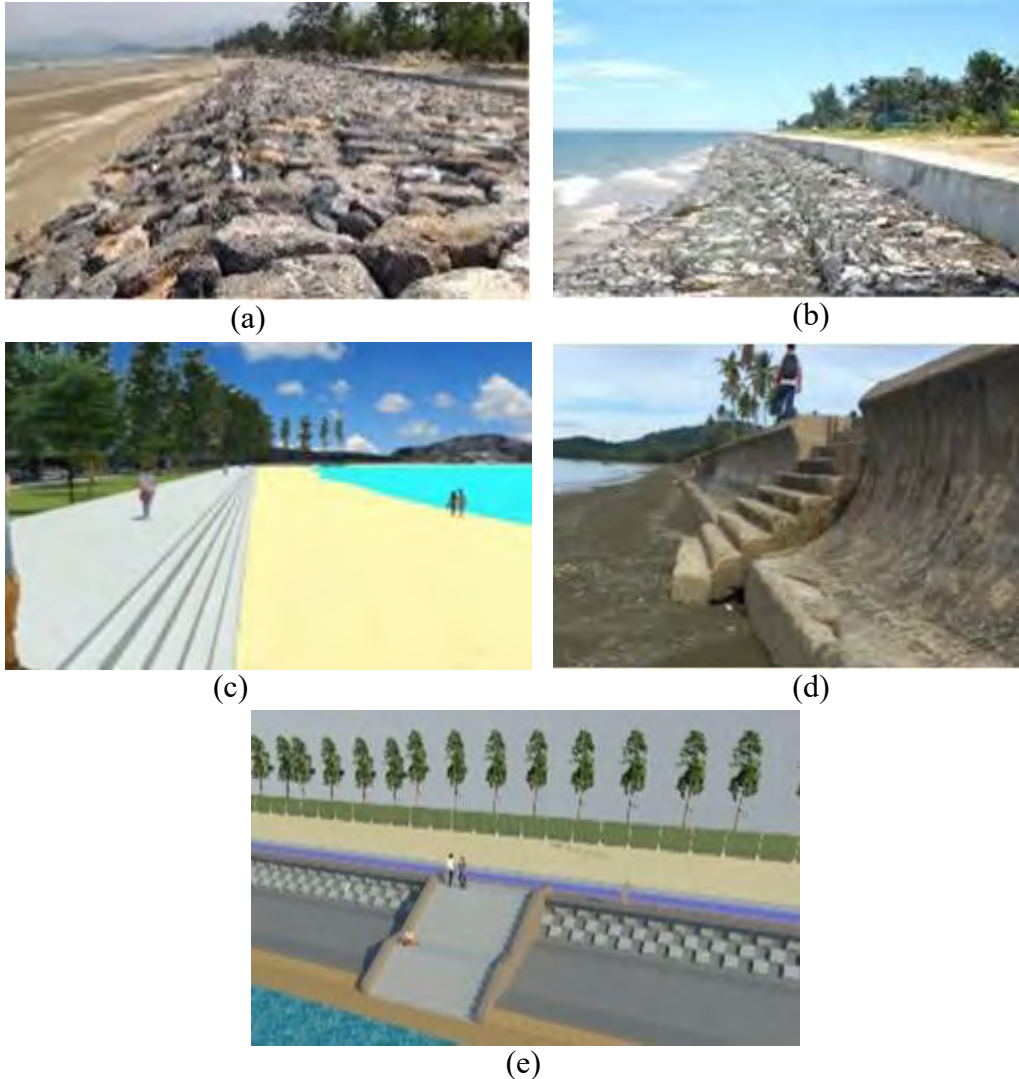
Figure 2.26: Photographs of (a) Rock Revetment; (b) Gabion Revetment; (c) Stepped Concrete Revetment; (d) Curve Faced Concrete Revetment; (e) Concrete Revetment with Blocks (Saengsupavanich, 2017)

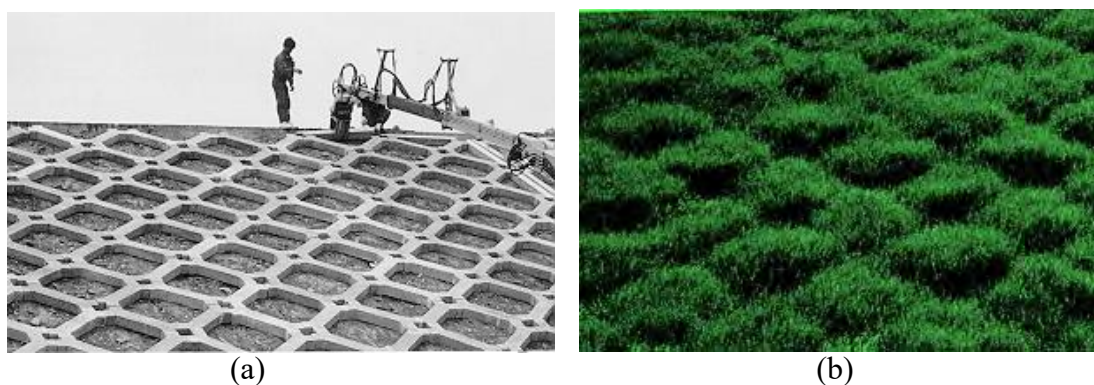
Figure 2.29: (a) Interlocking Concrete Grids Serve as Base for Plants (b) Salt Water Resistance Grass Planted on Top (USACE, 1984)

- (i) Revetment of grass and trees: Mainly to protect the banks of rivers, streams and some local erosion of the corner location ensures, vegetation, such as planting fir, willow and other water features with highly developed roots which can help to stabilize soil particles and to increase the stability of the embankment. The method is simple and low cost. But the anti-erosion property of the embankment is poor by the beginning erosion. In this case, geotextile slope works as a good assist. With the growth of trees and plants, the erosion capacity will grow gradually. With root system to protect native vegetation and ecological stability of embankments, plants in soil and water conservation of soil has a good effect. The use of plant roots for bank protection developed solid earth to protect both the sand and prevent soil erosion, which also meet the needs of the ecological environment and landscape formation. Ecological stream bank protection in rural areas can be given priority. Solid soil plants are plants like seabuckthorn forest, *Dalbergia*, *Taxodium ascendens*, *Eulaliopsis binata*, honeysuckle, etc. According to the region's soil, climate, and local people's preferences, the choice of plant species varies. This form of bank protection works well for the small towns with small surrounding flow and small rivers with low flow speed. Figure 2.28 and Figure 2.29 subsequently show the schematic diagram and construction procedure of vegetated riprap.

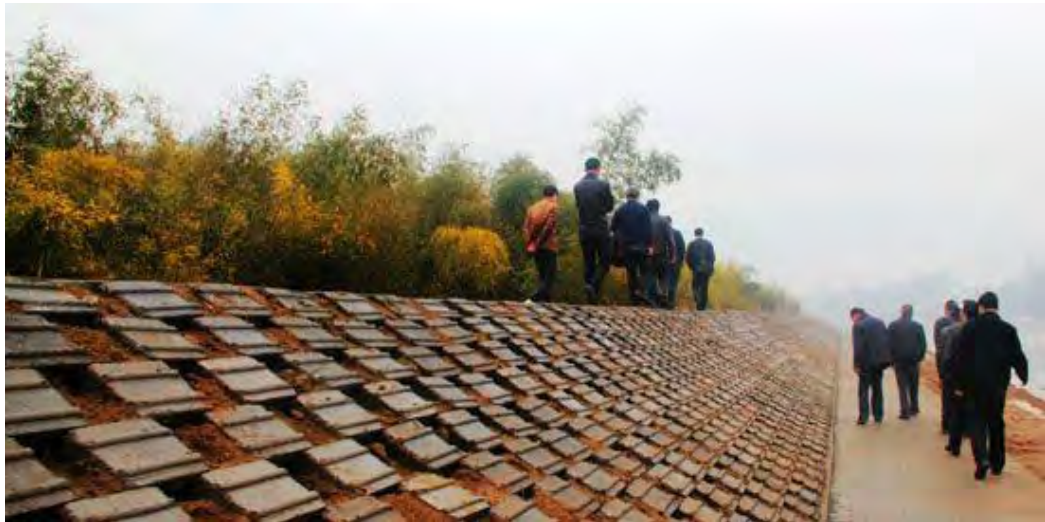
Figure 2.30: Ecological Revetment Built in Qiyun Mountain, China (2013)

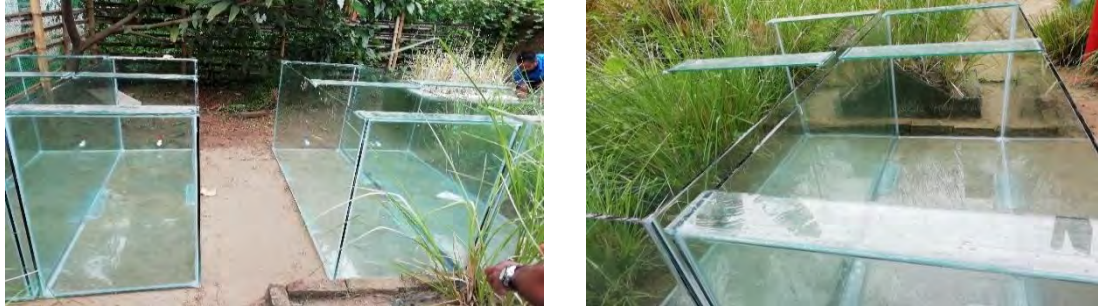
At first to conduct the experimental study for fabricating small scale ecological revetments, four glass models were made shown by Figure 3.2. The length of the rectangular glass models were 190 cm, width of 60 cm and height of 95 cm. 10 mm

thickness glass was used to construct the models, and a tap was attached 6 cm above from the bottom of each models to avoid water-logging. The glass models were fabricated and placed just beside BUET-Japan Institute of Disaster Prevention and Urban Safety (BUET-JIDPUS), (GPS: N23.725555, E90.387777) on 20th May 2019.

Figure 3.2: Photographs of Fabricated Glass Models in BUET

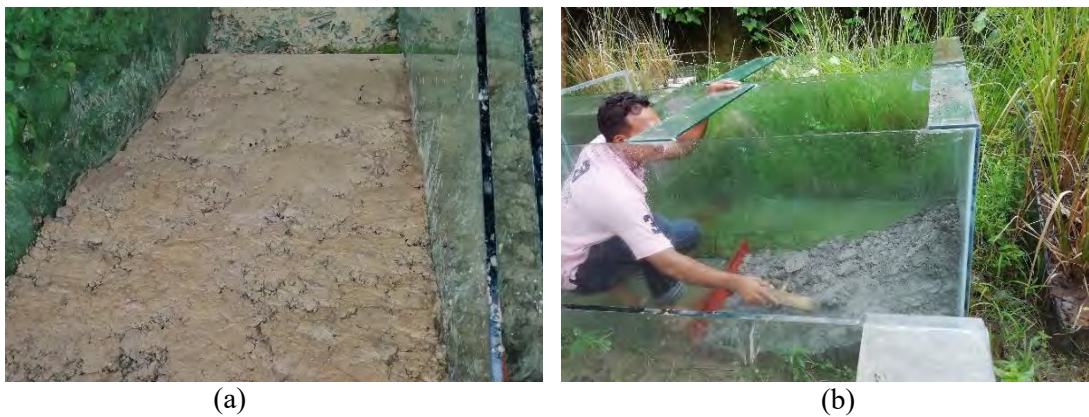
For the purpose of model setup, soils were carried out from a *haor* area named Ramrail Upazila, Brahmanbaria (GPS: N23.91964, E91.11228) with the cooperation of LGED officials. Soils were filled up within the model on 8th August 2019, shown in Figure 3.3. To fill up each model as per slope construction requirements, total 385 kgs of soils were required to fill each model (Wet unit weight of soil = 22.21 kN/m³).

Figure 3.3: Photographs of (a) Model after Completion of Soil Filling (VM); and (b) VFM Filling by Compaction

At first, the soils were pulverized properly. Half of the models were filled up with the powdered *haor* soils with a slope of 1:1.5 (V:H) as shown in Figure 3.3(a). The models BM and VM were filled with soils by compaction of ten layers by a wooden hammer. In case of VFM and VFGM, 8.5% fly ash (w/w) as stabilizer was mixed with the pulverized soil at first, and filled up by ten layer compaction afterwards, shown in Figure 3.3(b). VFGM was covered with JGT of 600 gsm (thickness at warp direction=0.19 cm, weft direction=0.48 cm) after soil compaction and slope preparation. After final slope preparation, a small wooden plank of 15 cm was installed at the toe of the soil slopes for each models as temporary guide walls.

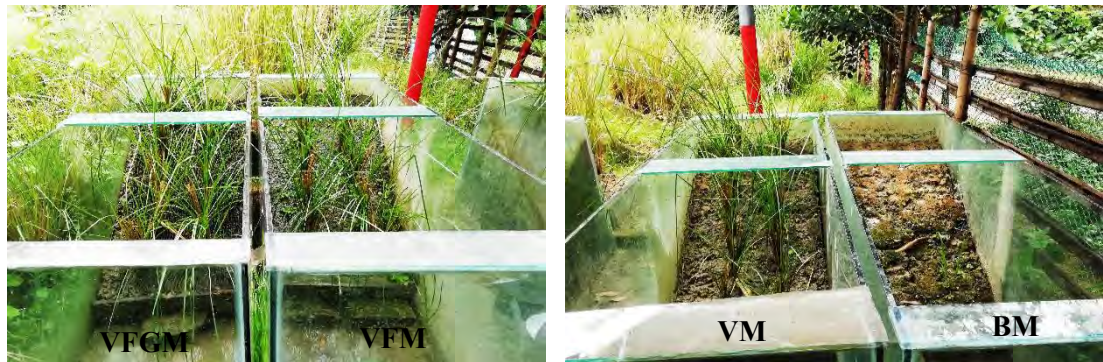
Figure 3.6: Photographs of Models (a) after 15 Days of Vetiver Plantation (8th September 2019) [Temperature: 30°C, moderate rain at afternoon]; (b) after 30 Days of Vetiver Plantation (23rd September 2019) [Temperature: 30°C, no rainfall]; and (c) after 60 Days of Vetiver Plantation (23rd October 2019) [Temperature: 31°C, no rainfall]

From the day of plantation, proper care was taken of the tillers by watering, nursing, cleaning weeds and monitoring the models. The tillers were allowed to grow up to 172 days (about 6 months) before submergence creation and wave action application. Figures 3.6 and 3.7 show the day by day growth of the vetiver by photographs mentioning the weather conditions.

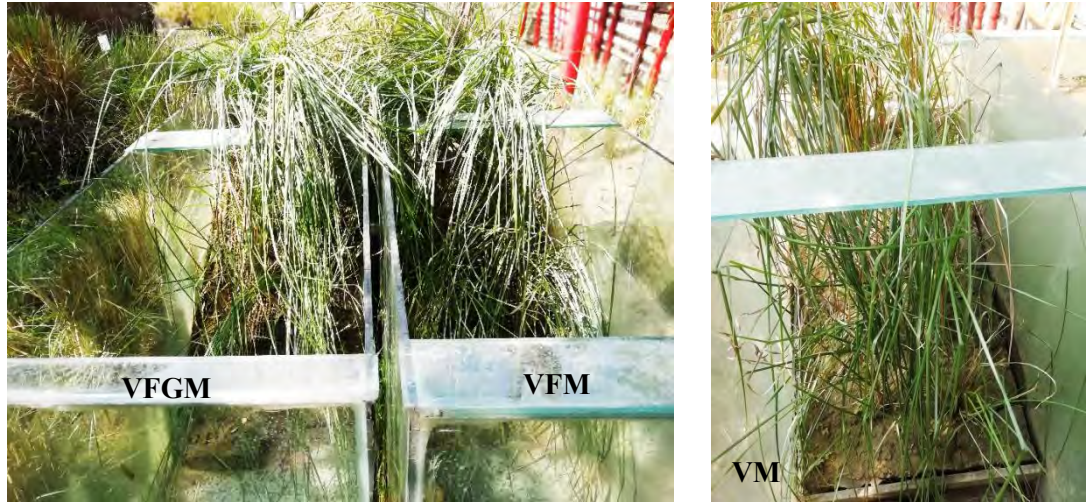
submergence is shown in Figure 3.8. Water was filled up to a height of 70 cm (15 cm below the hill of slope) to simulate with the submergence during flood at *haor* region. Figure 3.9 (a) and (b) show the submerged models. All models were kept under submerged condition for 5 days.

Figure 3.8: Model Condition on 11th February 2020 (Just before Submergence)
[Temperature: 27°C, no rainfall]

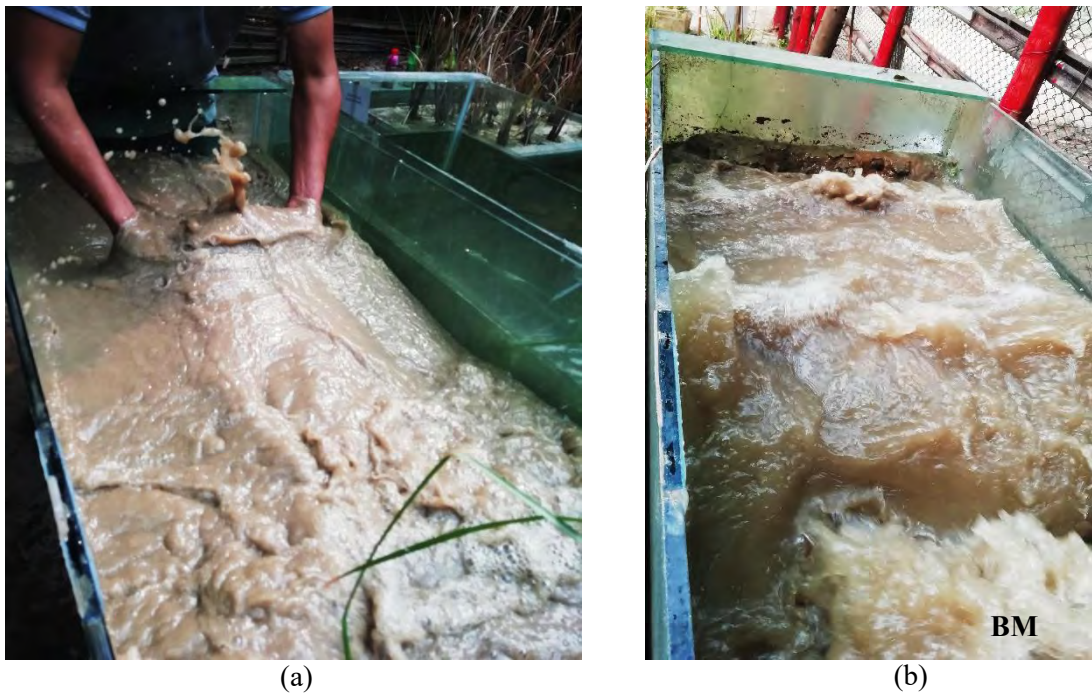
Figure 3.10: (a) Wave Action Propagation; and (b) Huge Wave Generation at Model BM

Figure 3.10 (b) shows wave action propagation on BM. Figure 3.11 and Figure 3.12 shows the wave propagation process of VM, VFM and VFGM, respectively. After wave generation through all four models, slope breakdown time, mass of soil loss and turbidity of each model were estimated. From the each three models, one vetiver tiller was uprooted carefully to measure the shoot and root length, width, diameter, number of tillers grown per point, and occurrence of inflorescence. Figure 3.13 shows the slope condition after wave propagation.

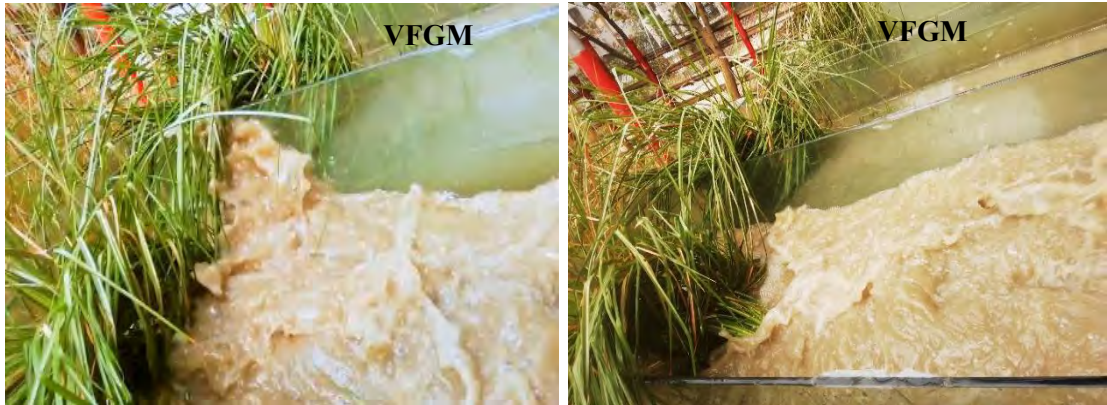
Figure 3.12: Photographs of Wave Action at VFGM

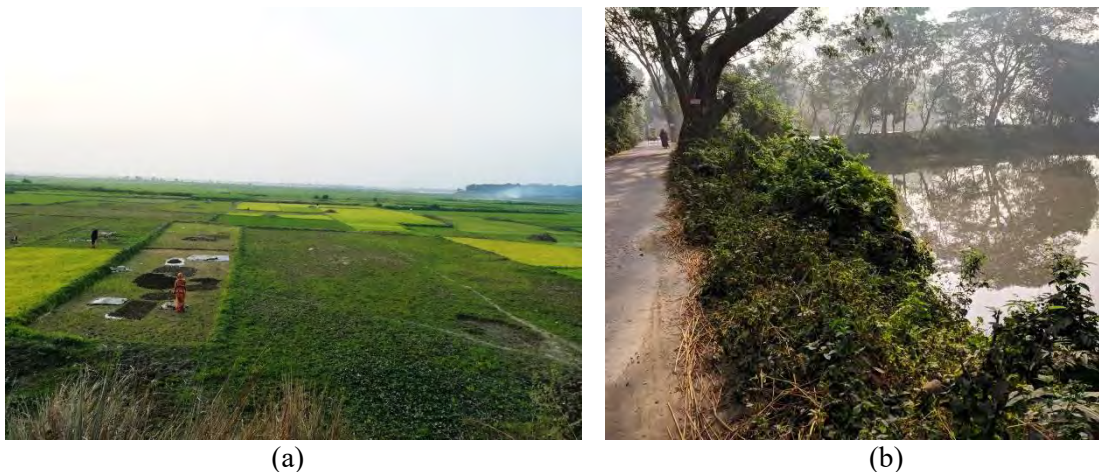
Figure 3.15: Photographs of (a) *Haor* of Brahmanbaria (Modhupur Temohoni, Branch of Meghna River) in Dry Season at 15th January 2019; and (b) Water Table Position beside Road Slope (Panchabaty, Brahmanbaria Sadar)

Brahmanbaria district has 4 municipalities, 39 wards, 97 mahallas, 9 upazilas, 98 union parishads, 1081 mouzas and 1329 villages. This district is mostly farmland, and according to the depth of surrounding wetlands, it can be categorized as shallow depth *haor* area. Four upazilas of Brahmanbaria district were selected as study area to evaluate the ecological revetment system by monitoring the growth performances of vetiver and application of bio-engineering technology in the field. Figure 3.15 (a) and (b) show the site condition during dry season.

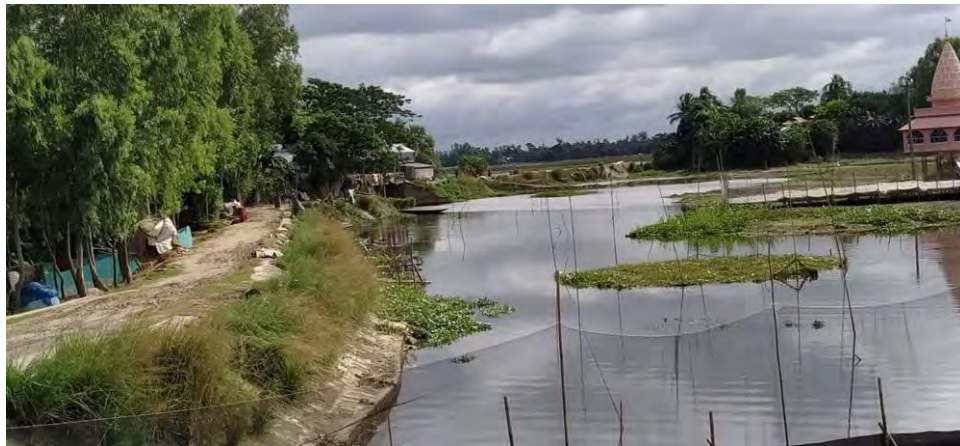
Figure 3.16: Photograph of *Haor* of Habiganj (Upazila: Baniachong) after Facing one Flood in Monsoon of 2019

Habiganj is a district of the Sylhet Division in the north-eastern part of Bangladesh. At present, it is a district of Sylhet Division. Habiganj consists of 9 upazilas, 6 municipalities, 54 wards, 78 union parishads, 124 mahallas, 1241 mouzas and 2076 villages (Roy, J.S., 2012). This district can be categorized as mid-depth *haor* area according to the depth of surrounding wetlands. Three upazilas of Habiganj district were selected as study area to evaluate the ecological revetment system by monitoring the growth performances of vetiver and application of bio-engineering technology in the field. Figure 3.16 (a) and (b) show a specific site of Habiganj during dry season and after facing a flood of 2019.

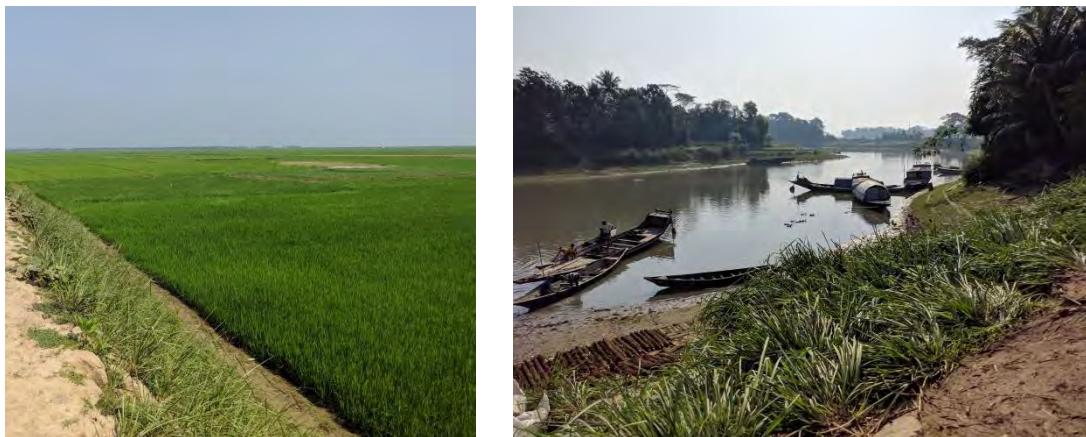
Figure 3.17: Photographs of (a) Village Island of Kishoreganj (Upazila: Nikli) in Dry Season at 8th March 2019; and (b) Road Slope of Kishoreganj (Upazila: Itna) in Dry Season at 8th March 2019

Figure 3.17 (a) and (b) show two sites of Kishoreganj during dry season. This district can be categorized as deep *haor* according to the depth of surrounding wetlands. Two upazilas of Kishoreganj district were selected as study area to evaluate the ecological revetment system by monitoring the growth performances of vetiver and application of bio-engineering technology in the field. Some places were very remote by geographical situation.

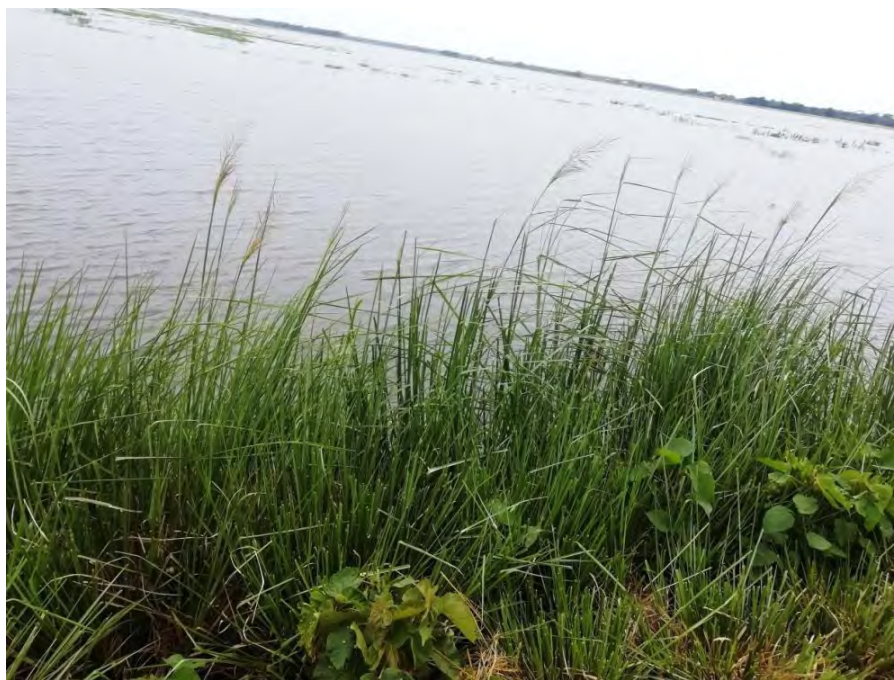
Figure 3.18: *Meda Beel* at Netrokona (Upazila: Kalmakanda) in the Initial Wet Season (23rd May 2019)

Netrokona is situated in the northern part of Bangladesh, near the Meghalayan border. There are five main rivers in Netrakona: Kangsha, Someshawri, Dhala, Magra, and Teorkhali. It is a part of the Surma-Meghna River System (Banglapedia 2018). The total area of Netrakona District is 2,794.28 km² of which 9.17 km² is under forest. It lies between 24°34' and 25°12' north latitudes and between 90°00' and 91°07' east longitudes. This district is bounded by the Garo Hills in Meghalaya, India on the north, Sunamganj District on the east, Kishoreganj District on the south and Mymensingh District on the west. This district is categorized as deep *haor* according to the depth of surrounding wetlands. One upazila of Netrokona district was selected as study area to evaluate the ecological revetment system by monitoring the growth performances of vetiver and application of bio-engineering technology in the field. All places were very distant by geographical situation. Figure 3.18 shows photograph of a beel connecting the *haor* areas at Kalmakanda, Netrokona during monsson period.

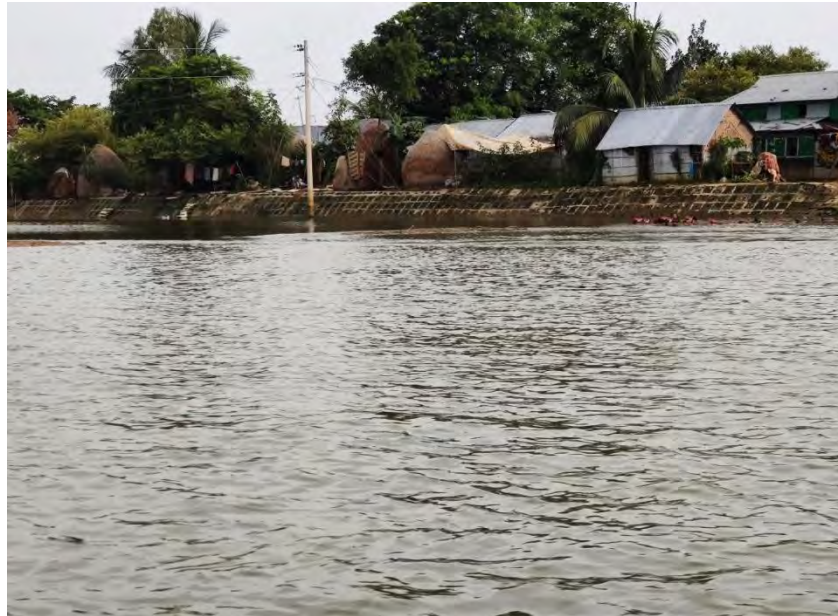
Figure 3.19: Village Island of Sunamganj beside *Kaliergota haor* (Upazila: Derai) in the Initial Wet Season (30th August 2019)

surrounding wetlands, and most of the time of the year the infrastructures of this area remain fully or partially submerged. One upazila of Sunamganj district was selected as study area to evaluate the ecological revetment system by monitoring the growth performances of vetiver and application of bio-engineering technology in the field. Figure 3.19 shows photograph of the village islands at Derai of Sunamganj during monsson.

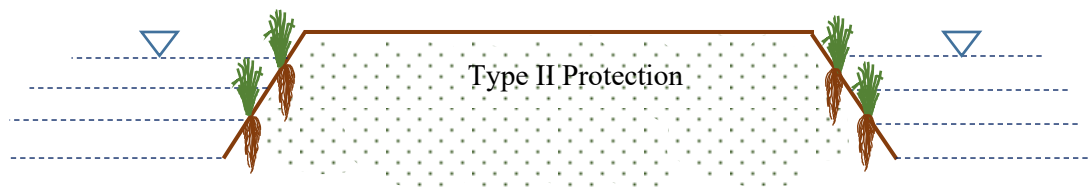
Figure 3.27: Schematic View of *Killa* Protection

Killa is a comparatively raised fallow land in the *haor* which is usually used in emergency during flash flood or early flood to save paddy & other wealth. As villages are located far away from *haor* basin, people very often use the *killa* land for crop harvesting purposes for the time being before monsoon flood come. Size of *killa* is usually 60 m×30 m. A *killa* was monitored for the purpose of field study. Figure 3.27 shows the schematic diagram of *killa* protection by LGED measures. Table 3.5 shows the location of the *killa* with GPS data and design type applied in that particular location.

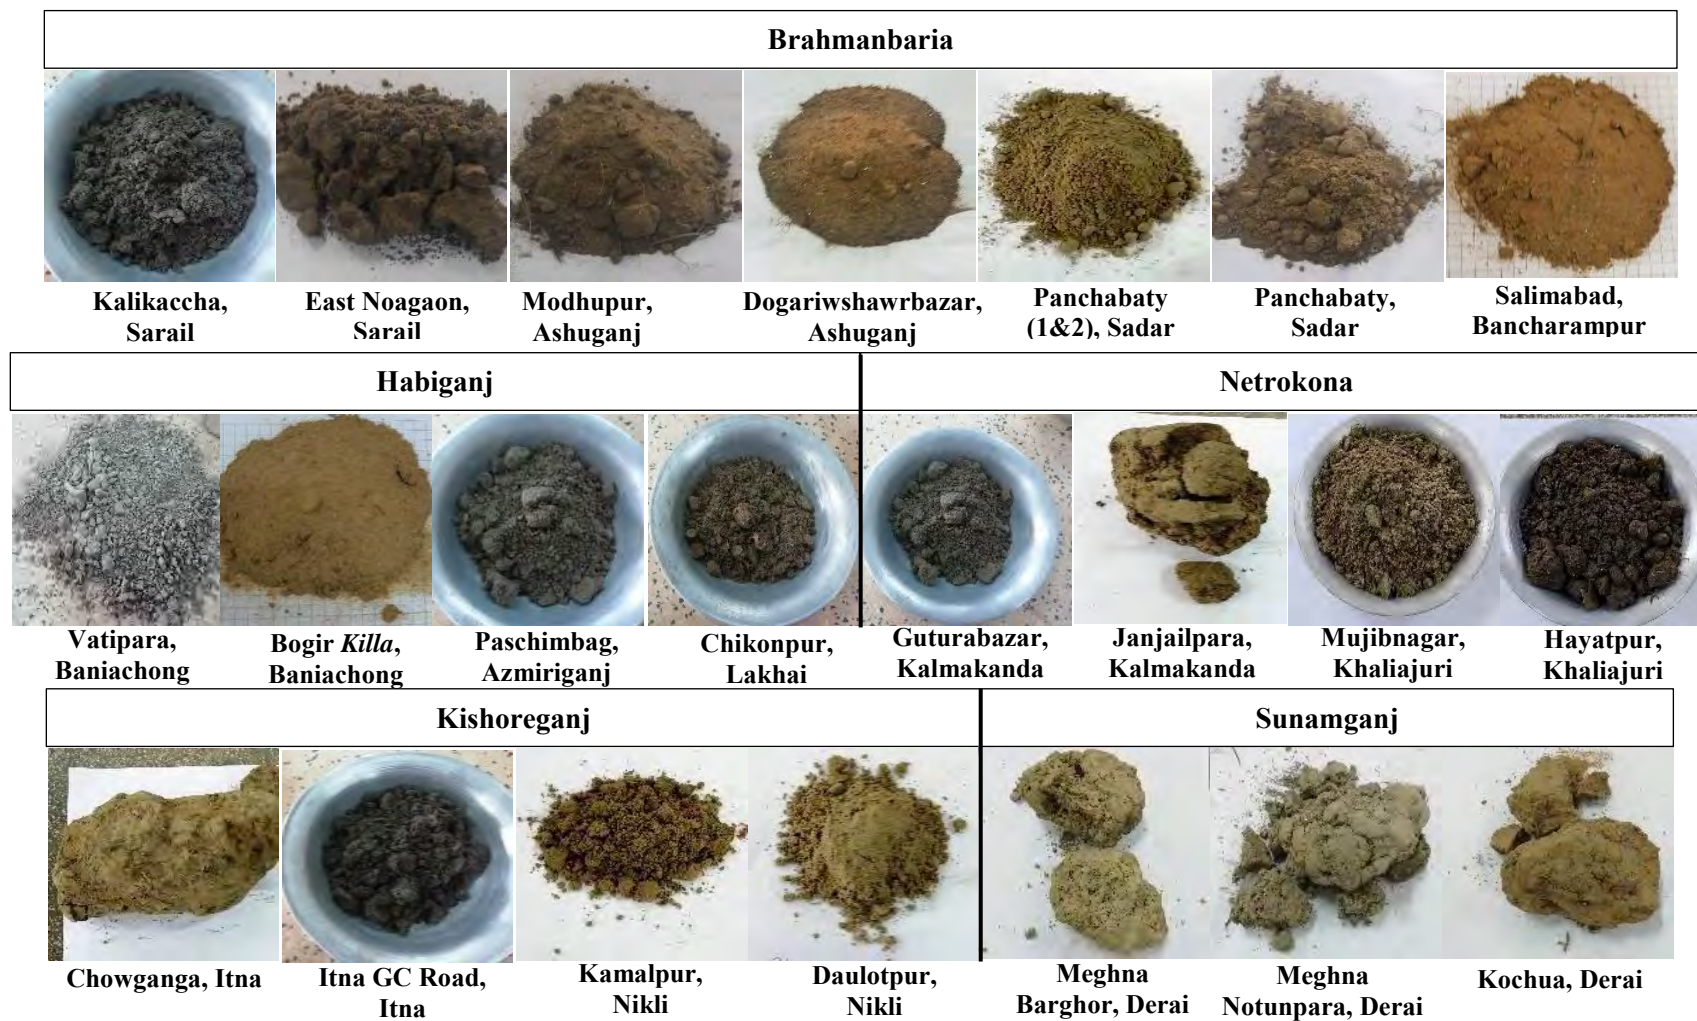
Figure 4.2: Visual Photographs of *Haor* Soils

Figure 4.2 shows the photographs of all collected soils from five *haor* districts. All graphs and tables indicate the variety and non-uniformity of soil type in *haor* region. It shows that almost all of the soil types are silty sand/sandy silt, i.e., non-plastic, are fine in nature. The more the fine the particles, it is more erodible. Among all the *haor* districts, soils of Sunamganj have been found most coarse, and the soils of Kishoreganj have been found as most fine. The details of the calculation including % finer of course, medium and fine sands are shown in Appendix A.

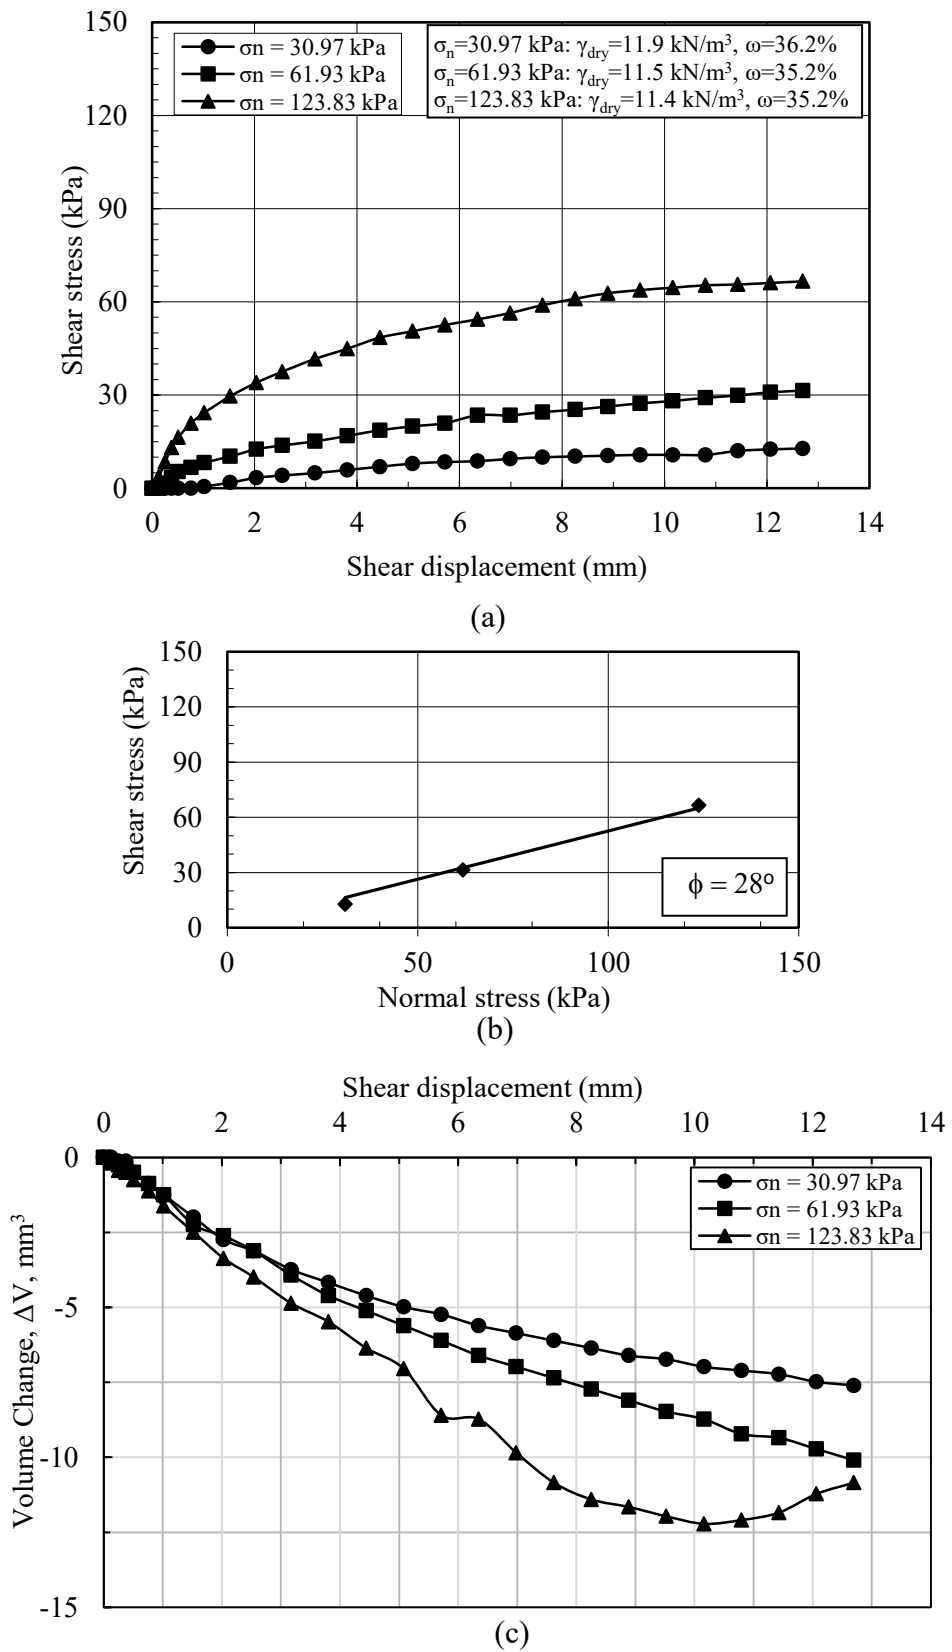
Figure 4.6: Direct Shear Graphs for Soil from Paschimbag, Azmiriganj, Habiganj: (a) Shear Stress vs. Shear Displacement; (b) Shear Stress vs. Normal Stress; and (c) Volumetric Change vs. Shear Displacement

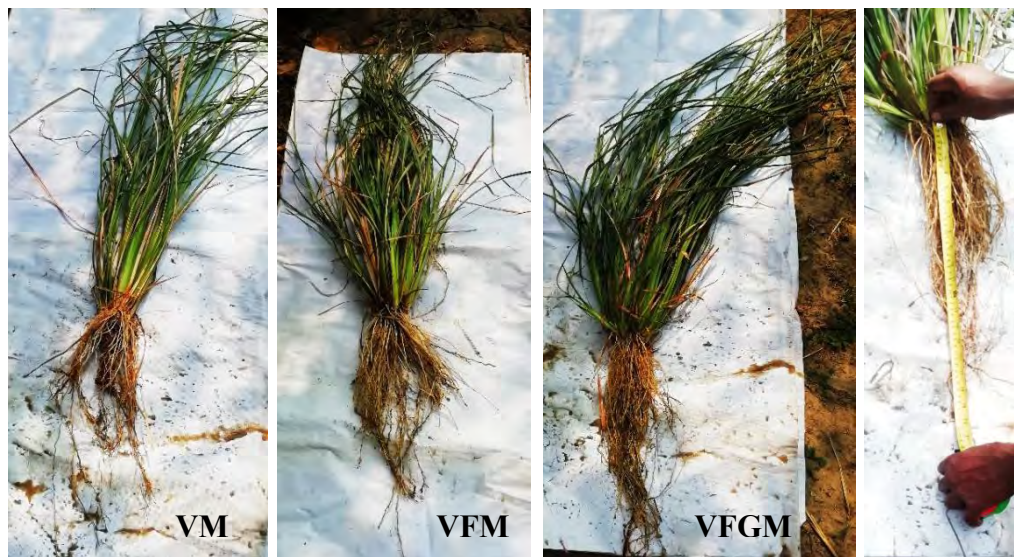
Figure 4.18: Measurement of Vetiver Tillers of Three Models (VM, VFM, VFGM)

Measurements were taken of shoot and root length of the vetiver tillers, as shown in Figure 4.18. Figure 4.19 shows the growth performance of vetiver tillers of 172 days age for the three wave tolerance models.

At the beginning, only 3 tillers were sown in one point, which increased to 13, 31 and 28 tillers for VM, VFM, and VFGM, respectively. The root of the tillers reached up to the bottom of the models, and it also formed a matrix with the other tillers in the vicinity. After submergence creation of the four models, the condition of vetiver tillers were similar as before, and no tillers were uprooted and washed away due to wave action. From the growth study, it can be observed that the growth of vetiver for VFGM is the maximum, because the tillers got more nutrients to grow for fly ash, and for JGT, the moisture was preserved with soil when watering was applied. The root of the tillers formed a reinforcing system with soil, which prevented the soil from washing away. So, soil loss was found less where the root matrixes were in a large scale. The shoot matrix also helped to protect the soil from washing away against erosion. The larger the canopy size, the less wave action could hit upon the soil and prevented it from mass movement. The canopy of vegetation (aboveground portion of plants, formed by the collection of individual plant crowns) of all models were measured to determine the total soil area covered by the area. The percentages of vegetation cover area with slope surface area of the three models are shown in

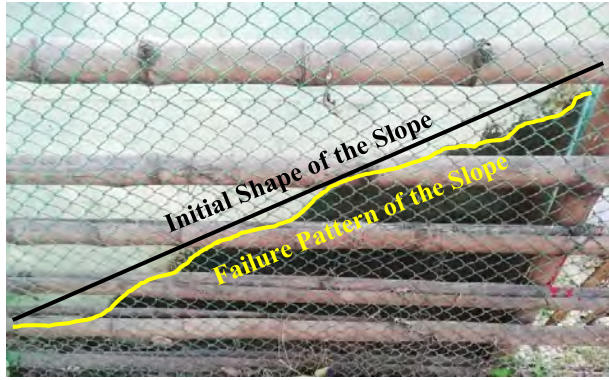
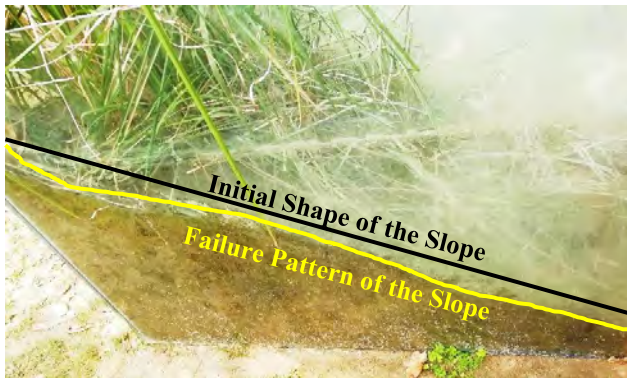
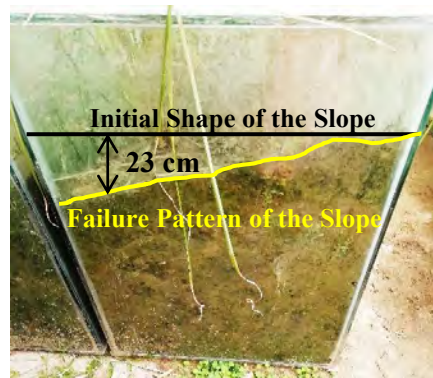
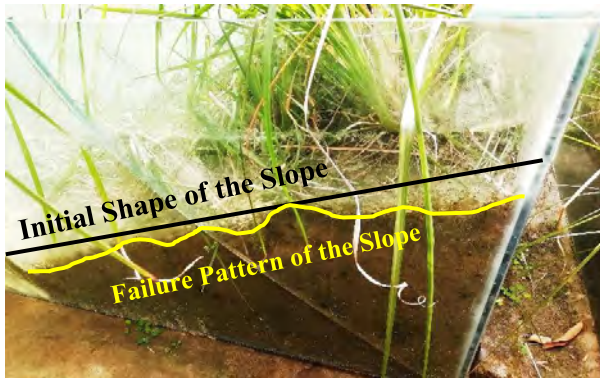
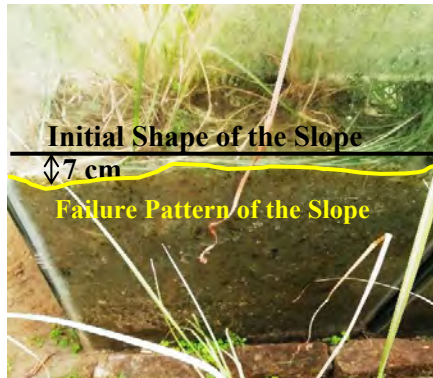
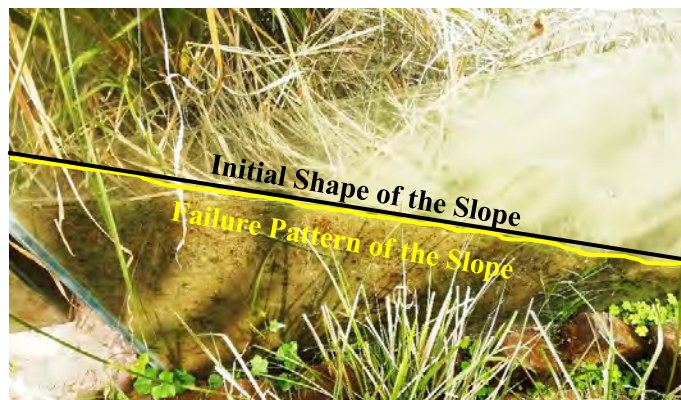
Figure 4.21: Photographs of Slope Deviation due to Wave Action of: (a) BM; (b) VM; (c) VFM; and (d) VFGM

Figure 4.21 shows the slope breaking pattern for the four models. The failure pattern was different for the four models which show how the top soil movement occurred due to wave action. Though the top soil erosion occurred for the four models, the slopes were more intact with more protection along with the depth of soil.

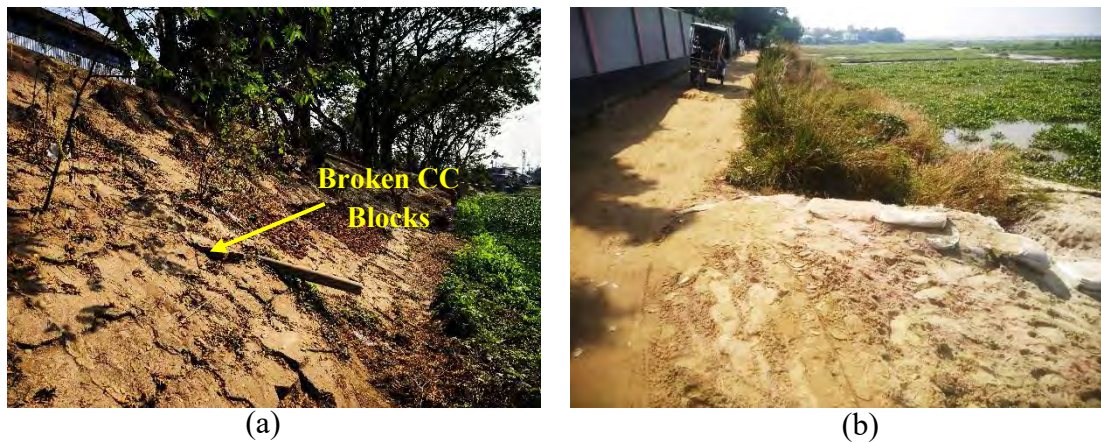
Figure 4.24: Photographs of Protection Type III; (a) Kalikaccha, Sarail, Brahmanbaria; and (b) Modhupur, Ashuganj, Brahmanbaria

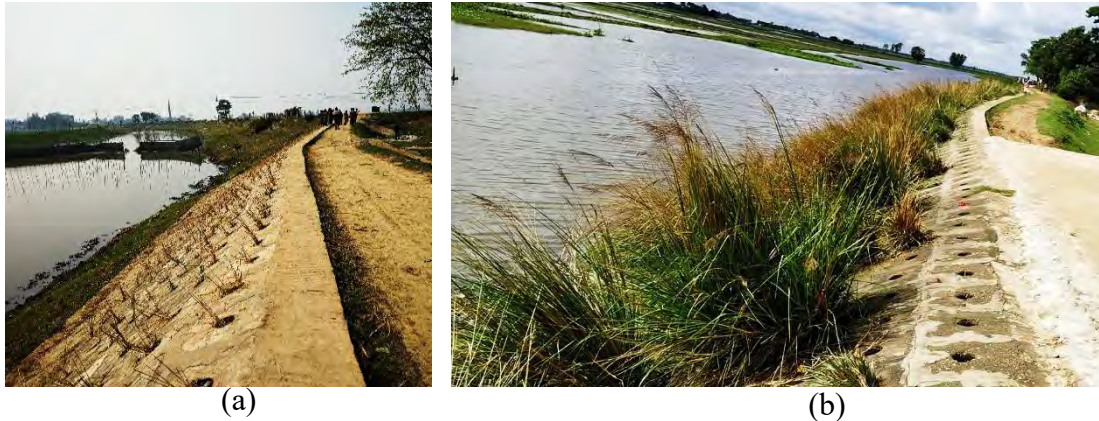
Figure 4.25: Photographs of Protection Type III at Vatipara, Baniachong, Habiganj; (a) 20 Days after Plantation (26th January 2019); and (b) After Facing One Flood (11th November 2019)
