PERFORMANCE OF ECOLOGICAL REVETMENT IN HAOR AREAS OF BANGLADESH

DEPARTMENT OF CIVIL ENGINEERING
BANGLADESH UNIVERSITY OF ENGINEERING AND TECHNOLOGY
Dhaka, Bangladesh

A Thesis Submitted to the Department of Civil Engineering in
Partial Fulfillment of the Requirements for the Degree of
Master of Science in Civil and Geotechnical Engineering

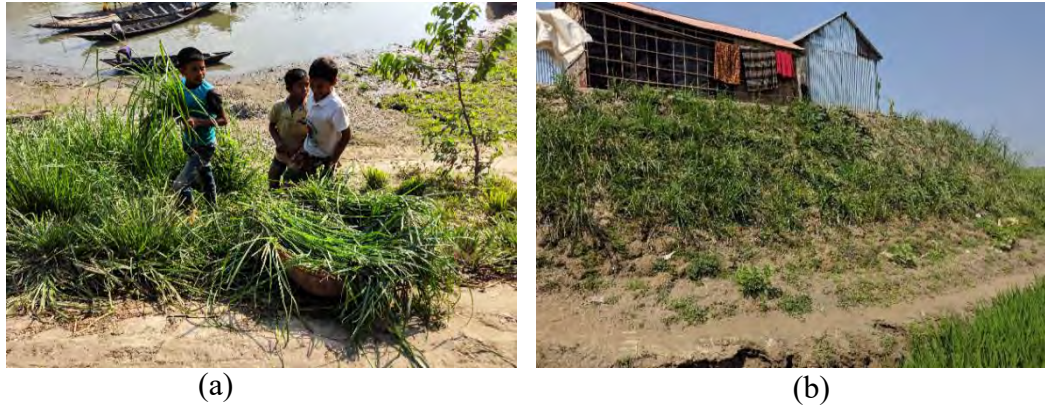
Figure 4.27: (a) Trimmed Vetiver Selling for Fuel and Fodder; (b) Slope Protection with Vetiver by Villagers in Kamalpur, Nikli, Kishoreganj

Figure 4.27(a) shows the different socio-economic aspects of vetiver tillers. This magical vegetation not only provides environmental friendly, cost effective and a compatible solution for slope protection, but also supports the locality economically by selling trimmed vetiver shoots as fuel or fodder. Figure 4.27(b) shows a village island of Kishoreganj, which is surrounded by the *Singua* River, where the villagers planted vetiver tillers to protect the homestead lands by their own, and also developed a nursery in their house premises. This village survived from three monsoon period, facing water fluctuation, submergence and high wave action (wave height of 3 m).

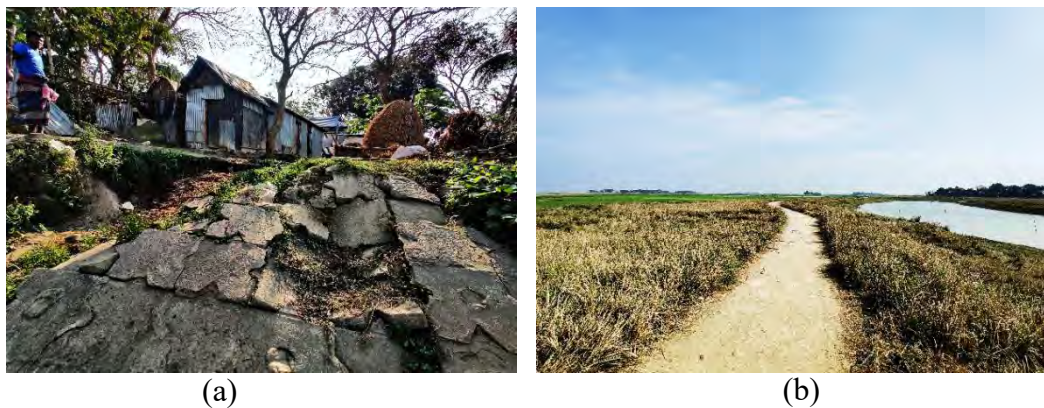
Figure 4.28: Site Condition of Hayatpur, Khaliajuri, Netrokona; (a) Slope Condition of the Village Island; (b) Well Condition of the Vetiver Source

Figure 4.28(a) presents a village island protection work in Hayatpur, Khaliajuri, Netrokona, where the block holes were sealed off by mortar instead of planting vetiver. The slope surface was filled by sandy soil, and the slope failed by loosening blocks easily as there was no interaction within the protection system and the soil. This site faced three monsoons, whereas a vetiver source was found at the same village which also faced three monsoon periods with the similar climatic conditions. The vetiver source is surrounded by the *Surma* River, which becomes fully submerged during flood, and wave action is also prominent here. The growth of the tillers are found well, so the road condition is also good as shown as Figure 4.28(b). So, raising more social awareness about ecological revetment system is requisite.

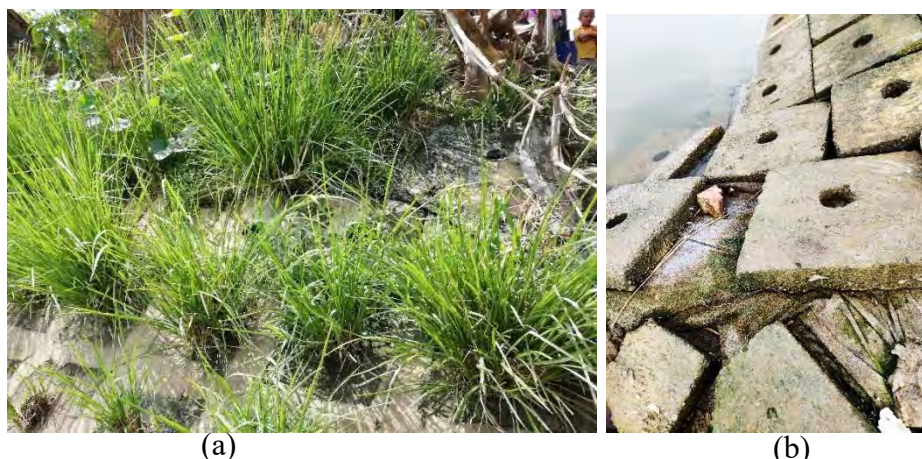
Figure 4.29: Photographs of Protection Type III; (a) Meghna Natunpara, Derai, Sunamganj; and (b) Kachua, Derai, Sunamganj

Figure 4.29(a) shows the slope condition of Meghna Natunpara village island, Derai, Sunamganj. This village island survived from two monsoons, where inundation occurred up to 1.8 m height from the toe of the slope, and wave action occurs from south-east direction during monsoon. Nevertheless, the growth of vetiver tillers and the slope condition is excellent, and slope failure did not happen, as vetiver tillers were planted and the slope was maintained properly. Figure 4.29(b) shows the Kachua village island condition of the same Upazila and district, which is situated beside the *Dahuk* River. At this site, flood occurred just after placing CC hollow blocks in April 2019, before plantation of tillers in this village slope. Consequently, blocks got unattached to soil due to no plantation of tillers. In this type of cases, it would be better to plant only vetiver without CC blocks, so at least the soil would be prevented from washing away and erosion could be minimized.

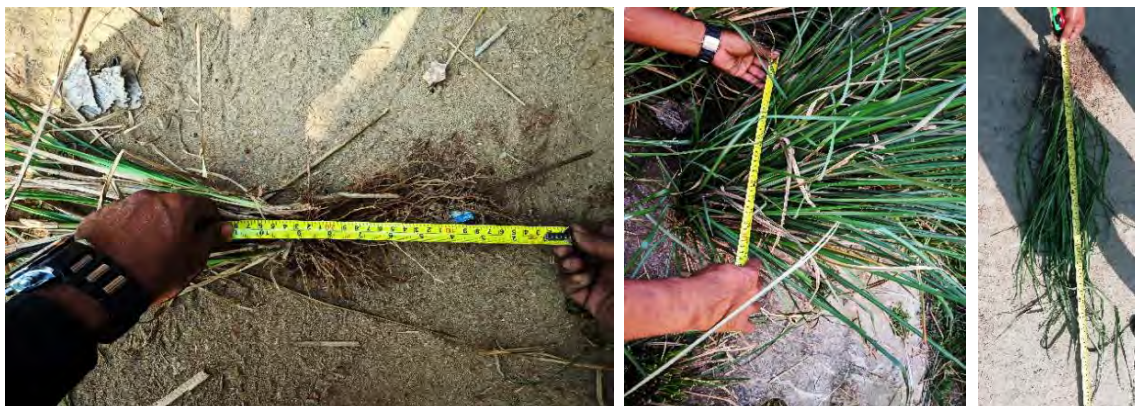
Figure 4.30: Measurement of Vetiver Grass at *Haor* Districts

By observing survival of the grasses, condition of slope and determining shoot and root length of the tillers, growth of vetiver tillers is found excellent in all districts. Figure 4.30 shows vetiver measurements in *haor* districts, and Figure 4.31 presents the growth data of vetiver tillers in Brahmanbaria.

In Brahmanbaria, the range of maximum of shoot length of vetiver was found as 122-178 cm after 4 years, and 66-168 cm after 2-3 years. The tillers could not be uprooted properly, so actual measurement of root was not possible. The maximum root length possible to uproot was found 36 cm.
