**EXPERIMENTAL STUDY ON THE EFFECT OF LINTEL
ON INFILLED FRAMES UNDER CYCLIC LOADING**

MASTER OF SCIENCE IN CIVIL ENGINEERING (STRUCTURAL)

DEPARTMENT OF CIVIL ENGINEERING
BANGLADESH UNIVERSITY OF ENGINEERING AND TECHNOLOGY
Dhaka, Bangladesh

July, 2022

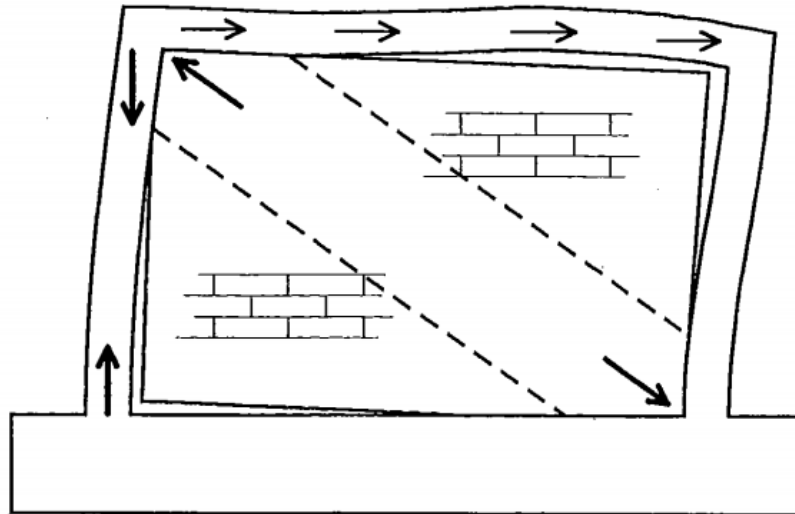
Figure 2.1: Equivalent truss mechanisms for infill frame (Polyakov, 1960).

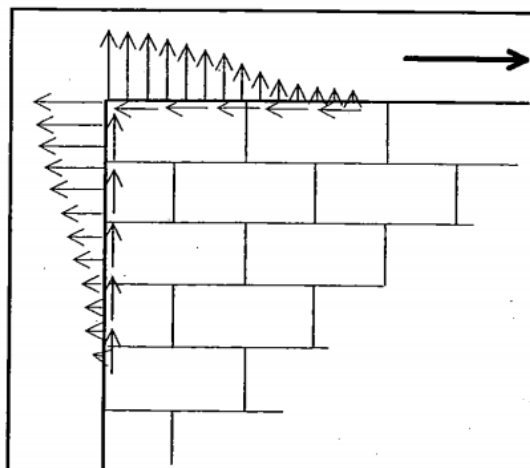
Leuchars (1973) showed nonlinear normal stress distribution along the contact point of infill and frame relying on the loading condition as presented in Figure 2.2. He also demonstrated that the shear stress generated between the infill and frame is proportional to the normal stress.

Figure 2.2: Normal and shear stresses acting in the infilled frame (Leuchars, 1973).

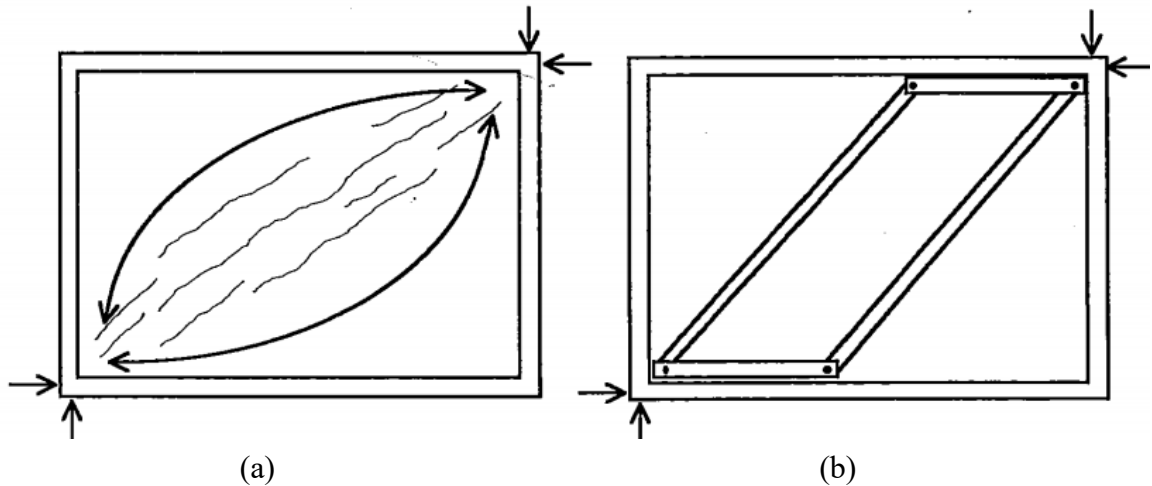
Smolira (1974) developed a qualitative model comprised of flexible frames and bricks without any other mortar or binder. In his experiment, he showed a double arching effect occurred in the panel as presented in Fig 2.3 (a) when the infilled frame is subjected to high lateral excitement. Again, Mainstone (1971) presented a similar type of experiment which dealt with the formation of two pinned diagonals as shown in Fig 2.3 (b) under high lateral load.

Figure 2.3: (a) Double arching effect (Smolira, 1974), (b) Proposed equivalent method (Mainstone, 1971).

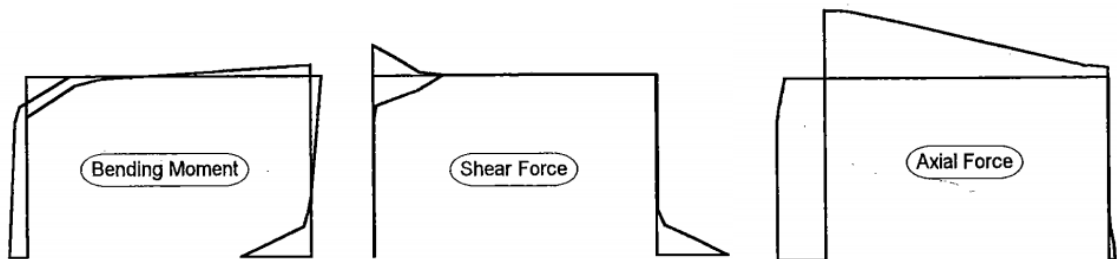
Dhanasekar et al. (1985), illustrated typical bending moment, shear force and axial force after segregation occurs where the lateral load was applied along the top beam which was totally free from any sort of vertical loading. And the resulting formations are shown in Figure 2.4. And the bending moment was found much smaller in comparison to the bare frame.

Figure 2.4: Bending moment, Shear force, and axial force diagram for a typical infilled frame (Dhanasekar et al., 1985).

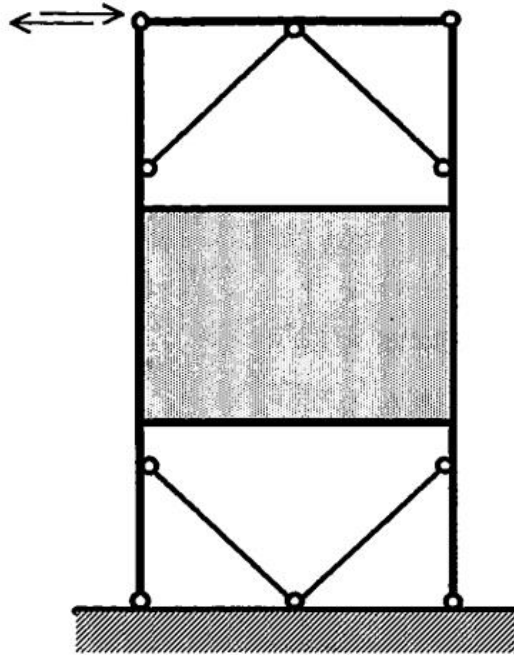
Mander et al. (1993) developed multi-storied infilled steel frames with semi-rigid beam-column connections. The full arrangement has been demonstrated in Figure 2.6. They observed and disclosed that in this case, the diagonal strut connecting two opposite corners is not sufficient to resist heavy lateral forces. Therefore, they introduced a secondary strut mechanism.

Figure 2.6: Testing device used by Mander et al. (1993).

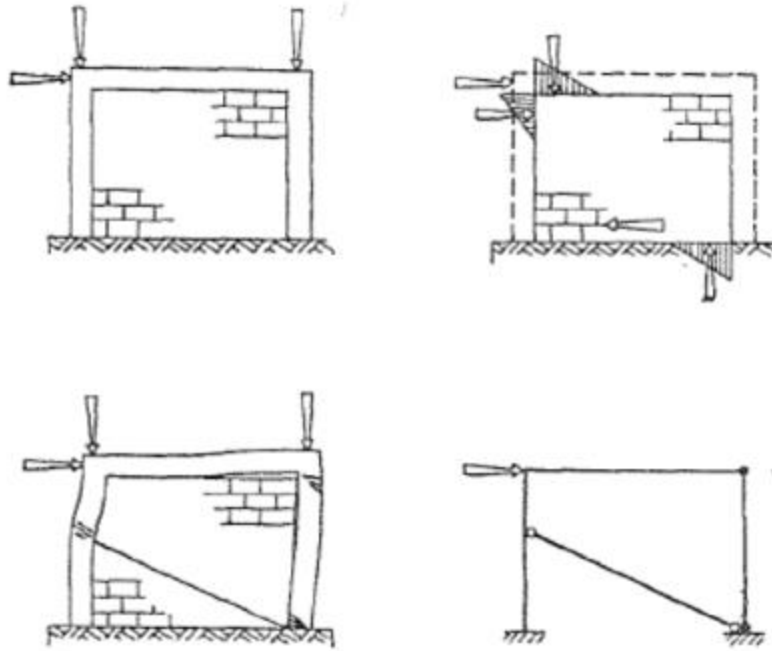
Tomazevic (1999) showed that an infilled frame operates as a monolithic load-resisting system at low lateral loads. Nevertheless, the crack is visible when there is an increment of loading. Moreover, the infill has a tendency to partially separate from the bounding frame as the load increases. This phenomenon is responsible for the formation of the compression strut mechanism. It may or may not develop into the principal load mechanism of the structure, contingent on the strength and stiffness characteristics of the infill relative to those of the frame. The behavior of this type of model is shown in Figure 2.7.

Figure 2.7: Modeling of seismic behavior before and after detachment of masonry infill (Tomazevic, 1999).

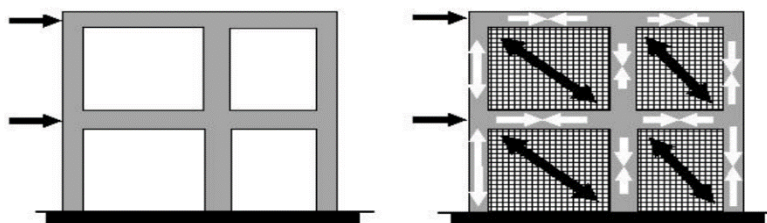
Murty and Jain (2000) stated that infills generate interference with the lateral deformations of the RC frame, which results in the segregation of the frame and the infill along one diagonal and the creation of a compression strut along the other diagonal. Therefore, infills contribute to the building's lateral rigidity. The frame action is replaced with a major truss action as the structural load transfer mechanism. As a result of this change, the frame columns are subjected to heavy axial forces, but they are also subjected to diminished bending moments and shear forces. The phenomenon is presented in Figure 2.8.

Figure 2.8: Change in the lateral load transfer mechanism owing to the inclusion of masonry infill walls (Murty and Jain, 2000).

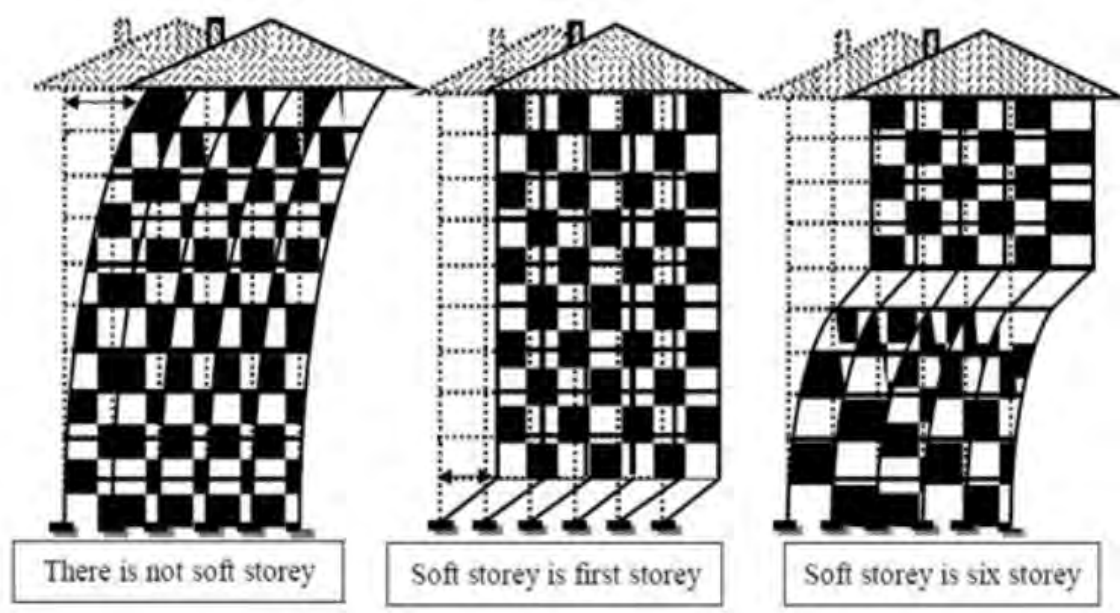
Soft-story refers to a level of a building that is much less rigid or resistant to lateral loads than the stories above it and the floors or foundation below it. According to BNBC (1993) and UBC (1997), a soft story is one with lateral stiffness that is less than 70 percent of the preceding story or less than 80 percent of the average stiffness of the three preceding stories. For buildings with an open ground floor, the presence of walls in upper stories makes them substantially stiffer than the ground story. Thus, the majority of the building's horizontal displacement arises in the soft ground story. Hence, during earthquake trembling, such buildings move backwards and forwards and the columns in the open ground story are heavily affected. If the columns are not adequately designed to resist this incident, then significant damage or major collapse can ensue. Because of their substantial commencing stiffness, the associated contribution of different modes in infilled RC framed structures relies on the quantity and position of infills in the frame. Shailendra and Babulal (2015) illustrated this behavior which is presented in Figure 2.9.

Figure 2.9: Behavior of soft-story in the earthquake (Shailendra and Babulal, 2015).

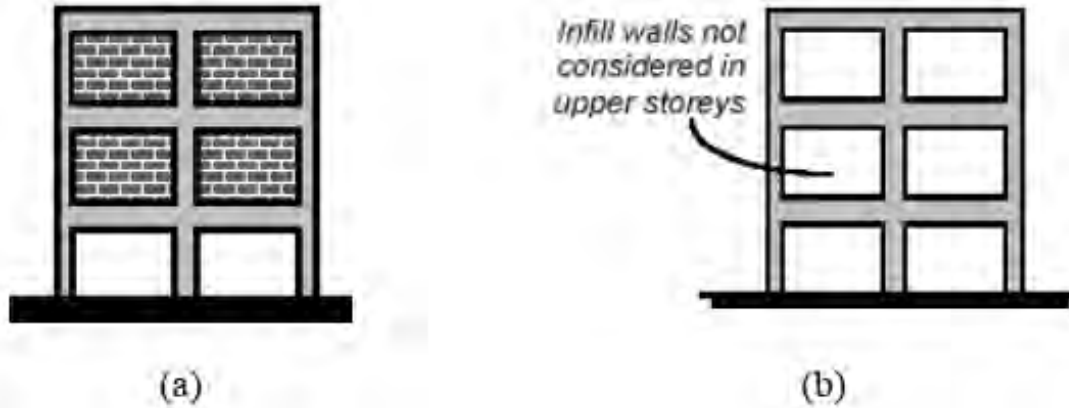
However, to avoid this type of damage, only bare frames are considered in modern design provisions. The effect of the infills is overlooked in these provisions as shown in Figure 2.10.

Figure 2.10: Buildings with open ground story (a) actual building (b) building being assumed in current design practice (Zerin, 2018).

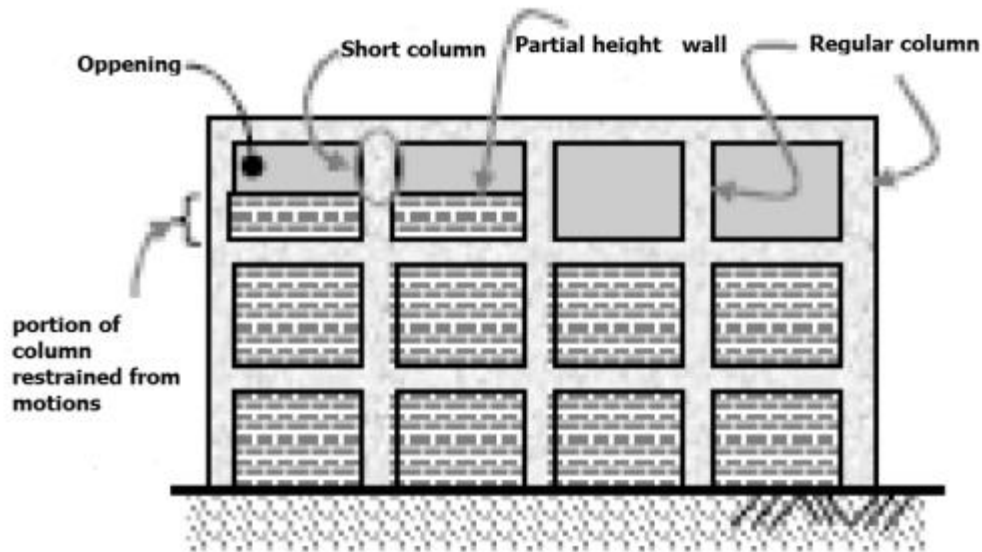
Generally, a short column is stiffer than a tall column and comparatively a short column attracts more earthquake force. For this consequence, if a short column is not designed to resist such a heavy load, it will be undergone significant damage. The overall phenomenon is called as ‘short column effect’. According to Yadollahi et al. (2016), the short column effect mostly occurs when a partial-height wall is constructed to fit a window over the remaining height. During an earthquake, the floor slab and columns move horizontally. The stiff walls prevent the horizontal movement of a short column's lower portion and deform fully across its short height near the window opening. Regular columns distort along with their height. Since a short column's effective bending height is modest, it resists horizontal motion and attracts a bigger force than a conventional column. The incident is presented in Figure 2.11. They also explained some other reasons for the short column effect. It can also occur when a structure stands on the sloping ground containing columns of different heights. Additionally, this effect may be found in columns that endorse mezzanine floors or loft slabs that are attached in between two regular floors.

Figure 2.11: Formation of Short columns due to partial height of brick masonry infill wall (Yadollahi et al., 2016)

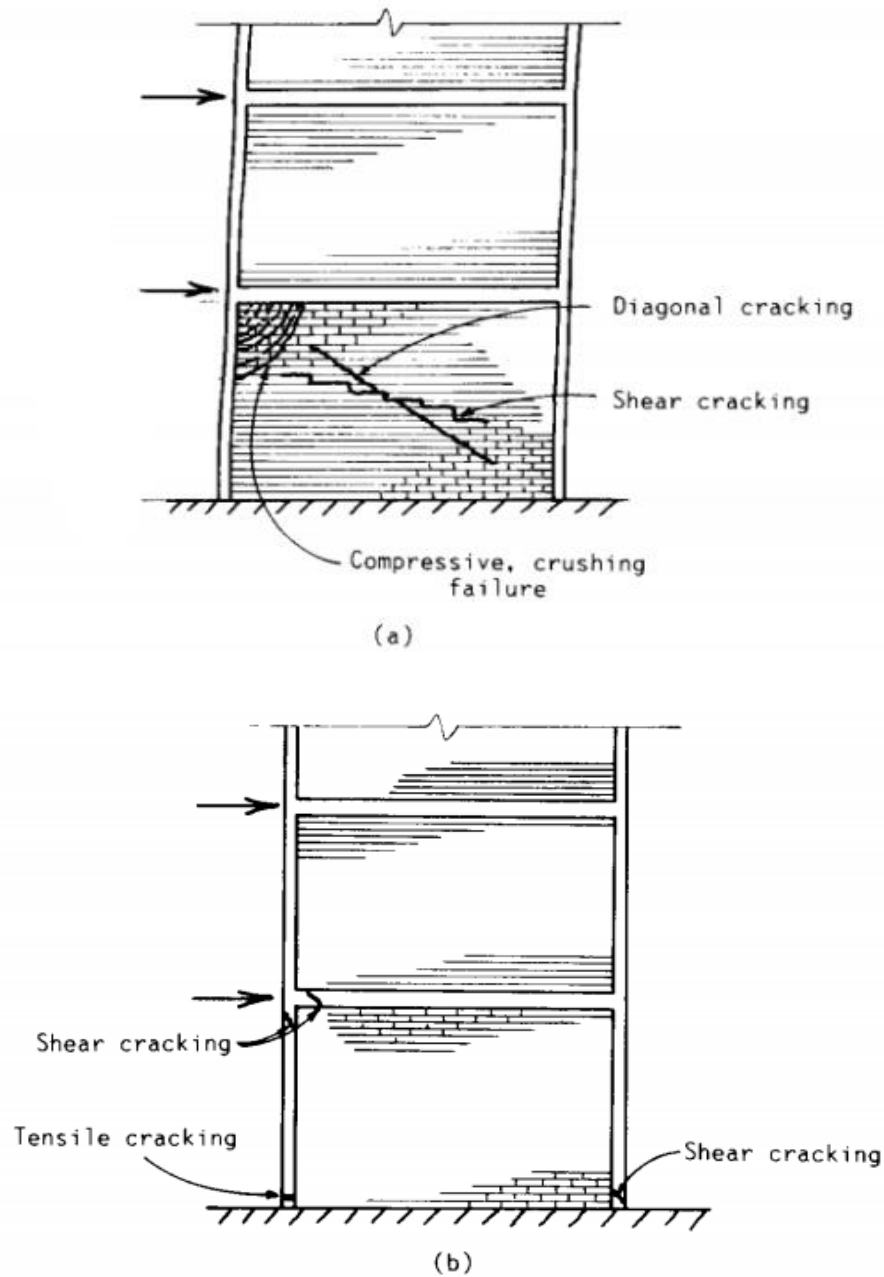
Smith and Coull (1991) showed different failure modes for both wall and frame individually. For the wall, they illustrated three types of failure (shear failure, diagonal cracking failure, and corner crushing failure) as shown in Figure 2.12(a). Firstly, shear failure descends through the masonry bond and is triggered by horizontal shear forces in the bed joint. Secondly, diagonal cracking failure is caused by the tensile stresses perpendicular to the leading diagonal and it creates along the leading diagonal of the wall. Thirdly, corner crushing failure occurs when there is the formation of high compressive stresses in corners. For the frame, they presented two types of failure (shear failure and tensile failure) as shown in Figure 2.12(b). When a frame is subjected to lateral cyclic excitation, the beam-column joint tends to fail in shear whereas the column receiving the excitation first tends to fail in tension at the base.

Figure 2.12: (a) Mode of infill failures (b) mode of frame failures (Smith and Coull, 1991).

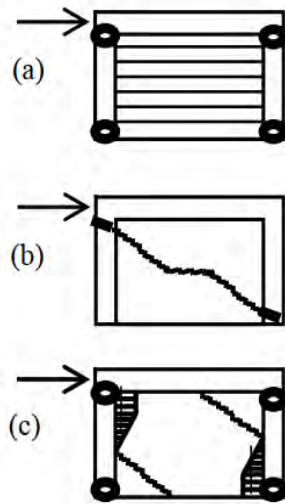
Mehrabi et al. (1994) observed three major types of failure mechanisms (horizontal sliding failure, diagonal cracking failure, and panel crushing failure) as shown in Figure 2.13. Firstly, the sliding of the masonry bed joints throughout the height of the wall typically exhibited a somewhat ductile behavior in frames with weak infill panels, which was dominant. This could occasionally result in masonry crushing at the compression corners and flexural yielding or shear cracks in the concrete columns. The whole phenomenon is termed a horizontal sliding failure. Secondly, a shear failure of the adjacent column was caused by a diagonal crack that started in the infill near the top windward corner. In non-ductile frames with robust infills, this procedure took place. Such brittle behavior was linked to a sharp decline in the loading carrying capacity. Thirdly, the panel crushing failure befalls when both the frame and the infill are adequately strong.

Figure 2.13: Failure mechanisms of infilled frames (Mehrabi et al., 1994).

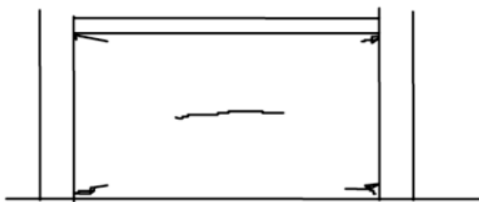
Crushing of mortar around perimeter of frame. This is particularly noticeable adjacent to the columns near the corners of the infill panels.

Figure 2.14: Typical degree of damage for bed joint sliding (FEMA 306, 1998).

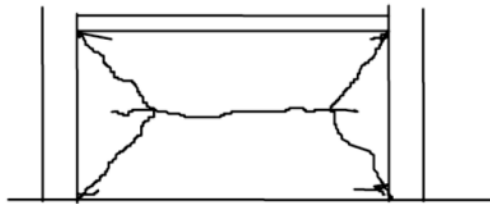
Crushing of mortar and cracking of bricks extend over larger zones adjacent to beam and column

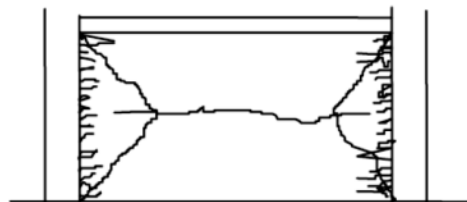
Significant crushing of mortar and bricks extends around most of the perimeter frame, particularly along the height of the column.

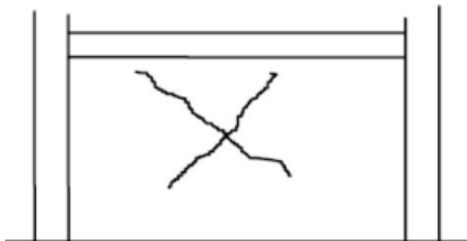
Initial hairline cracking occur on diagonals in masonry. This is mostly associated with breaking of the bond between mortar and bricks. Cracking mostly concentrated within center region of panel

Figure 2.16: Typical degree of damage for diagonal tension cracking (FEMA 306, 1998).

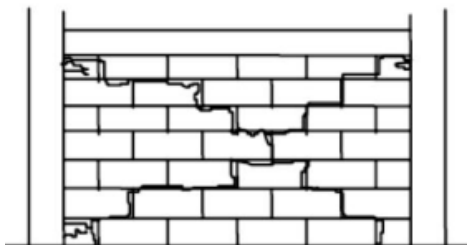
Hairline cracks fully extend along diagonals following the mortar courses in a stairstep fashion, but sometimes propagate through bricks. Some crushing and/or "walking-out" of the mortar may be observed. Cracks mostly closed due to confinement provided by frames.

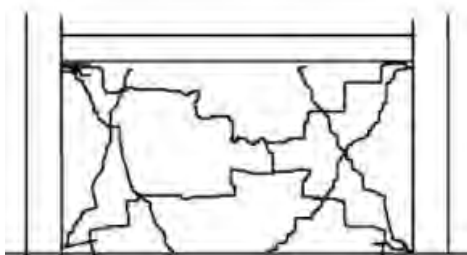
Cracks widen to about 1/8", and are usually associated with corner crushing. Much loss of mortar is evident. More than one diagonal crack is generally evident. Crushing/cracking of the bricks is also evident. Portions of the entire infill may "walk" out-of-plane under cyclic loading.

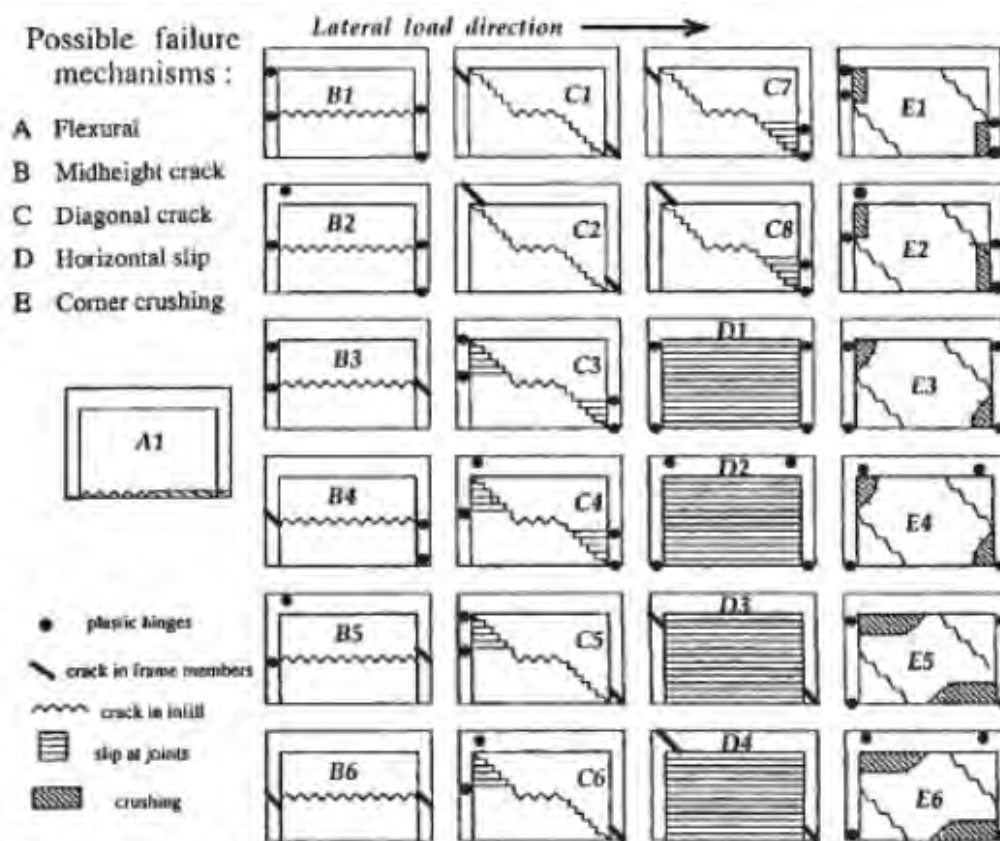
According to Alam (2014), the probable modes of the collapse of masonry-infilled frame structures result from the interplay between the infill walls and the frame. He mentioned several failure patterns such as tension failure of tensioning column due to overturning moments, flexure or shear failure of the columns, compression failure of the diagonal strut, diagonal tension cracking of the panel, and sliding shear failure of the masonry along horizontal mortar beds.

Figure 2.18: Collapse mechanism of solid infill masonry with reinforced concrete frame (Shing and Mehrabi, 2002)

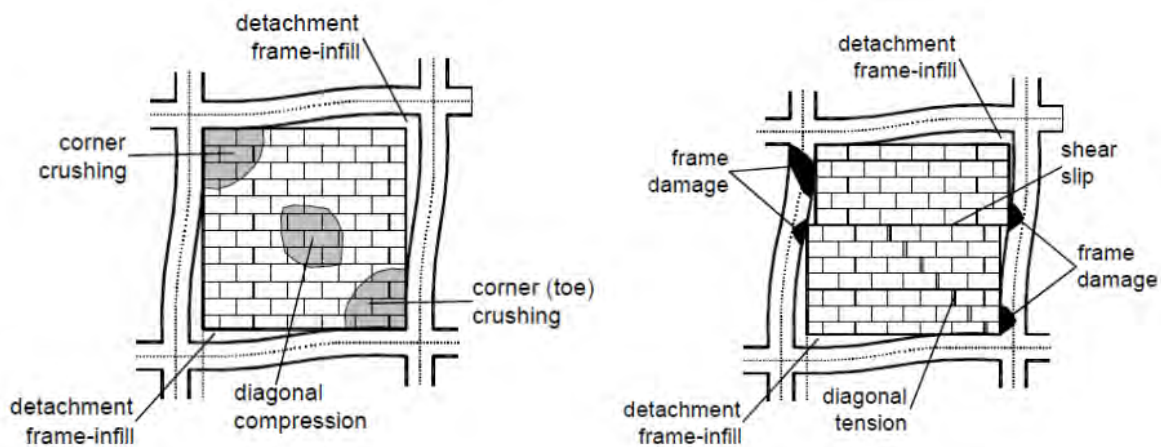
According to Asteris et al. (2011), the failure of the infilled frame occurs as a confluence of the distinctive modes. Those individual modes described by him are presented in Figure 2.19. An experimental project was conducted to determine the relationship between the fracture pattern, the decrease in infill strength, and the extent and placement of the openings by him. Later, he identified various patterns and failure modes associated with very particular types of apertures and discovered a very sophisticated behavior that was distinct from the strut model.

Figure 2.19: Modes of failure of infilled frames (Asteris et al., 2011)

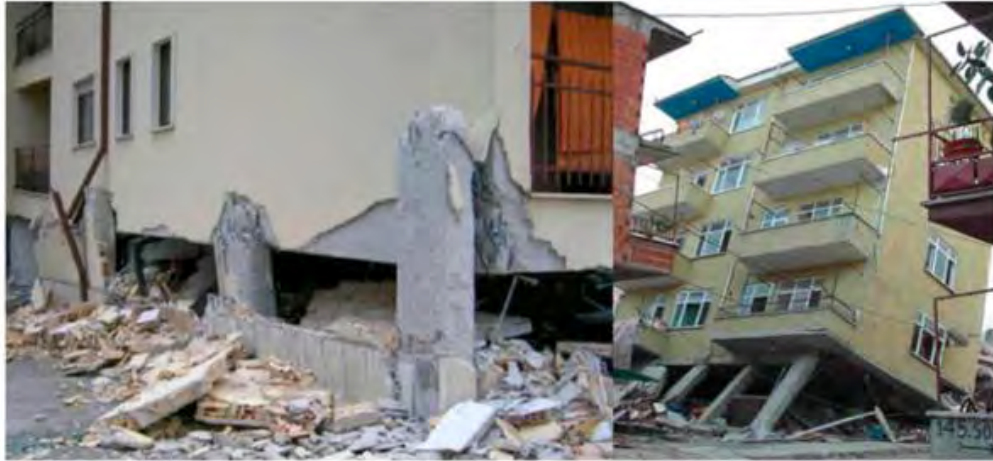
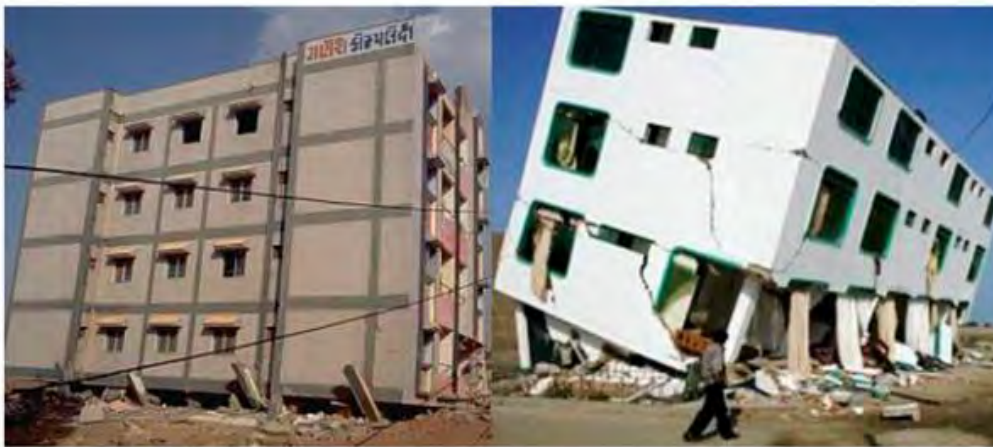
Figure 2.20: Samples of collapses occurred for irregular distribution of infills over the height (Trapani et al., 2015).

Several real-life photos of different failure modes of masonry infilled RC frame structures under cyclic loading are presented in figure 2.20, Figure 2.21, Figure 2.22, and Figure 2.23.

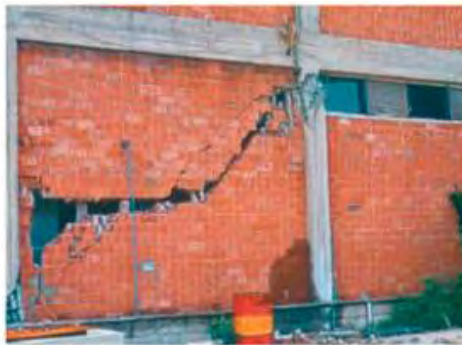
Figure 2.21: Frame-infill interaction effects: local collapse due to the different infill–column height: (a) short column double plastic hinge mechanism; (b) short column shear failure (Trapani et al., 2015).

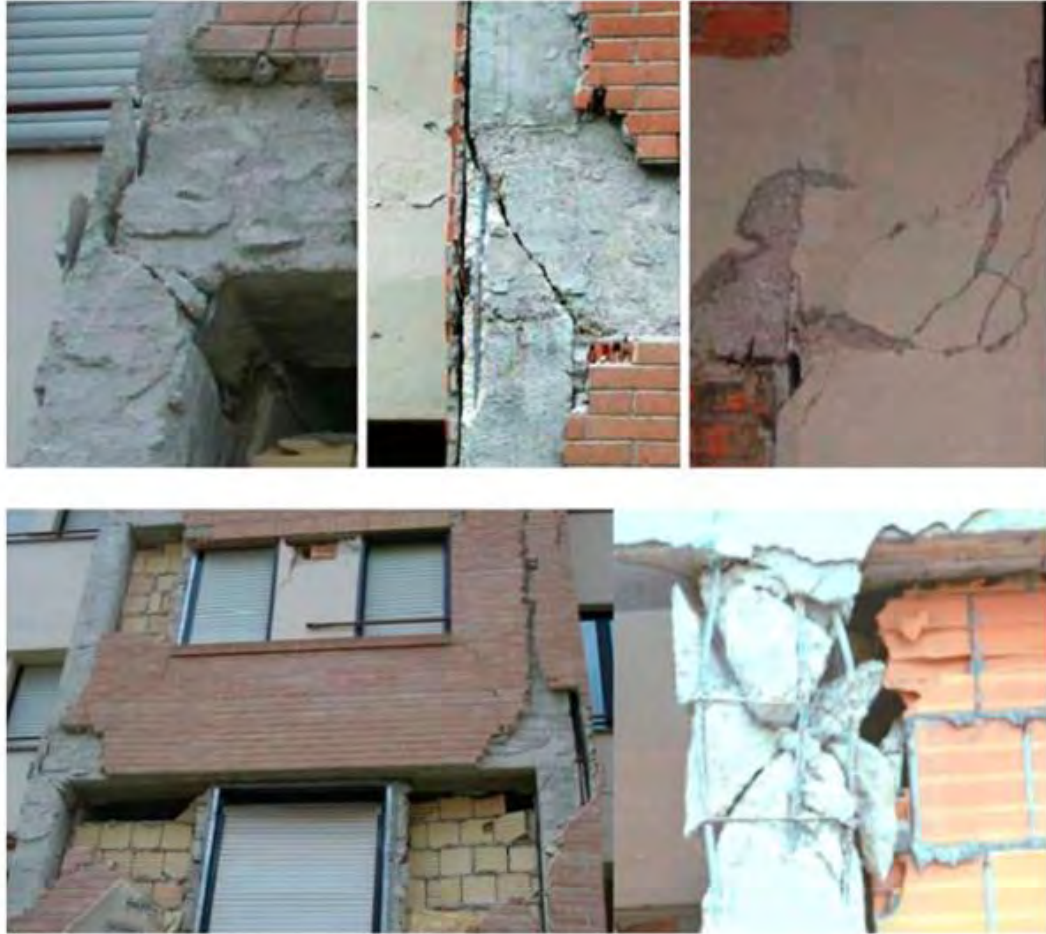
Figure 2.22: Effects of local infill–frame interaction: Sample of the local shear collapse of column ends and joints due to the interaction with the infills (Trapani et al., 2015).

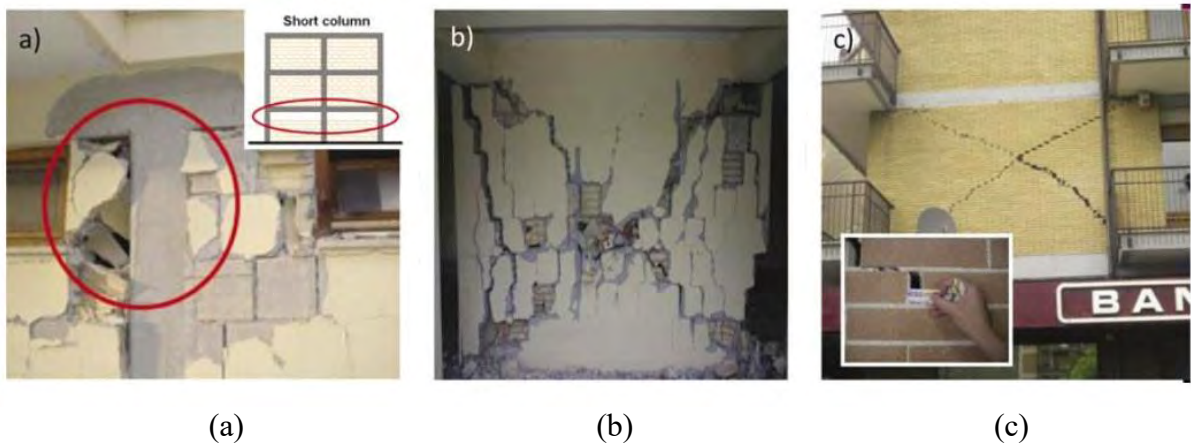
Figure 2.23: (a) Corner crushing of the infill; (b) in-plane cracking and crushing of masonry wall (c) horizontal bed joint sliding (Vicente et al., 2012).

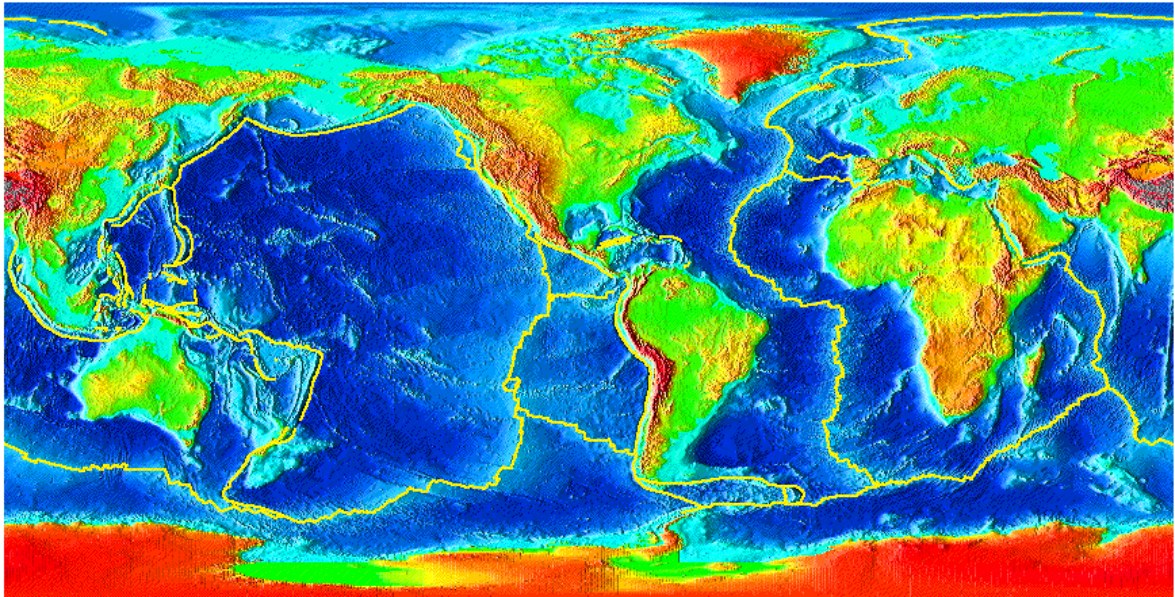
Figure 2.24: Crustal plate boundaries (burro.case.edu., 2002).

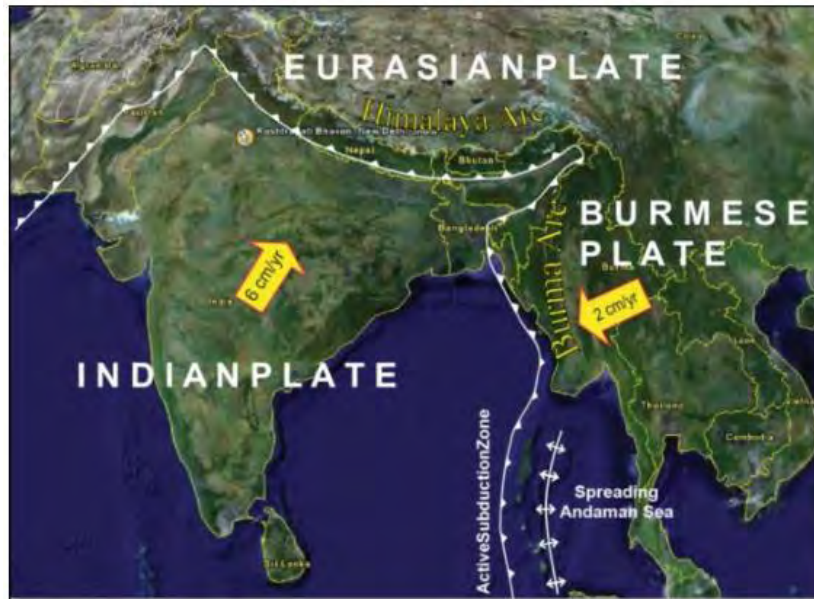
Bangladesh and the surrounding area (Ansary and Arefin, 2020). The tectonic setup of Bangladesh is presented in Figure 2.25.

Figure 2.25: Tectonic setup of Bangladesh and plate boundaries (Akhter, 2010).

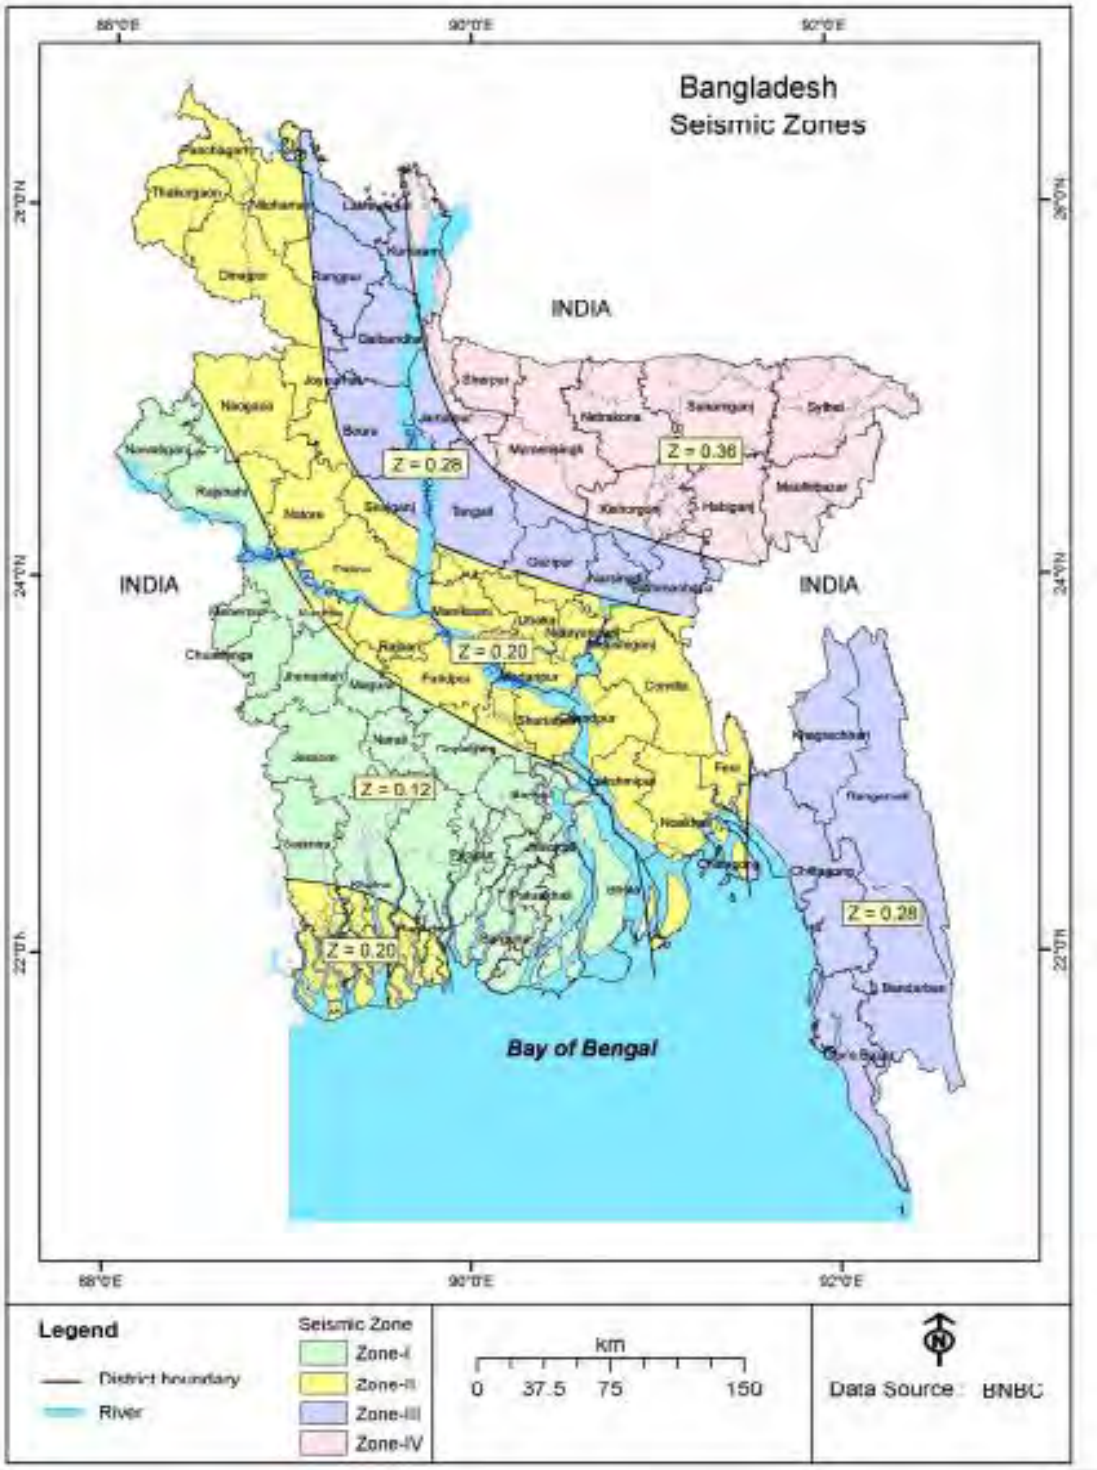
Figure 2.26: Seismic zoning map of Bangladesh (BNBC, 2020).

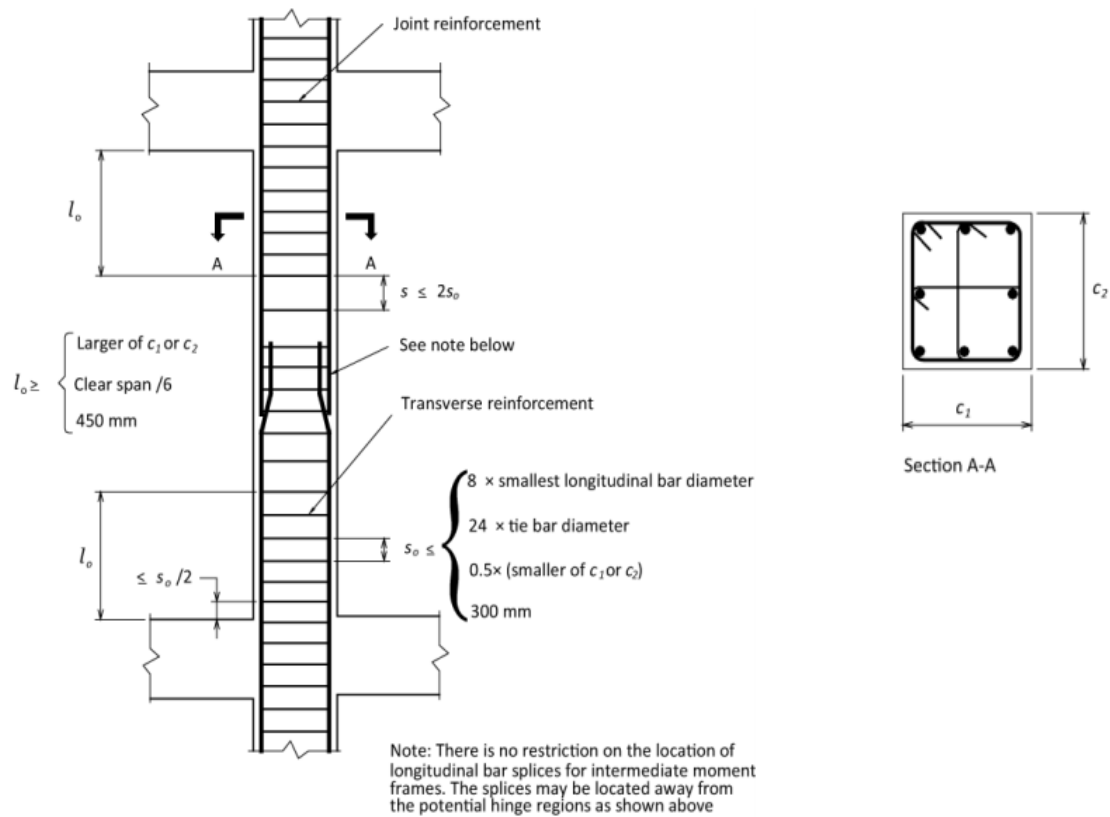
- I. Maximum tie spacing shall not exceed s_0 over a length l_0 measured from the joint face. The spacing s_0 shall not exceed (i) 8 times the diameter of the smallest longitudinal bar enclosed, (ii) 24 times the diameter of the tie bar, (iii) one-half of the smallest cross-sectional dimension of the frame member, and (iv) 300 mm. The length l_0 shall not be less than (i) one-sixth of the clear span of the member, (ii) maximum cross sectional dimension of the member, and (iii) 450 mm (Figure 2.32)
- II. The first tie shall be located not more than $s_0/2$ from the joint face.
- III. Joint reinforcement shall conform to Sec 6.4.9.
- IV. Tie spacing shall not exceed $2s_0$ throughout the length of the member.

Figure 2.32: Transverse reinforcement requirements for columns (IMF) (BNBC, 2020).

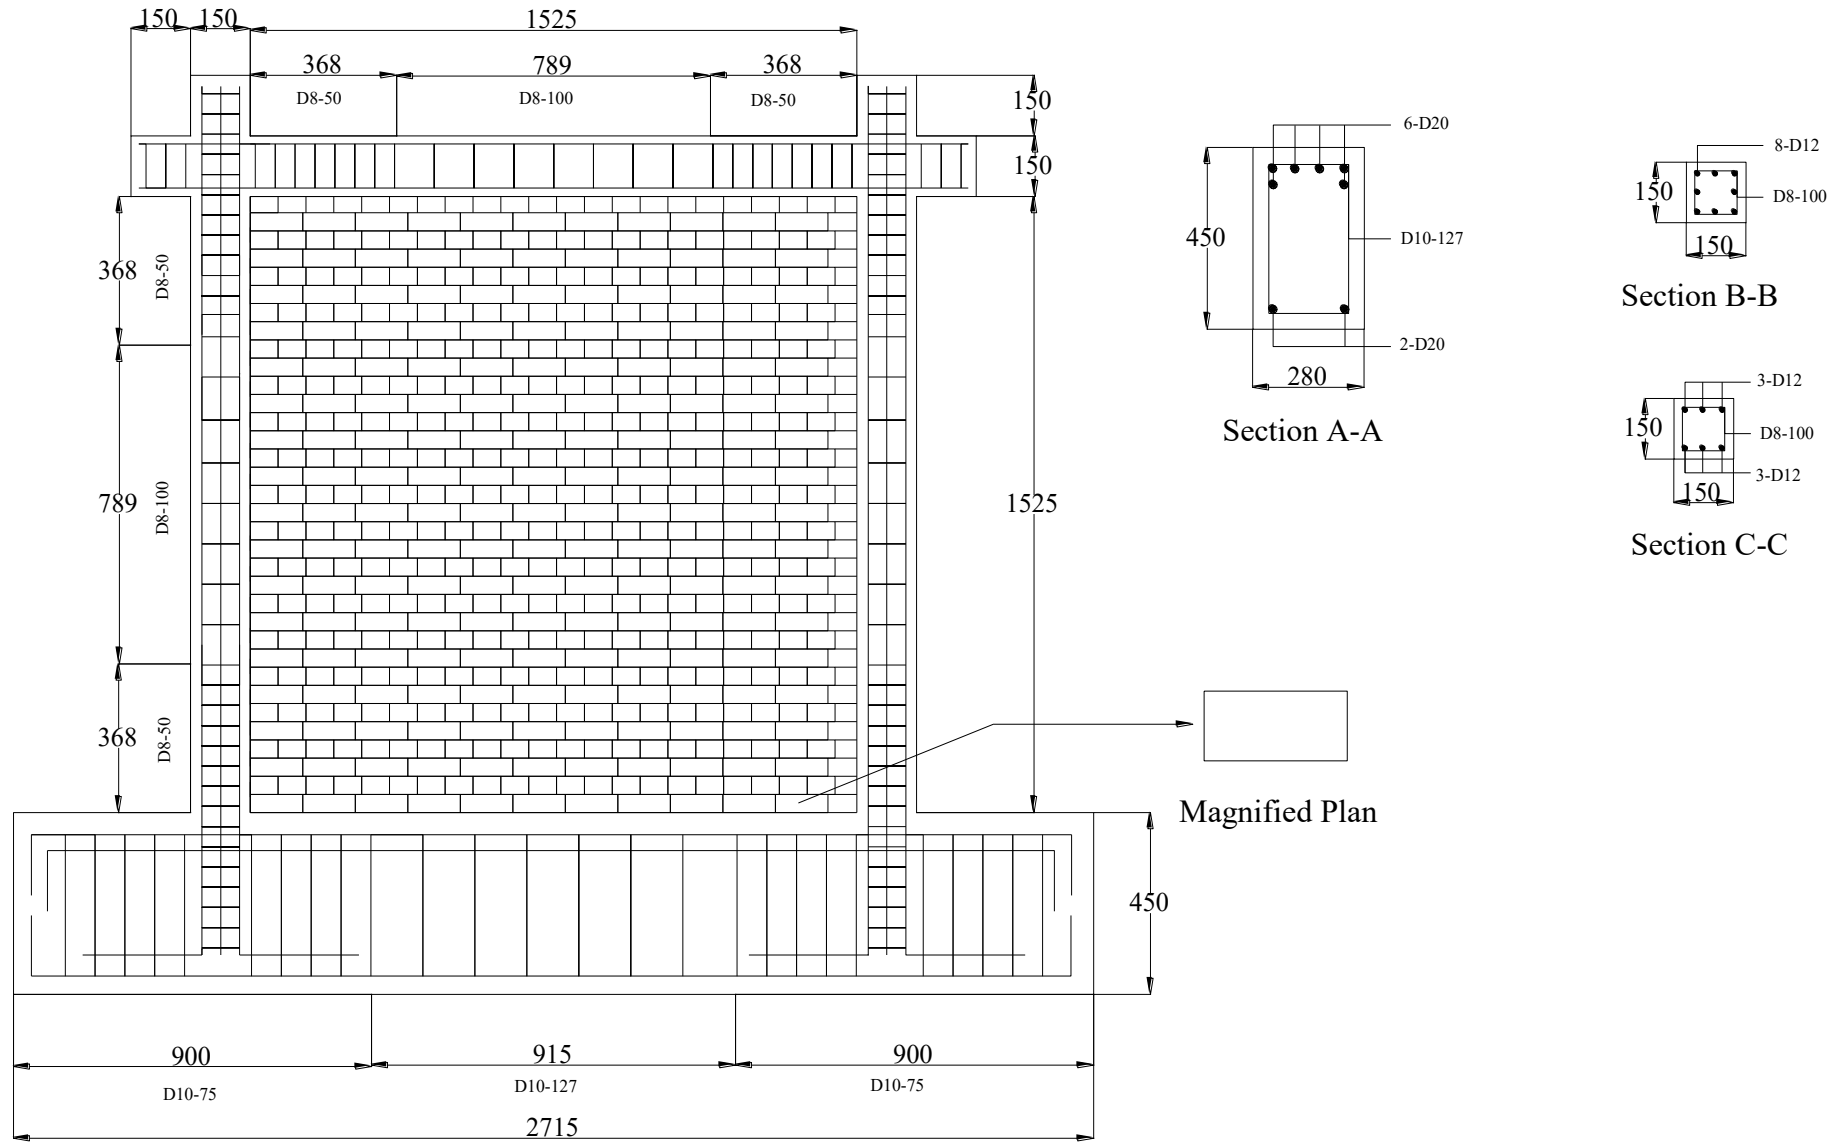
Figure 3.5: Schematic drawing of SB (Every unit is in mm) [Note: Section A-A, B-B and C-C are the midsection of base, column and beam respectively].

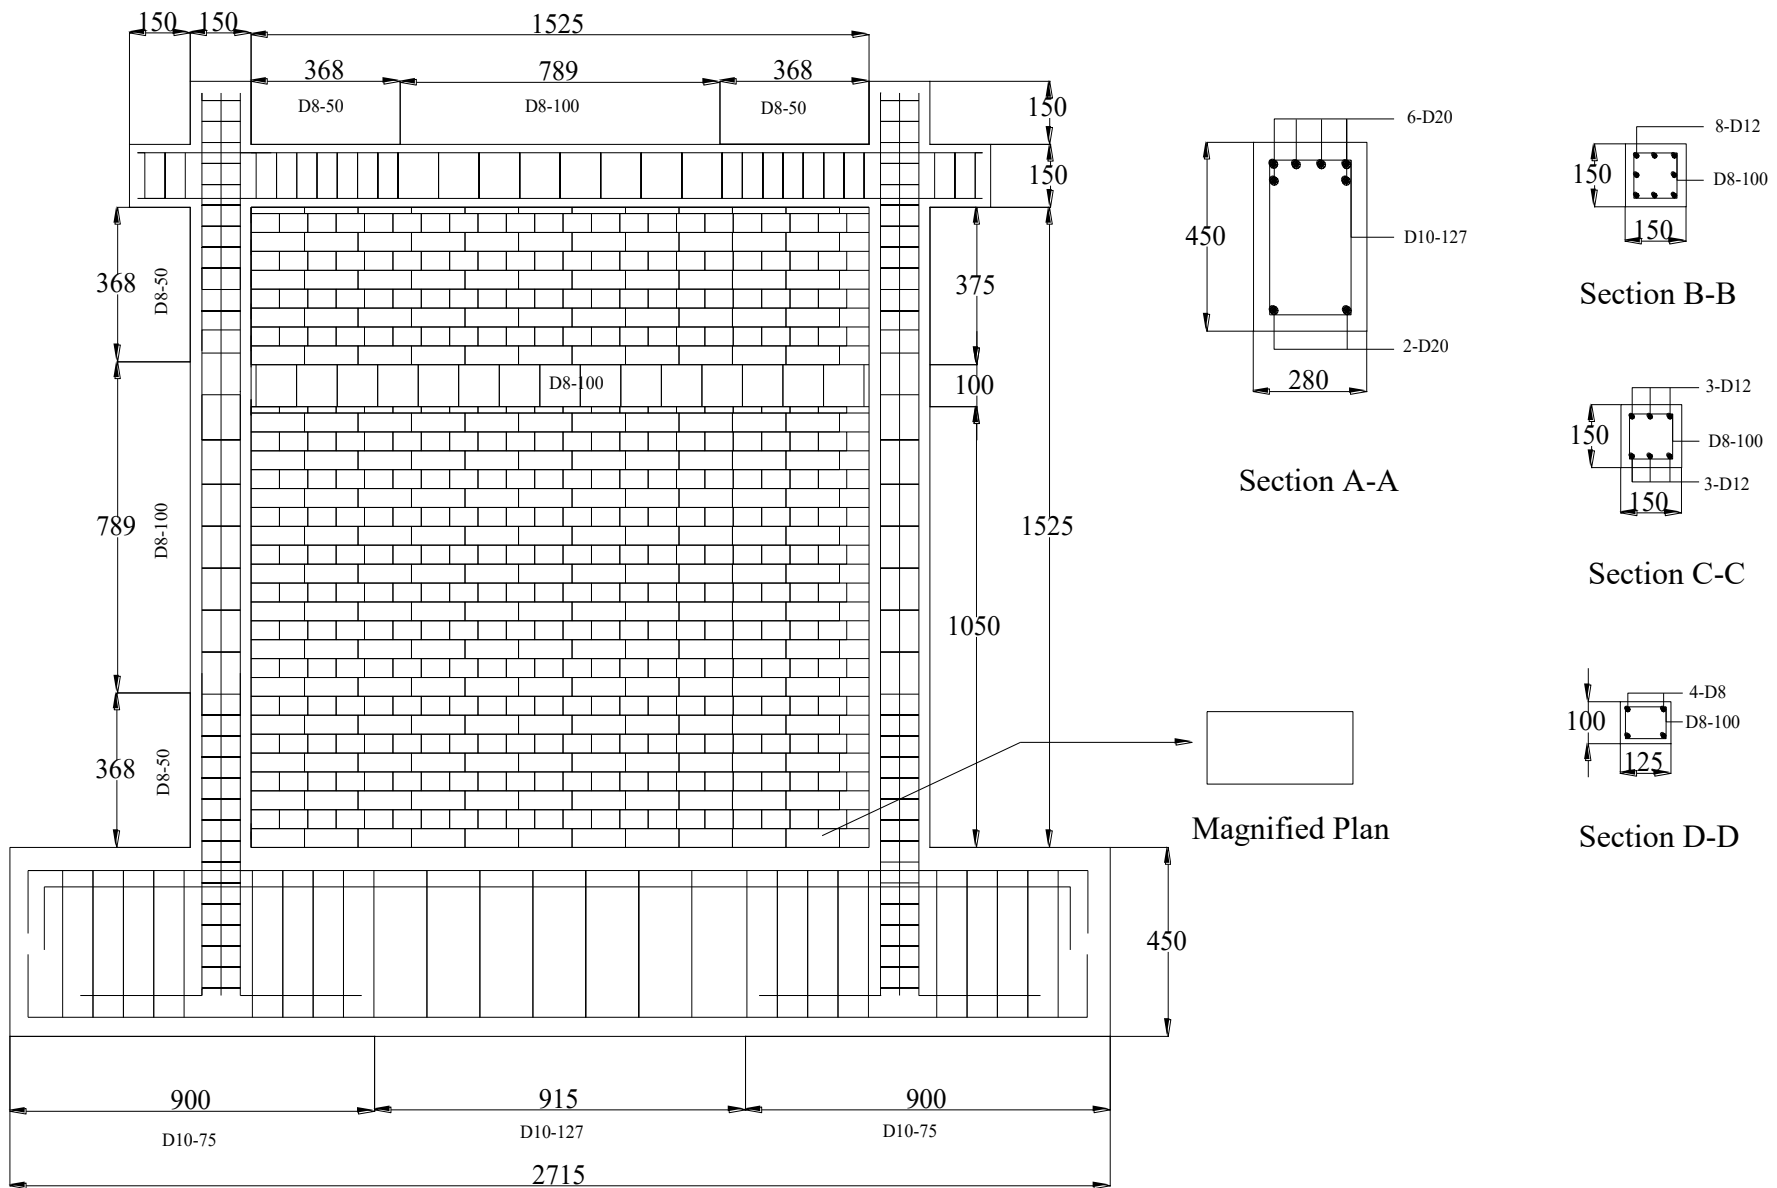
Figure 3.6: Schematic drawing of SBL (Every unit is in mm) [Note: Section A-A, B-B, C-C and D-D are the midsection of base, column, beam and lintel respectively].
