**EXPERIMENTAL STUDY ON THE EFFECT OF LINTEL
ON INFILLED FRAMES UNDER CYCLIC LOADING**

MASTER OF SCIENCE IN CIVIL ENGINEERING (STRUCTURAL)

DEPARTMENT OF CIVIL ENGINEERING
BANGLADESH UNIVERSITY OF ENGINEERING AND TECHNOLOGY
Dhaka, Bangladesh

July, 2022

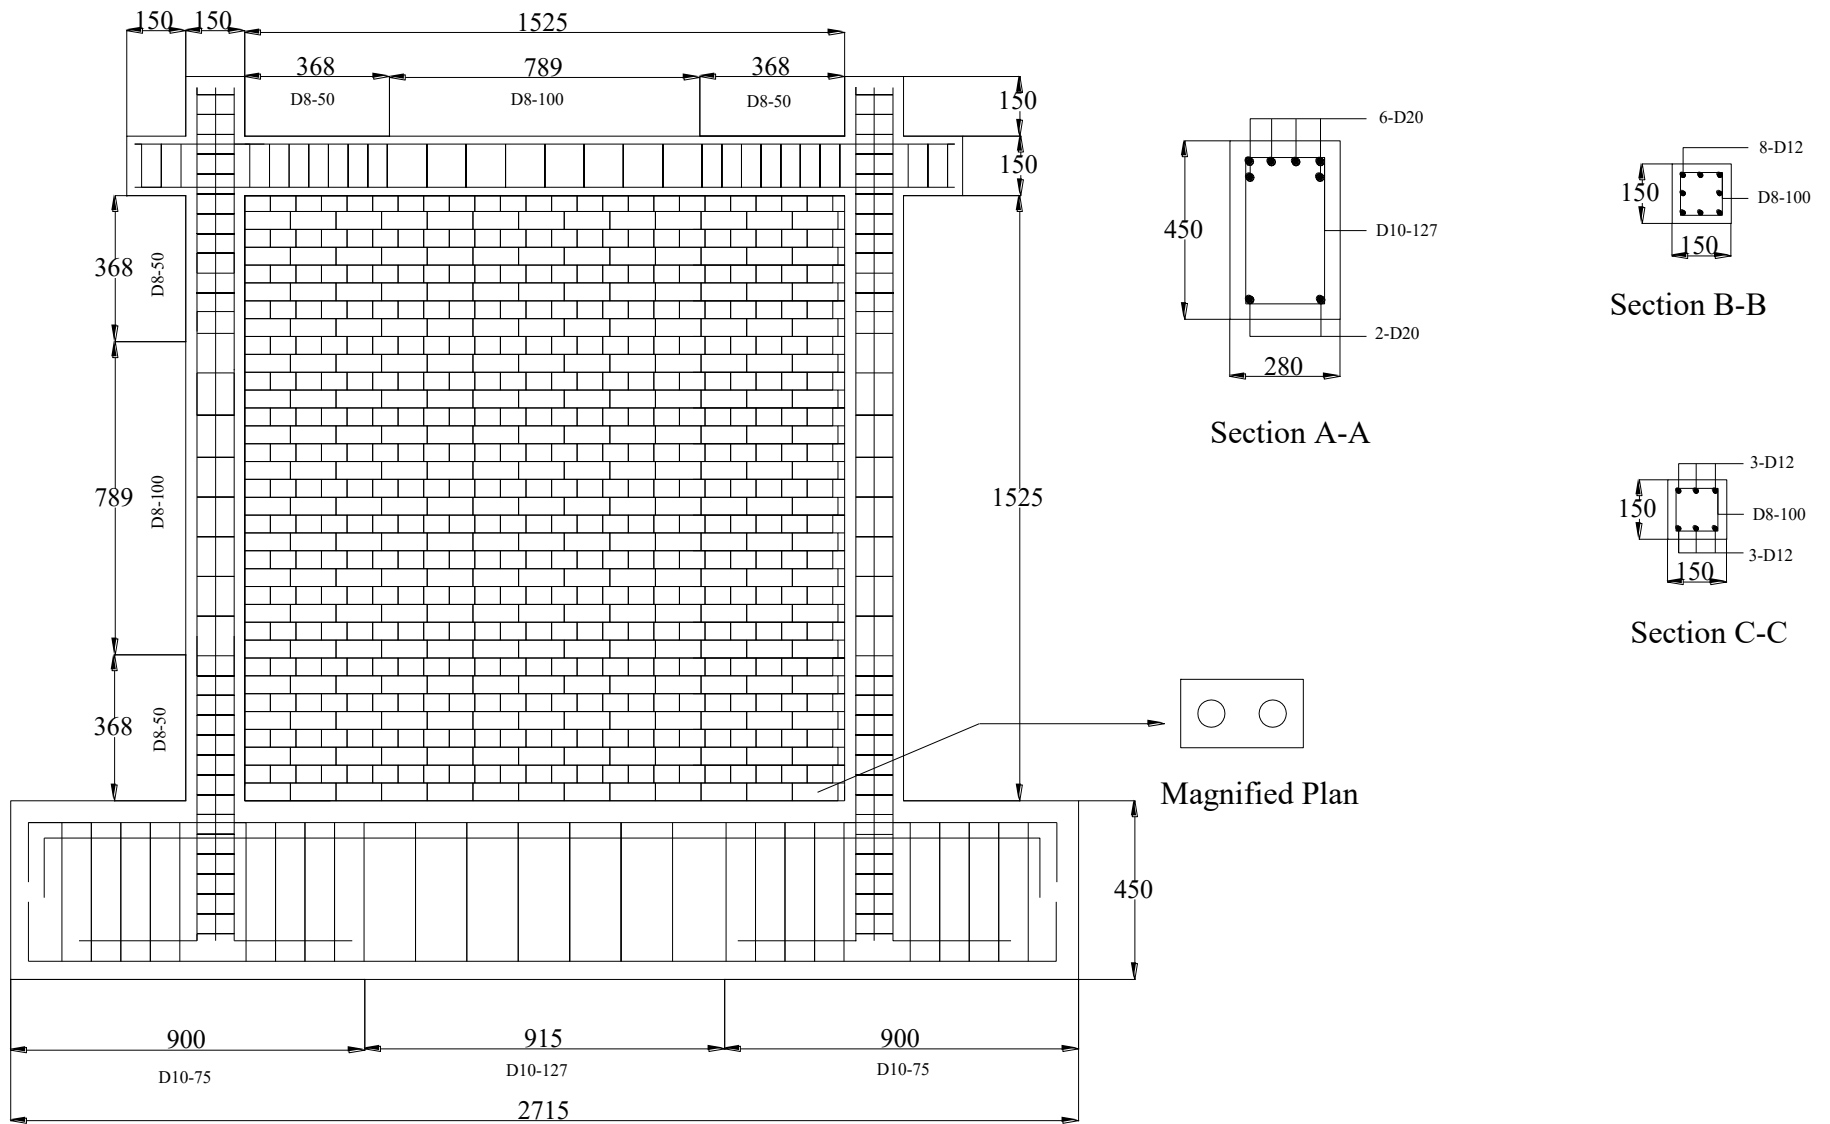
Figure 3.7: Schematic drawing of PB (Every unit is in mm) [Note: Section A-A, B-B and C-C are the midsection of base, column and beam respectively].

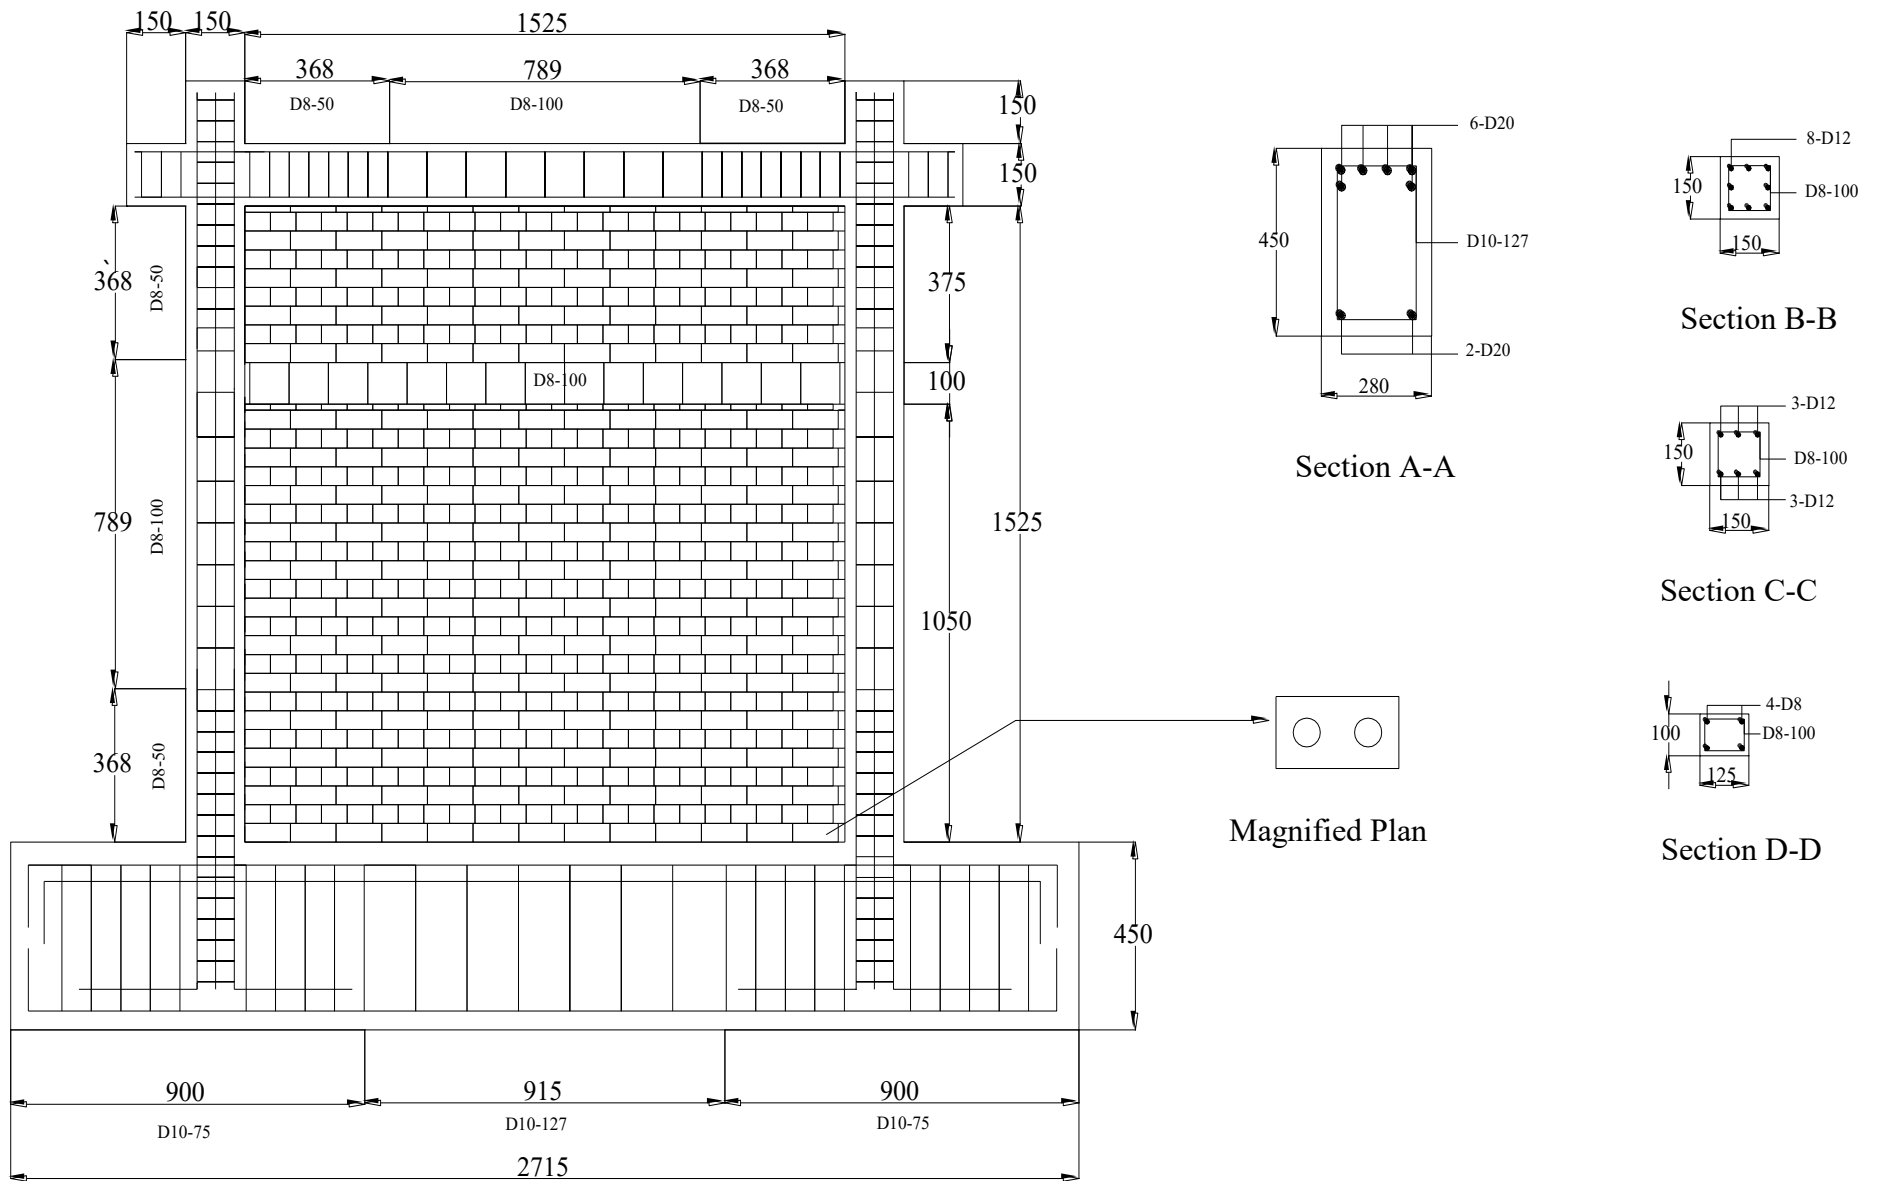
Figure 3.8: Schematic drawing of PBL (Every unit is in mm) [Note: Section A-A, B-B, C-C and D-D are the midsection of base, column, beam and lintel respectively].

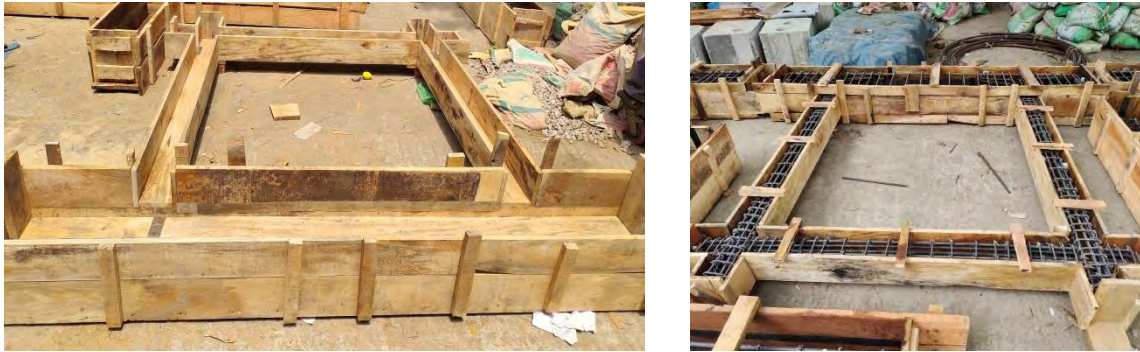
In step 2, a wooden formwork is constructed to facilitate the concrete casting. Afterward, the previously built reinforced structure was placed in the wooden formwork as shown in Figure 3.10.

Figure 3.10: Shuttering work.

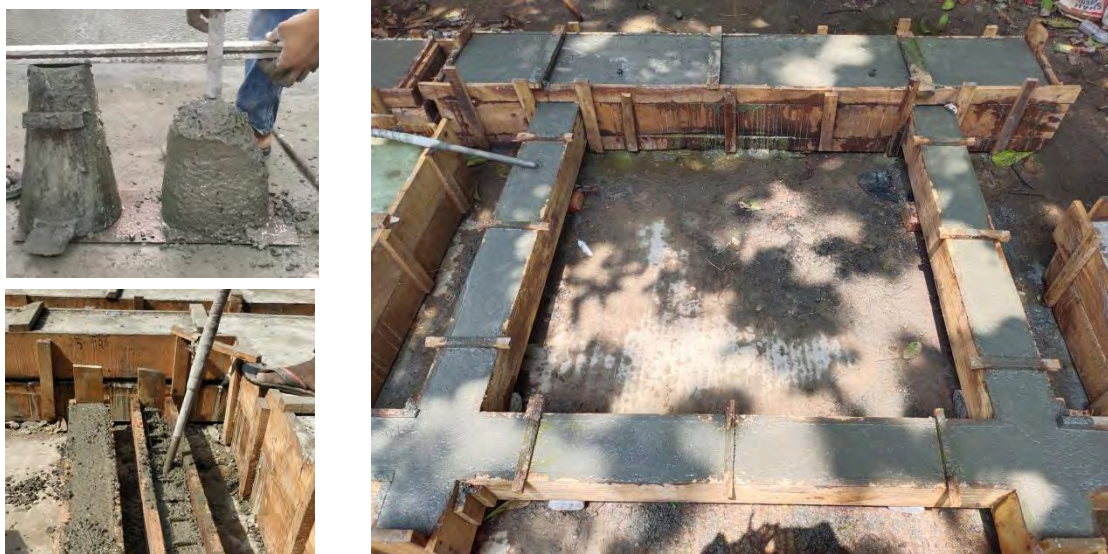
In step 3, cement, sylhet sand, and coarse aggregate were mixed at 1:1.5:3 ratio by volume in a mixture machine to prepare concrete. The water/cement ratio was kept at 0.45. During casting slump was kept between the range of 75 mm to 100 mm. After preparing fresh concrete, they were poured carefully in the formwork and compacted cautiously with a vibrator. Different stages of these processes are presented in Figure 3.11.

Figure 3.11: Measuring slump and concrete casting.

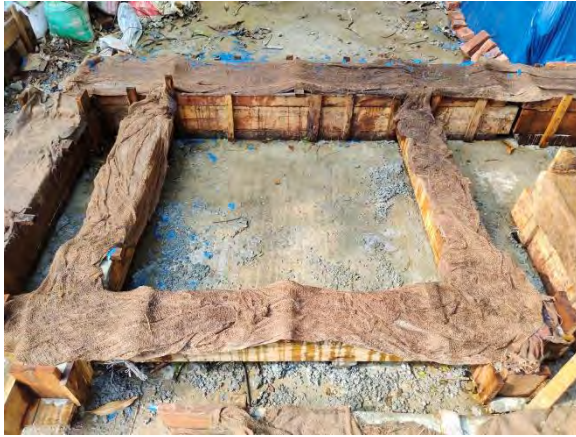
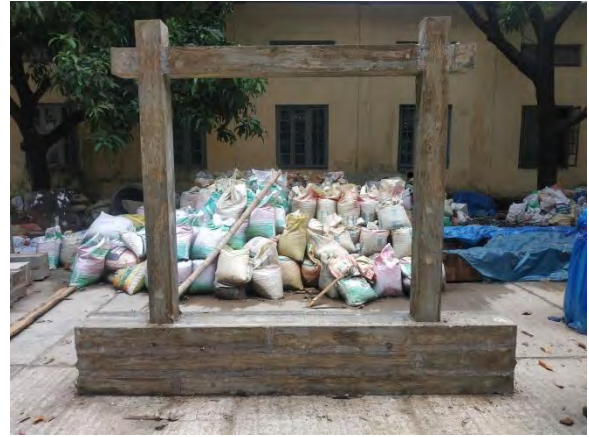
In step 4, the concrete was led to curing for 28 days as shown in Figure 3.12 (a). Curing provided enough scope for hydration. Wet gunny bags were used for curing. After 28 days of casting, the concrete became strong enough for commencing the masonry work. The full concrete frame is shown in Figure 3.12 (b).

Figure 3.12: (a) curing, (b) a concrete frame after 28 days of casting.

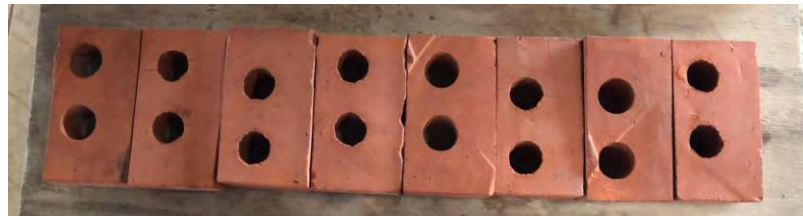
In step 5, all clay bricks (both solid and perforated) were cut through predetermined lines so that a full-scale brick ($240 \text{ mm} \times 115 \text{ mm} \times 67 \text{ mm}$ in dimension each) can be converted to eight half-scale bricks (solid brick $120 \text{ mm} \times 57.5 \text{ mm} \times 33.5 \text{ mm}$ in dimension each and perforated brick $104 \text{ mm} \times 57.5 \text{ mm} \times 33.5 \text{ mm}$ in dimension each). Eight half-scale perforated clay bricks produced from a single full-scale perforated clay brick are shown in Figure 3.13.

Figure 3.13: Eight half-scale bricks produced from a single full-scale brick.

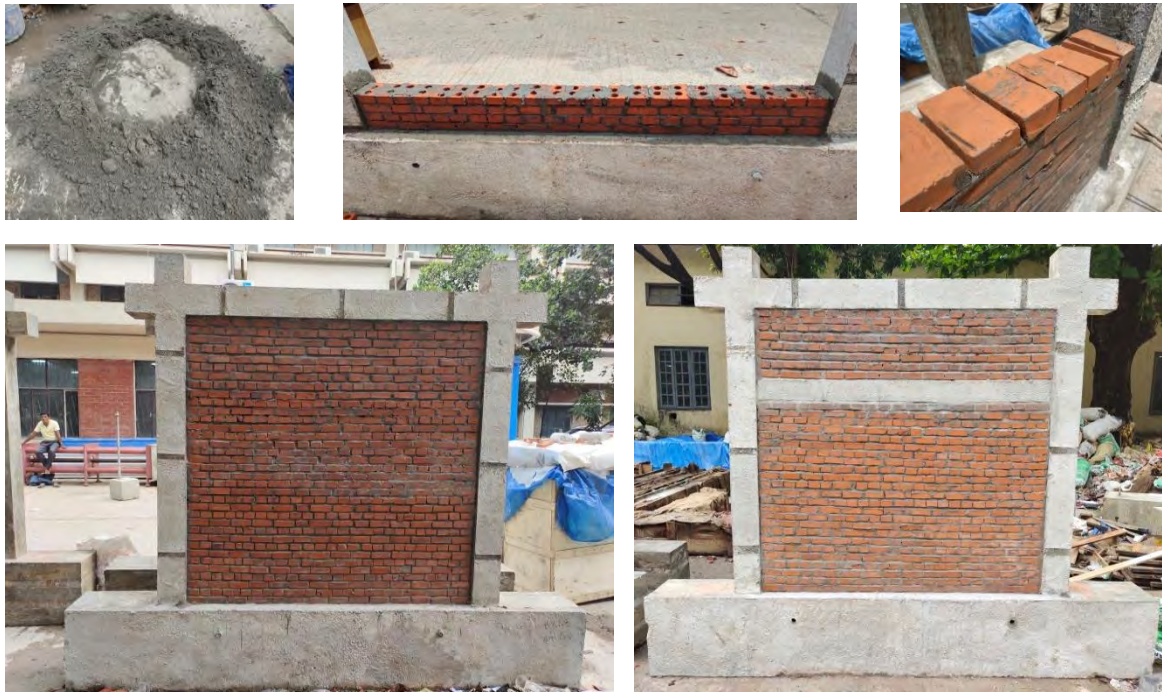
ratio was maintained at 0.45. After that, the whole $1525 \text{ mm} \times 1525 \text{ mm} \times 125 \text{ mm}$ wall of each specimen was filled up with bricks in two layers. Masonry units were joined using english bond. The lintel ($1525 \text{ mm} \times 125 \text{ mm} \times 100 \text{ mm}$) was connected both with masonry and column at two sides by mortar. After completing the masonry work, the specimens were kept 28 days more before testing. Different stages of masonry work are presented in Figure 3.14.

Figure 3.14: Masonry work.

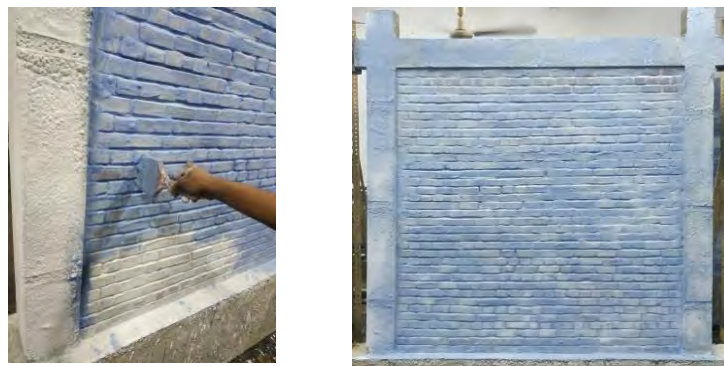
In the last step, all the specimens were whitewashed such as in Figure 3.15 to identify the cracks properly during testing.

Figure 3.15: Whitewashing.

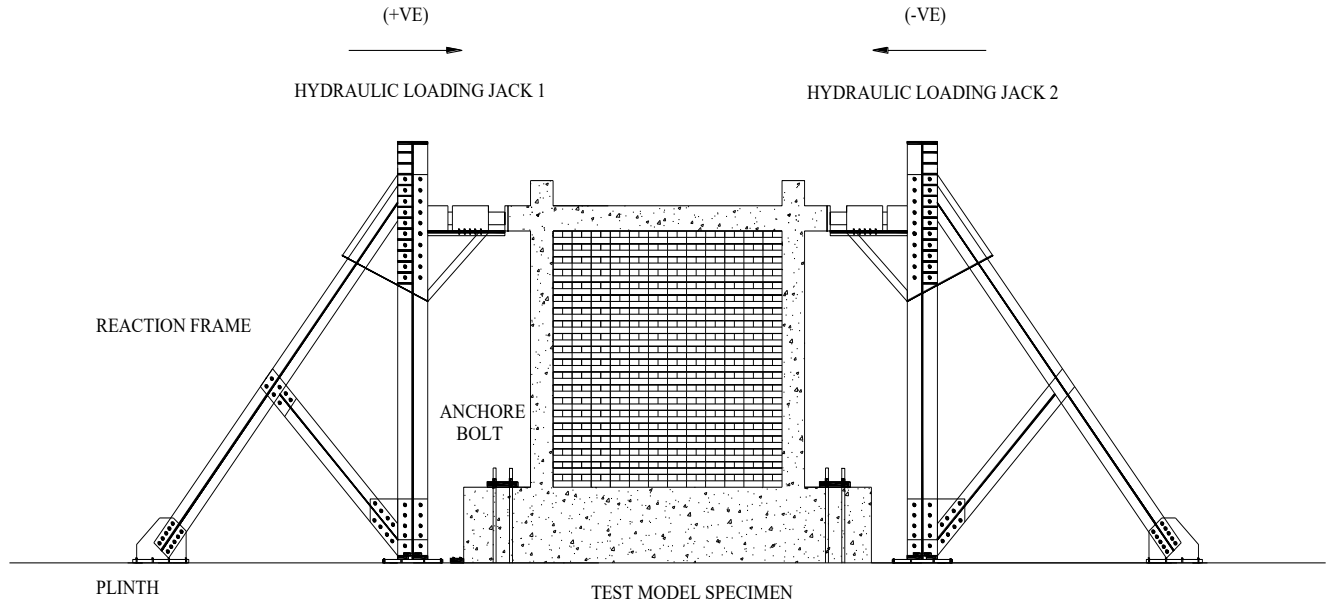
Figure 3.16: Schematic diagram of the experimental setup.

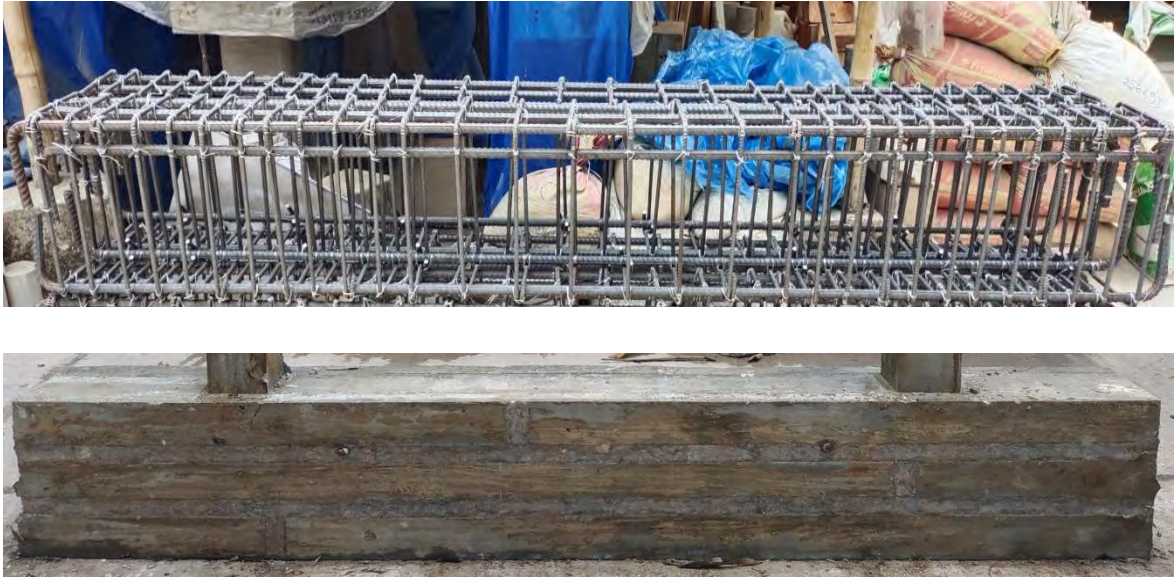
A firm base was essentially needed to make the infilled frame stable on it. For this, a firm reinforced concrete base was prepared monolithically with the reinforced concrete frame. The base of each specimen was 2715 mm × 450 mm × 280 mm in dimension. In base, 20 mm rebar was used as the main bar and 10 mm rebar was used as shear reinforcement. During construction, the mixing ratio was 1:1.5:3 (cement: fine aggregate: coarse aggregate by volume). Moreover, the water-cement ratio of the base was maintained at 0.45. The base is shown in Figure 3.17.

Figure 3.17: Firm base.

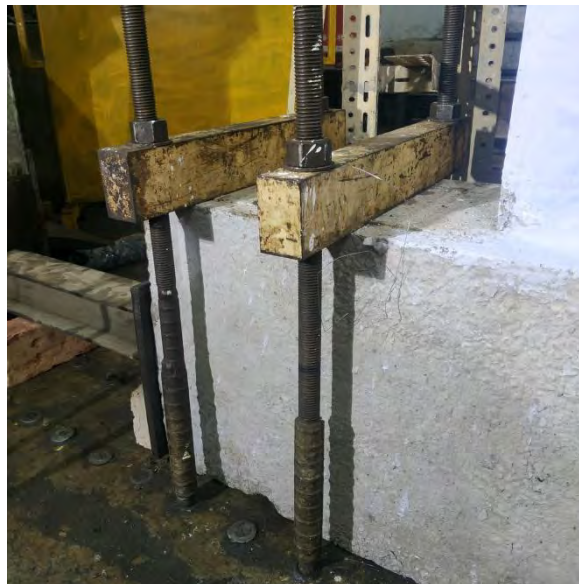
Four pairs of anchor bolts were used to fasten the base with the ground as shown in Figure 3.18. Each pair of anchor bolts was accompanied by a 475 mm × 75 mm × 50 mm steel plate. Each anchor bolt was 24 mm in dimension. Each side of the base was attached with two pairs of bolts. The bolts were strong enough to restrain the base from moving when the specimen is subjected to in-plane lateral loading.

Figure 3.18: Anchor bolt and steel plate.

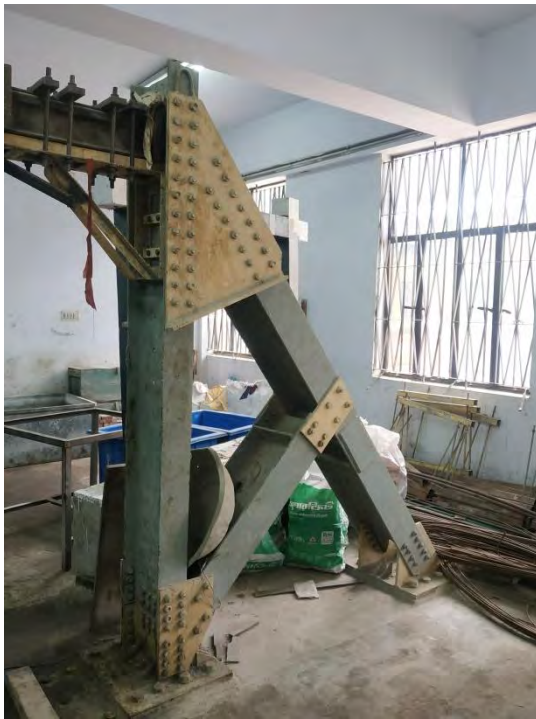
The test setup's structure consisted of two reaction frames, which are steel truss sections fastened to the sturdy foundation. Each reaction frame incorporated a hydraulic jack which was used to apply cyclic loading. One of the reaction frames is demonstrated in Figure 3.19 (a).

Figure 3.19: (a) Reaction frame, (b) tripod stand.

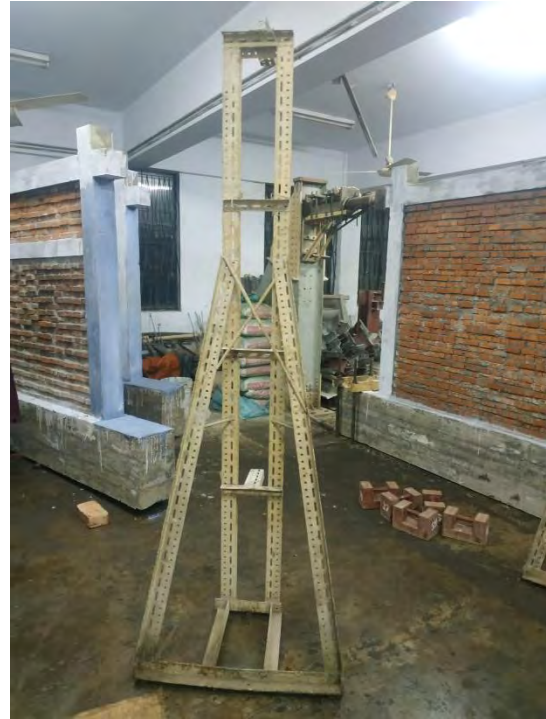
(b)

To hold the dial gauges at predetermined places two tripod stands were used as shown in Figure 3.19 (b).

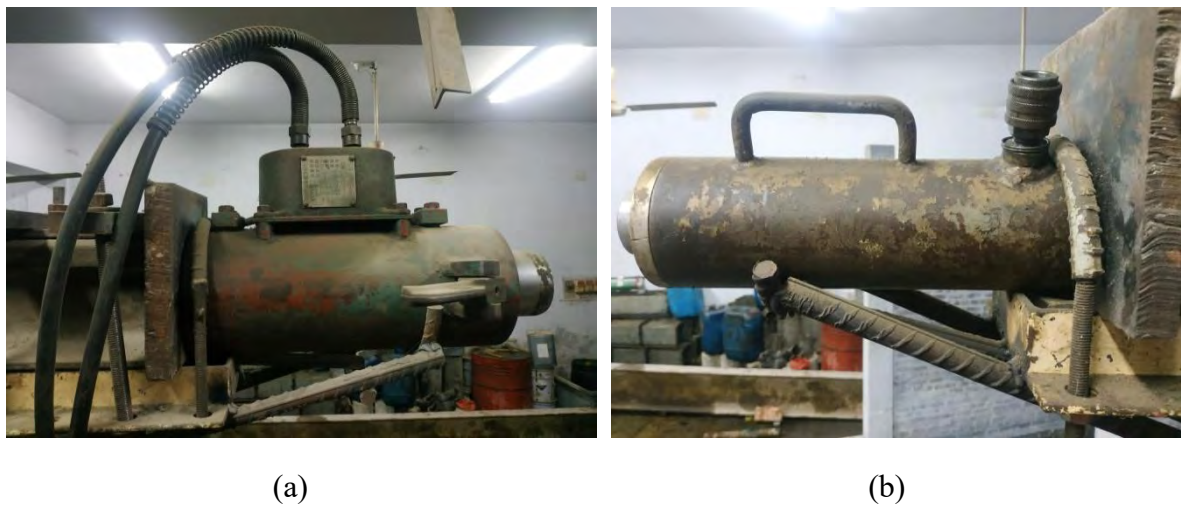
Two Hydraulic jacks were utilized in this experiment for applying lateral load. Hydraulic jack 1 (Capacity : 50 ton) was attached to the left reaction frame and the Hydraulic jack 2 (Capacity : 30 ton) was attached to the right reaction frame. The jacks are shown in Figure 3.21. The deformation of the specimen due to the applied load by hydraulic jack 1 is assumed as positive direction. On the contrary, the deformation of the specimen due to the applied load by hydraulic jack 2 is assumed negative direction. Details of the hydraulic jacks are illustrated in Appendix-G.

Figure 3.21: (a) Hydraulic Jack 1, (b) hydraulic jack 2.

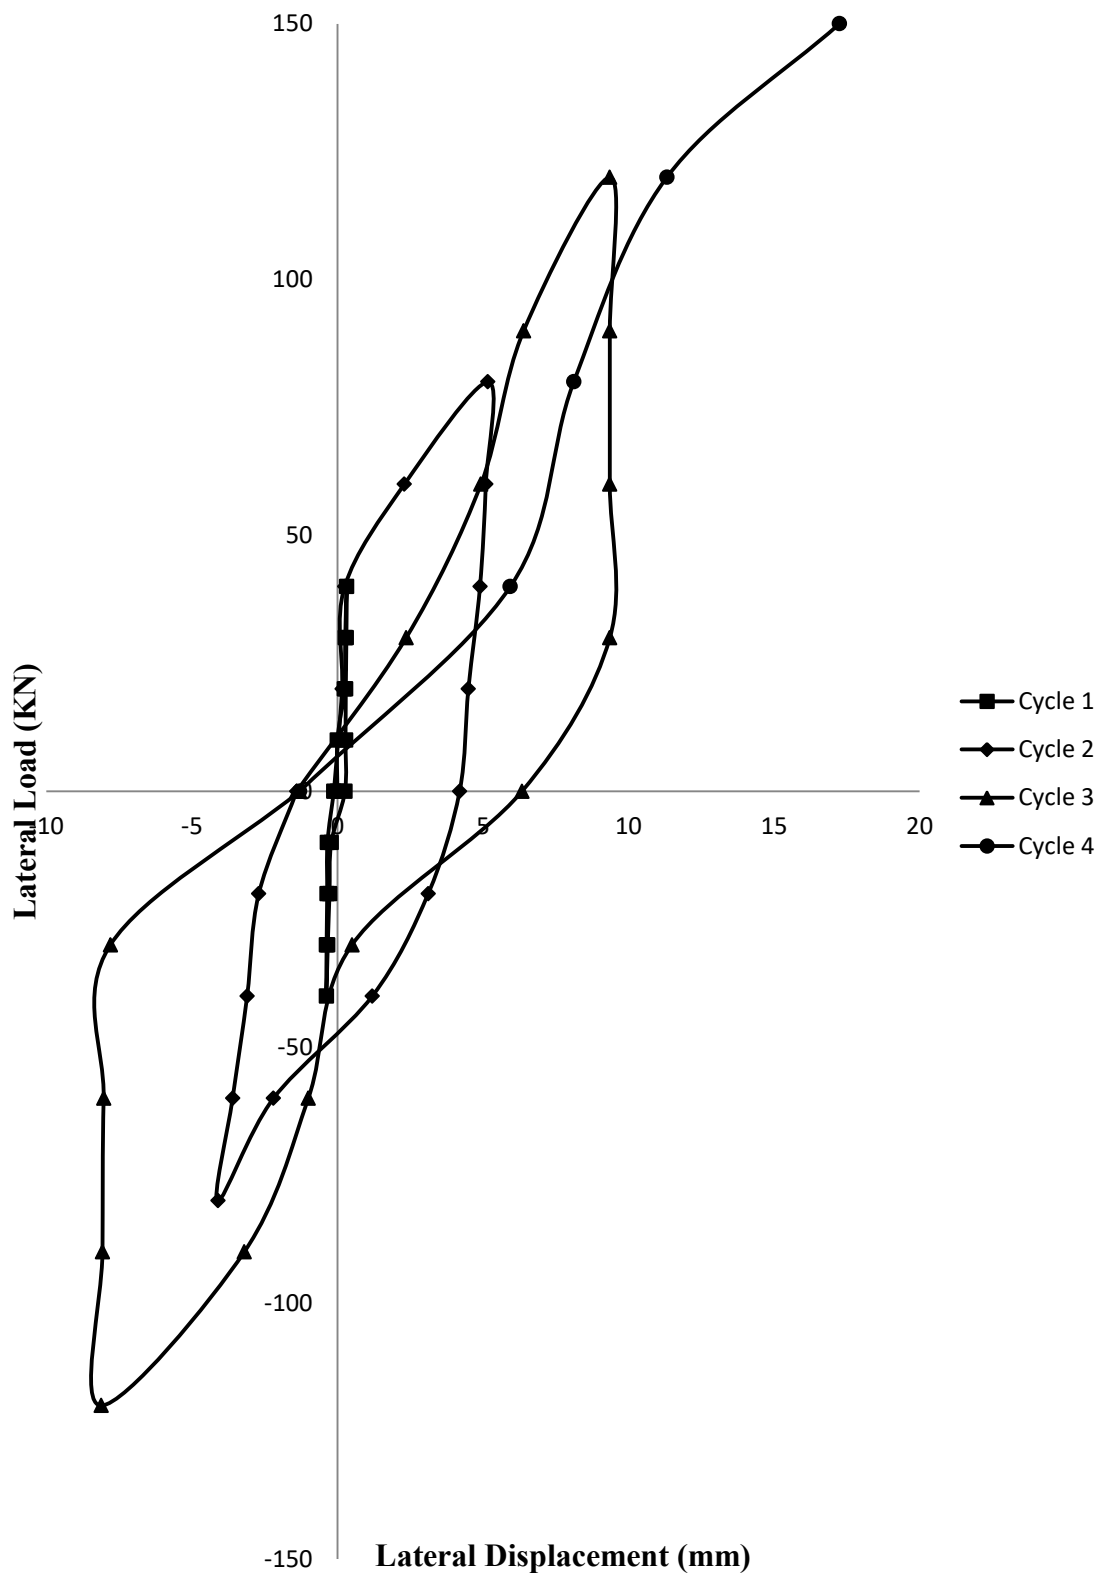
Figure 4.1: Hysteretic load-displacement curve for SB.

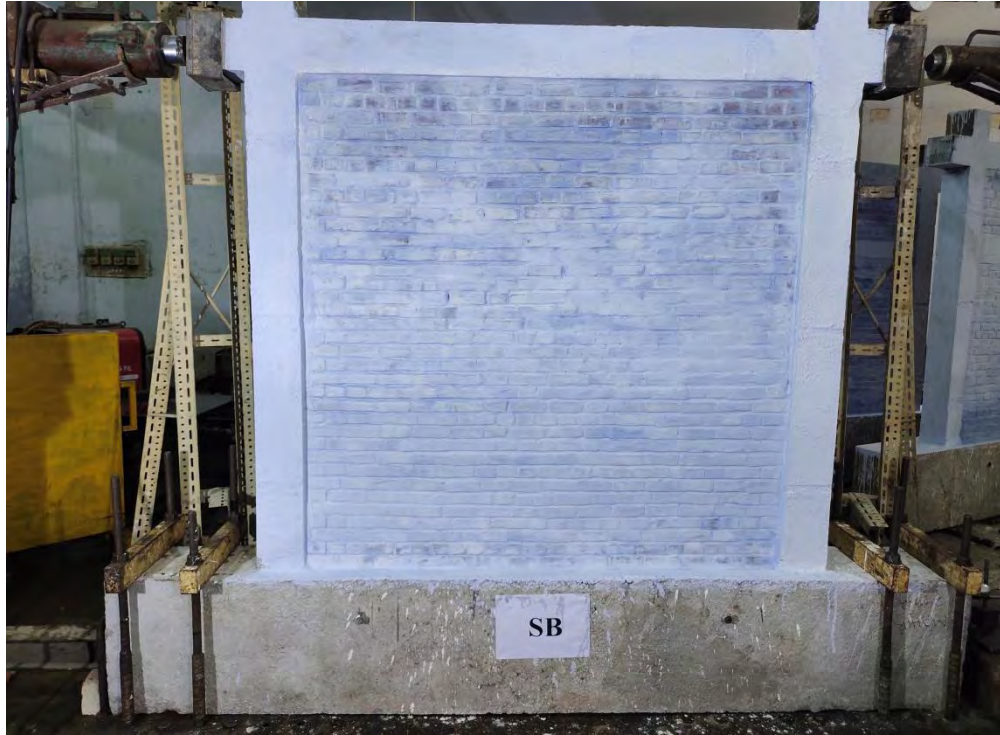
Figure 4.2: SB after the completion of cycle 1.

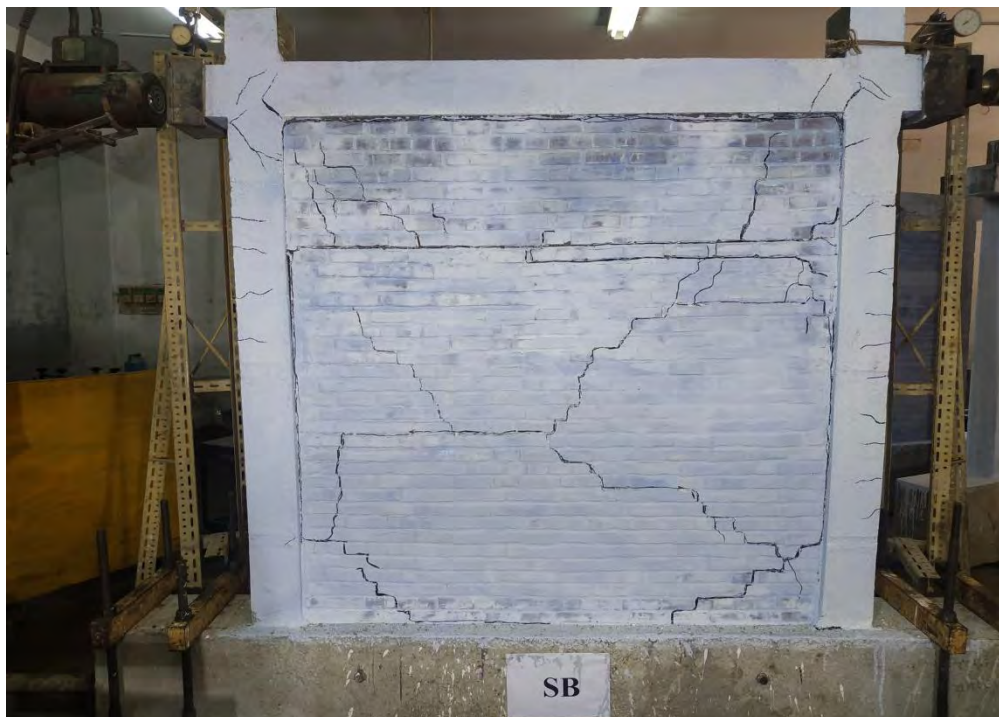
Figure 4.5: SB at complete failure (at cycle 4).

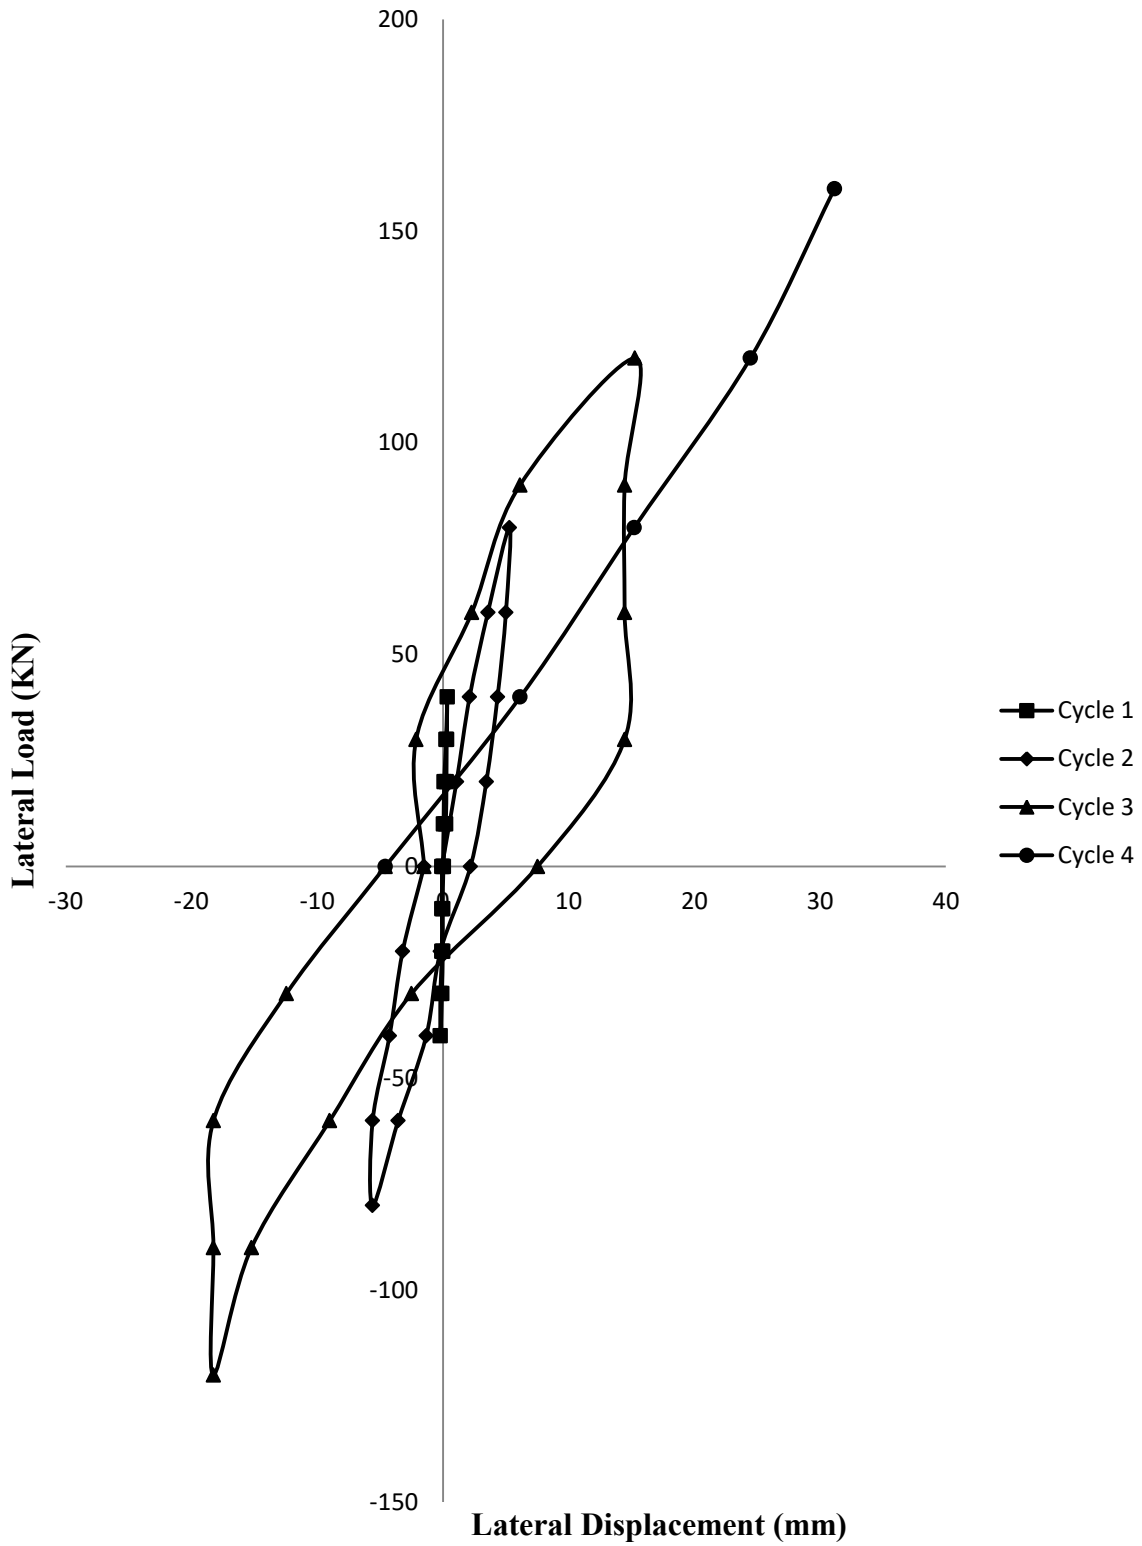
Figure 4.6: Hysteretic load-displacement curve for SBL.

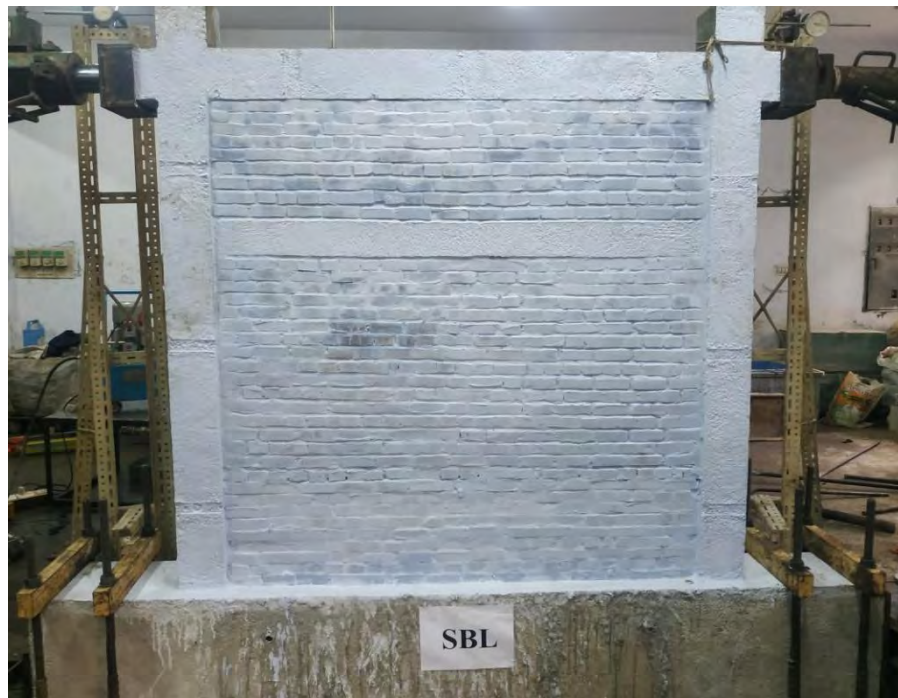
Figure 4.7: SBL after the completion of cycle 1.

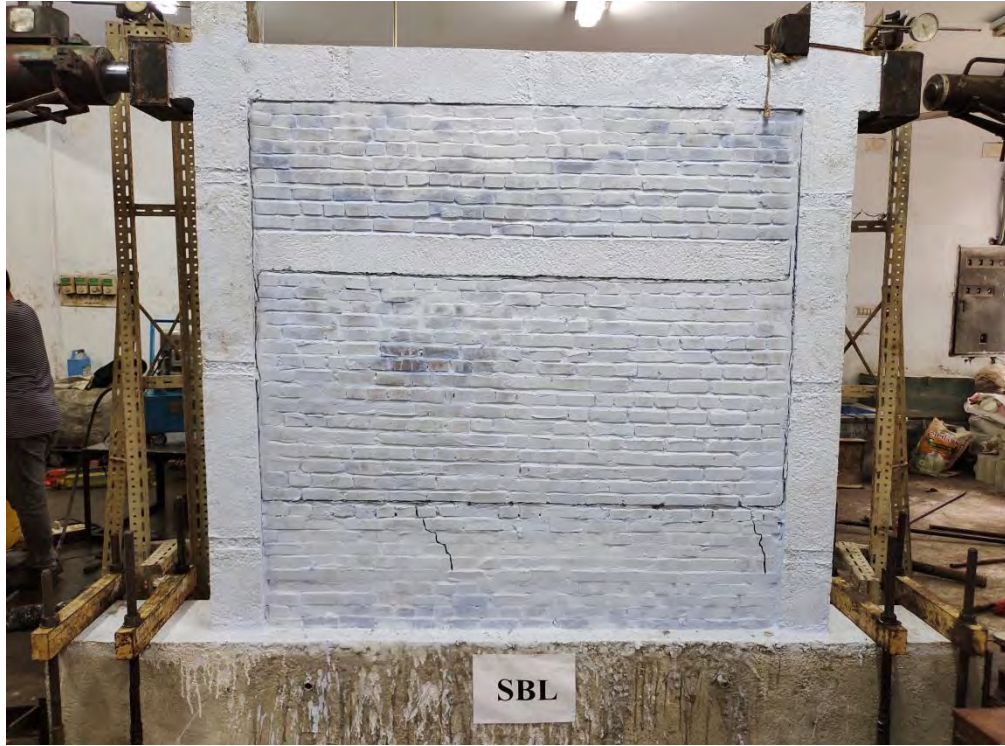
Figure 4.8: SBL after the completion of cycle 2.

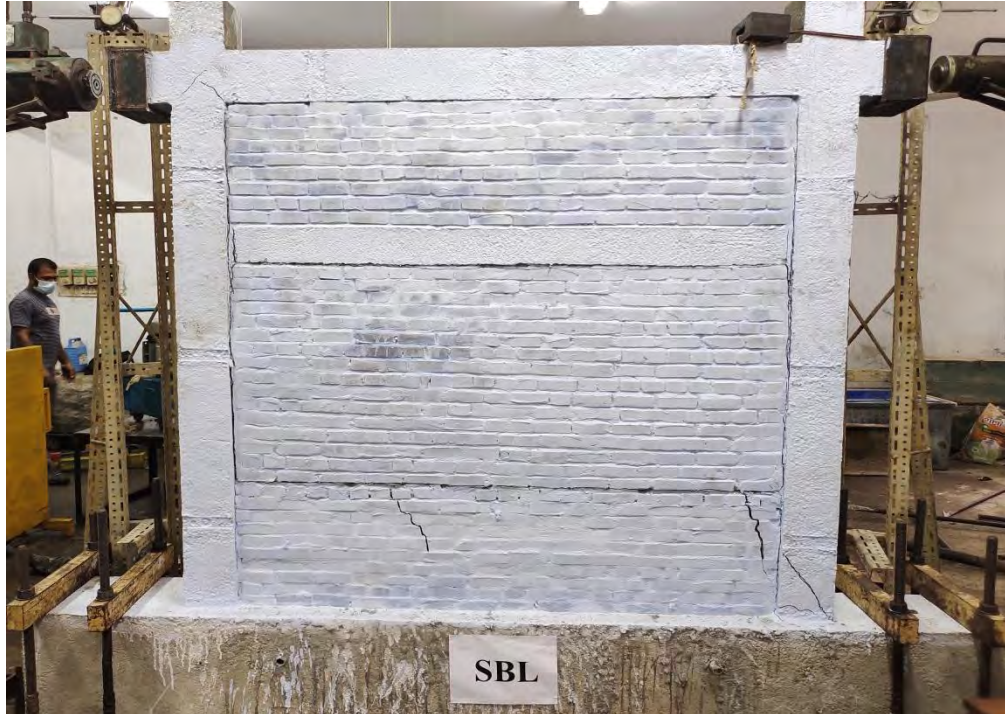
were observed at the base column (right). It occurred due to excessive shear and short column effect. State of the specimen after completion of the cycle 3 is shown in Figure 4.9.

Figure 4.9: SBL after the completion of cycle 3.

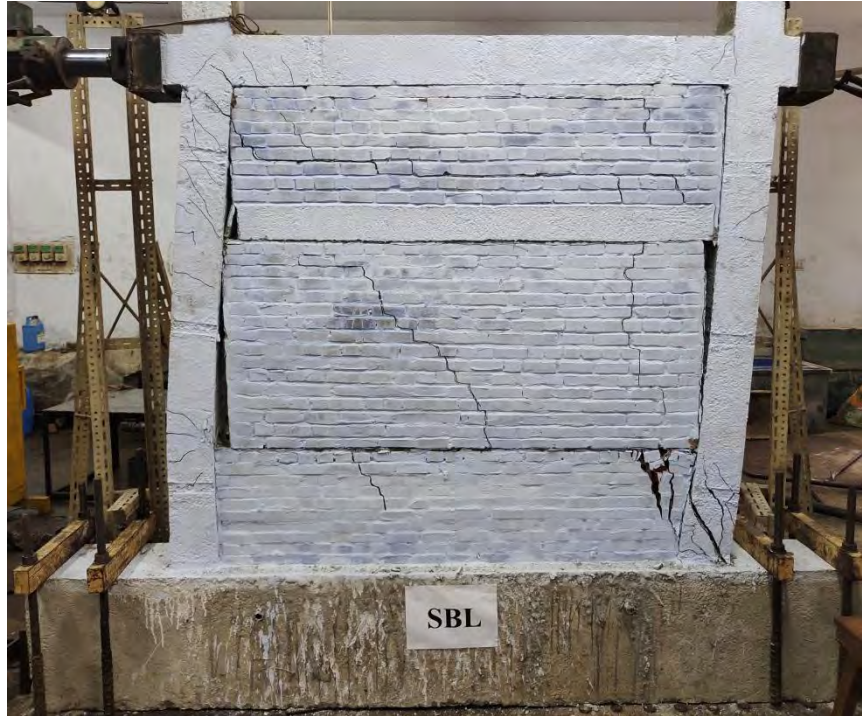
Figure 4.10: SBL at complete failure (at cycle 4).

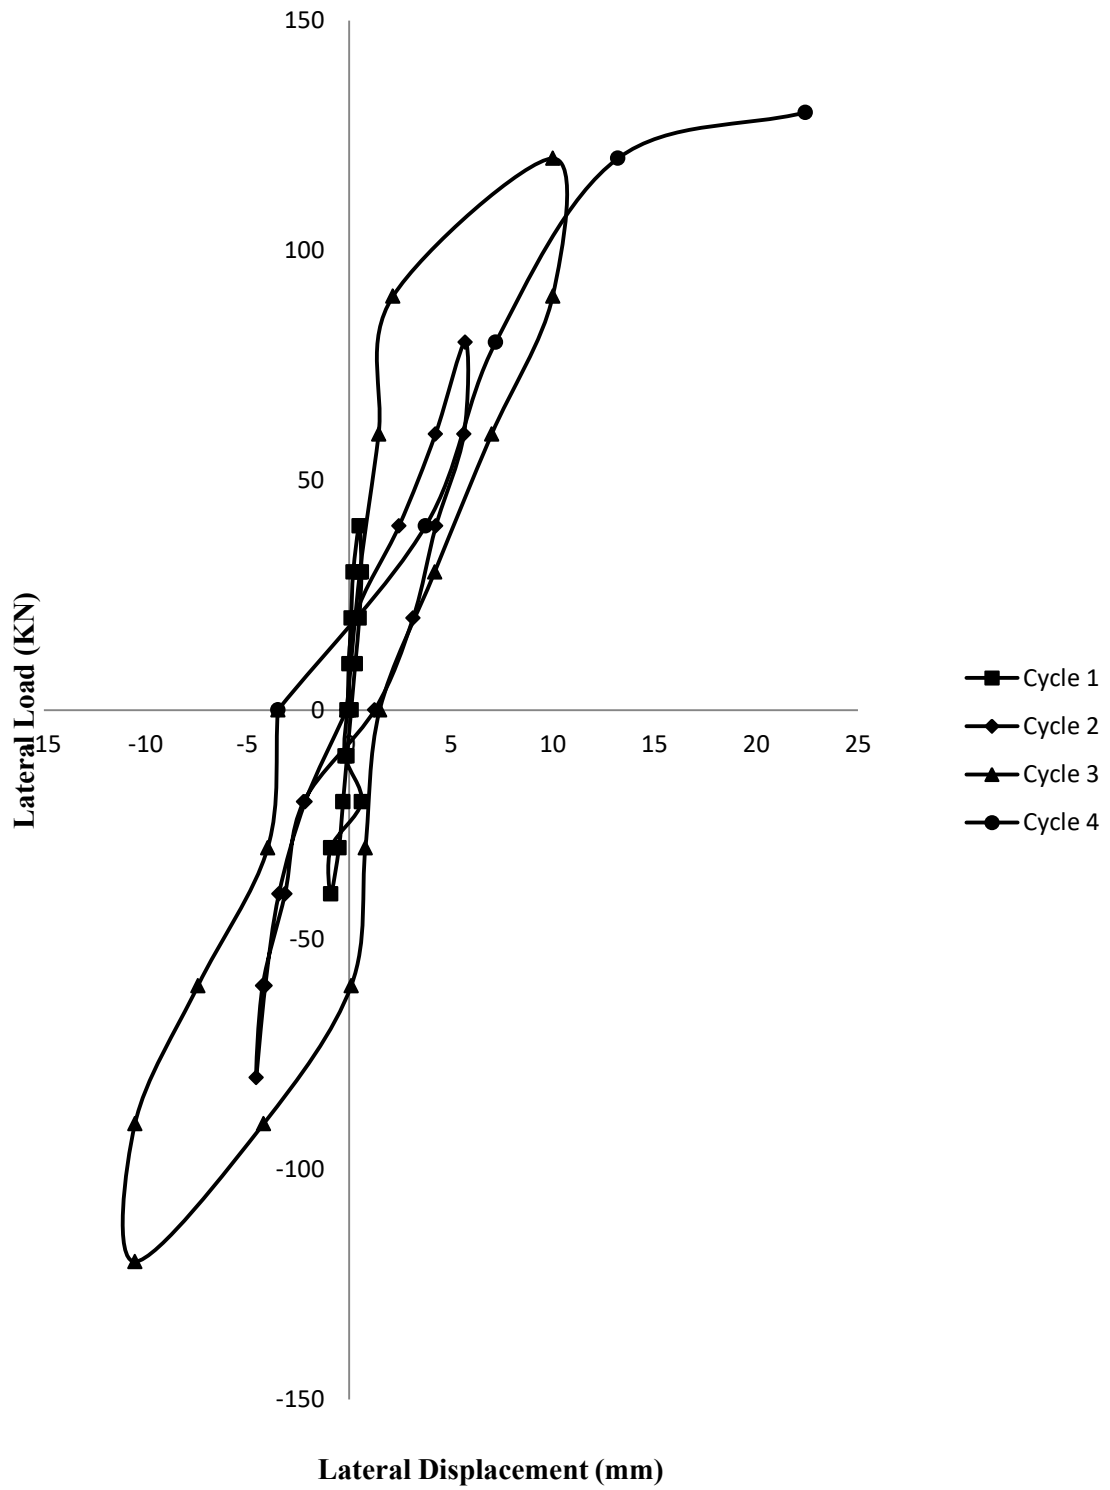
Figure 4.11: Hysteretic load-displacement curve for PB.

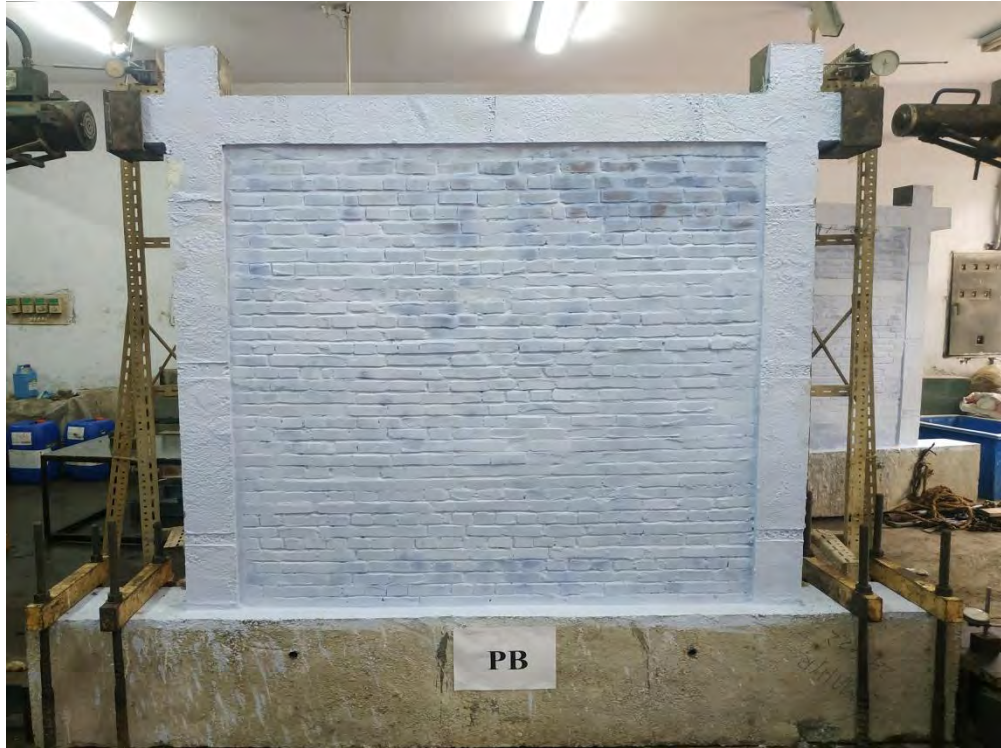
Figure 4.12: PB after the completion of cycle 1.

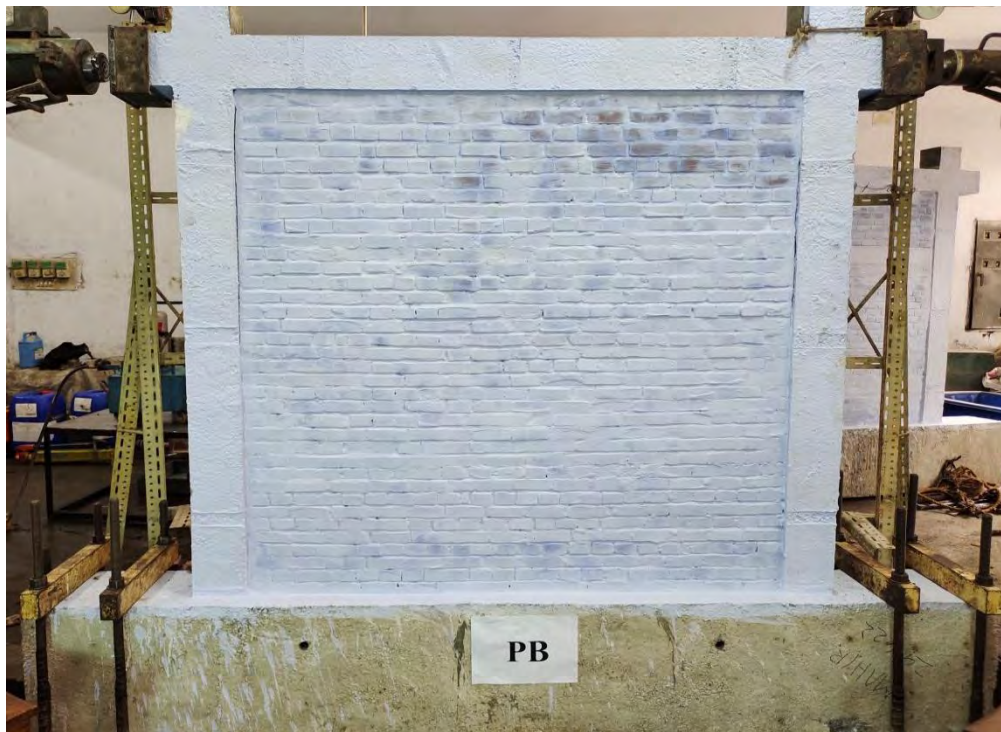
At cycle 2, a maximum of 80 KN load was applied from each direction of the specimen. At 80 KN (towards positive direction) load, no significant changes were observed on the specimen. At 80 KN (towards negative direction) load, several mild cracks were identified on the infill wall. The wall was slightly segregated from the frame due to weak mortar strength in the wall-column joint. As a result, some cracks were spotted on those joints. State after completion of the cycle 2 is shown in Figure 4.13.

Figure 4.13: PB after the completion of cycle 2.
