**EXPERIMENTAL STUDY ON THE EFFECT OF LINTEL
ON INFILLED FRAMES UNDER CYCLIC LOADING**

MASTER OF SCIENCE IN CIVIL ENGINEERING (STRUCTURAL)

DEPARTMENT OF CIVIL ENGINEERING
BANGLADESH UNIVERSITY OF ENGINEERING AND TECHNOLOGY
Dhaka, Bangladesh

July, 2022

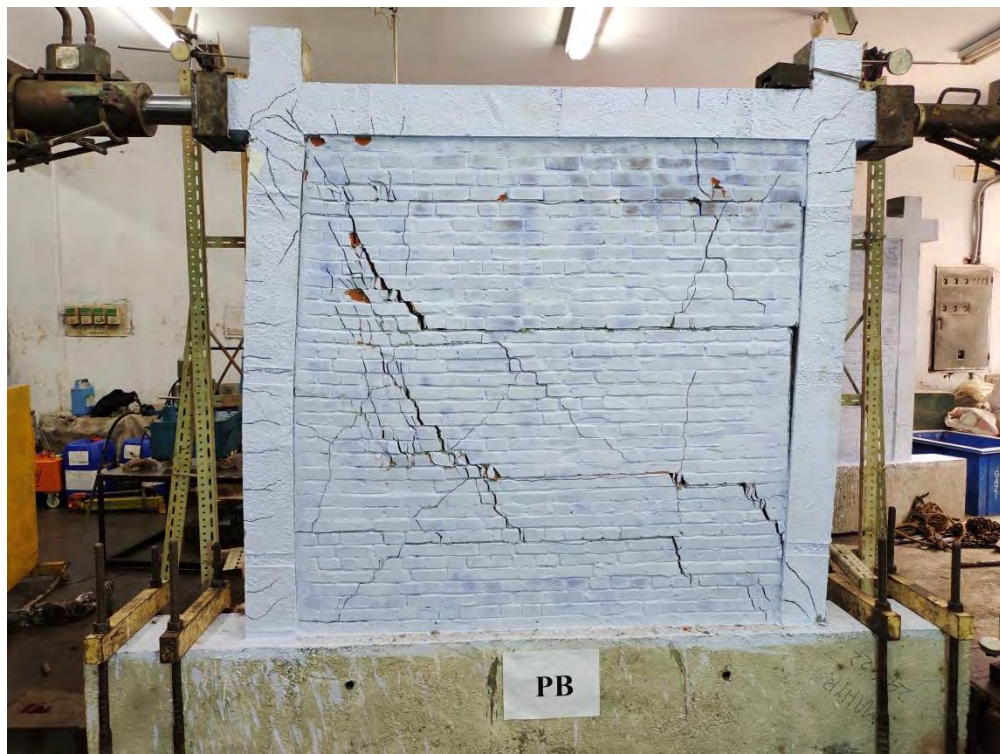
Figure 4.15: PB at complete failure (at cycle 4).

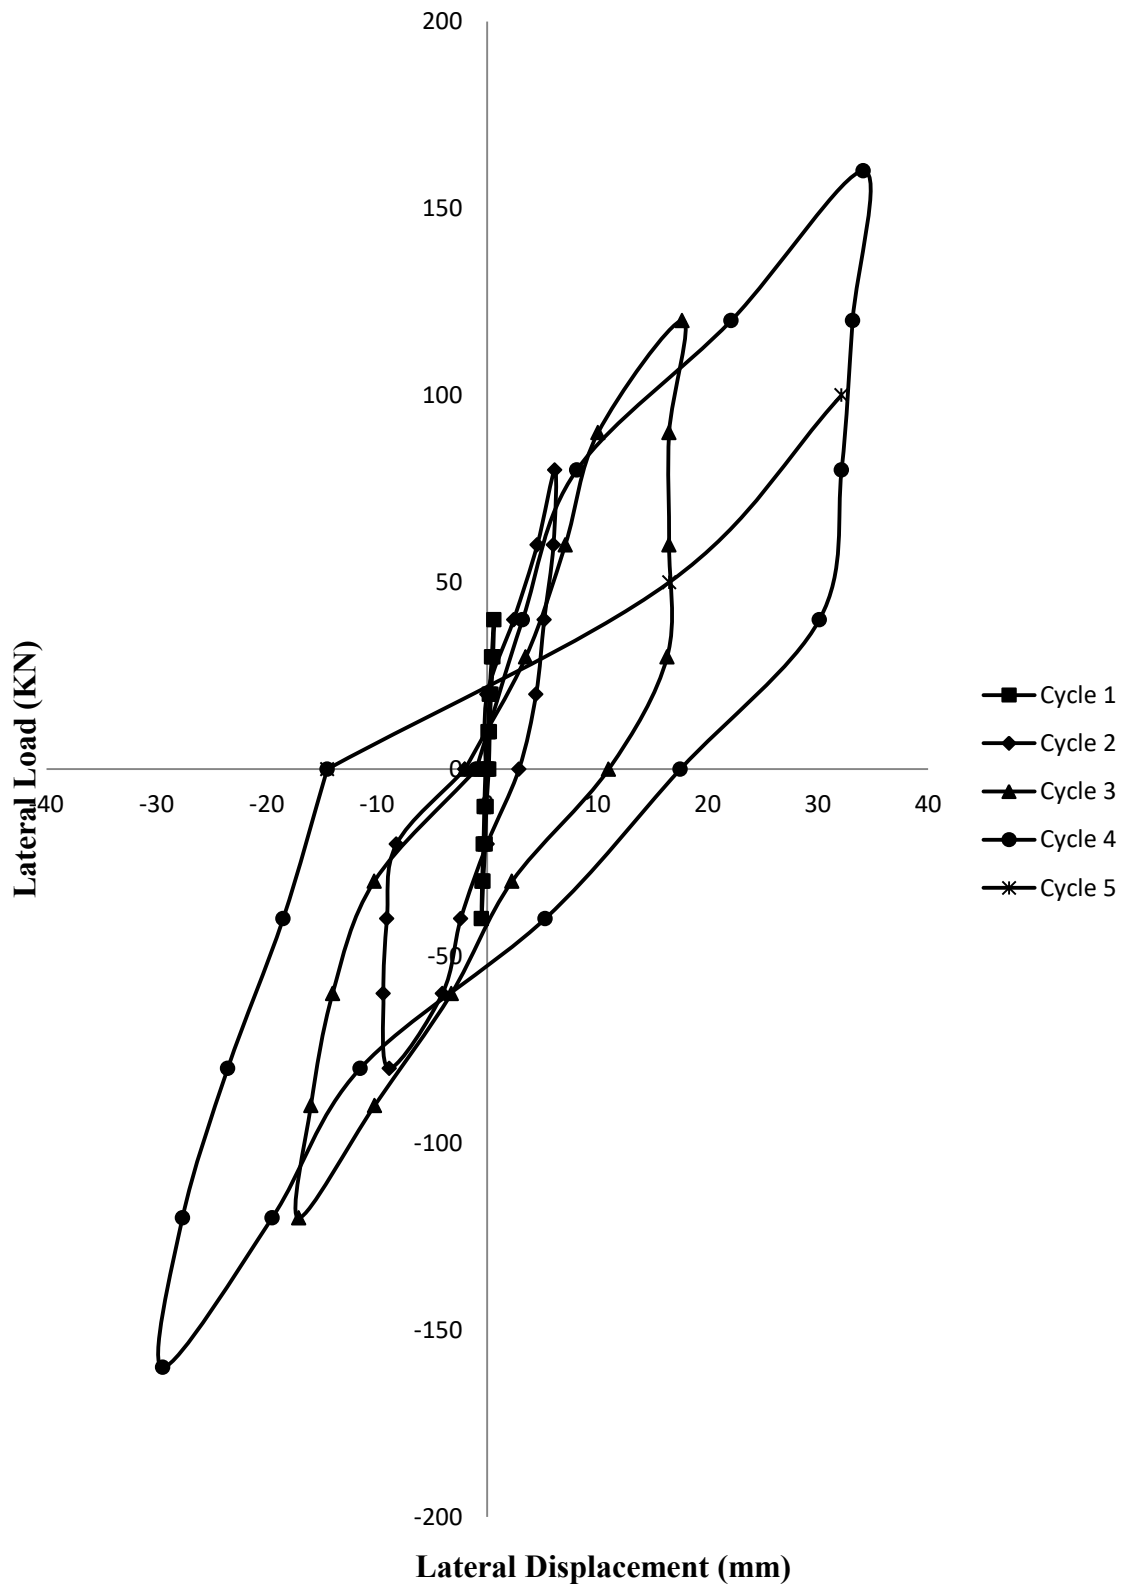
Figure 4.16: Hysteretic load-displacement curve for PBL.

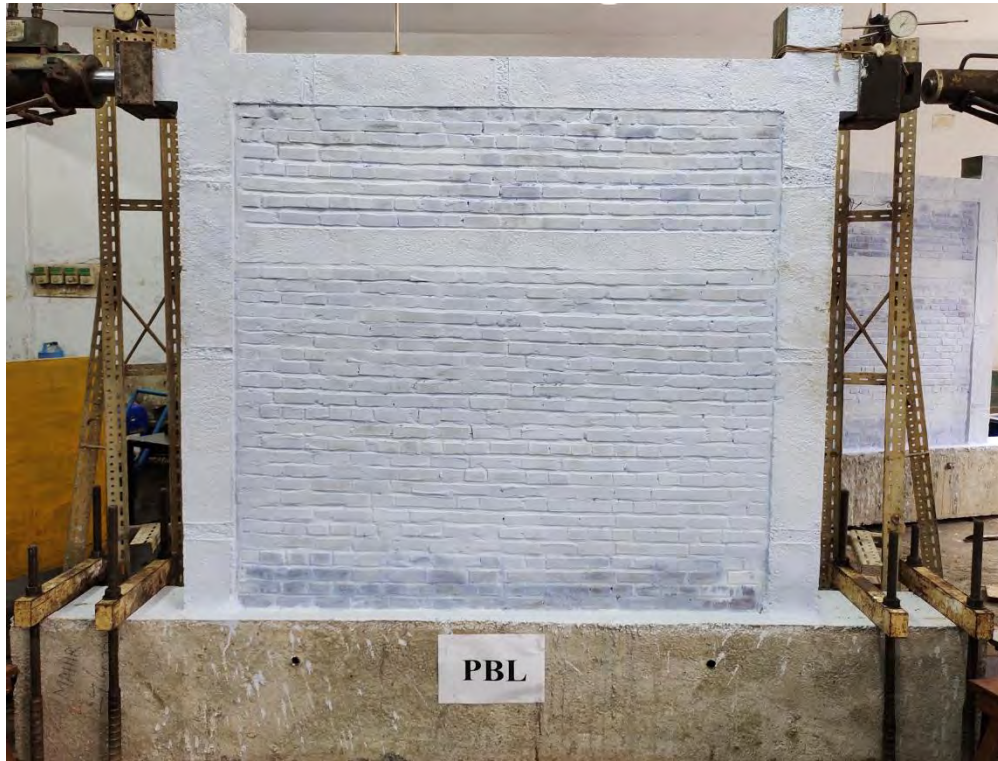
Figure 4.17: PBL after the completion of cycle 1.

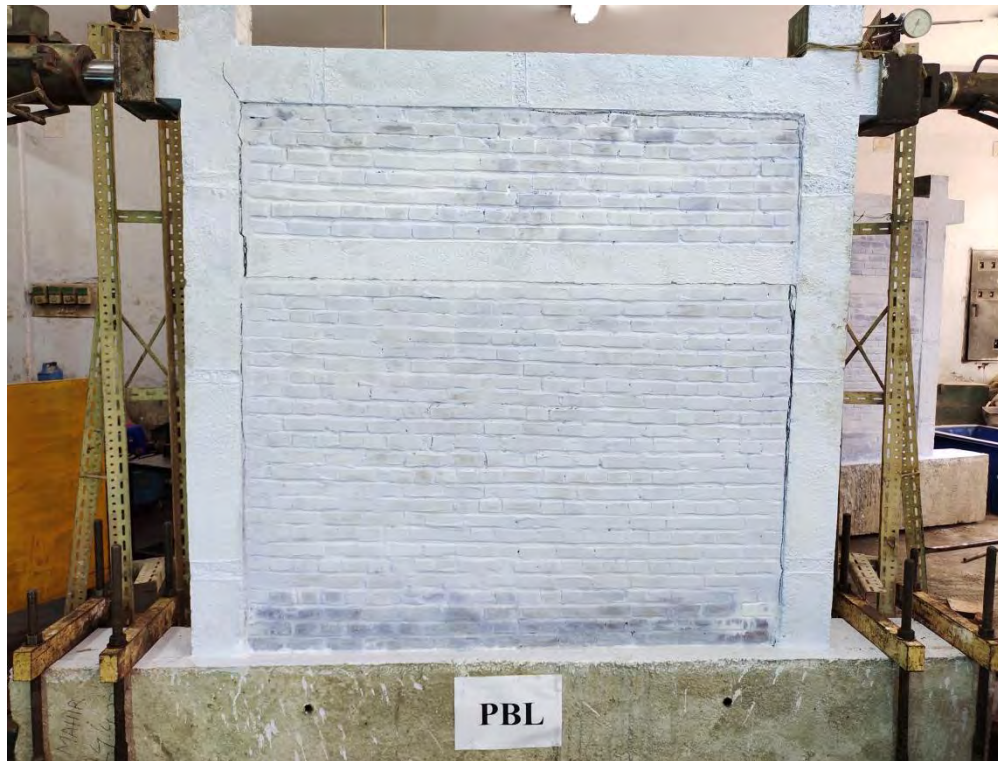
Figure 4.18: PBL after the completion of cycle 2.

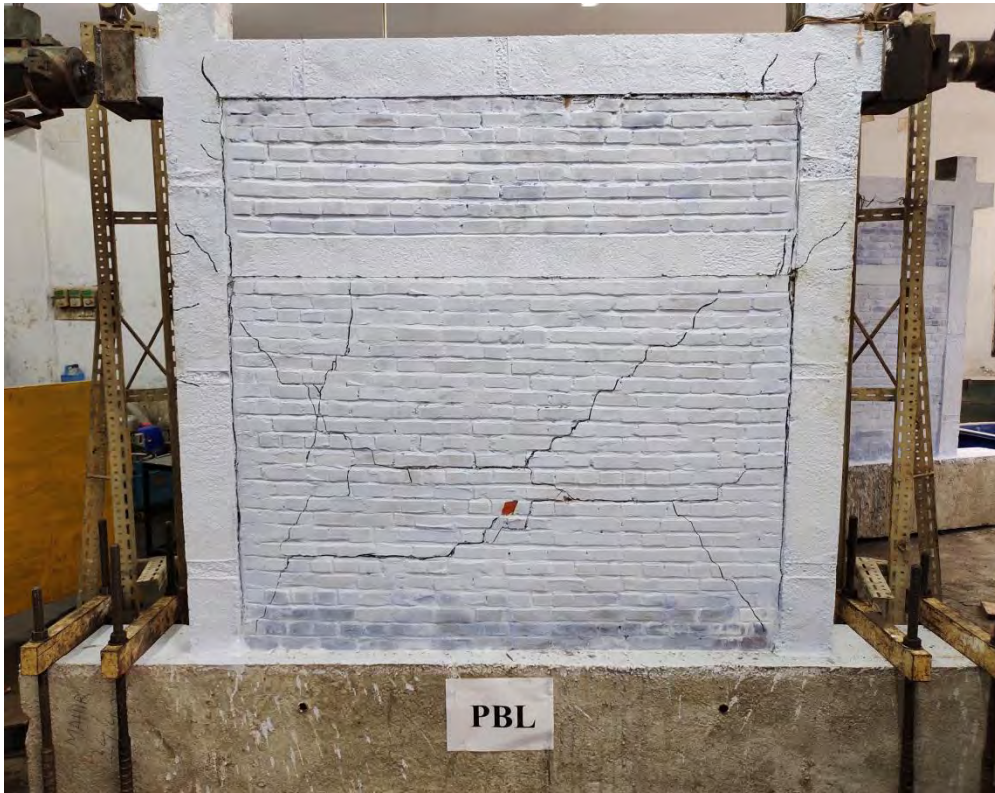
Figure 4.19: PBL after the completion of cycle 3.

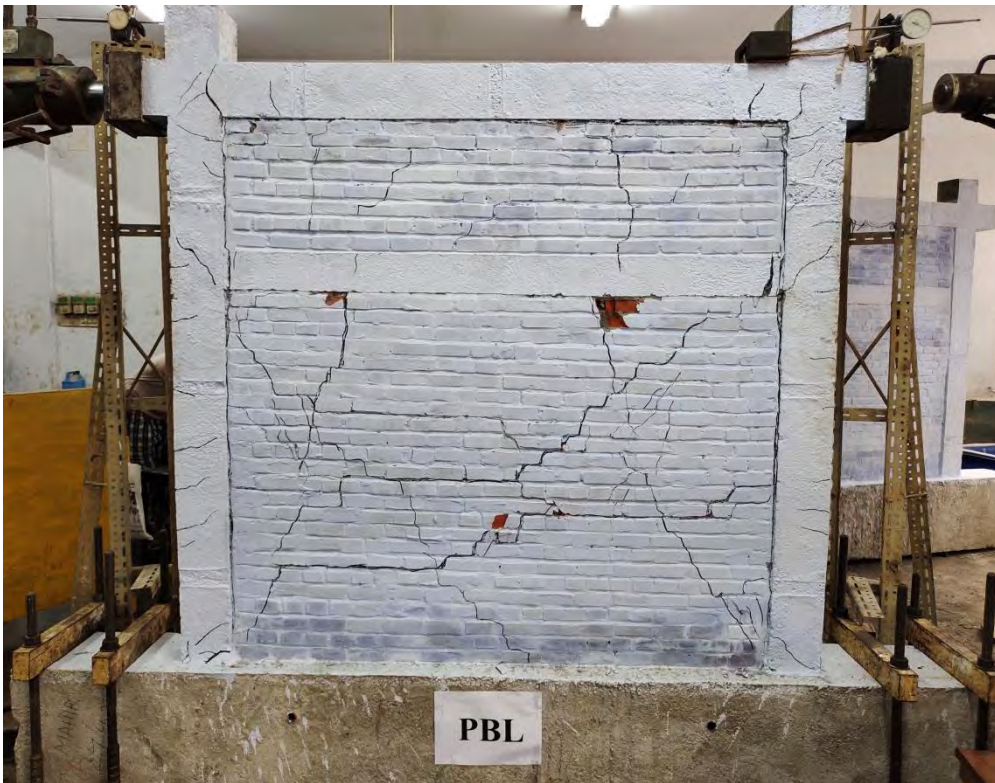
Figure 4.20: PBL after the completion of cycle 4.

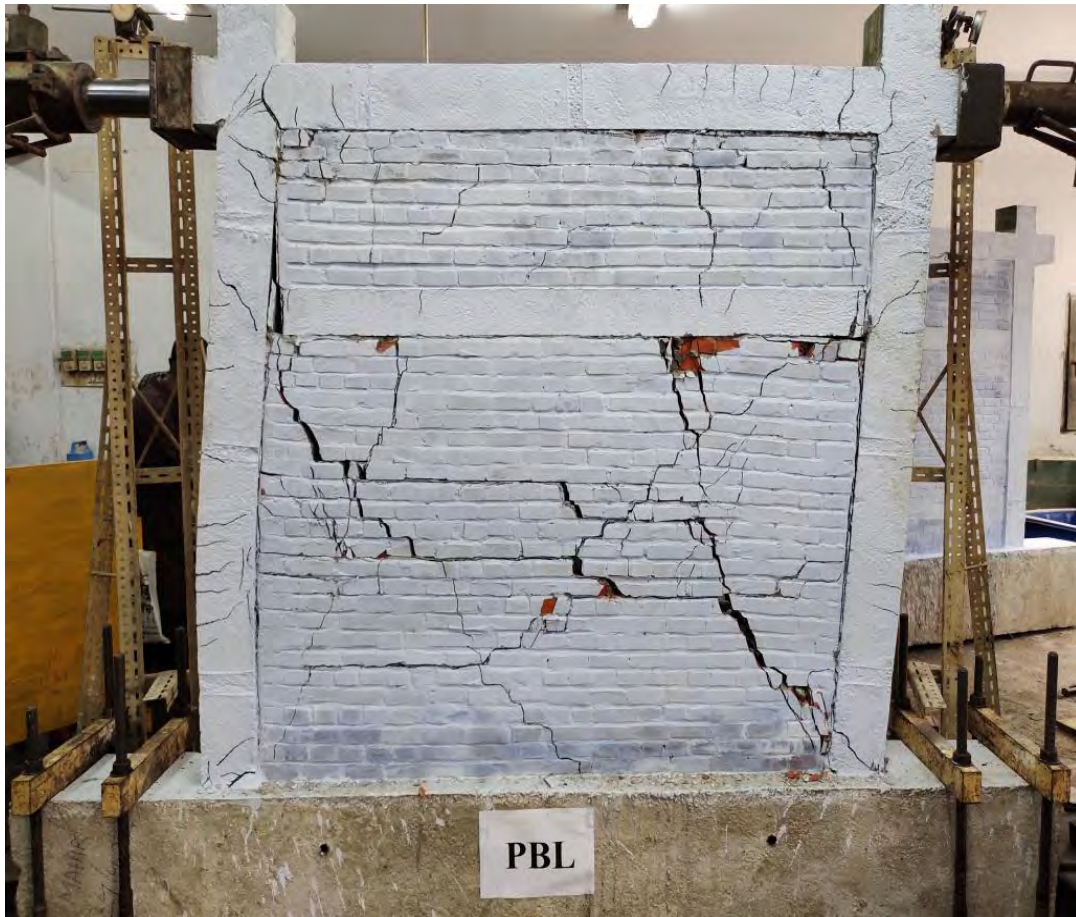
Figure 4.21: PBL at complete failure (at cycle 5).

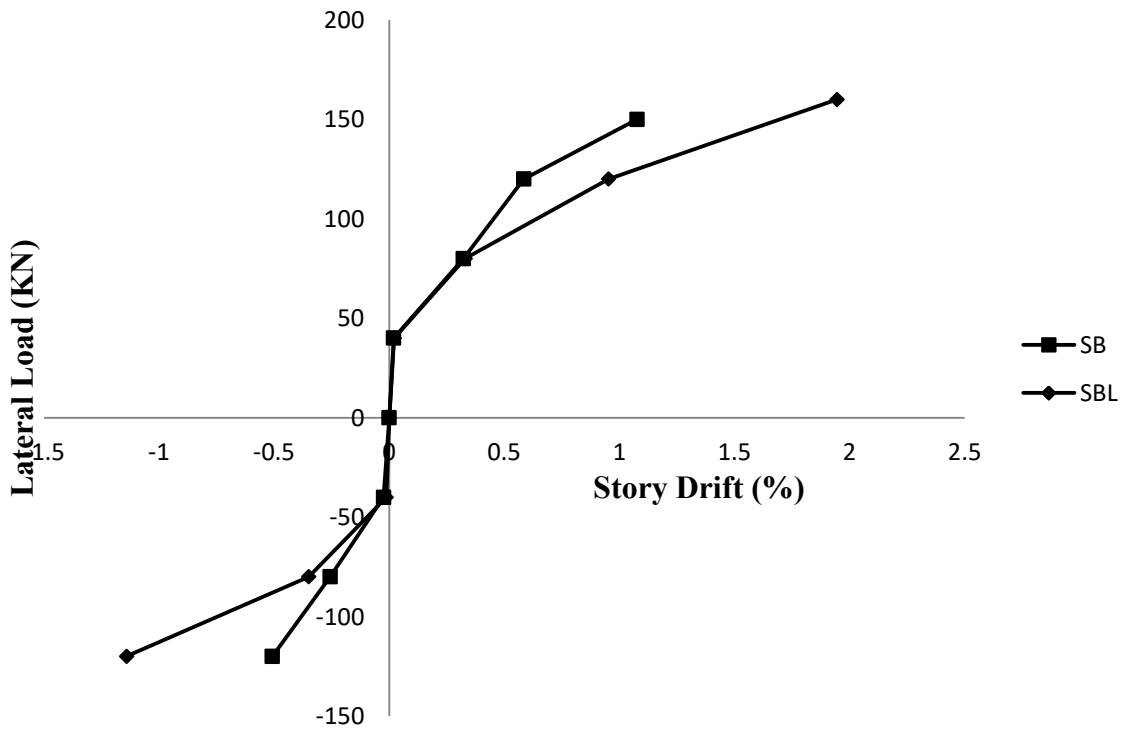
Figure 4.22: Relation between lateral load and story drift.

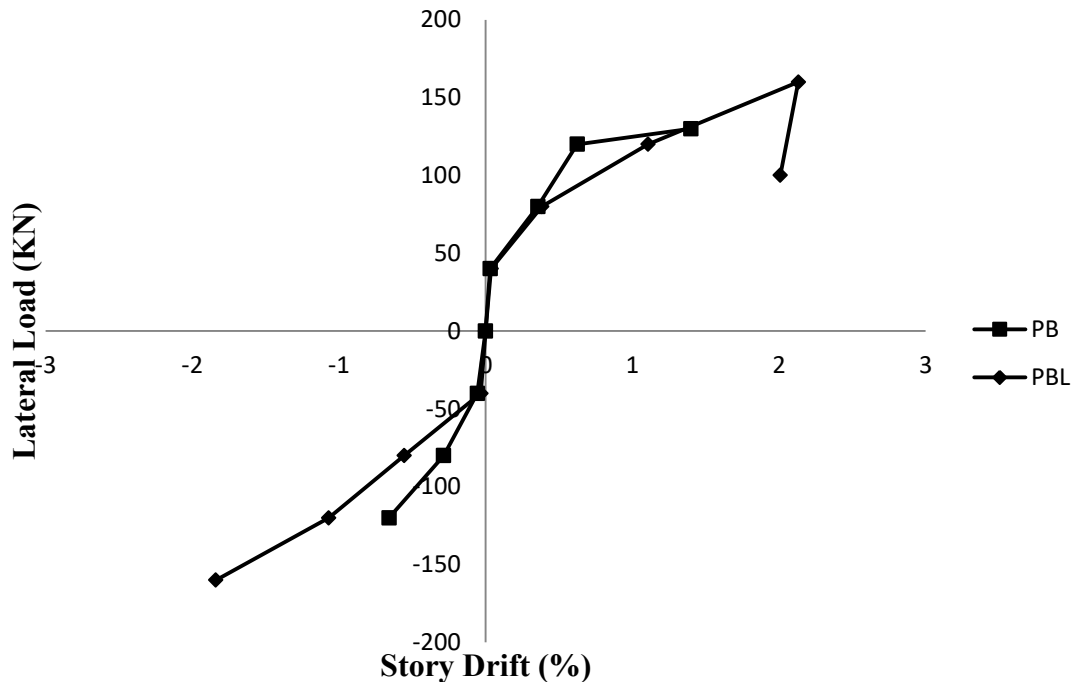
Figure 4.27: Relation between lateral load and story drift.

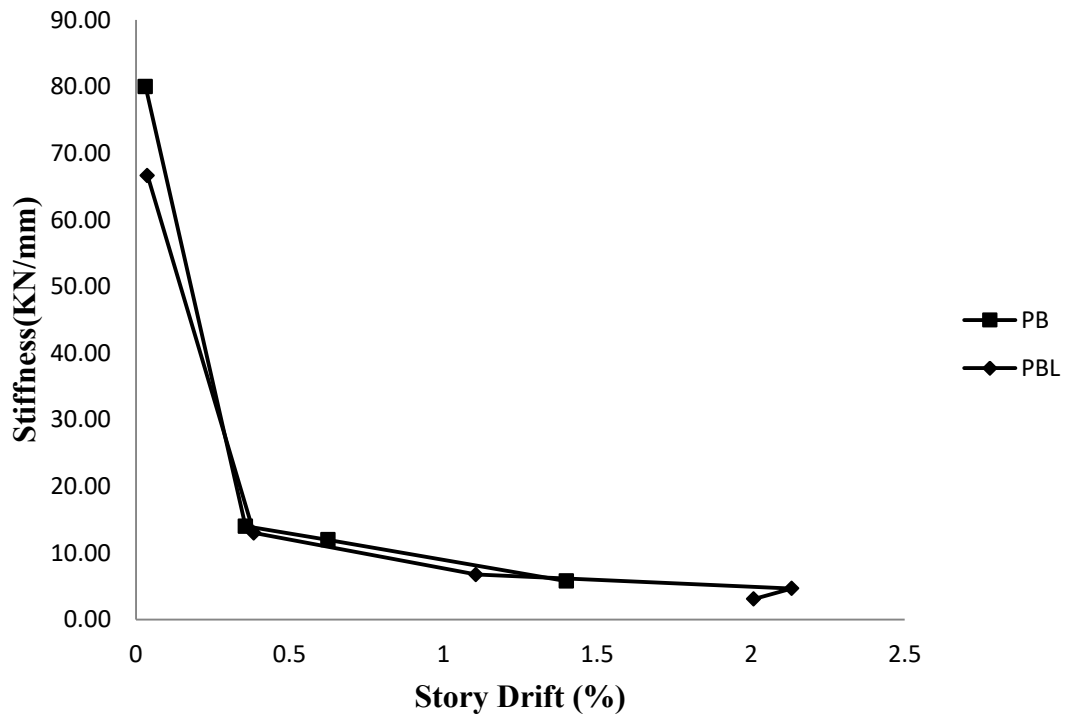
Figure 4.28: Relation between stiffness and story drift.

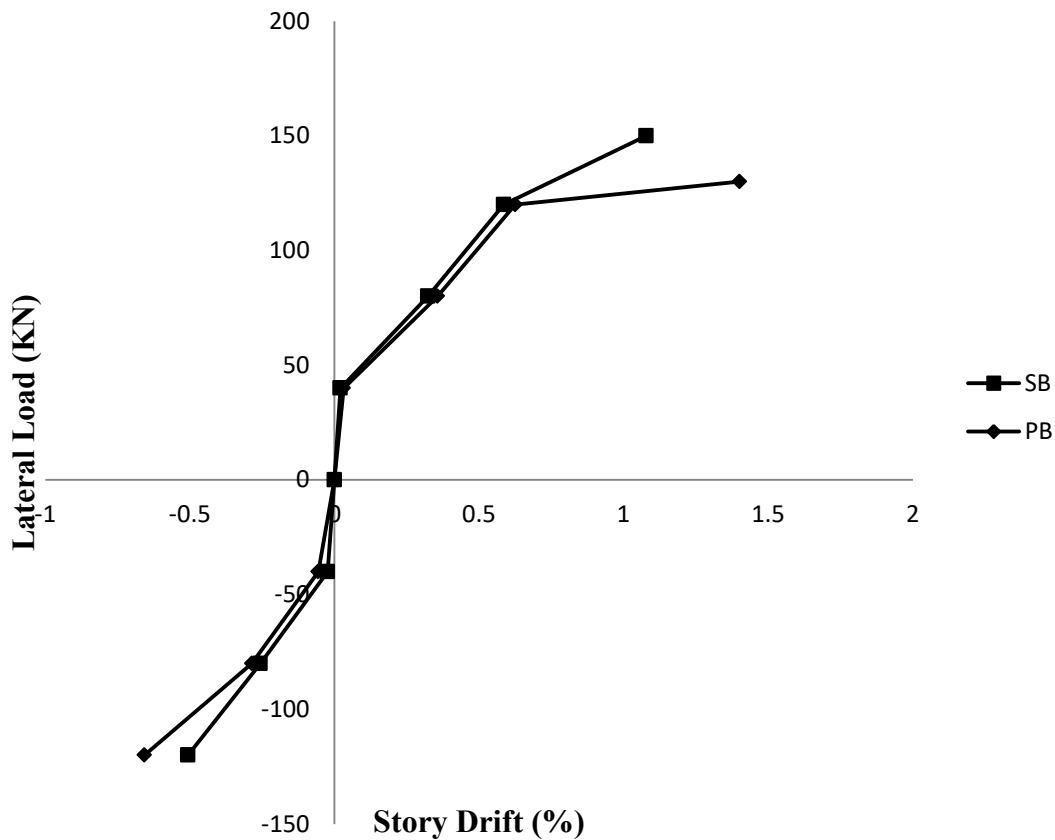
Figure 4.32: Relation between lateral load and story drift.

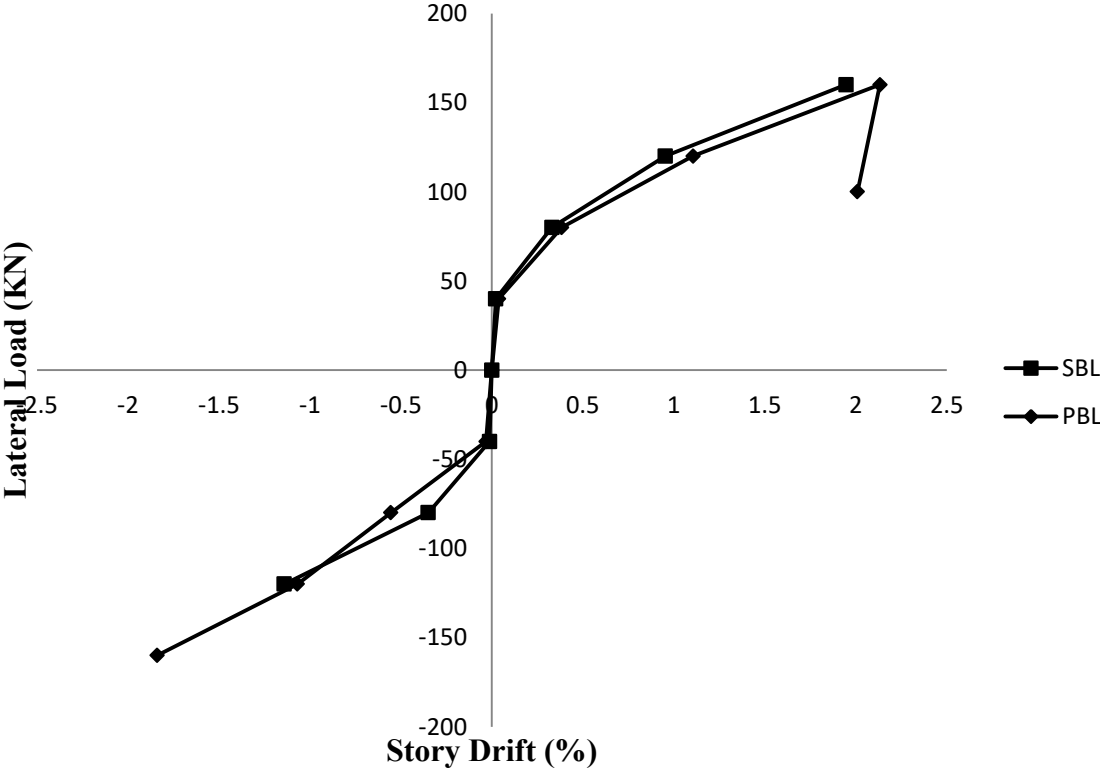
Figure 4.37: Relation between lateral load and story drift.

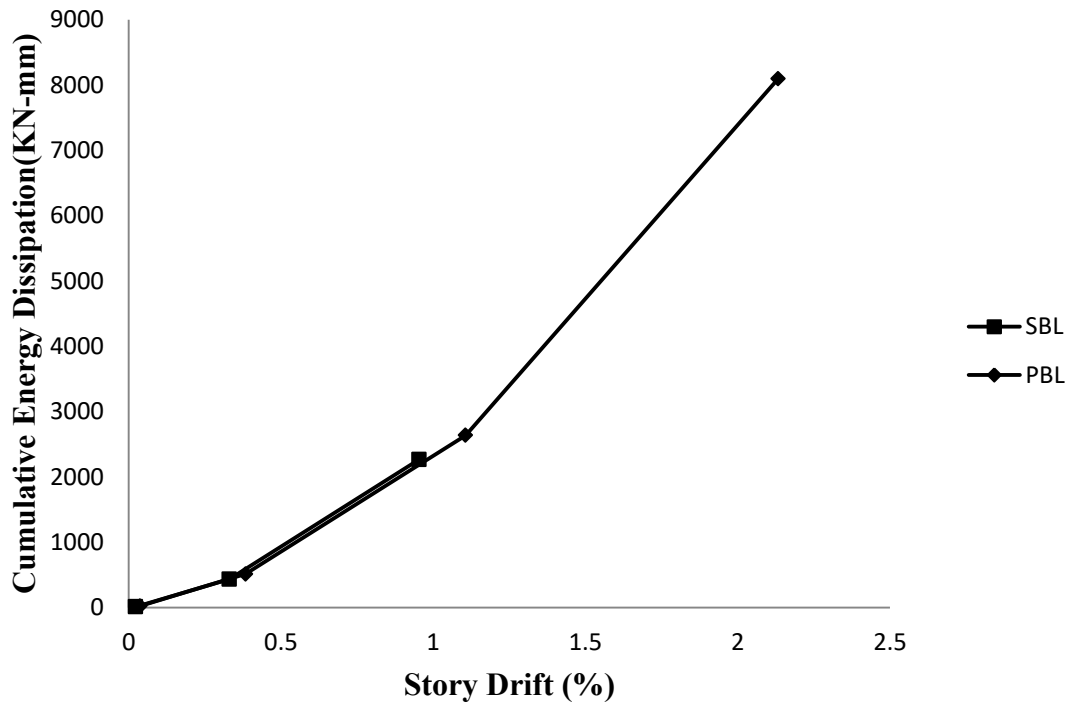
Figure 4.39: Relation between cumulative energy dissipation vs. story drift.

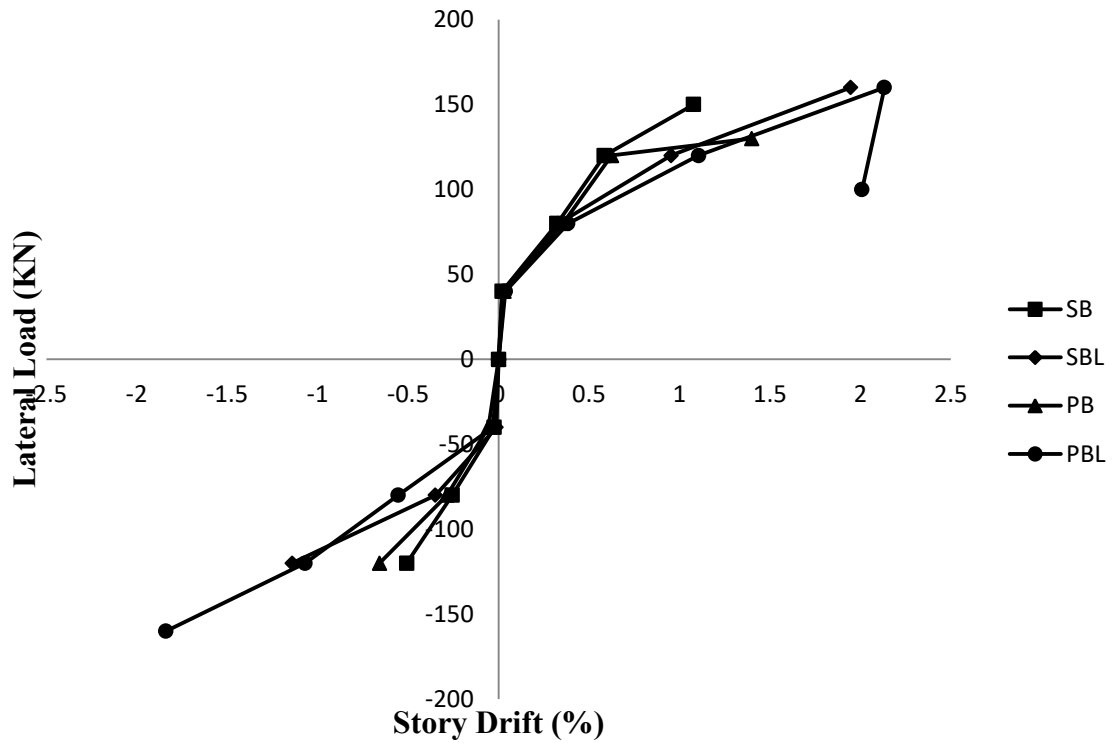
Figure 4.42: Relation between lateral load and story drift.

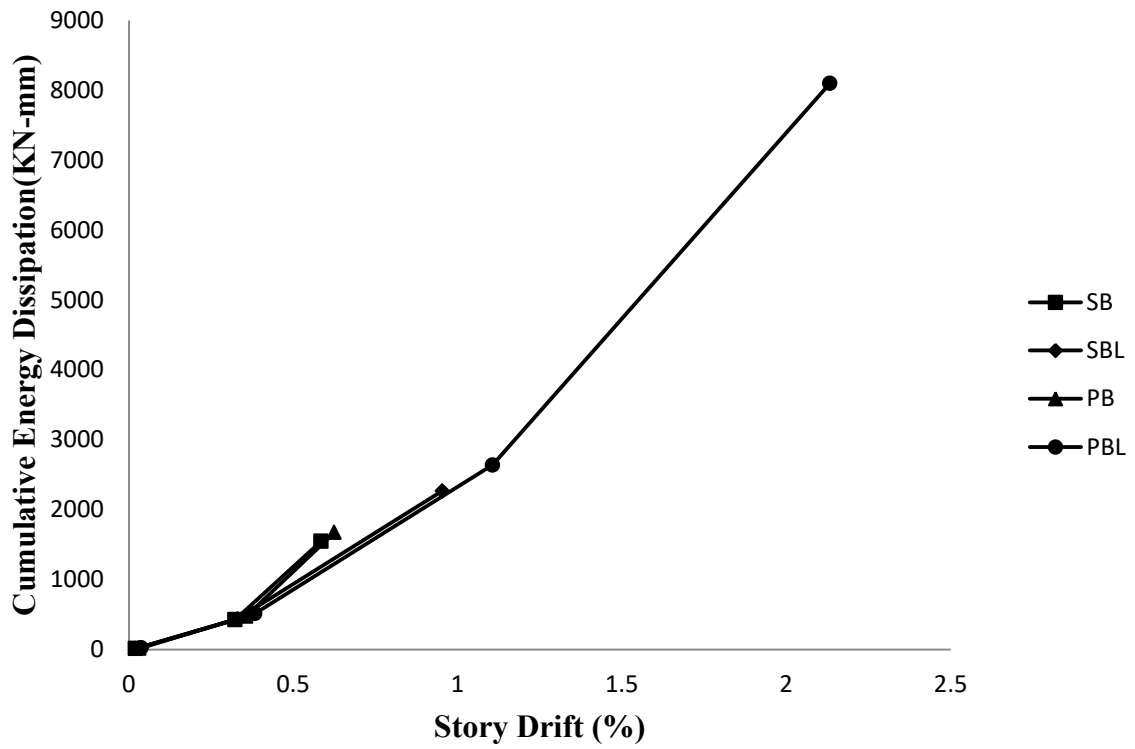
Figure 4.44: Relation between cumulative energy dissipation vs. story drift.

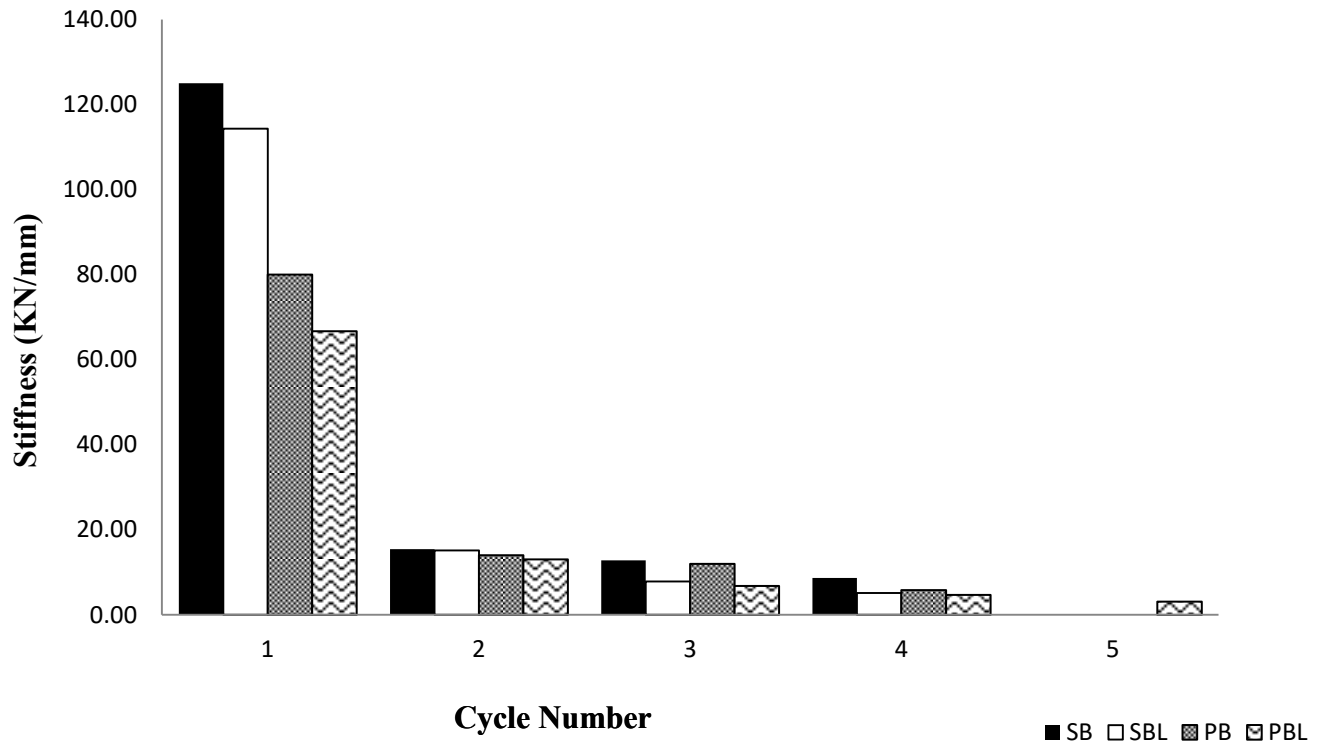
Figure 4.46: Stiffness at maximum displacement at each cycle.

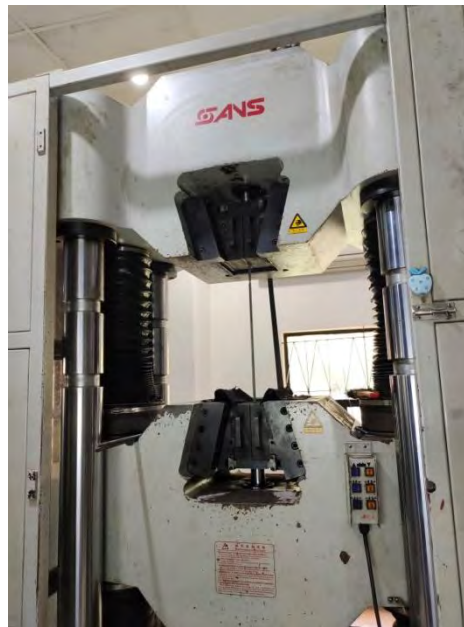
Dia (mm)	Weight /Length (kg/m)	Area of Bar (mm ²)	Yield Load (KN)	Yield Strength (MPa)	Average Yield Strength (MPa)	Ultimate Load (KN)	Ultimate Strength (MPa)	Average Ultimate Strength (MPa)	Elongation (%)
8	0.399	50	23.4	468	472	34.3	686	686	15
8	0.398	50	23.6	472		34.3	686		15
8	0.399	50	23.8	476		34.3	686		15
12	0.886	113	53.0	469	465	72.0	637	637	17
12	0.887	113	52.5	465		72.0	637		16
12	0.883	113	52.0	460		72.0	637		17

Figure A.1: Testing of rebar.

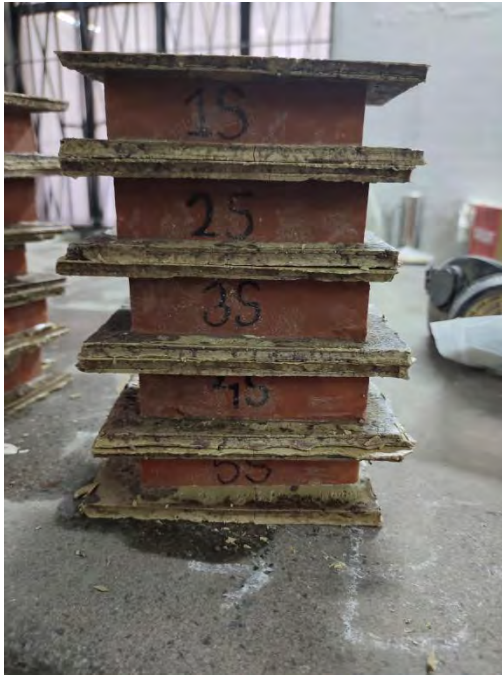
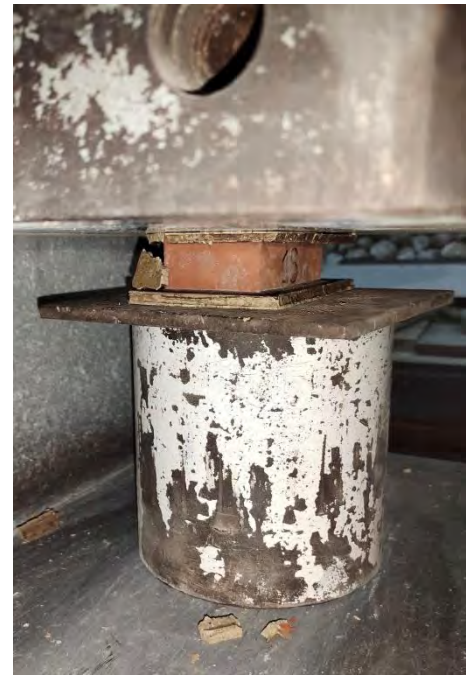
Brick	Length (mm)	Width (mm)	Height (mm)	Area (mm ²)	Observed load (KN)	Actual load (KN)	Compressive Strength (MPa)	Average Compressive strength (MPa)
1	102.50	58.00	30.00	5114.05	140.00	129.86	25.39	26.80
2	103.00	55.50	33.00	4885.55	196.00	186.08	38.09	
3	102.00	56.00	32.00	4881.05	112.00	101.75	20.85	
4	102.00	57.50	33.00	5034.05	124.00	113.80	22.61	
5	100.00	57.00	33.00	4869.05	142.00	131.87	27.08

Figure B.1: (a) Capping of bricks before testing, (b) Compressive strength testing of brick.

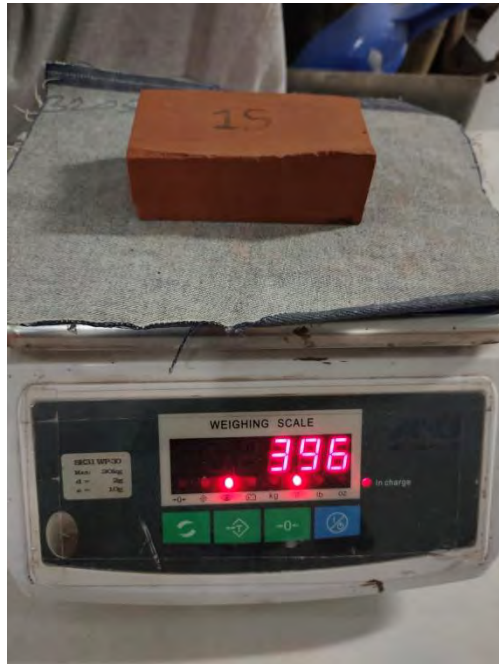
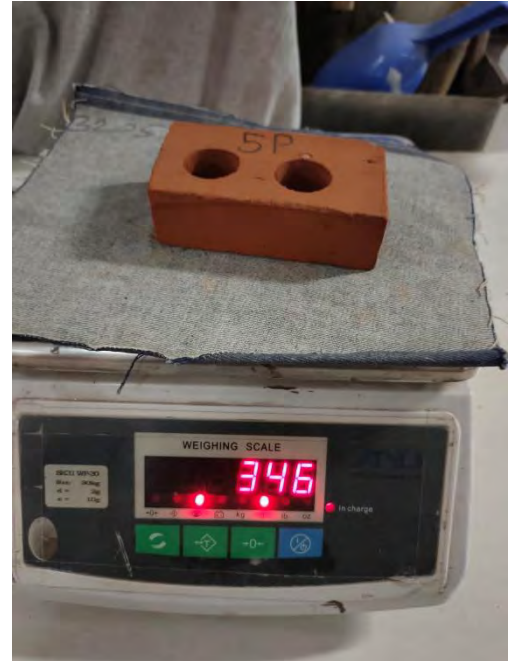
Brick	SSD weight (gm)	Dry Weight (gm)	Absorption Capacity (%)	Average Absorption Capacity (%)
1	353.00	313.00	12.78	12.84
2	351.00	310.00	13.23	
3	326.00	290.00	12.41	
4	346.00	306.00	13.07	
5	346.00	307.00	12.70

Figure C.1: Weighting of (a) solid clay brick and (b) perforated clay brick during absorption capacity testing.

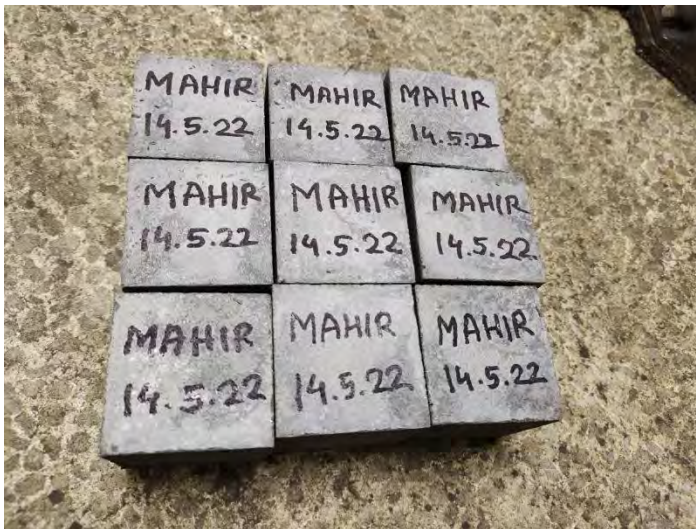
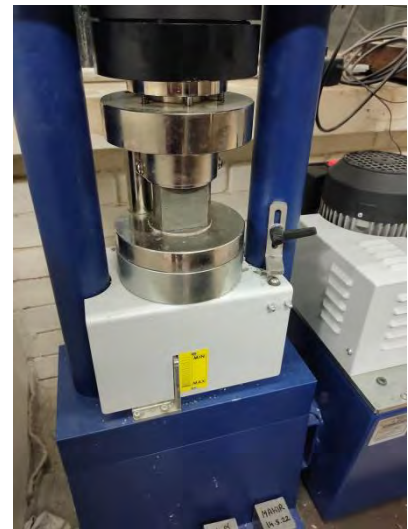
Days	Cube	Area (mm ²)	Observed load (KN)	Actual load (KN)	Stress (MPa)	Average stress (MPa)
7	1	2500	17.00	17.64	7.06	7.19
	2	2500	20.00	20.67	8.27	
	3	2500	15.00	15.63	6.25	
14	4	2500	28.60	29.33	11.73	12.61
	5	2500	30.50	31.25	12.50	
	6	2500	33.20	33.97	13.59	
28	7	2500	31.98	32.74	13.10	14.39
	8	2500	35.80	36.59	14.64	
	9	2500	37.78	38.59	15.43

Figure D.1: (a) Prepared mortar cubes (b) mortar testing.

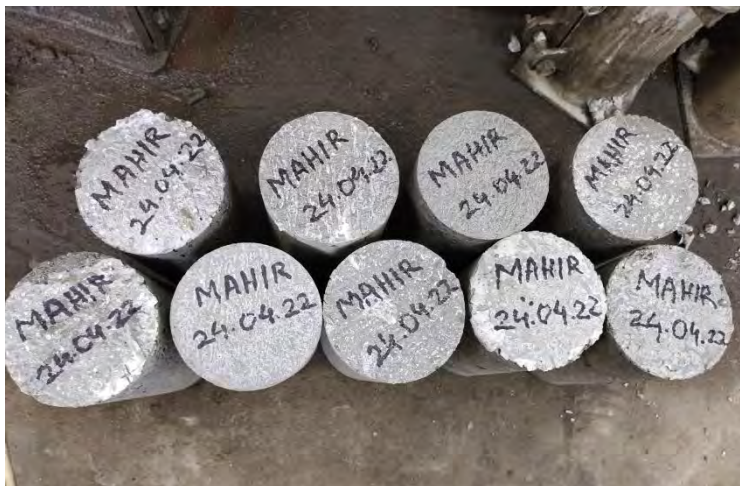
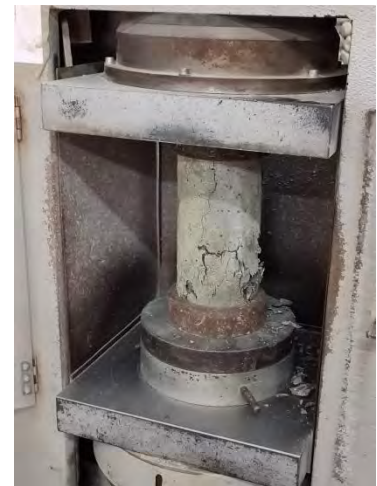
Days	Cylinder	Average Dia (mm)	Area (mm ²)	Observed load (KN)	Actual load (KN)	Compressive Strength (MPa)	Average Compressive Strength (MPa)
14	1	101.225	8047.60	150.00	147.13	18.28	17.90
	2	101.05	8019.80	150.00	147.13	18.35	
	3	101.225	8047.60	140.00	137.28	17.06	
21	4	101	8011.87	185.00	183.14	22.86	20.72
	5	101.15	8035.68	170.00	168.12	20.92	
	6	101.3	8059.53	150.00	148.09	18.37	
28	7	101	8011.87	181.00	177.64	22.17	21.63
	8	101.325	8063.51	178.00	174.69	21.66	
	9	101.325	8063.51	173.00	169.77	21.05

Figure E.1: (a) Prepared concrete cylinders (b) cylinder testing.

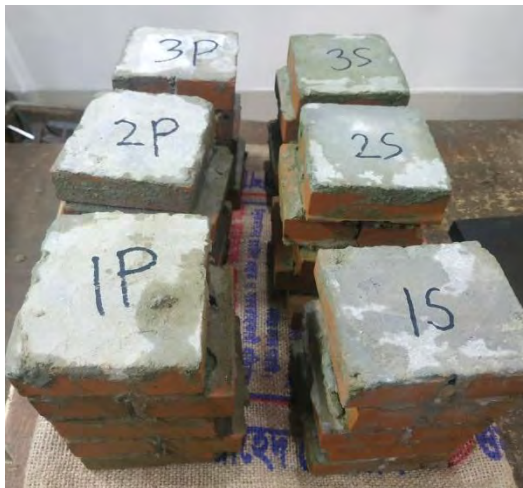
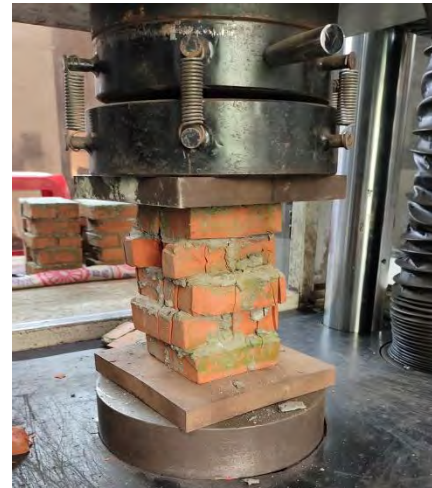
Brick	Length h (mm)	Width (mm)	Height (mm)	Area (mm ²)	Applied load (KN)	Compressive Strength (MPa)	Average Compressive Strength (MPa)
1	120	100	190	10338.09	54	5.22	4.50
2	118	102	190	10374.09	40	3.86	
3	115	105	180	10413.09	46	4.42

Figure F.1: (a) Prepared prisms (b) testing of prisms.
