**MORPHOLOGICAL STABILITY OF A DREDGED CHANNEL FOR RIVER
TRAINING: A CASE STUDY ALONG THE BRAIDED JAMUNA RIVER**

**INSTITUTE OF WATER AND FLOOD MANAGEMENT
BANGLADESH UNIVERSITY OF ENGINEERING AND TECHNOLOGY**

NOVEMBER 2013

In partial fulfillment of the requirement for the degree of
MASTER OF SCIENCE IN WATER RESOURCES DEVELOPMENT

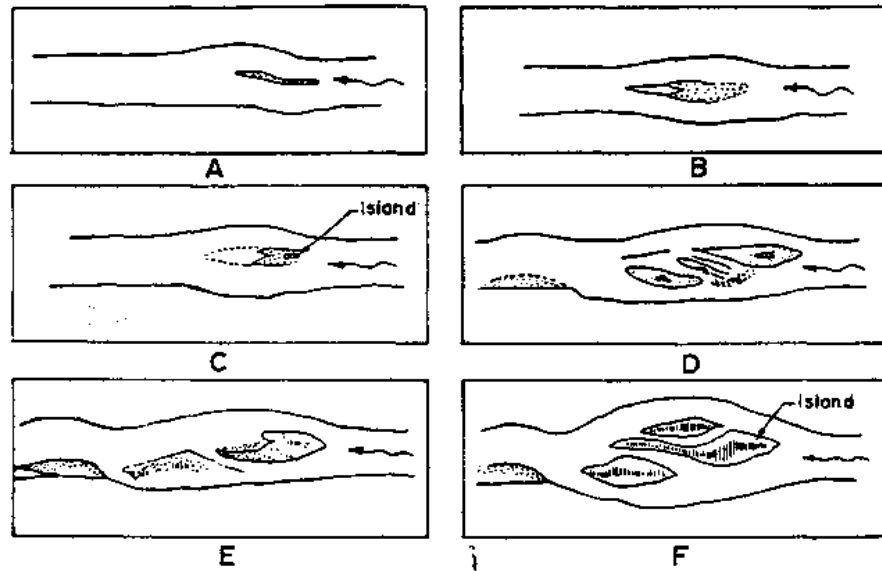
Figure 2.2: Steps in the development of a braiding process (Leopold and Wolman, 1957).

The velocity distribution over a mid-channel growing bar reduces after accreting the bar to a certain level shown in “E” (Ashworth, 1995). This forces the flow further towards the bank attributing the further widening of the channel. Widening of the channel increases the flow area and drops the water level, which results in the bar emerging (“F”) for constant discharge. These are the mechanisms of the mid-channel bar initiation as based on (Leopold and Wolman, 1957). Migration of channels within the braid belt is mainly related

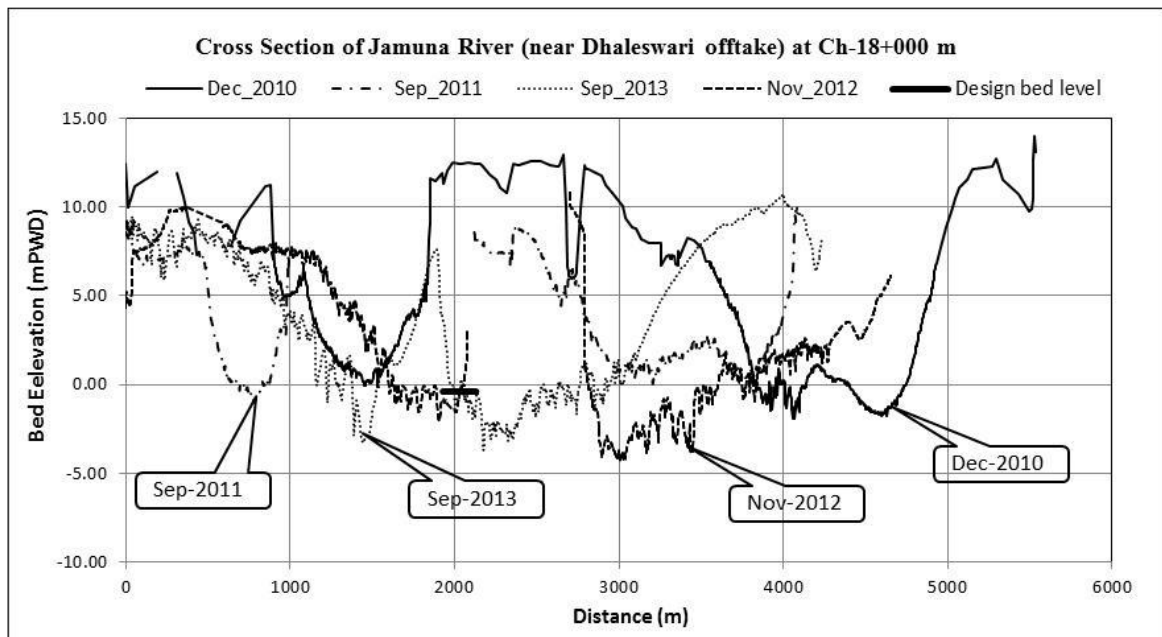
Figure 5.11: Cross-sections of Jamuna River near downstream of Bangabandhu Bridge.

The cumulative backfill percentage was found to be around 28% from downstream of Bangabandhu Bridge to Dhaleswari offtake (Source: IWM, 2013). Figure 5.11 represents, insignificant impact of dredging is found at D/S of Bangabandhu Bridge near Dhaleswari Offtake, because during implementation of dredging we cannot change the upstream river morphology as well as the hydraulic condition of the dredged channel.

Summary results from cross-section comparison: Cross-section data has been plotted at six locations, shown in (Figure 5.6 to Figure 5.11) from upstream of Sirajganj Hardpoint to downstream of Bangabandhu Bridge near Dhaleswari offtake. These cross-section data which is plotted is from the year 2010 to 2013, because pilot capital dredging was implemented on 2011-2012. Figure 5.6 and Figure 5.7 represents, insignificant impact of dredging is observed at upstream of Sirajganj Hardpoint as well as the Sirajganj Hardpoint area. Figure 5.7 also represent, a minor rate of sedimentation is observed around Sirajganj Hardpoint area during implementation of dredging. At that time, the scour depth at Sirajganj Hardpoint was reduced up to maximum 5m. However, it seems that dredging would help to reduce scour depth around Bangabandhu Bridge guide bundh and it would provide safety to the guide bundh for a very short period.

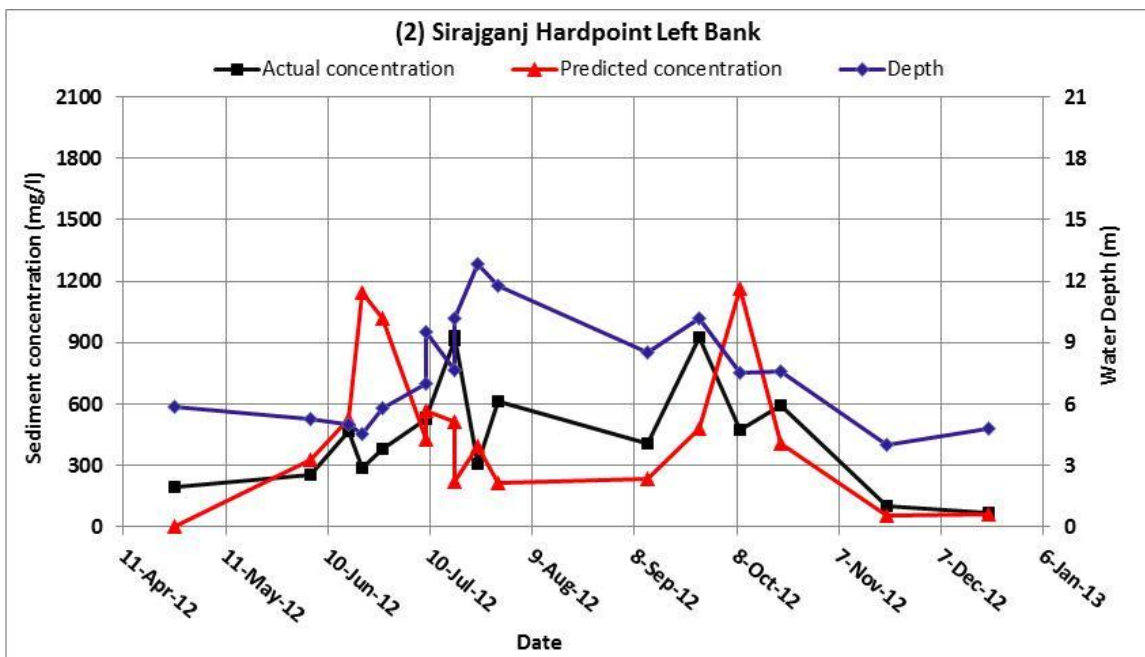
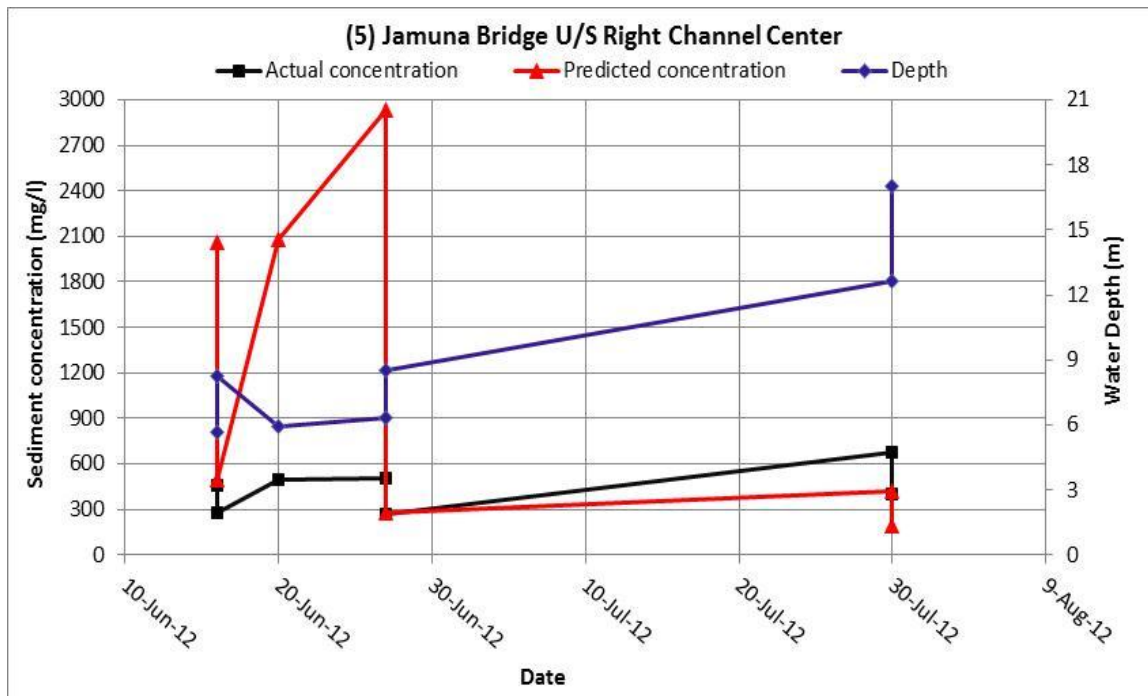
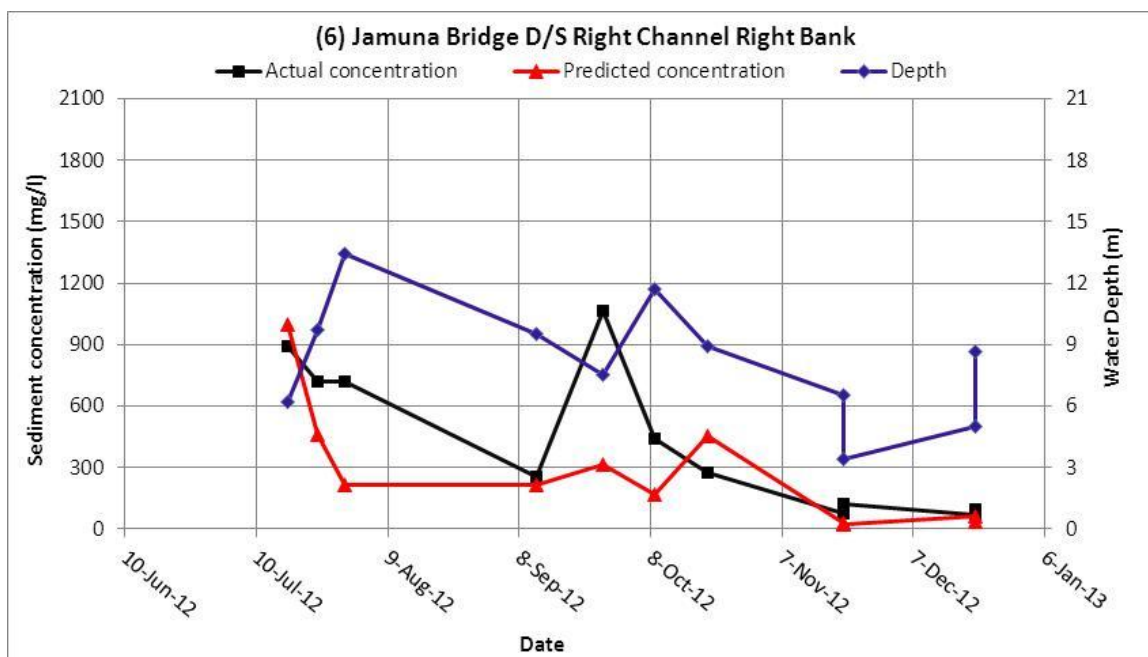
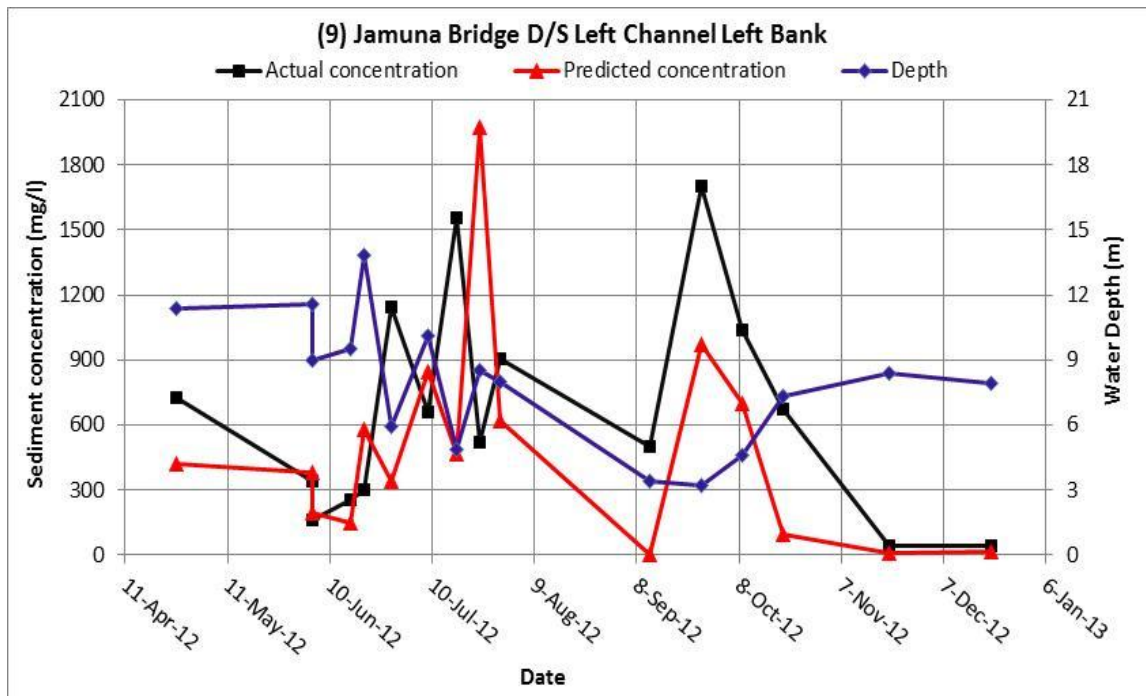
Figure 5.22: Depth, predicted and actual sediment concentration at Sirajganj Hardpoint Right Bank of Jamuna River in period April, 2012 to January, 2013.

Figure 5.23: Water depth, predicted and actual sediment concentration at Sirajganj Hardpoint left bank of Jamuna River in period April, 2012 to January, 2013.

Figure 5.26: Depth, predicted and actual sediment concentration at Bangabandhu Bridge U/S right channel center of Jamuna River in period June-August, 2012.

Figure 5.27: Depth, predicted and actual sediment concentration at Bangabandhu Bridge D/S right channel right bank of Jamuna River in period June, 2012 to January, 2013.

Figure 5.28: Depth, predicted and actual sediment concentration at Bangabandhu Bridge D/S right channel left bank of Jamuna River in period April-November, 2012.

Figure 5.29: Depth, predicted and actual sediment concentration at Bangabandhu Bridge D/S left channel right bank of Jamuna River in period May, 2012 to January, 2013.

Figure 5.30: Depth, predicted and actual sediment concentration at Bangabandhu Bridge D/S left channel left bank of Jamuna River in period April, 2012 to January, 2013.

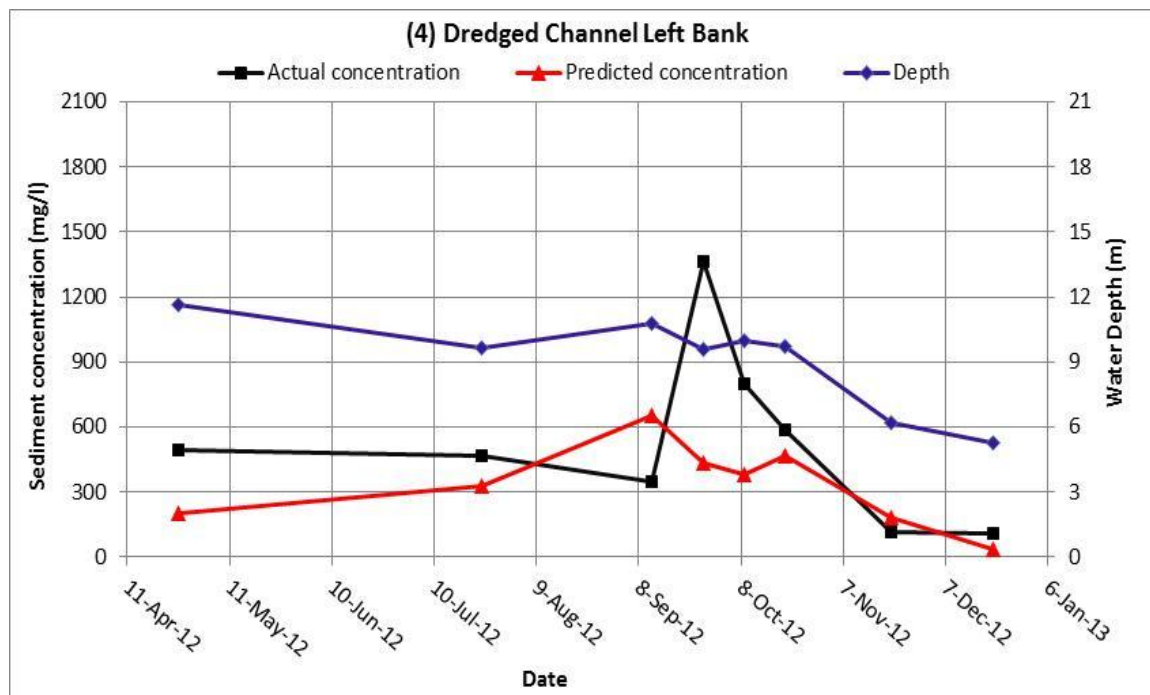
Figure 5.24: Depth, predicted and actual sediment concentration at dredged channel right bank of Jamuna River in period May to November, 2012.

Figure 5.25: Depth, predicted and actual sediment concentration at dredged channel left bank of Jamuna River in period April, 2012 to January, 2013.

- Figure 5.24 shows, the rate of actual sediment concentration is higher than the predicted sediment concentration and Figure 5.25 shows, the actual sediment concentration is higher than the predicted sediment concentration on dredged channel right bank and left bank of Jamuna River. In this location the dredging alignment passing through the high char. It was happening due to loose soil material at the char, when flow was passing through the dredged channel. The right bank of the dredged

channel was eroded due high flow velocity and left bank was silted up due to slope failure of the bank. Due to this condition the size of the dredged channel was widening but the depth of the channel were decreased which is compared with the measured cross section shown in Figure 5.8.
