**A STUDY ON WALKABILITY FOR SUSTAINABLE DEVELOPMENT IN CENTRAL
BUSINESS DISTRICT MOTIJHEEL, DHAKA**

A Thesis submitted in partial fulfillment of the requirement for the degree of

MASTER OF ARCHITECTURE

Department of Architecture
BANGLADESH UNIVERSITY OF ENGINEERING AND TECHNOLOGY

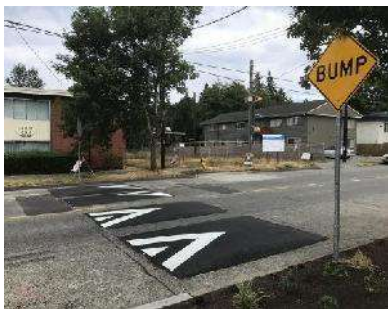
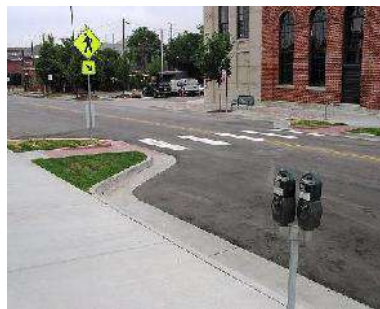
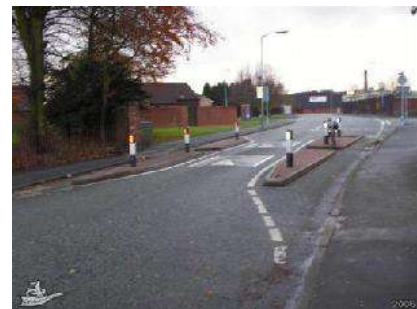
Figure 2.3: Traffic Calming Measures (J. Owen, 2021)

a) Speed Tables

b) Curb Extensions

c). Narrowed Lanes

Here, On-street parking spots are typically minimized while walking spaces are typically widened. If relocation is not feasible, taxi stands and green minibus stands can be available. Access for vehicles is unrestricted. By traffic-calming devices like speed tables (a), curb extensions (b), sharpened corners, and narrowed lanes (c), are made the vehicles go more slowly (Fig 2.3).

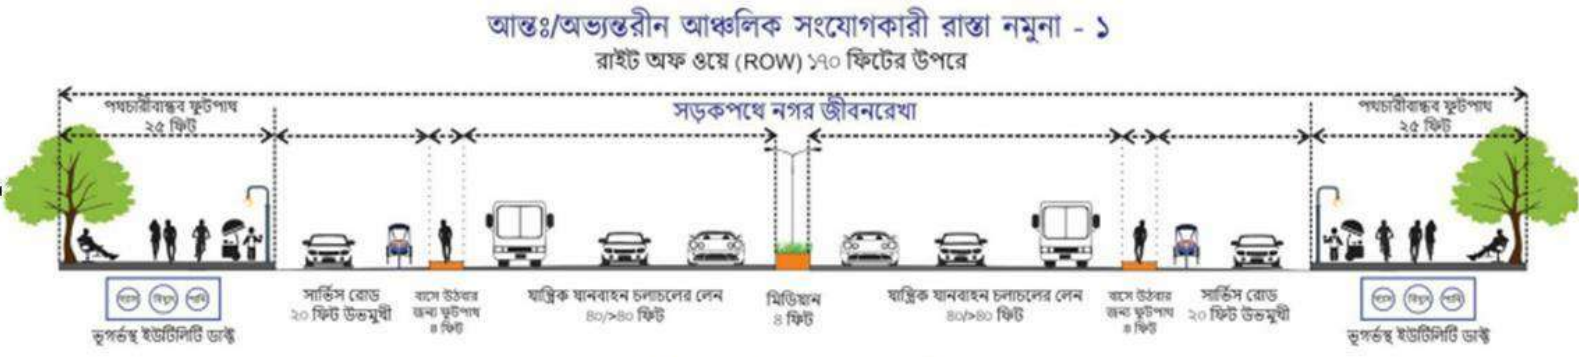
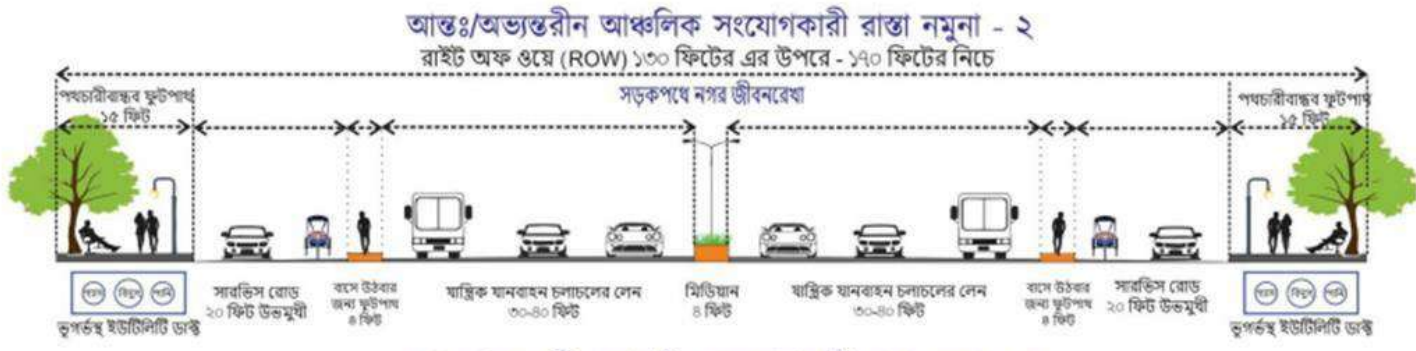
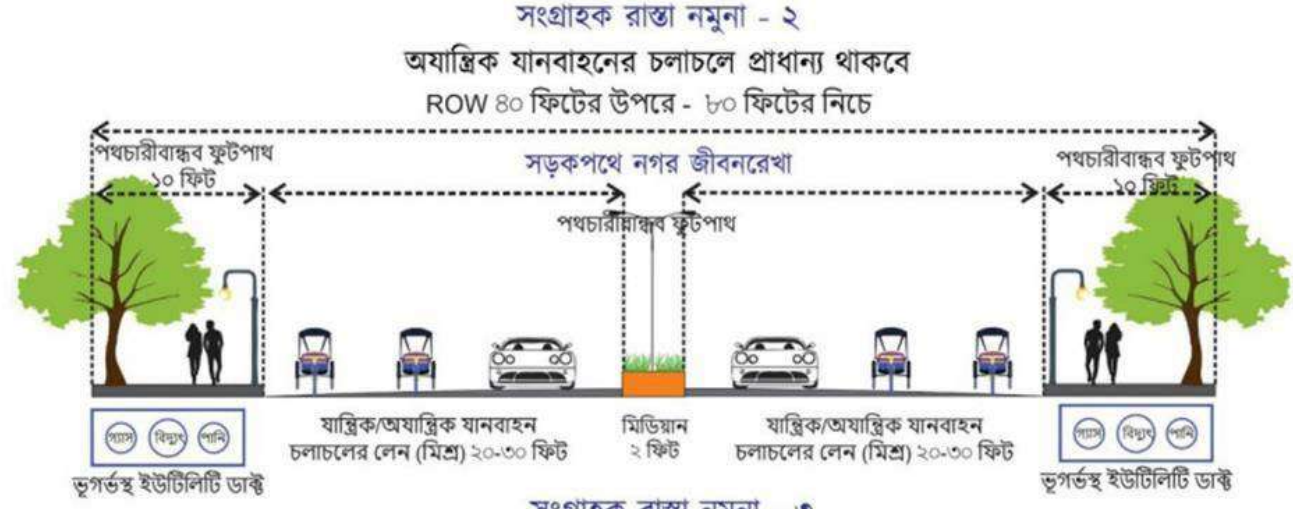
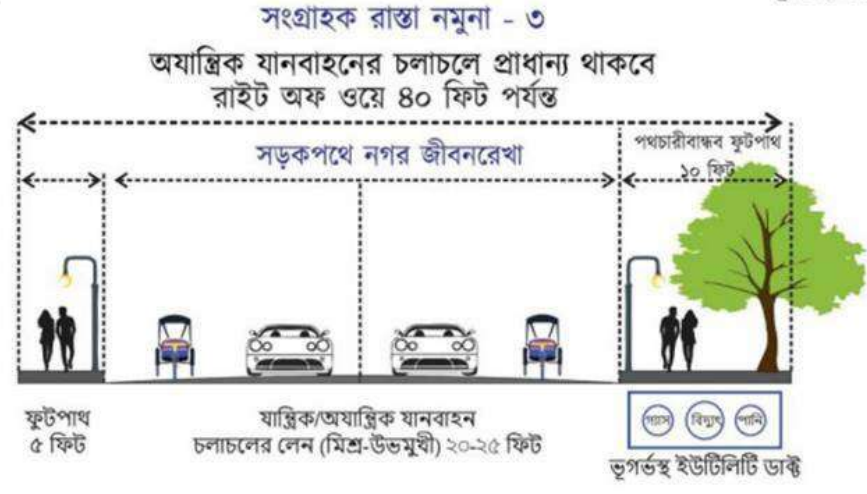
Figure 2.7: Road Classification and Lane Configuration (Detail Area Plan, 2022)

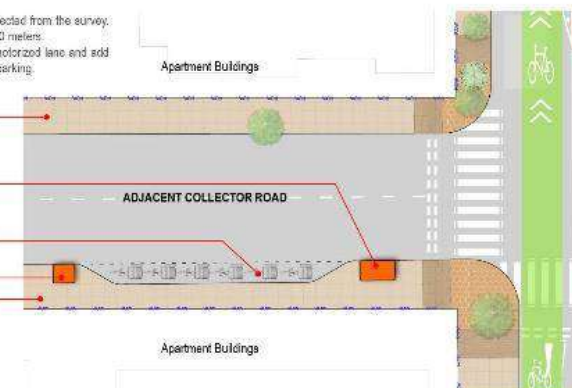
- FOOTPATH - Approx. 2M width
- RICKSHAW REPAIRING & MANAGEMENT KIOSK IN ALTERNATE ROADS (Can be used as Bus Ticketing Booth near segregated Bus Stops)
- PARKING AREA
- TEA AND DRINKING WATER STALL
- FOOTPATH - Approx. 2M
- + 1M width extra width for proposed parking

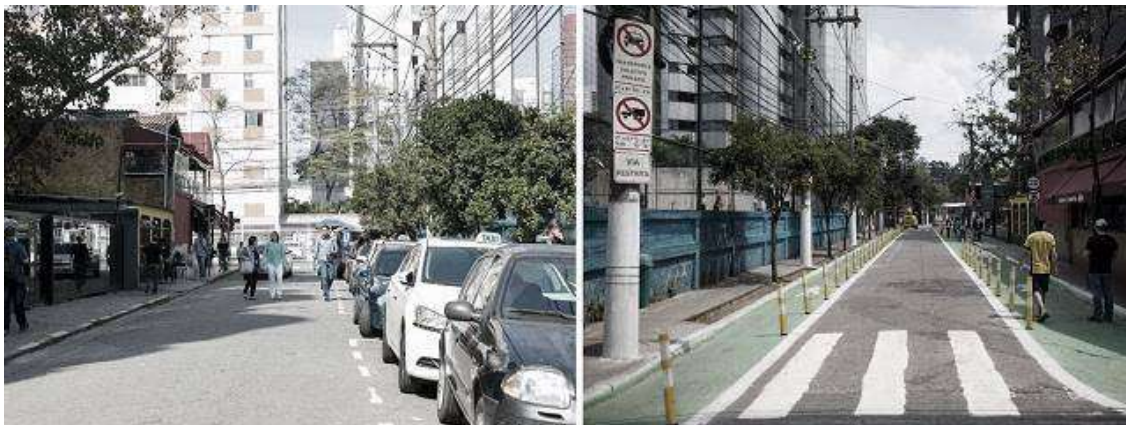
The Berrini Train Station in So Paulo and the city's core business district are connected by Joel Carlos Borges Street, which is home to numerous everyday patrons. Prior to September 2017, the street's confined sidewalks were unable to securely handle the dense foot traffic (about 22.5 persons per vehicle during peak hours). With an additional 3.5 meters of width, the previously cramped and dilapidated sidewalks now have enough room for foot traffic after expansion. The quality of life and safety of everyone are improved by enlarging walkways and narrowing car lanes, which also slow down traffic.

Before

After

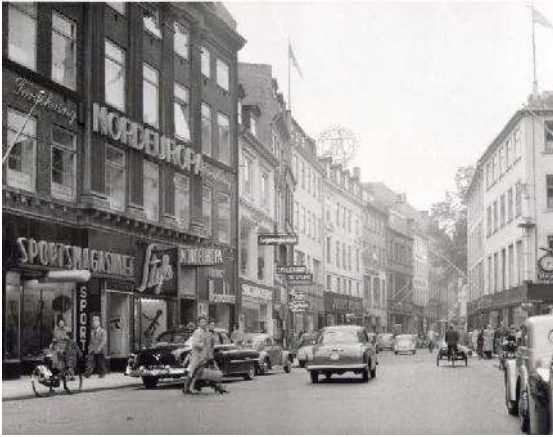
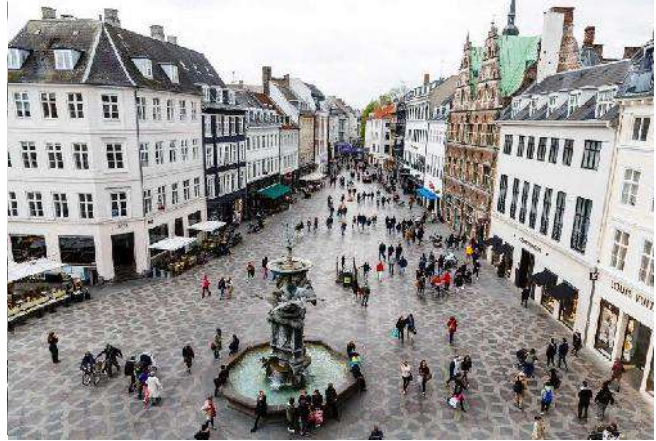
Until 1962, all the streets and squares of central Copenhagen were used intensively for vehicle traffic and parking, and were under pressure from the rapidly growing fleet of private vehicles. The pedestrianization of Copenhagen began with the city's main street, Stroget, which was converted in 1962 as an experiment. The conversion of the 1.15 km-long main street into a pedestrian street was seen as a pioneering effort, which gave rise to much public debate before the street was converted. Soon, Stroget proved to be a huge success, with businesses realizing that traffic-free environments provide increased financial revenue. Magasin Torv, the square by Nikolaj Church, and Grabrodre Torv were the first squares to be renovated. The Key elements was to Removal of all traffic from the street, Removal of curbs and sidewalks, addition of new paving, and Consolidation of street furniture to facilitate pedestrian movement. The ultimate Goals was to

Before

After

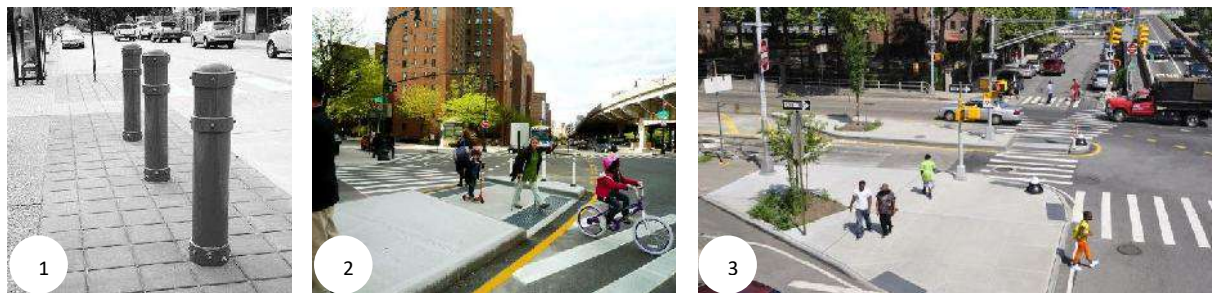
Figure 2.12: 1. Examples of the bollard in Amsterdam (Maas & van Eekelen, 2004), 2. Median cut-through – Nagoya (Iryo-Asano & Alhajyaseen, 2014), 3. Pedestrian refuge island – Hongkong (Saleh, Grigorova, & Elattar, 2020)

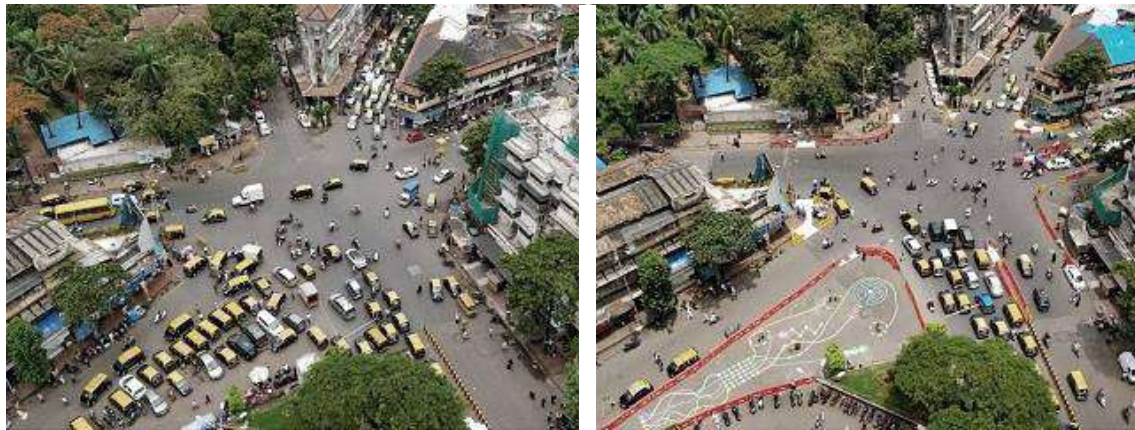
Figure 2.14: Nagpada intersection, Mumbai, India, August 2017 (MMRC, 2017)

Like many others in Mumbai, the Nagpada intersection is hectic and difficult to maneuver for all users, both vehicular and non-vehicular. At peak periods, the triangular junction, which joins six main routes, can only handle 3,000 vehicles per hour while being extremely congested. There was little to no pedestrian sidewalk space, and the current sidewalk was in poor condition. These elements combined to create an intersection that was ineffective, risky, and perplexing. In August 2017, In order to direct traffic and create secure pedestrian

walkways, the city temporarily changed the intersection's triangle form. Distances between crossings were kept to a minimum, and marked crossings were put in on each side of the intersection. A sizable unlawful parking lot was also reclaimed by the design and converted into a pedestrian plaza. The chaotic crossroads developed become a hub for social interaction. The city has committed to implementing the Nagpada redesign on a long-term basis as a result of its success.

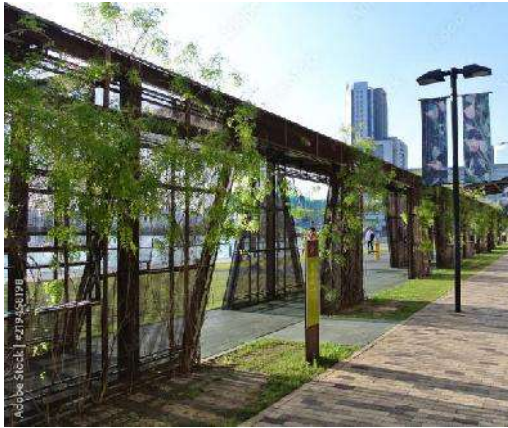
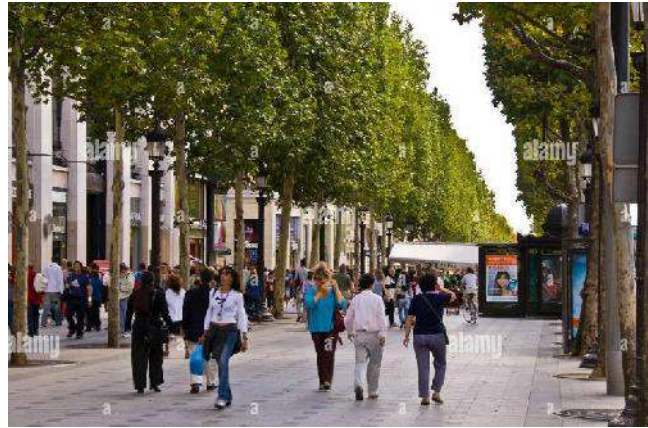
Figure 2.15: Shaded walkway (Ahmad, Ahmad, & Aliyu, 2021)

The vision for walkable Jakarta 2022 entails that, to ensure comfort, shade facilities can be installed when walking. Shade facilities can be an artificial or natural shade that protects from the weather. This component includes trees, a canopy, or also the roof of a building. After examining the previous cases, it became clear that each city had certain goals, such as restricting vehicular access, reducing the greenhouse effect, revitalizing the urban fabric, boosting retail activity, and reviving the economy.

Artificial Shading

Natural Shading

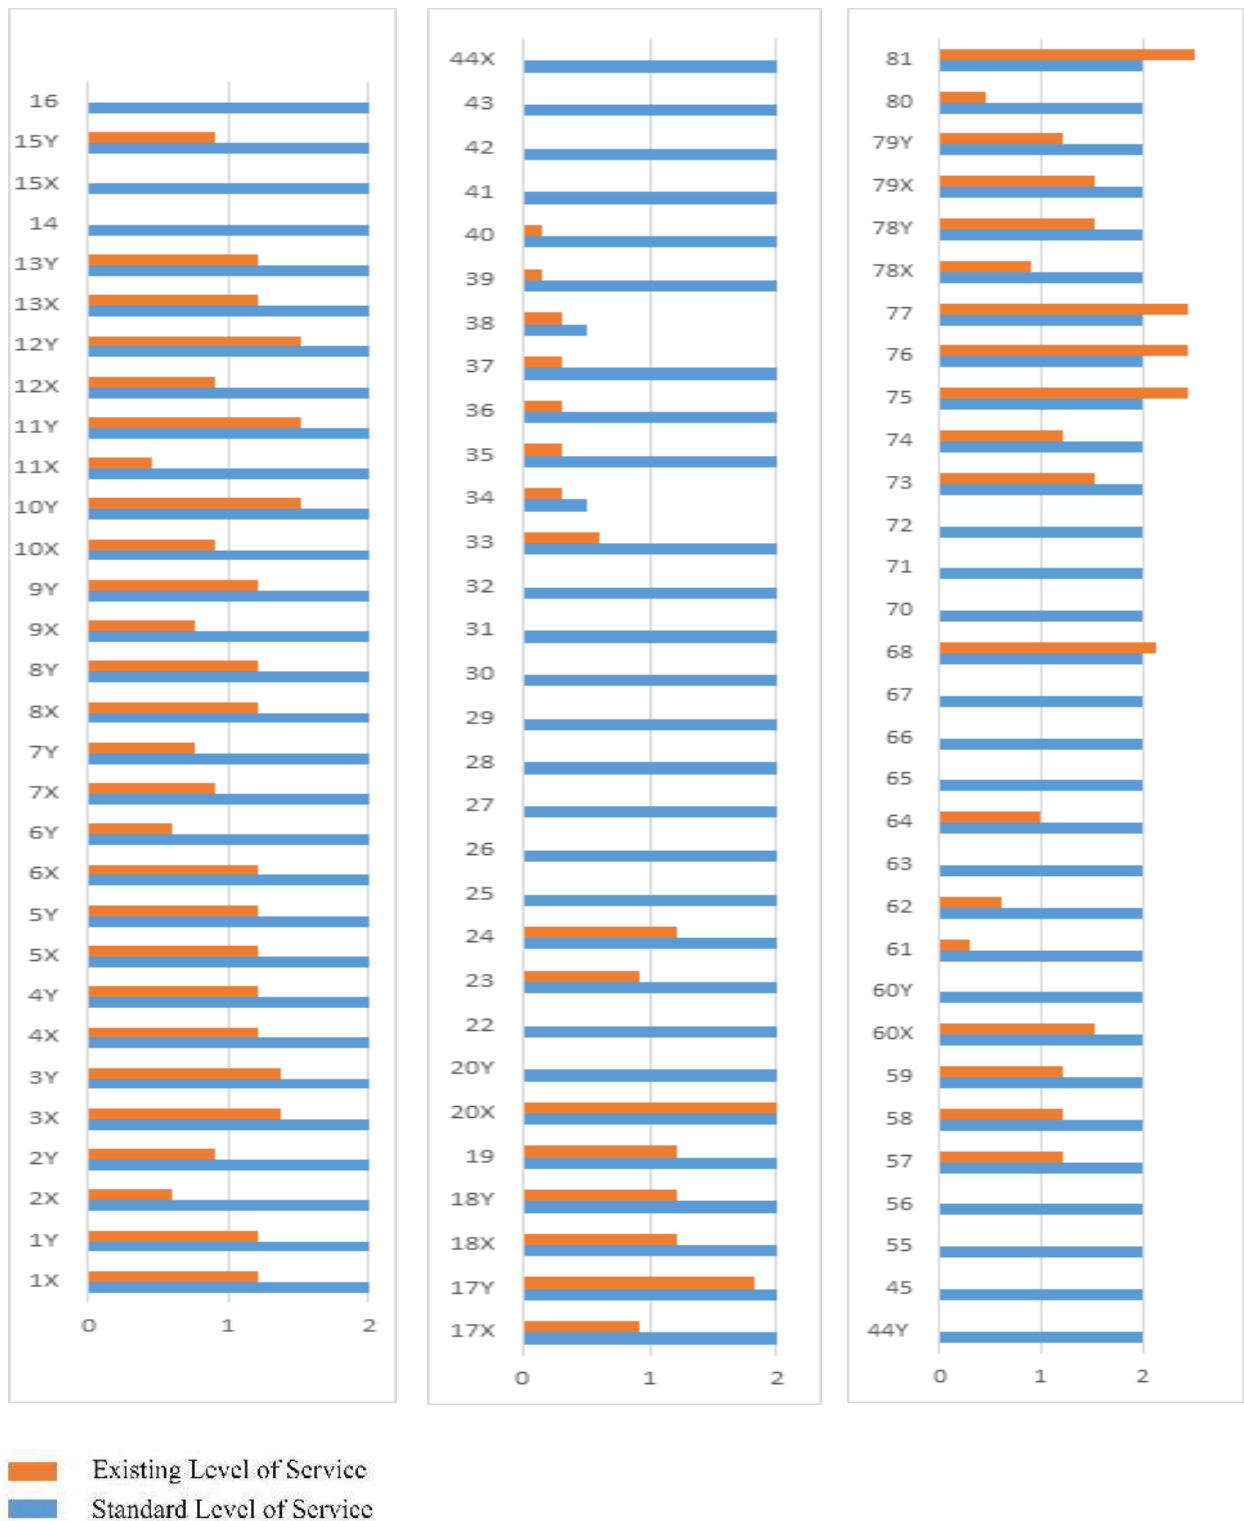
Figure 4.9: Graphical Presentation of Level of Service Analysis

Adequate, effective walkable space is specifically related to the pedestrian movement pattern. A person requires a frictionless walkable space on the both-way directional pavement. Effective walkable space means a clear space dedicated to walking without any obstruction.

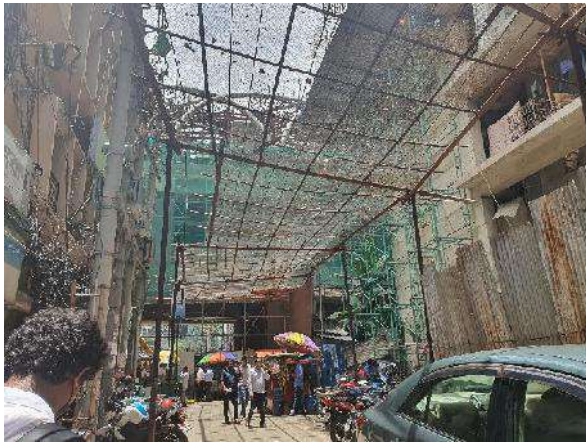
Figure 4.10: The Future Metro Station Transit Area

Figure 4.10 portrays the future metro station area where the movement will start with insufficient space, and Figure 4.11 shows the collector road congestion at 2.30 pm. The reason for congestion or space inadequacy has been evaluated in detail by SCI analysis. Apart from the congestion, the available walkable parts are not properly used because of the enormous infrastructural deficits that threaten the walkable environment of the Motijheel CBD area, such as surface irregularities, water accumulation problems, discontinuity, pitiable pavement construction material, loss of concrete at drainage covering, filthy garbage stand overflows on walkable space, absence of crossing demarcation, bus stoppage, and informal van rickshaw parking and so on in this research, the assessment on these existing physical attributes are the core fact to notify the faults in walkability within the CBD context.

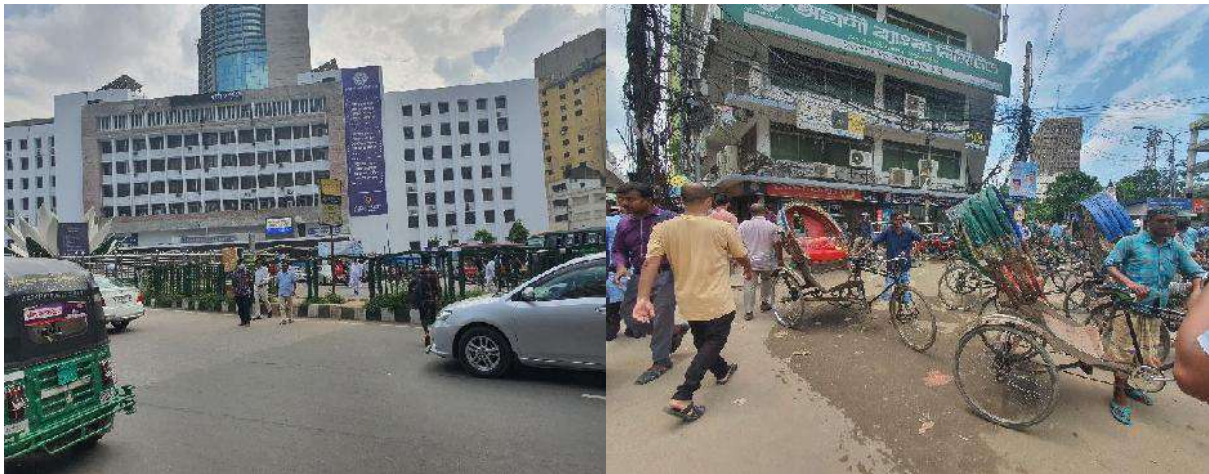
Figure 4.13: Crossing at Shapla-chatter node and Crossing at Dainik-Bangla Node

The second most serious obstruction has been notified is rickshaw or bike parking (29% severe and 15% dense) on walkable spaces because they have no separate zone to stand. Subsequently, it affects the pedestrian flow rate and overall width throughout the pavement, which is unexpected and problematic for pedestrians. Existing pedestrian users are already a pressure on the existing walkable space. This CBD's efficiency in walkability is worsening daily in north-south and east-west directions both, which is severely discontinuous. At the same time, with the discontinuity issue, the scope of organized crossing facilities is completely underprivileged within the overall walkable network. Ordinarily, no signage exists for a pedestrian crossing at several points (Figure 4.13).

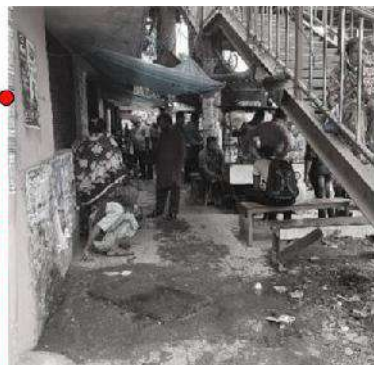
<p>Base Layer Damage (7x)</p>

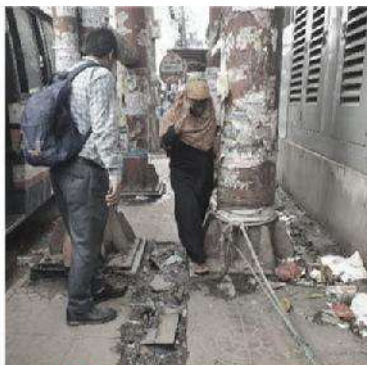
<p>Brick Tile Damage (7y)</p>

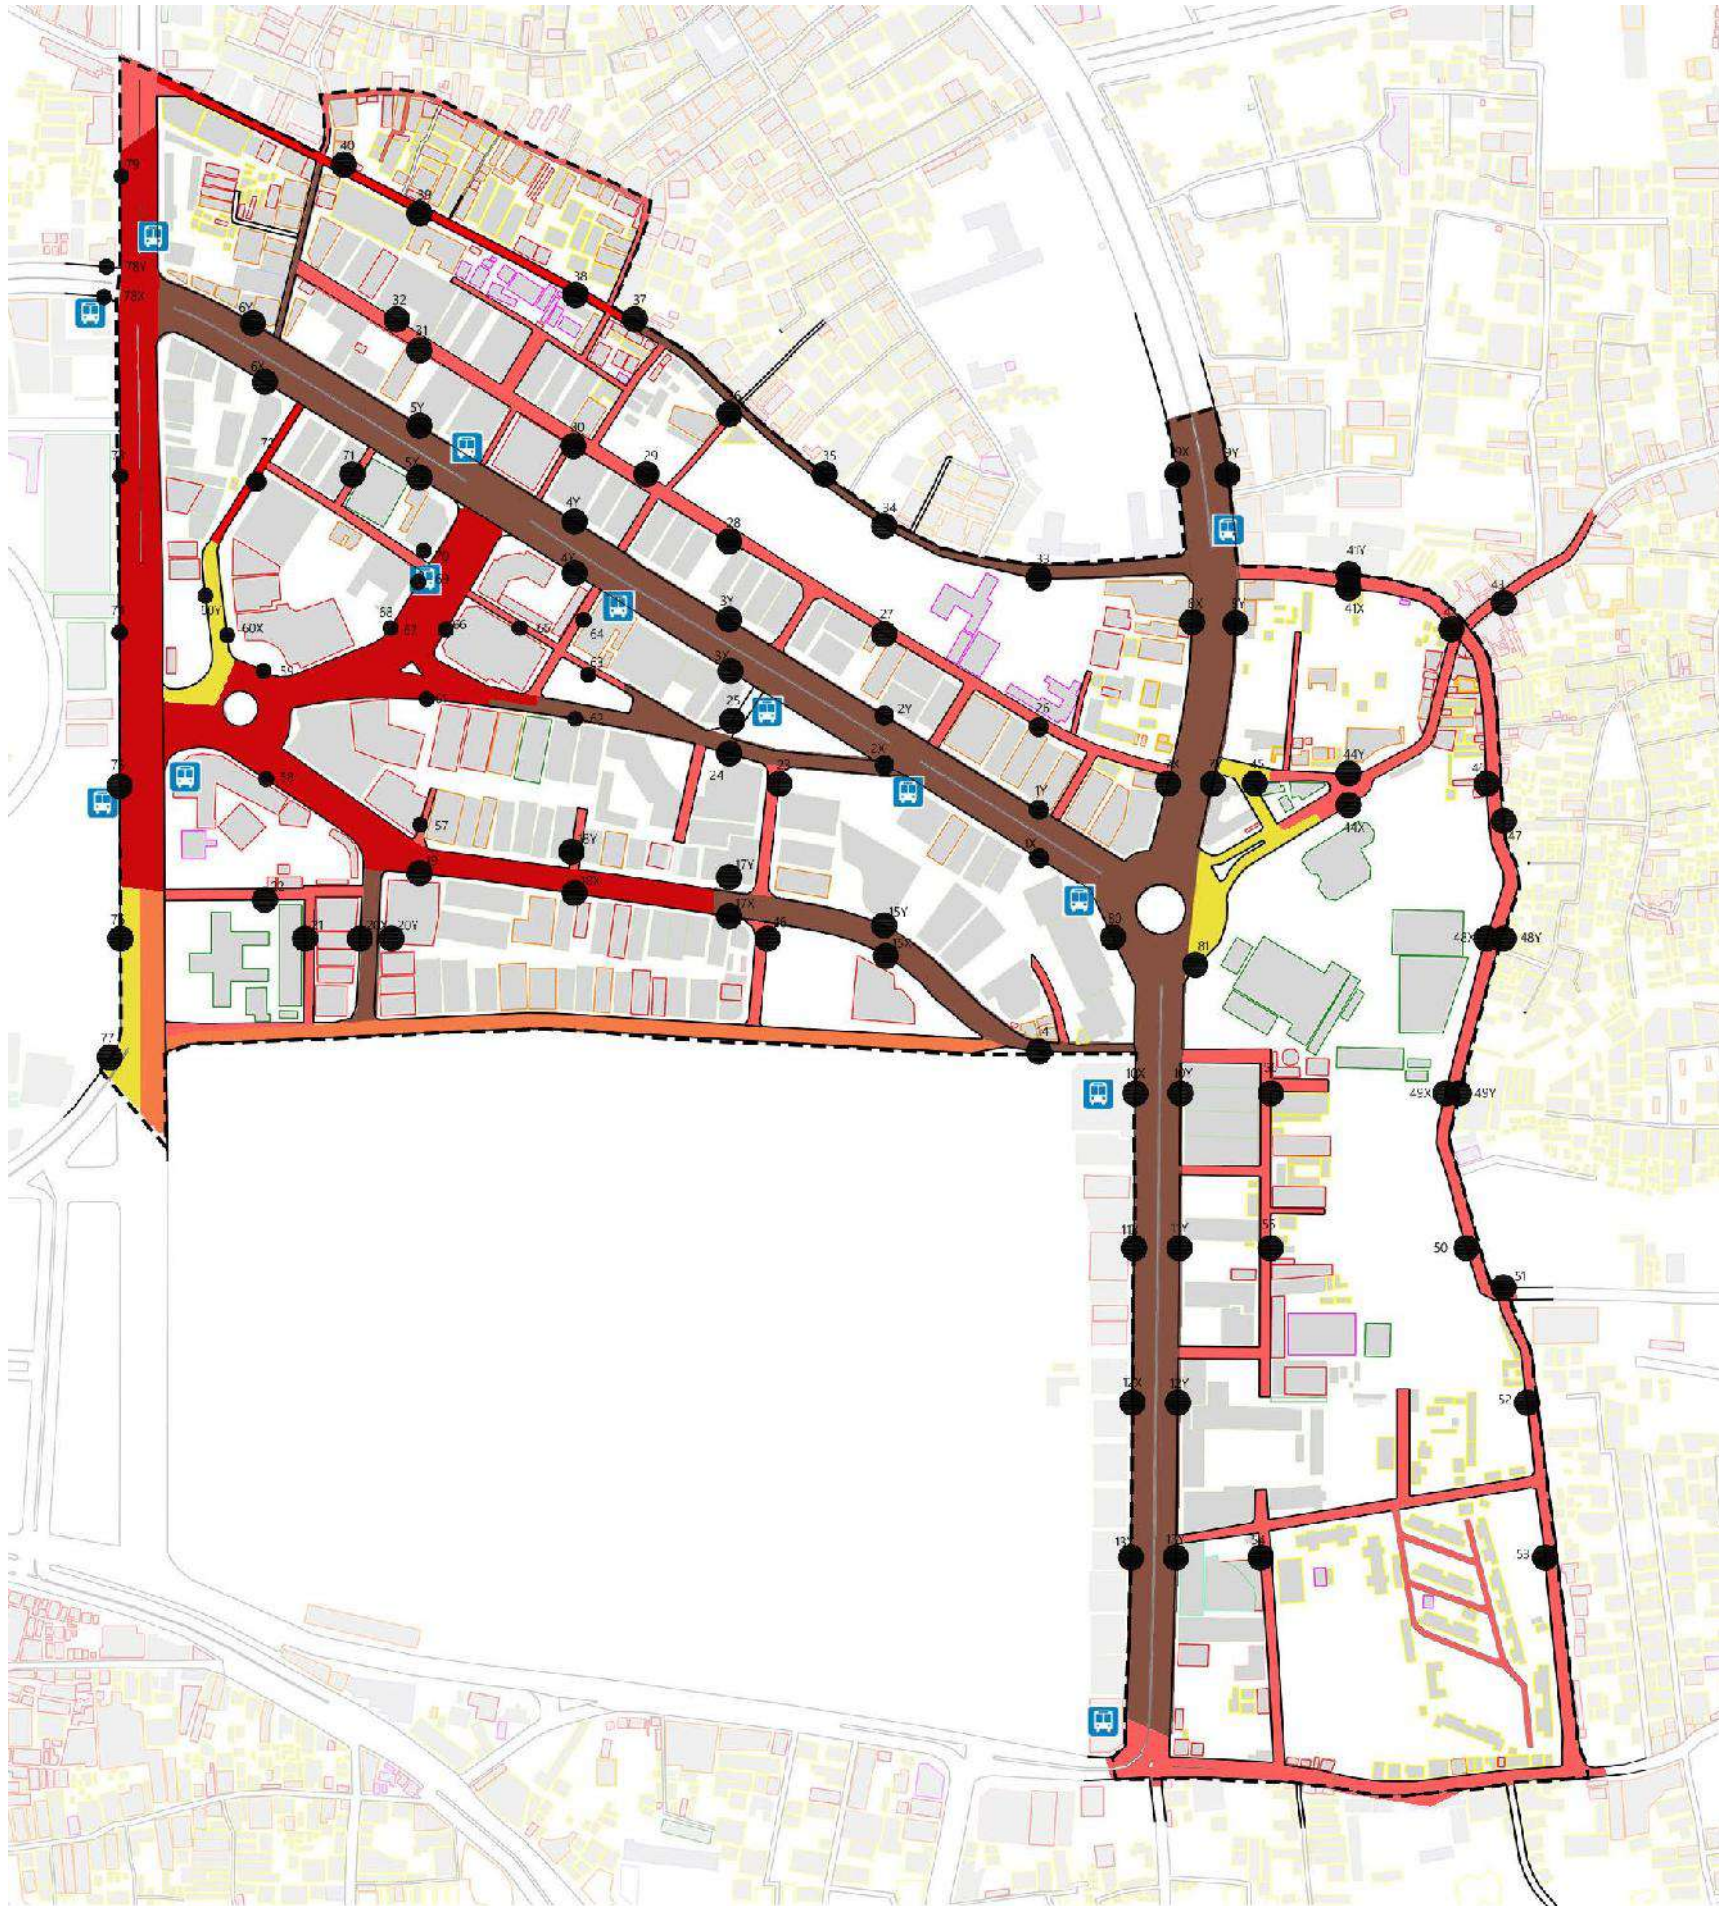
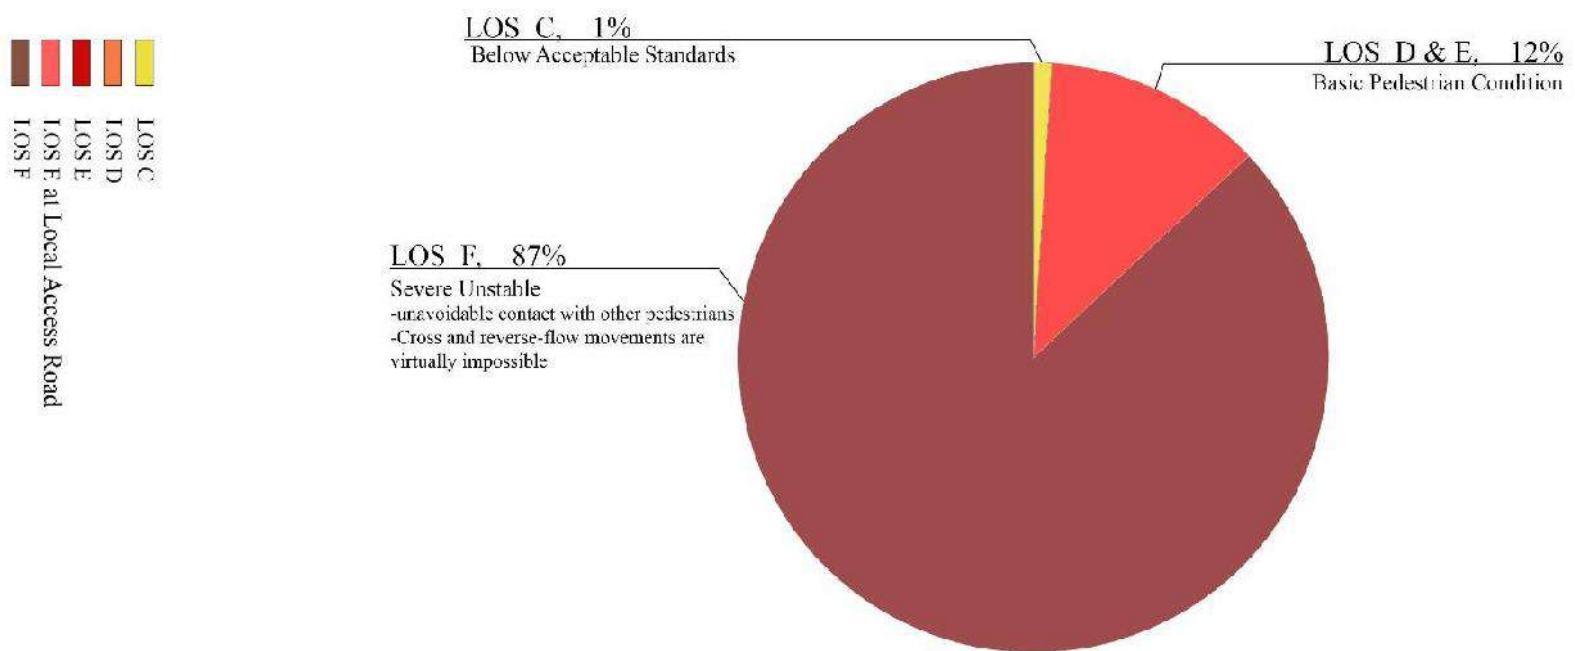
Figure 5.1: Existing Pedestrian Infrastructure according to Level of Service (LOS) (Chapter 04, Figure 4.9)

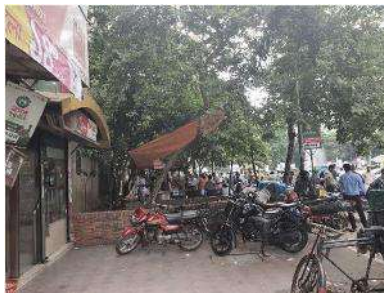
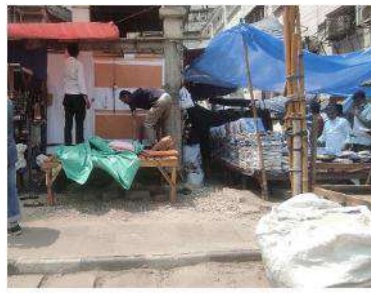
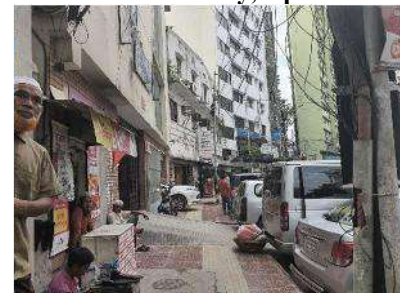
Figure 5.2: Questionnaire Analysis Outcome (Details in Table 4.8)

a. Highly obstructed road

b. Discontinuous sidewalk

c. Absence of green shading

For decoding the public experience, the questionnaire analysis has been categorized into three parts, i.e., Accessibility, Convenience, and Walk appeal features. Accessibility, according to public review, is pathetic because of excess conflict within passenger transfer provoked by massive obstructions. The next concern is the convenience of walkable segments, and the user experiences in connectivity have been rated 76% poor. Observation also entails that no marked pedestrian crossing exists in the CBD area, which creates discomfort for most users to travel by walking. The data from Table 4.8 of Chapter 4 regarding public encounters are shown in Figure 5.2. Finally, 30% of the user demand prioritizes the unobstructed walkable space while

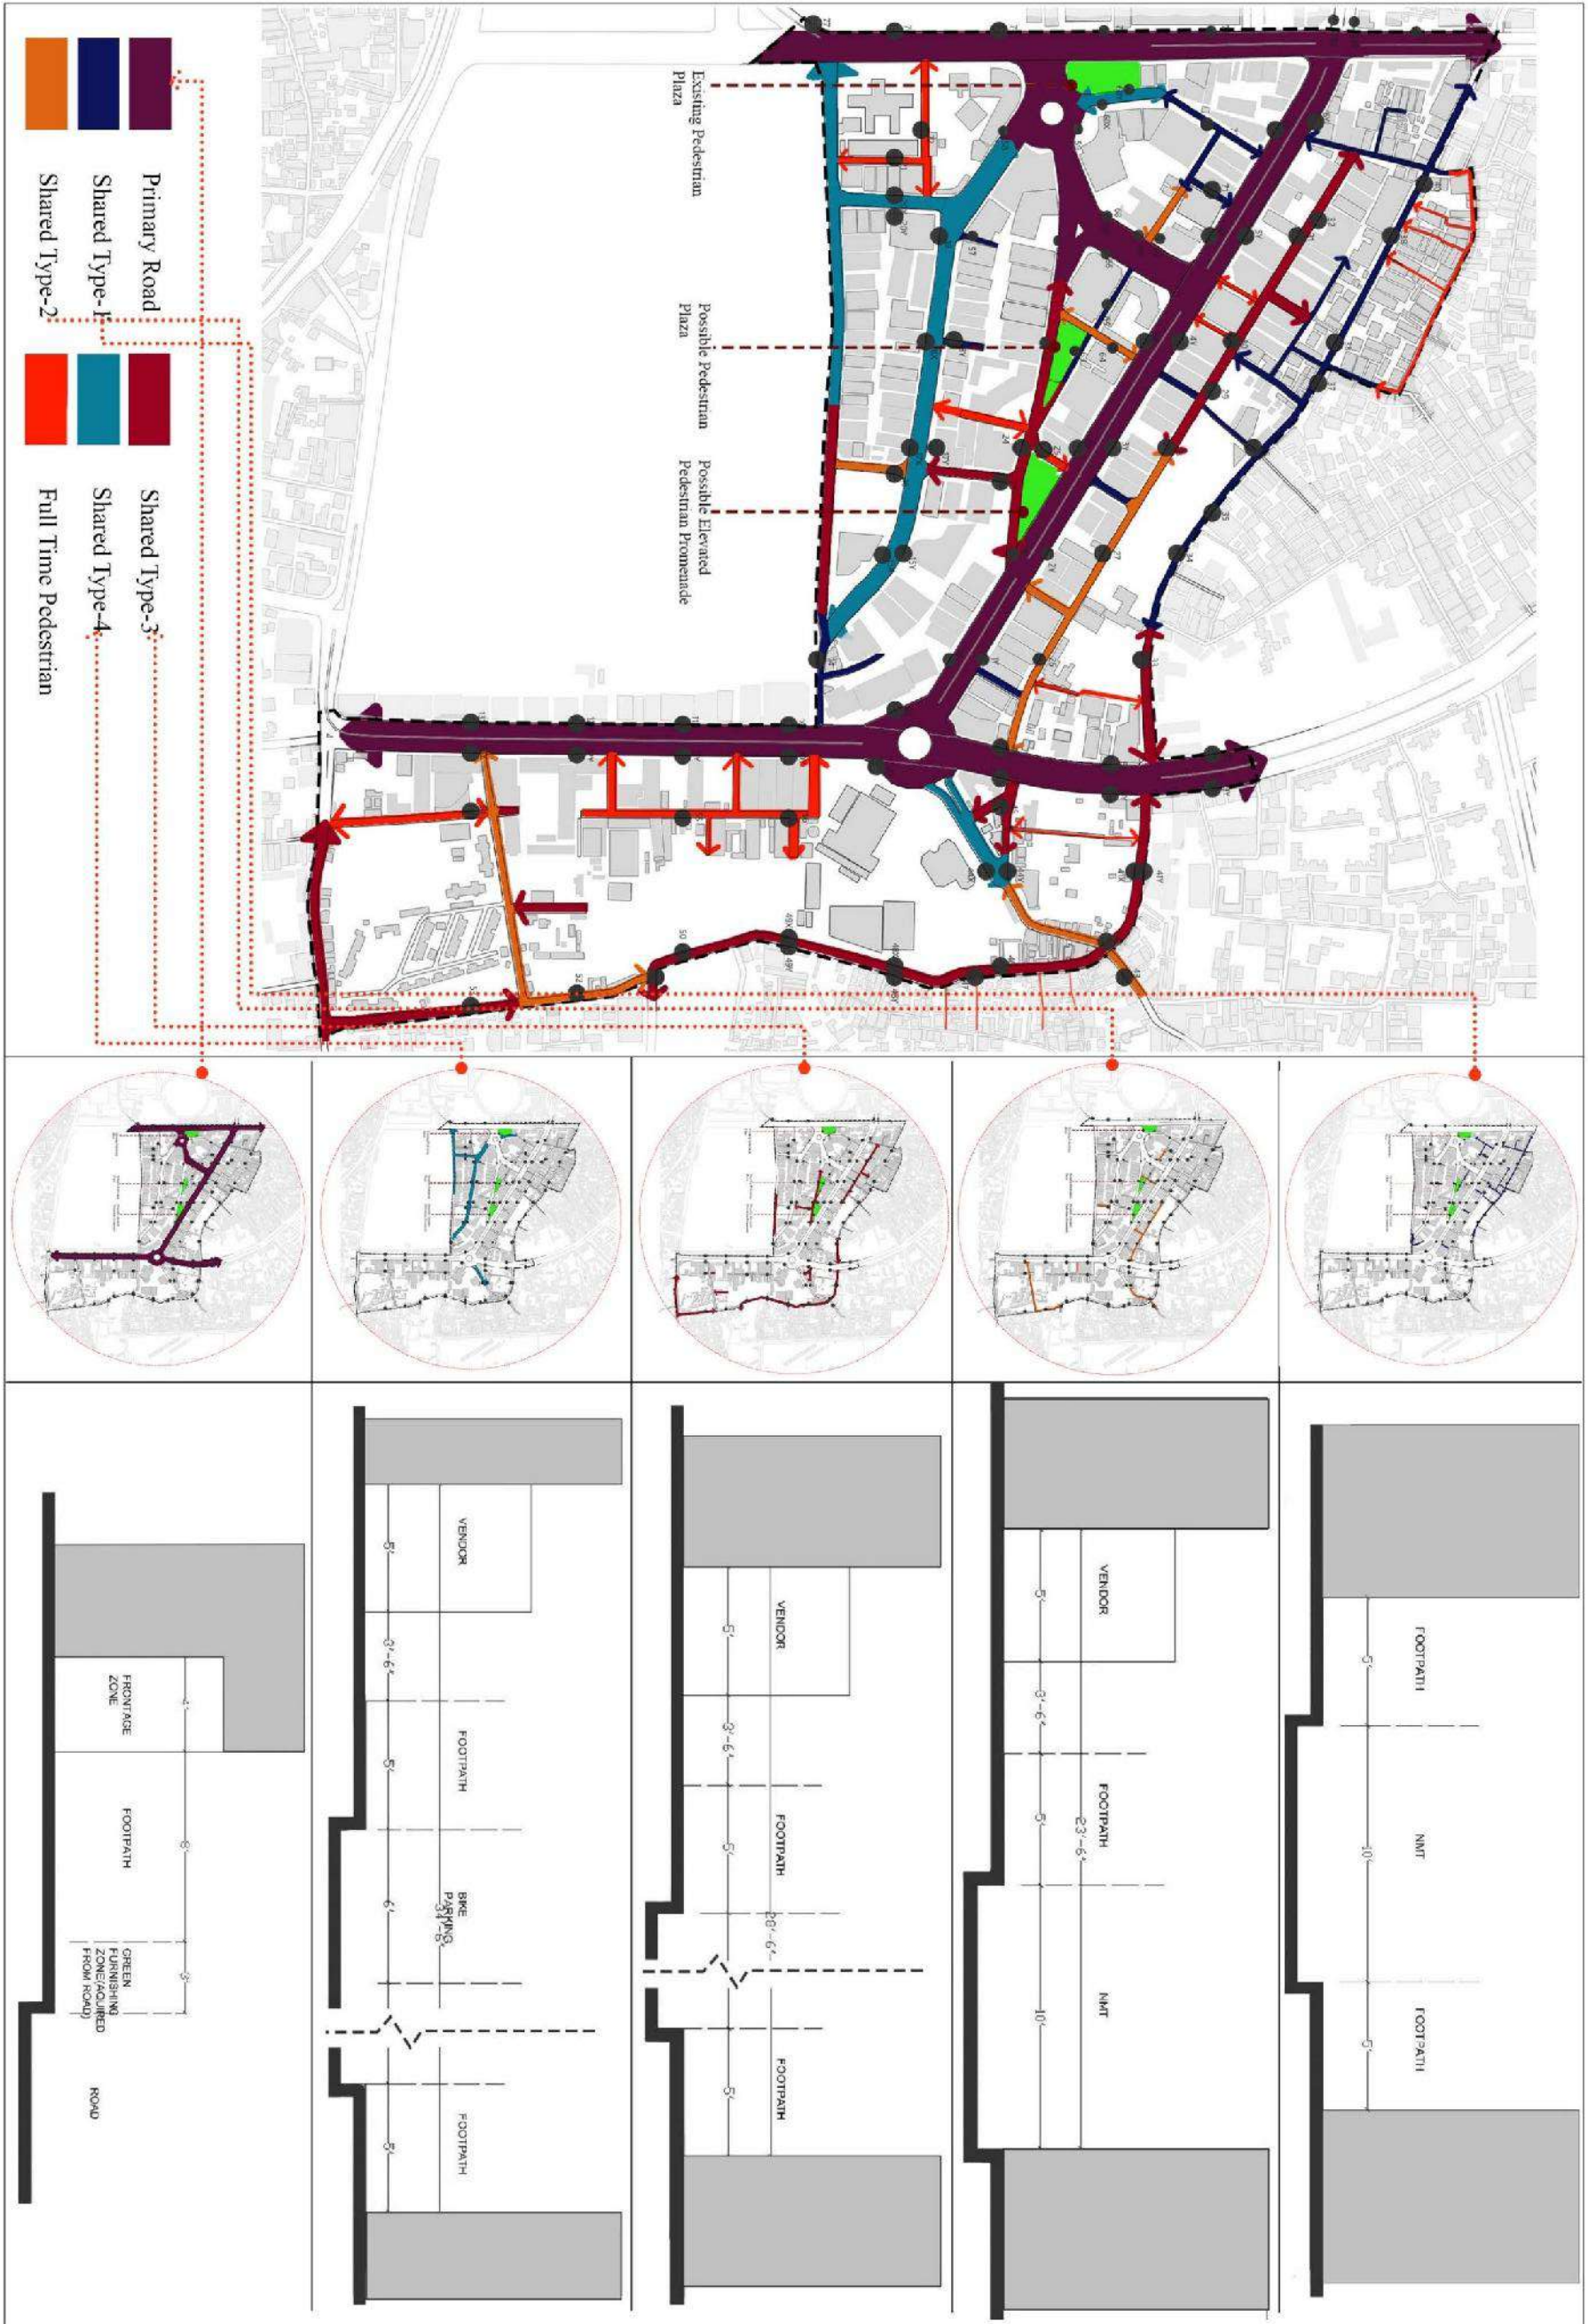
Figure 6.2: Applicable Street Segments for Specific Recommendations

- Conflict Free Walkable Space (Applicable for 53.54% Primary Road)
- Redirected Pedestrian Flow by Shared Walkable for Better Connectivity (Applicable for 33.34% Local Access Road)
- Existing Fulltime Walkable Network
- New Interventions for Fulltime Walkable Network
