STUDY OF FAILURE OF REINFORCED CONCRETE

HIGHWAY BRIDGES IN EAST PAKISTAN

A
THESIS

JANUARY, 1967

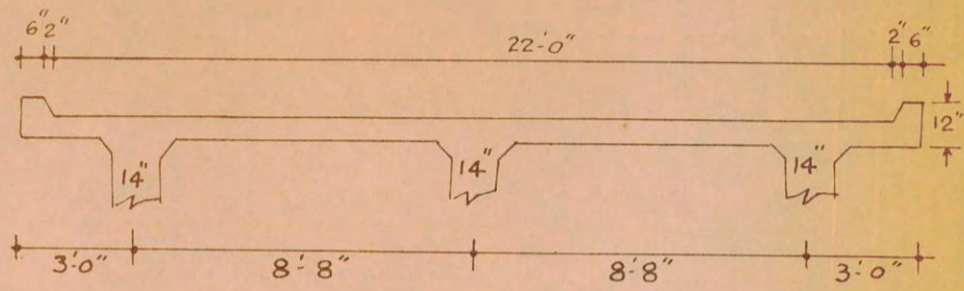
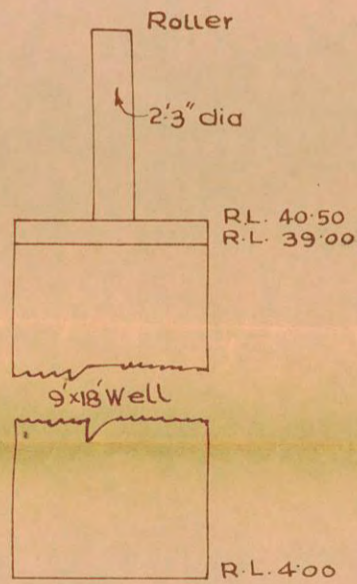
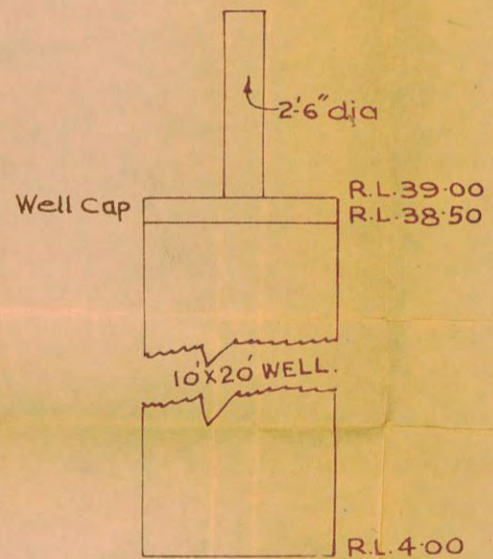
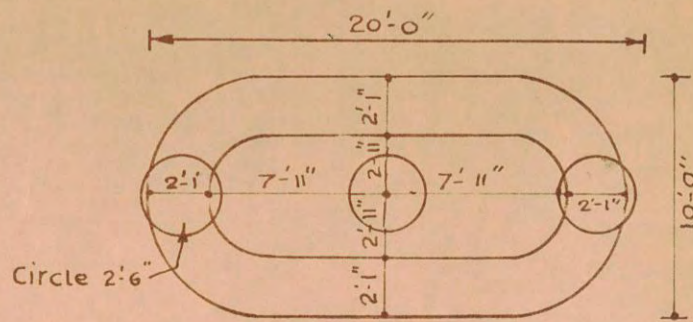
FIG. NO. 2.1

This is a balanced cantilever two-lane highway bridge of total length 348 ft. ; the suspended span is at the middle. The piers rest on well foundation (fig.2.1).

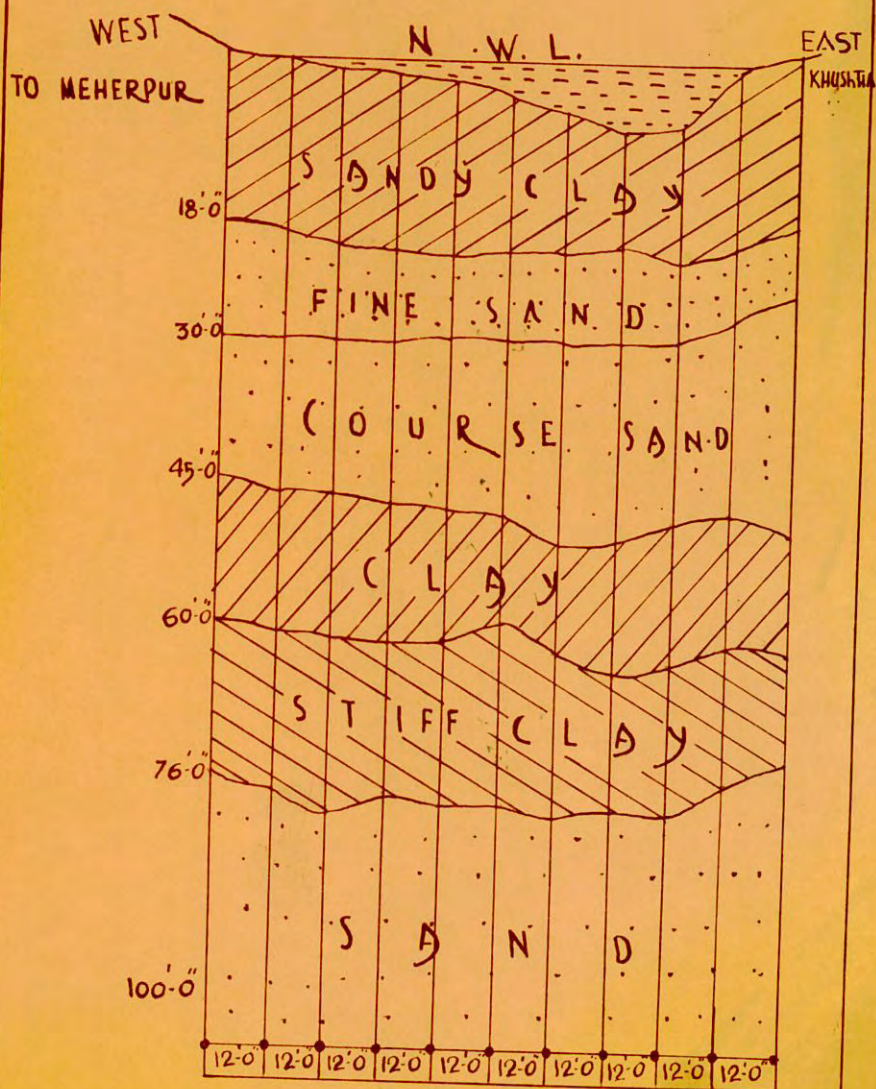
FIG. 2.3

b) The soil boring data were collected (Fig. 2.3). The test boring shows the different strata of soil encountered at different depths. The depth of the well of the second pier below the river bed was $42'-0''$ indicating that the well rested on coarse sand (11).

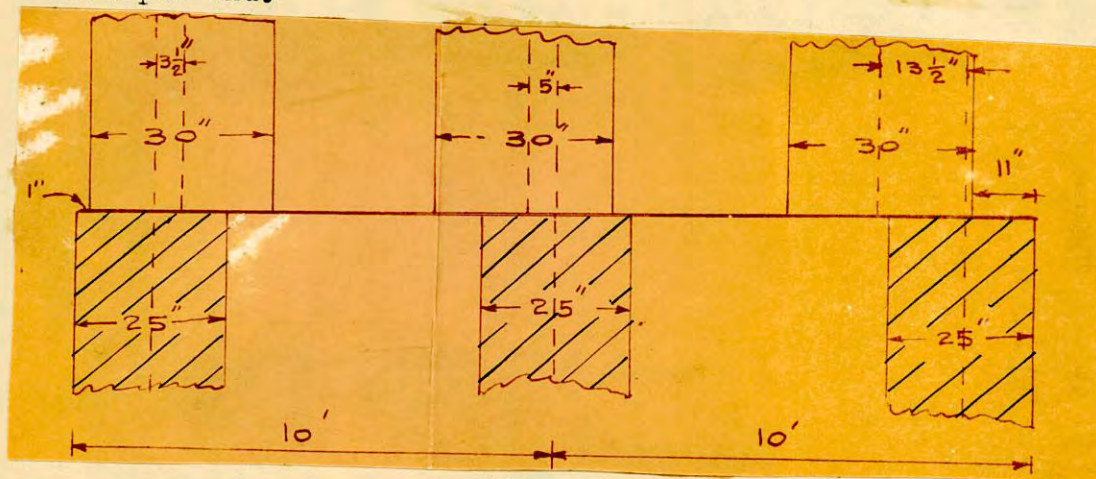
3) From an examination of the position of well No. 2 on the Meherpur end it is evident that the downstream end of the downstream column is 1 inch from the end of the well cap and the upstream end of the upstream column is 11 inches away from the end of the well cap. So the eccentricity in the position of the middle column is 5".

On the Kushtia side the well and well cap that failed have broken and the columns have been displaced; it may be said that the eccentricity of the middle column with respect to the centreline of the middle wall was 5 inches as in the Meherpur end.

4) This eccentricity in the position of the middle column produced a stress of 15 tons/sft. in the brickwork of the midsteining wall and put the well-cap in bending.

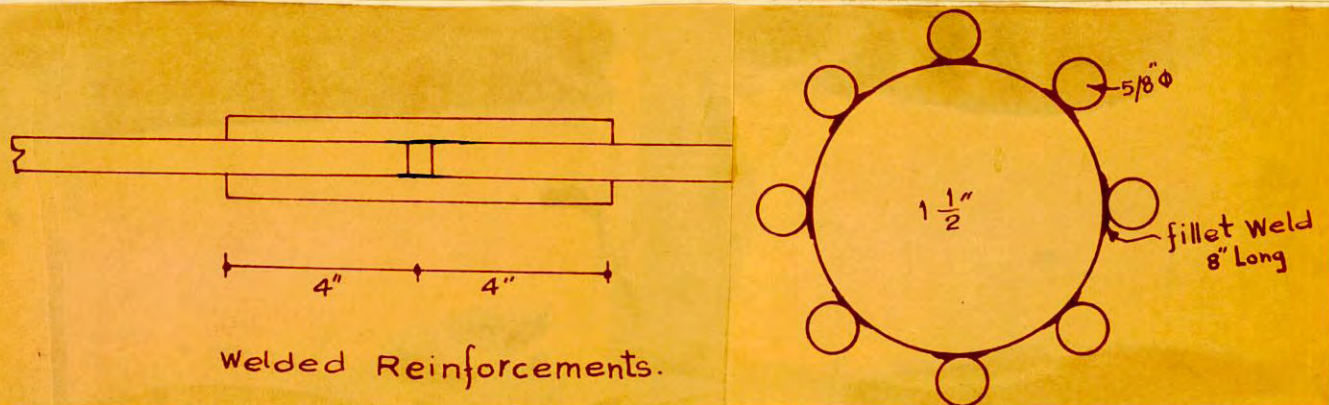
The bars used as reinforcements were $1\frac{1}{2}$ " dia. Eight $\frac{5}{8}$ " dia. rods were welded with these bars for jointing(12).

The exact location of welded joints could not be obtained. The effective diameter of bars at welded joint failure to $1\frac{1}{2} + 2 \times \frac{5}{8} = 2\frac{3}{4}$ ". All the reinforcements were welded at one section. This resulted in reduction of concrete round the reinforcements thereby weakening the portion of the structure to bond stresses. Horizontal cracks along the longitudinal reinforcement indicate bond failure.

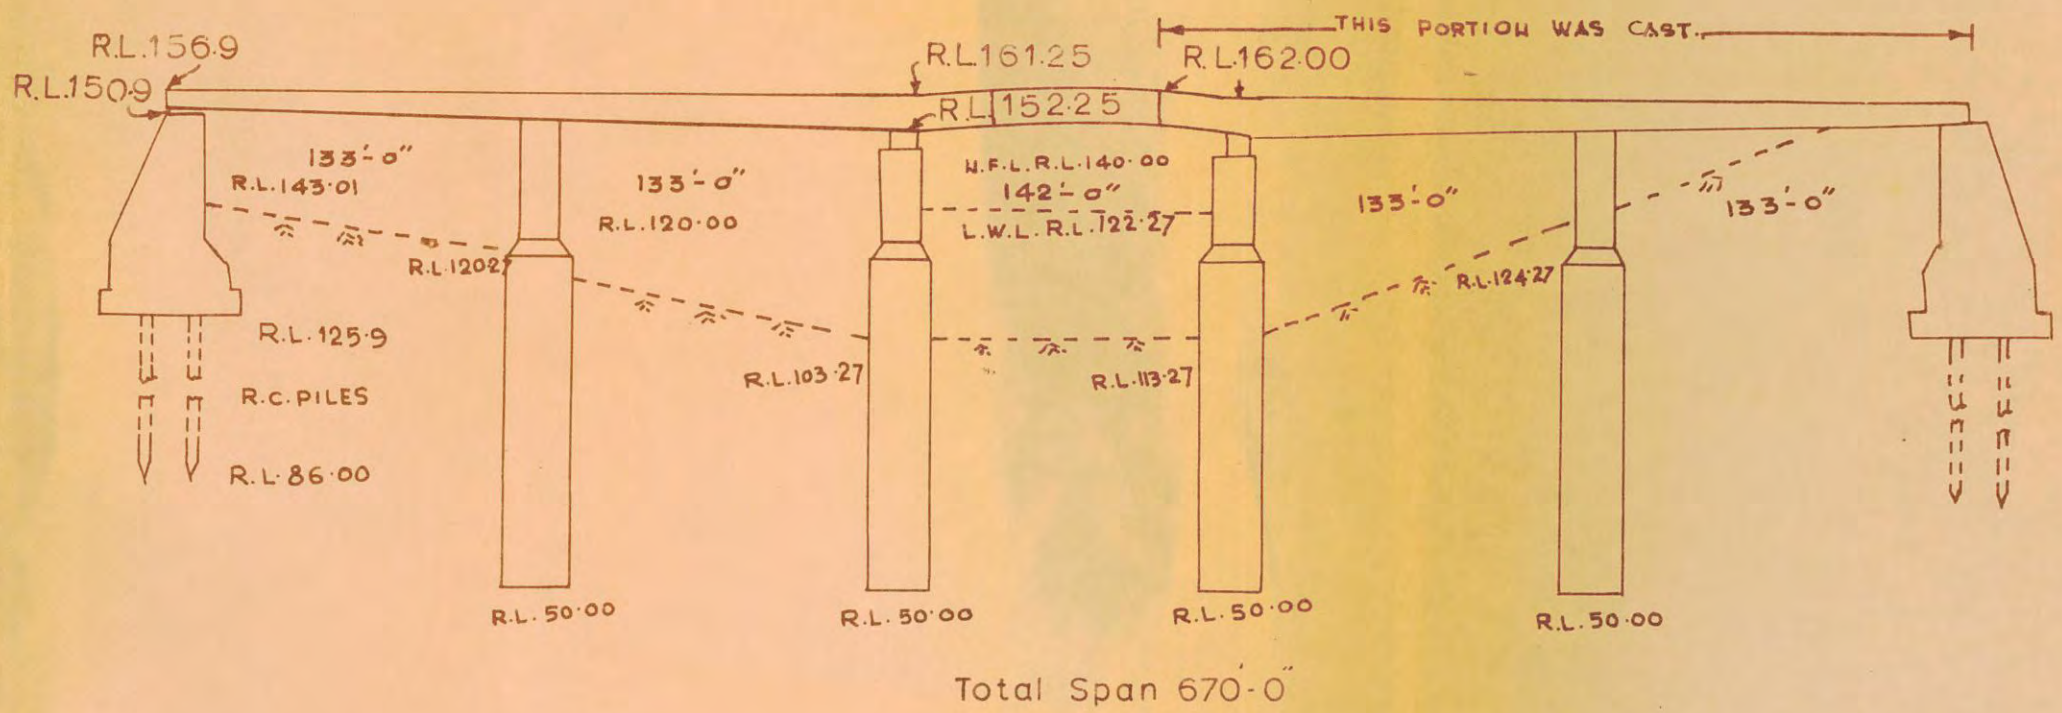
FIG. NO 4.1

It is a balanced cantilever type bridge having the suspended span at the middle (Fig. 4.1). The abutments rest on R.C. piles of 12" x 12" x 40' size and the piers on well foundation of depth 50'-0" (Fig. 4.1).

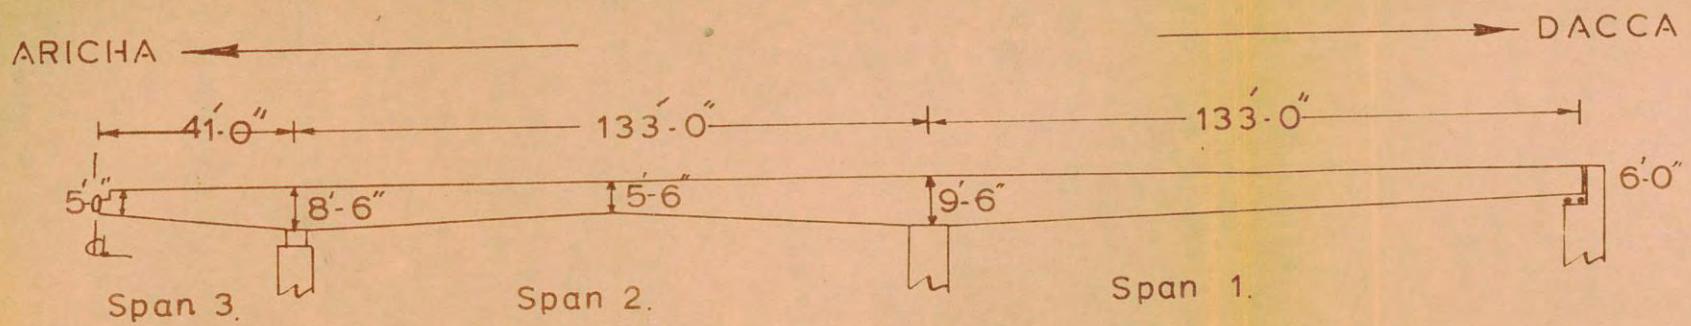
Stages of failure of Mirpur Bridge Girder

Foundation of the bridge was complete, abutments and piers were erected and were ready to receive the superstructure. The casting of superstructure was planned in two stages - the casting of the girder ribs at the first stage and that of the slab at the second stage. About the time when the casting of the girder ribs were completed, it was noticed that the form-work for the girder deflected laterally due to incorrect and insufficient propping and the work had to be stopped. Subsequently, the salballah props were worn out and damaged causing the spans to sag. It was apprehended that the girder would fall and block the waterway. The girders were, therefore, dismantled slowly by cutting concrete to small fragments.

Stage 1-as originally constructed : only girder ribs cast.

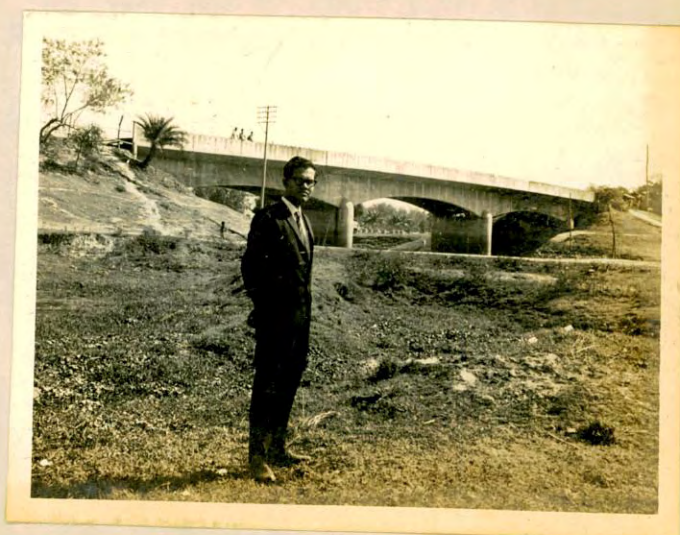
This is a R.C. two-lane highway bridge. The main span is rigid frame (plate 5.1). The two-way deck slab rests on two main longitudinal girders and a number of suitably spaced cross-girders. The deck slab is continuous as cantilevered sidewalk on both sides. The piers rest on wells in the river. The pier has a multiple hollow section with rounded ends(Fig.A in Appendix).

Plate 5.1 Tongi Bridge
(The general view showing the spans, girders, etc)

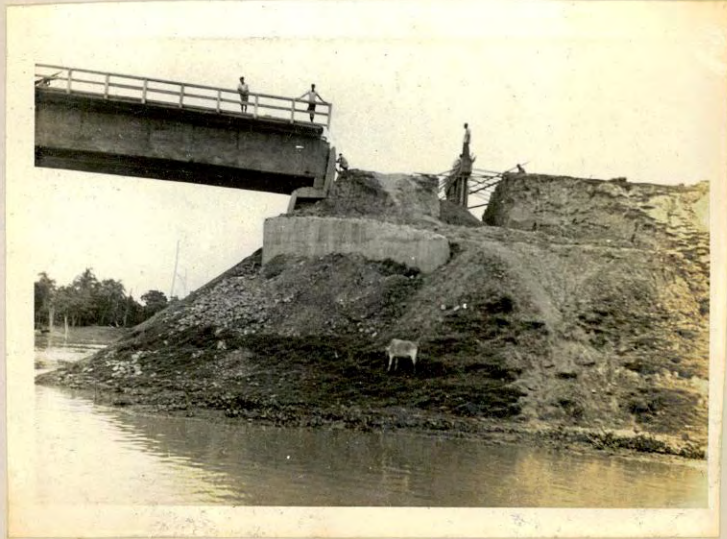
Plate 6.1. A Bhangaghat Bridge
(Extra shore-span under construction)

In order to release the load on the heel, the abutments were converted into piers by adding two 20' shore spans on the two sides (plate 6.1.A). The overburden on the heel was
